STATE OF
COLORADO

Inspections Complete PBSC and WF

COLORADO
Division of Reclamation,
Mining and Safety
Department of Natural Resources

Permit Number: C2009087 Mine Name: Sage Creek Operator Address: Peabody Sage Creek Mining LLC Ms. Miranda Kawcak 29515 Routt County Road No. 27 Oak Creek, CO 80467	County: Routt Operation Type: Surface Permit Status: Permanent Cessation Ownership: Private Operator Representative Present: Mike Howard
Operator Representative Signature: (Field Issuance Only) This report was issued electronically from the Divisions' Denver Office.

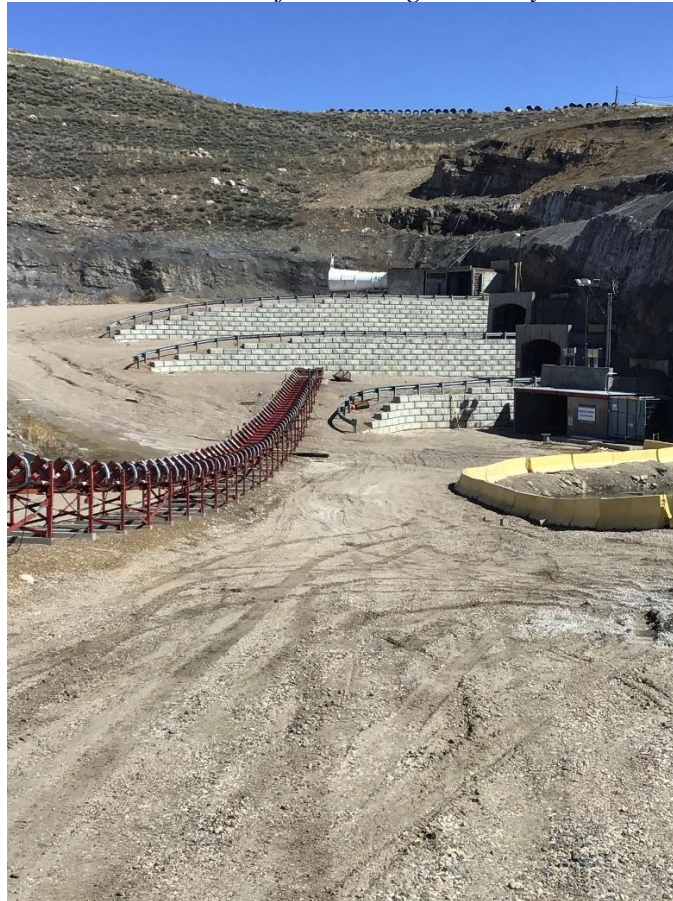
Photo 2: Portal Area.

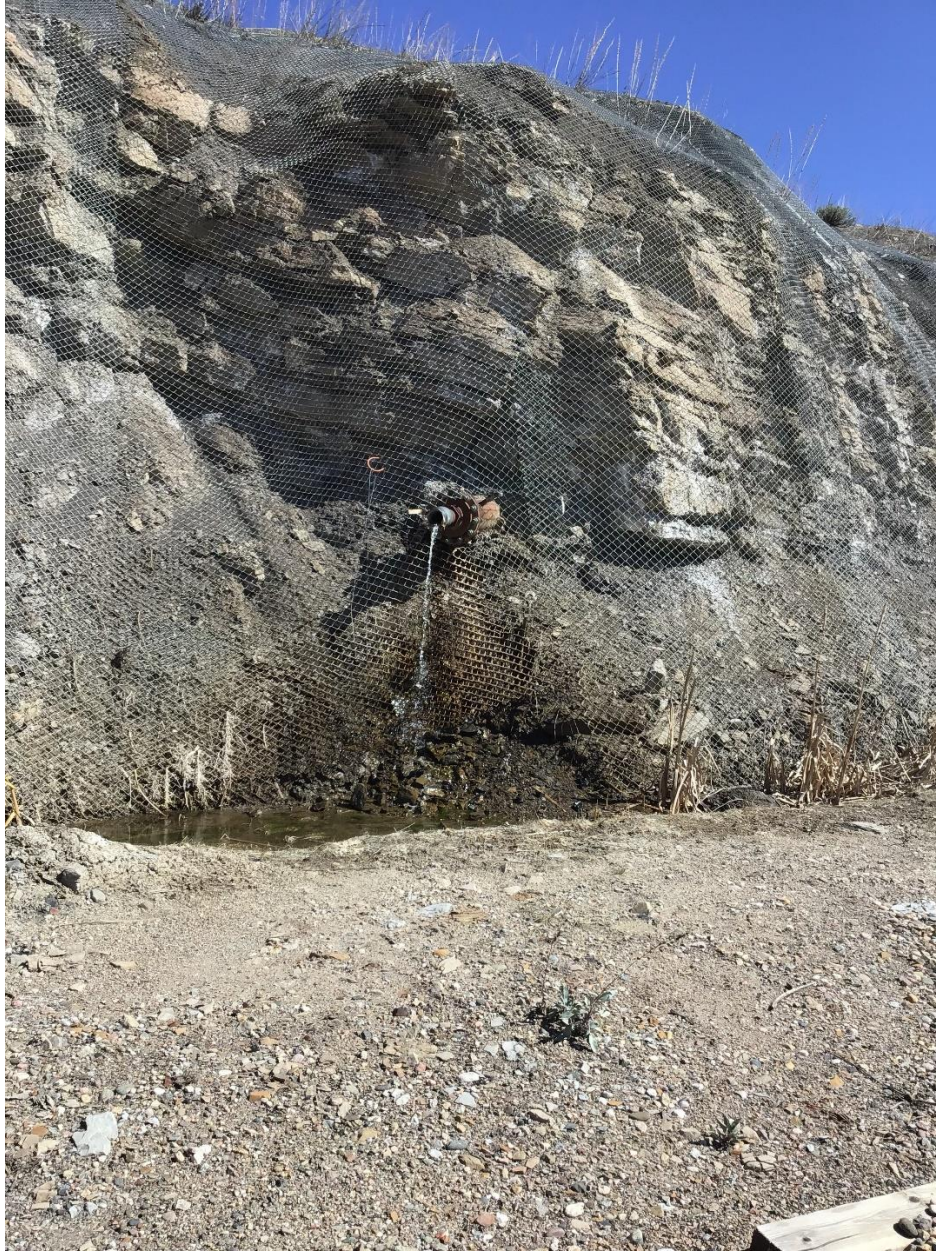
At the portal there is a spoil spring draining into a ditch through a French drain. The north cliffwall above the ditch seeps water. Not all drainage from the cliffwall and the drain is contained in the ditch as it travels down the ditch to a sump. The ditch requires clean out of vegetation and deepening to contain the spoil spring discharge.

Photo 3: Spoil Spring at cliff near the portal.

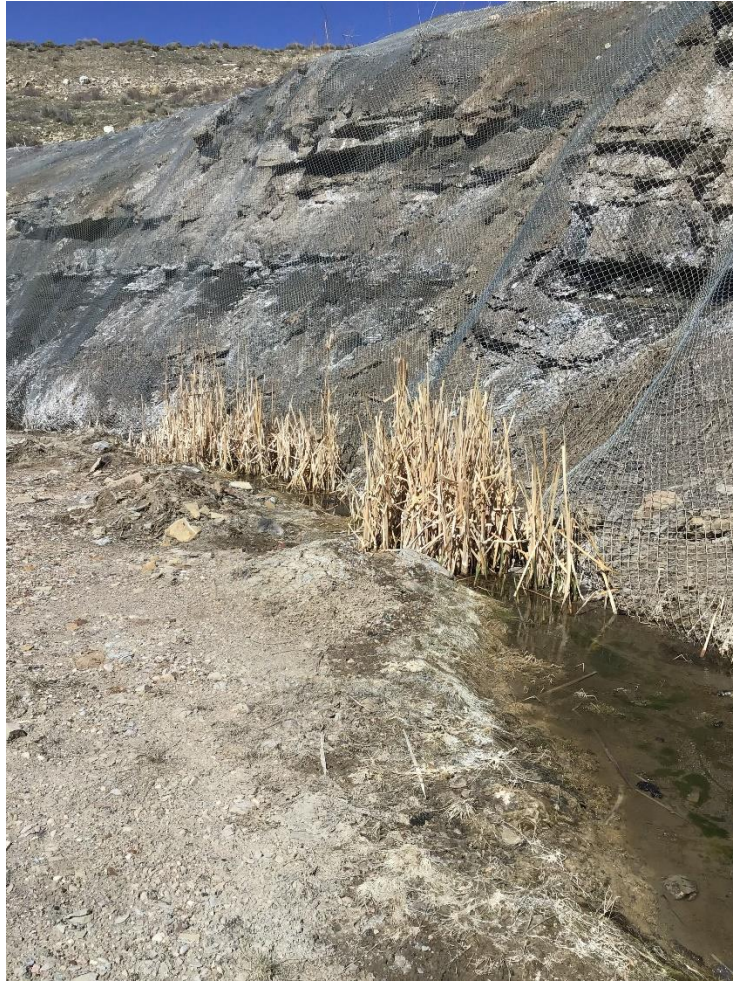
Photo 4: Spoil Spring drainage ditch, flow impeded by cattails.

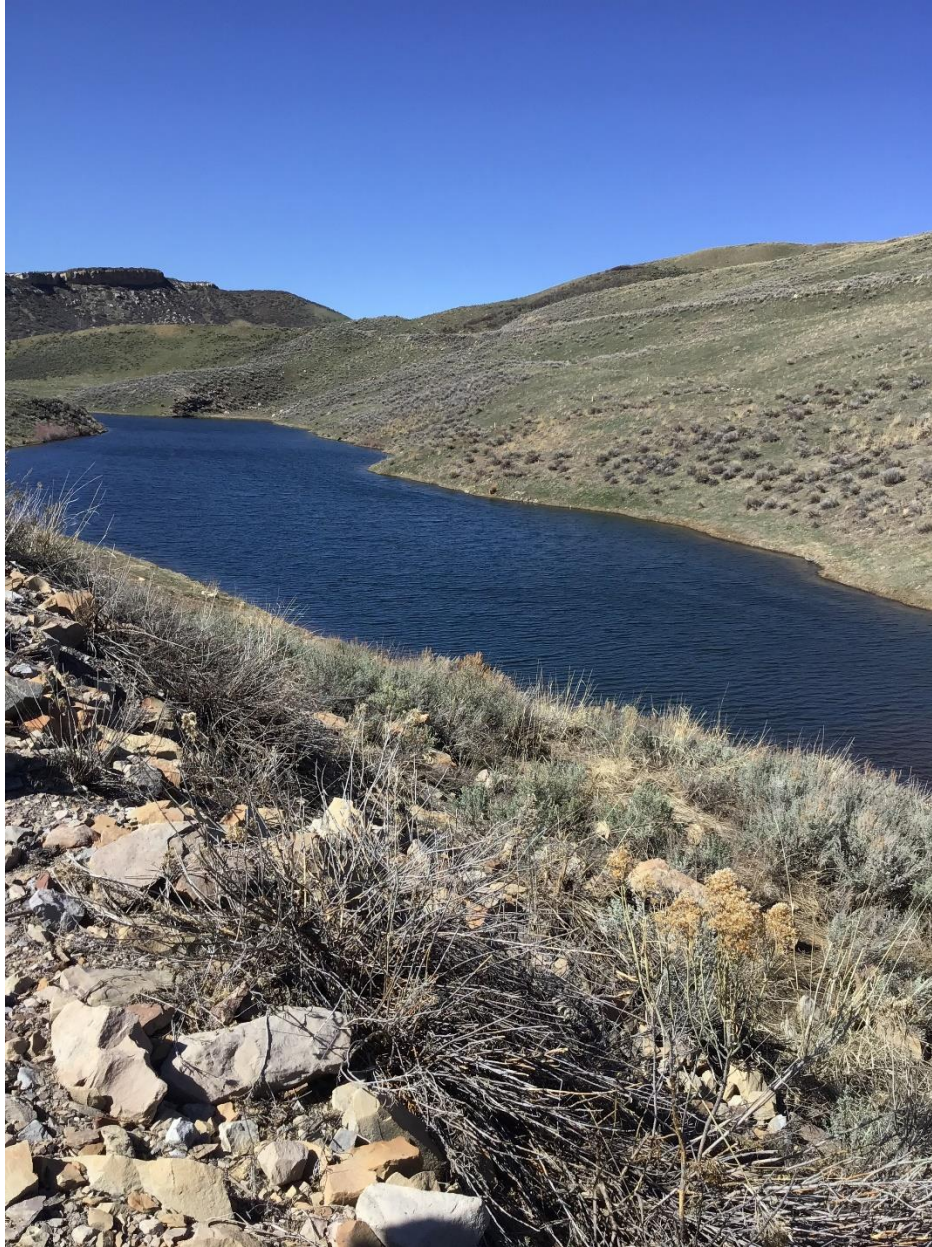
- Pond 2 was discharging clear water.
- A culvert discharges into Pond 2 from the slopes to the north about halfway up the length of the pond. The culvert did not appear to be discharging at the time of inspection.
- A primary settling pond is located above Pond 2 and was discharging. The settling pond dam appears in good repair.
- Pecoco pond is discharging, clear water to the small pond below. The discharge culvert is partially collapsed at the top.
- Pond 3 was discharging clear water.

Photo 5: Pond 2 holding water.

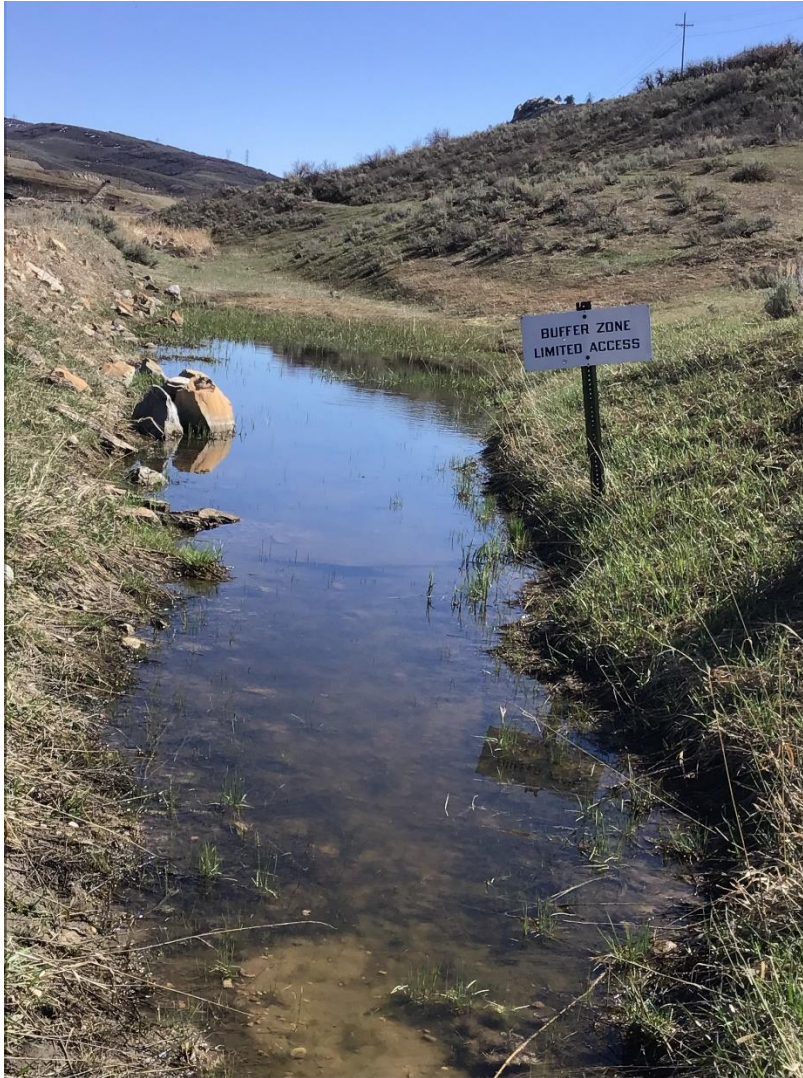
Photo 6: Grassey Creek Stream Buffer Zone marker..

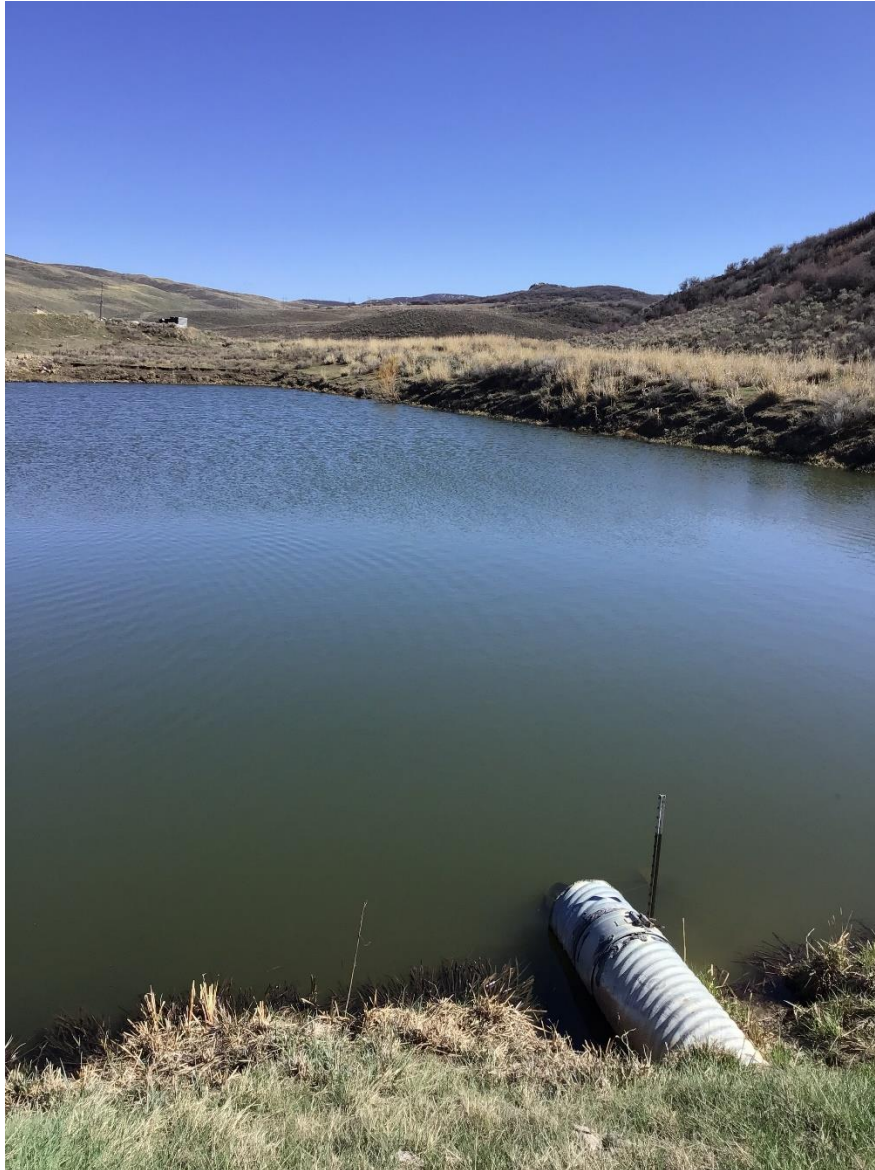
Photo 7: Pond 3 and its discharge culvert looking southeast.

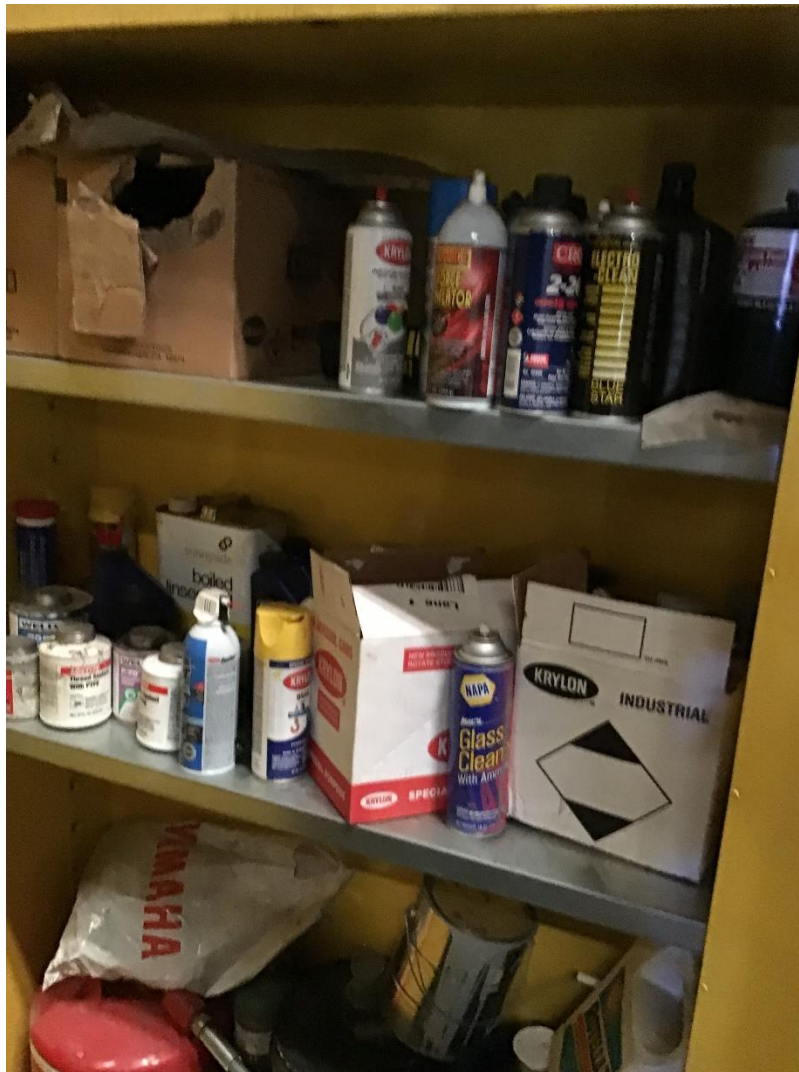
Photo 8: Storage of cleaning and chemical agents.

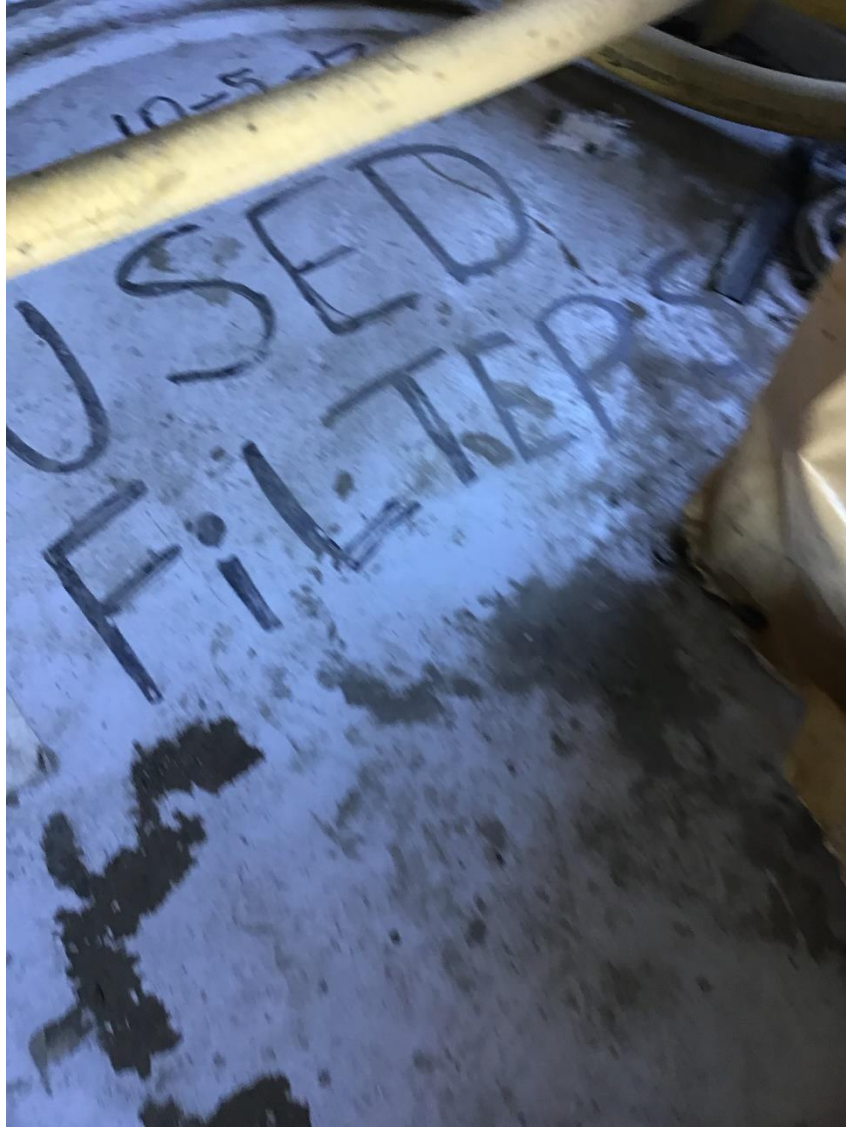
Photo 9: Storage of discarded oil filters.
