COLORADO
 Division of Reclamation,
 Mining and Safety
 Department of Natural Resources

14 April 2025

Permit Number: C-1981-044 Mine Name: Williams Fork Mines Operator: Moffat County Mining, LLC Operator Address: Ms. Miranda Kawcak 29515 Routt County Road #27 Oak Creek, CO 80467	County: Moffat Operation Type: Underground Permit Status: Active Ownership: Private
	Operator Representative Present: Miranda Kawcak
This report was issued electronically from the Divisions' Denver Office.

This was complete inspection of the Williams Fork Mine; permit C1981044, operated by Moffat County Mining LLC. The images were collected and the report prepared by me, Robin Reilley of the DRMS. Miranda Kawcak, Seneca Properties Inc. representative was present throughout the inspection. No hydrologic or air quality issues were detected at the time of inspection. The sky appeared cloudy. The air was calm, and temperatures hovered around 68 degrees Fahrenheit. The site is in reclamation.

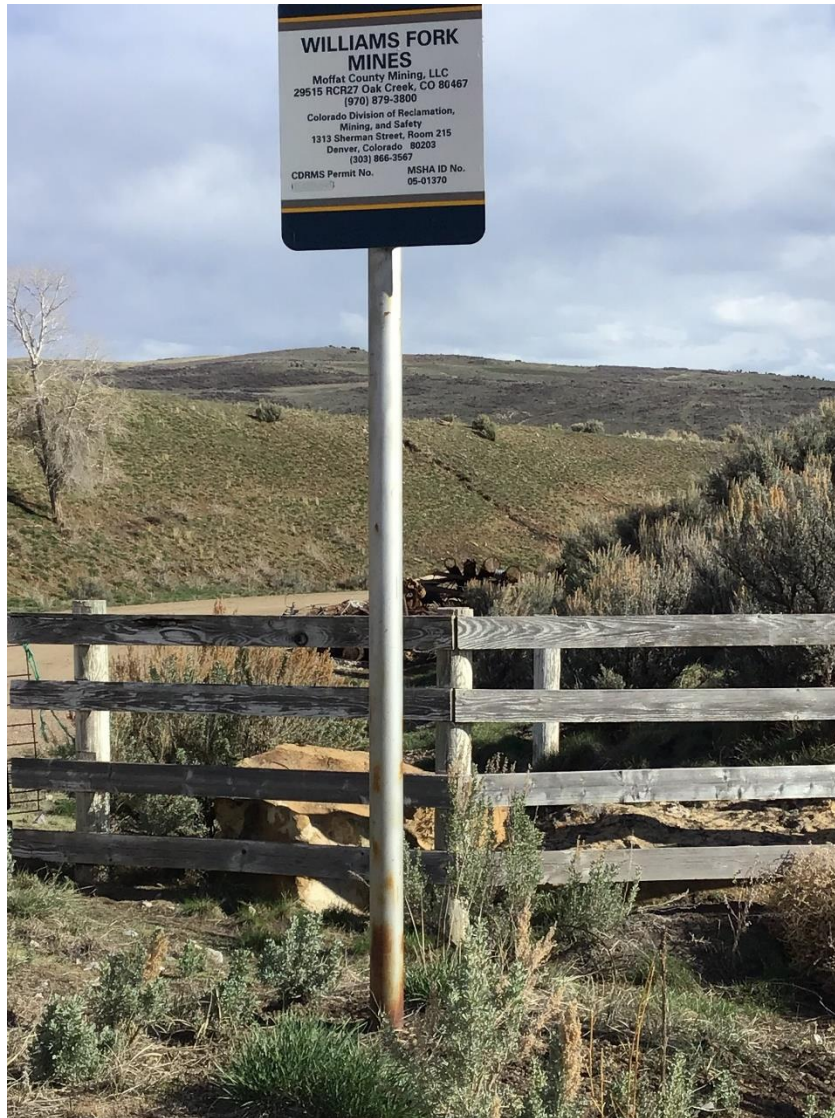
- The mine identification sign was in place at the site entrance. The sign was intact, displaying all required information: mine name, operator name, address, phone number, DRMS permit number and contact information.
- Topsoil piles and ponds are marked with a T-stake.
- Permit boundary markers are in place along the east and north perimeters.

Photo 1: Mine Id sign at the entrance form Highway 13 South.
Overview of the Williams Fork mine site, located on the left of the photo, looking south.

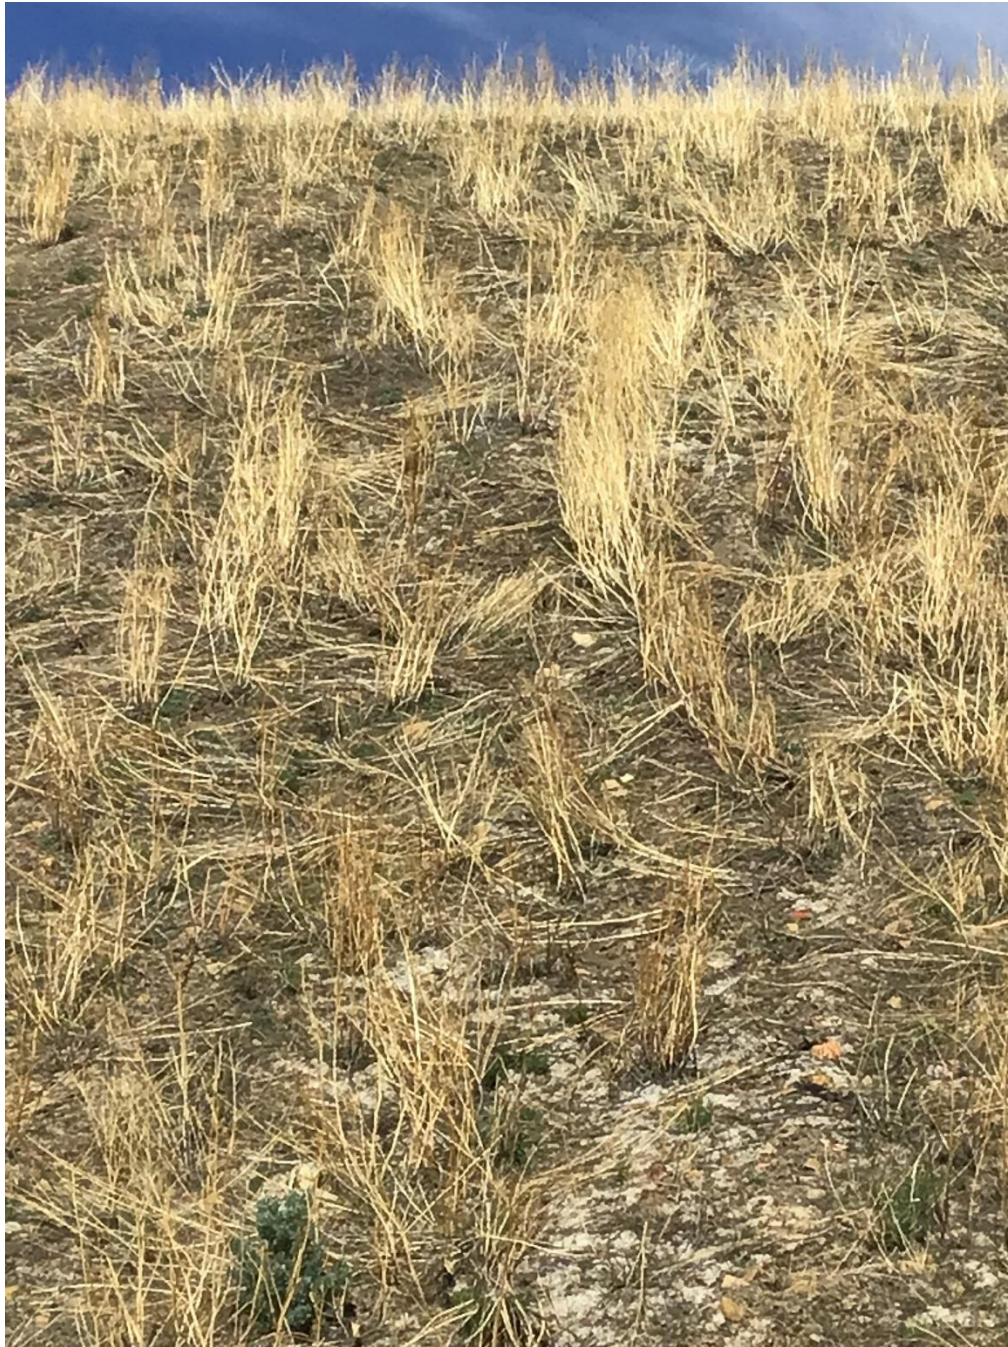
Shrubs on the portal, slopes are coming in well grasses are sparse but beginning to emerge.

- Revegetated areas of reclamation appear stable.
- Portal area exhibits significant shrub establishment.
- Grass is sparse but beginning to emerge.
- Refuse area vegetation appears vigorous with robust grass growth and good grass coverage.

***Photo 2:** Portal slopes exhibiting last season's vegetation stalks and this year's green shrub growth.*

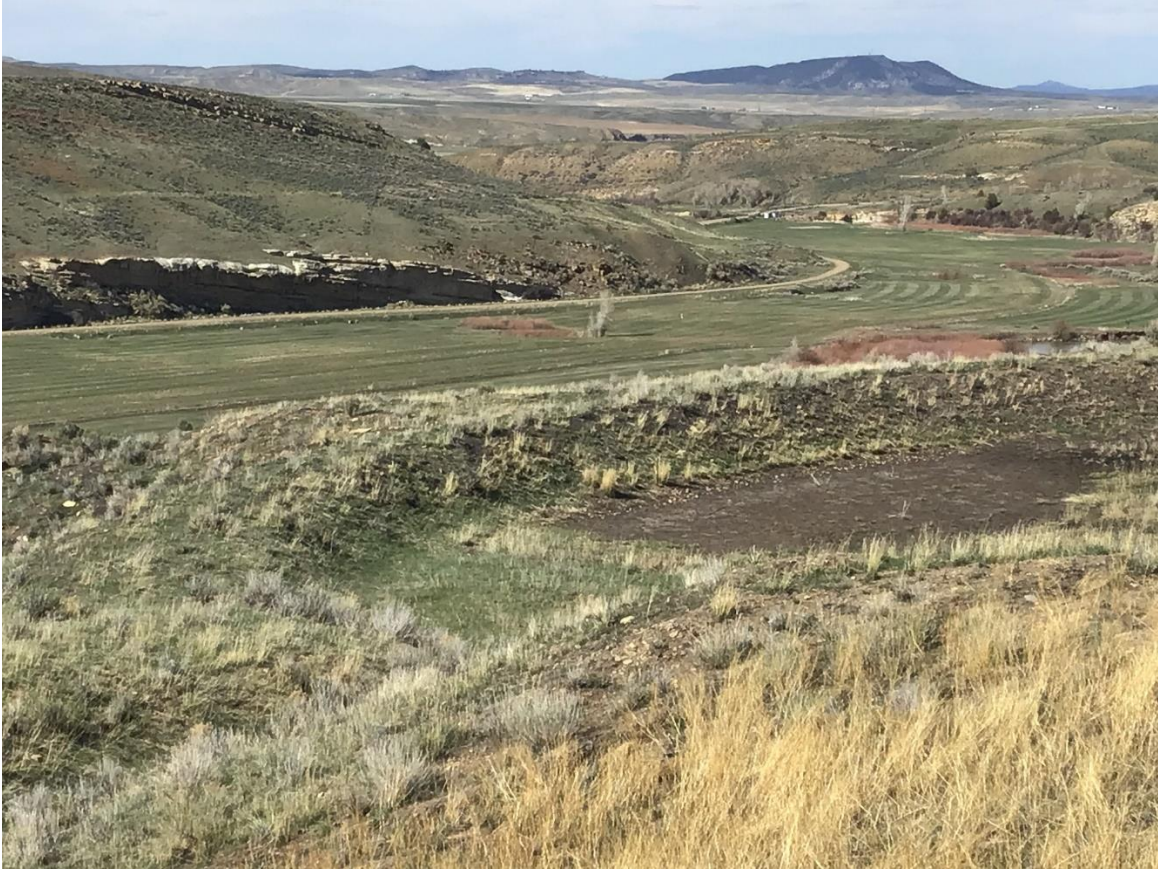
Photo 3: Dry 9A Pond below the portal area with the harrowed cropland area below, looking north.

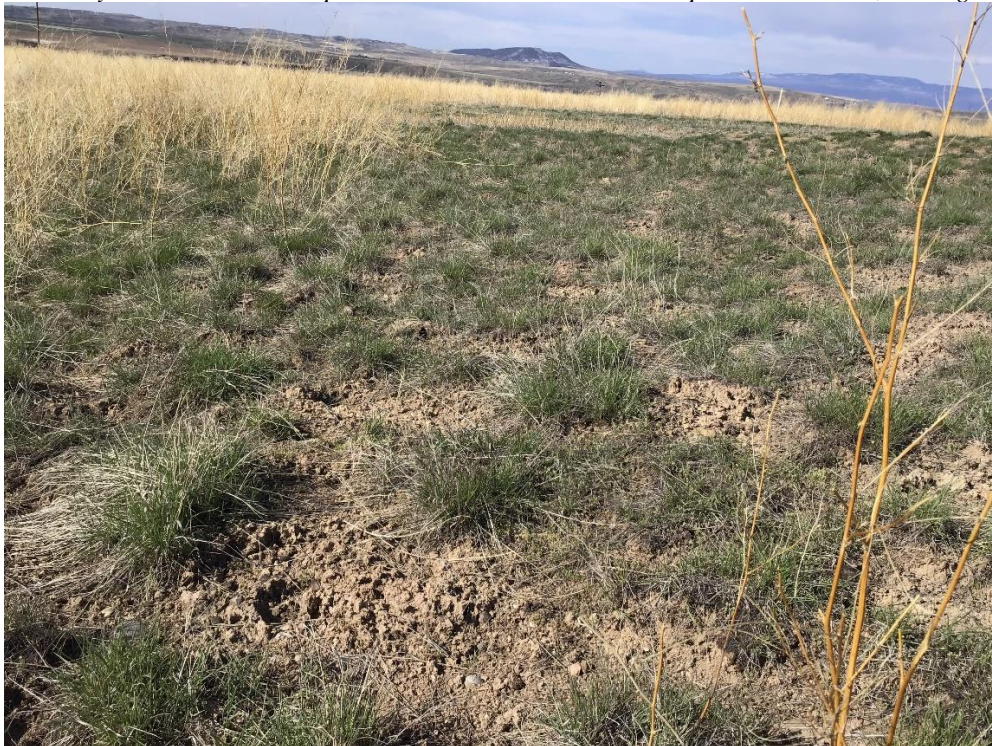
Photo 4: Refuse area grass establishment looking west.

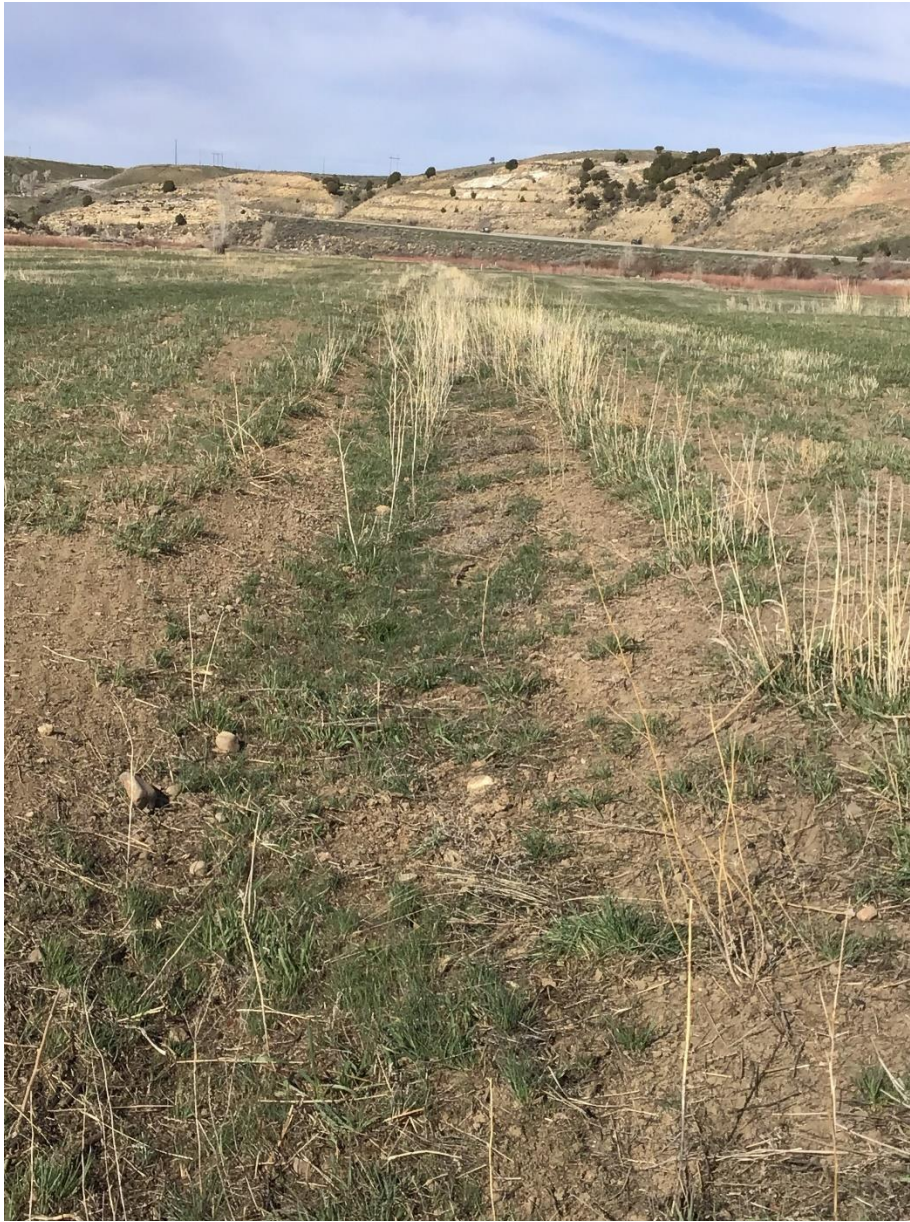
Photo 5: Ditch along eastern edge of the cropland area.

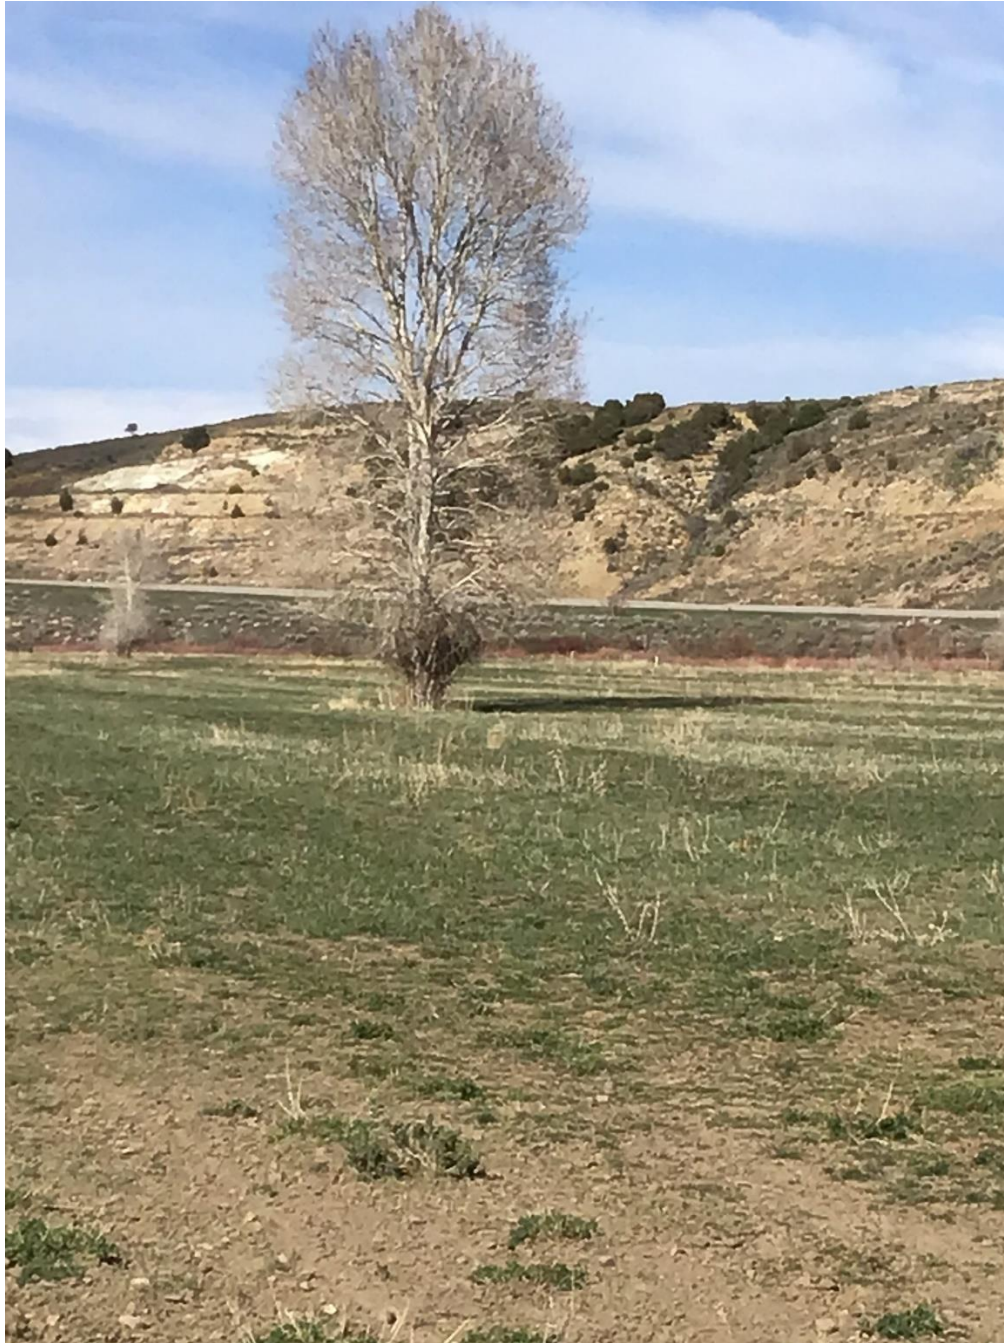
***Photo 6:** Cropland area looking north. A couple of sparsely vegetated patches exist.*
