### MINERALS PROGRAM INSPECTION REPORT

<b>MINE NAME:</b> Buffalo Stone Quarry	<b>MINE/PROSPECTING ID#:</b> M-2007-050	<b>MINERAL:</b> Stone	<b>COUNTY:</b> Las Animas
<b>INSPECTION TYPE:</b> Monitoring	<b>WEATHER:</b> Cloudy	<b>INSP. DATE:</b> March 27, 2025	<b>INSP. TIME:</b> 10:05
<b>OPERATOR:</b> Yocam Stone LLP	<b>OPERATOR REPRESENTATIVE:</b> None	<b>TYPE OF OPERATION:</b> 110c - Construction Limited Impact

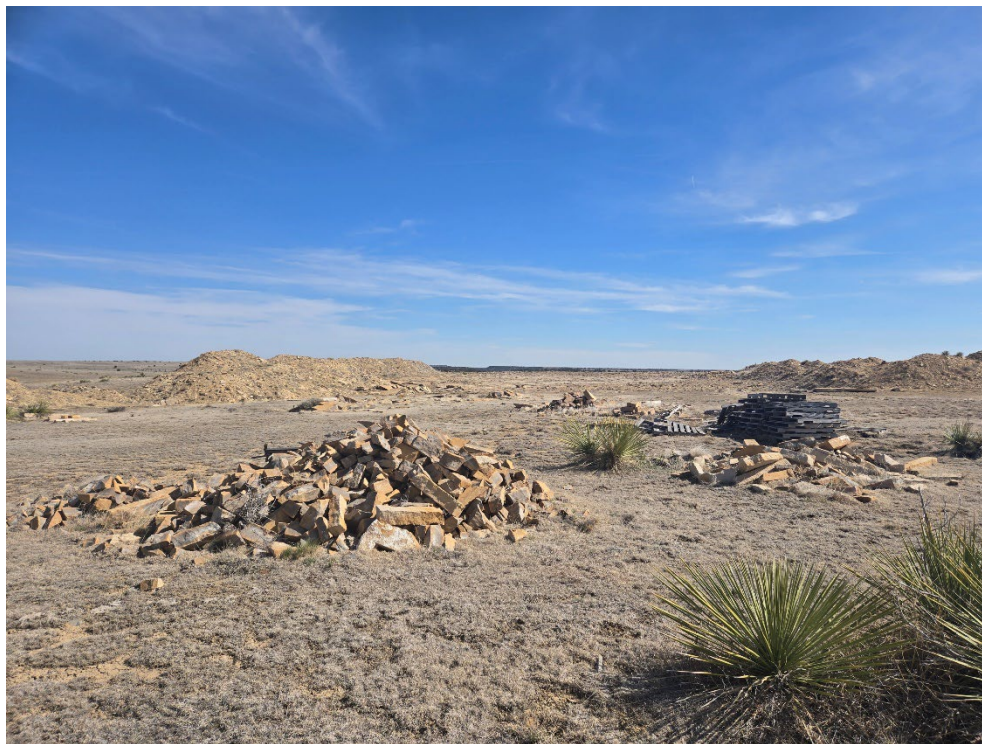
**Photo 1:** Looking east at the main pit area.

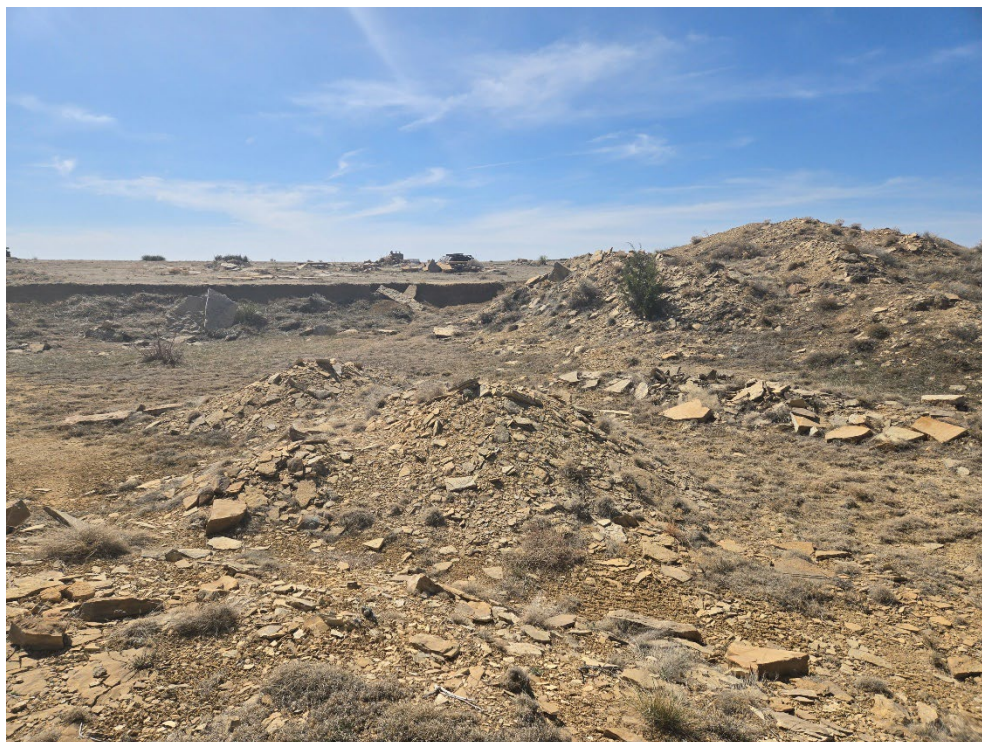
**Photo 2:** Looking west at the small highwall within the pit area.

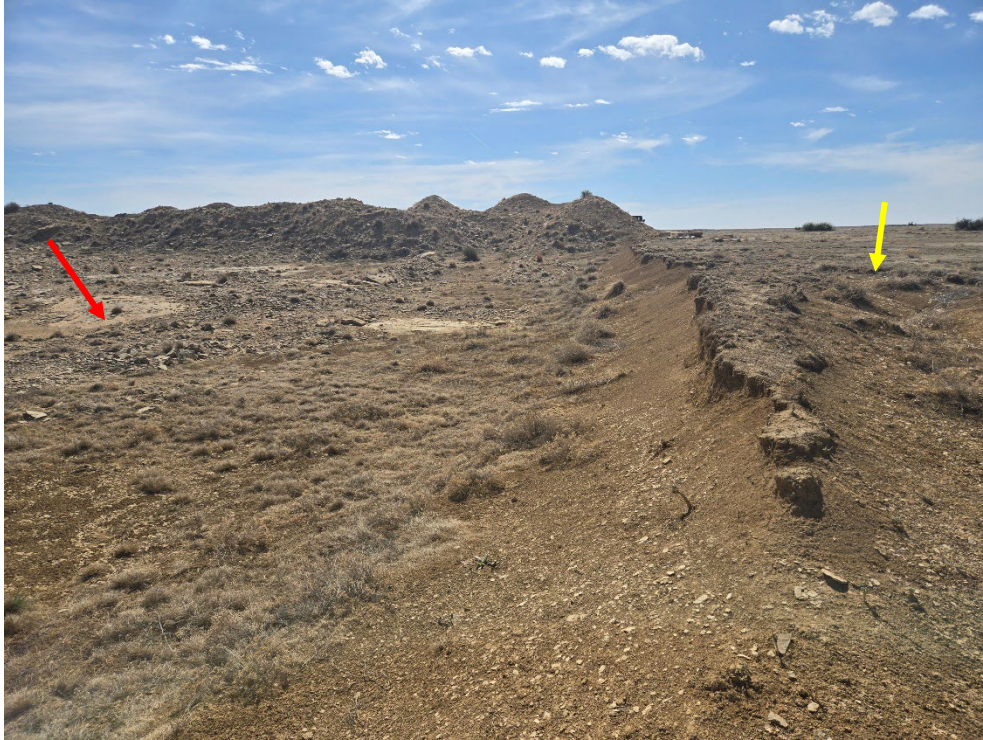
**Photo 3:** Looking south along the drop-down section behind the small highwall. The red arrow points to the highwall. The yellow arrow points to the erosion area mentioned in the Division's 2020 inspection report.

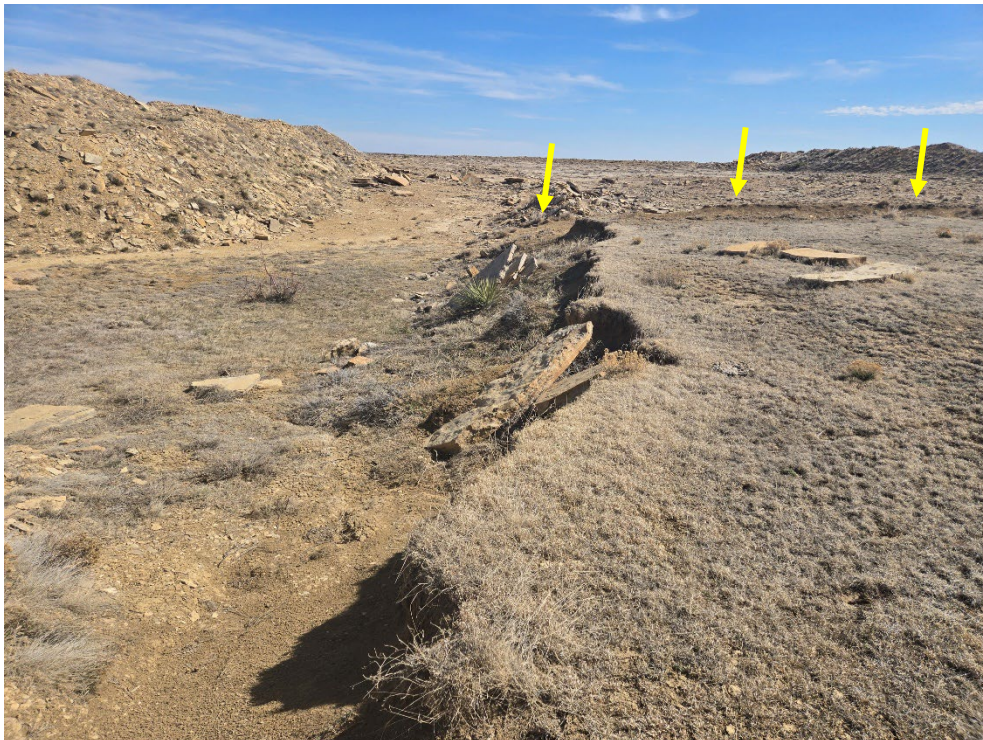
**Photo 4:** Looking east along where there is a small drop-down area running east-west near the main pit. The arrows point to the erosion area mentioned in the Division's 2020 inspection report. The sediment that runs down from that area is contained within a designated sump area in the pit.

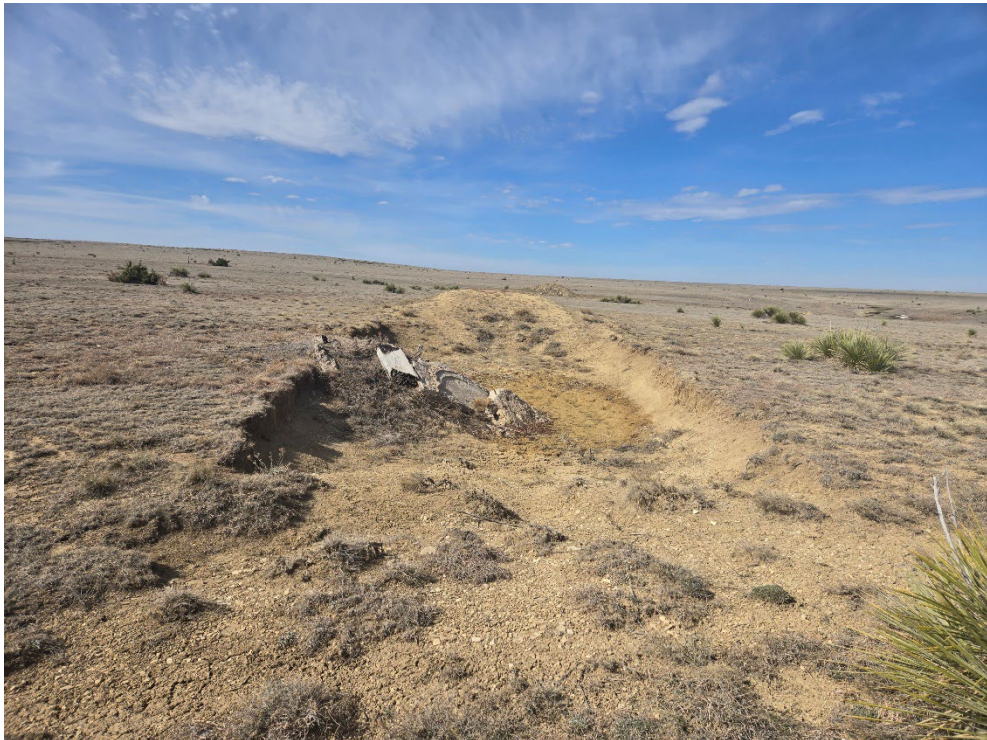
**Photo 6:** Looking west at a smaller disturbance area, west of the main pit.

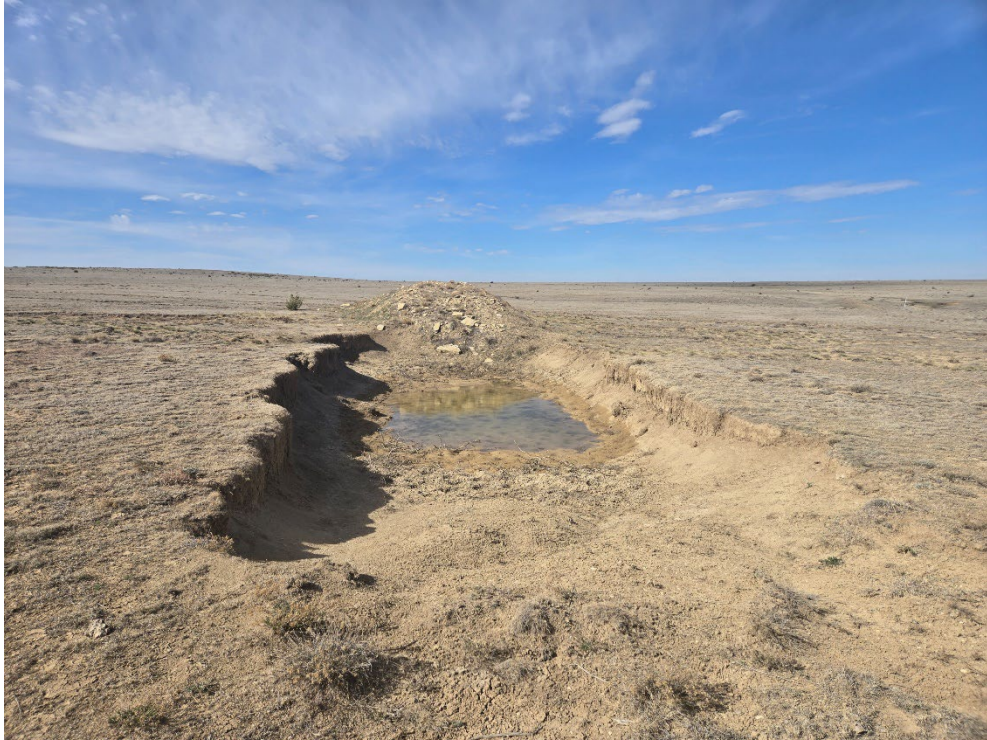
**Photo 7:** Looking west at a smaller disturbance area, west of the main pit, and west of the area in Photo 6.

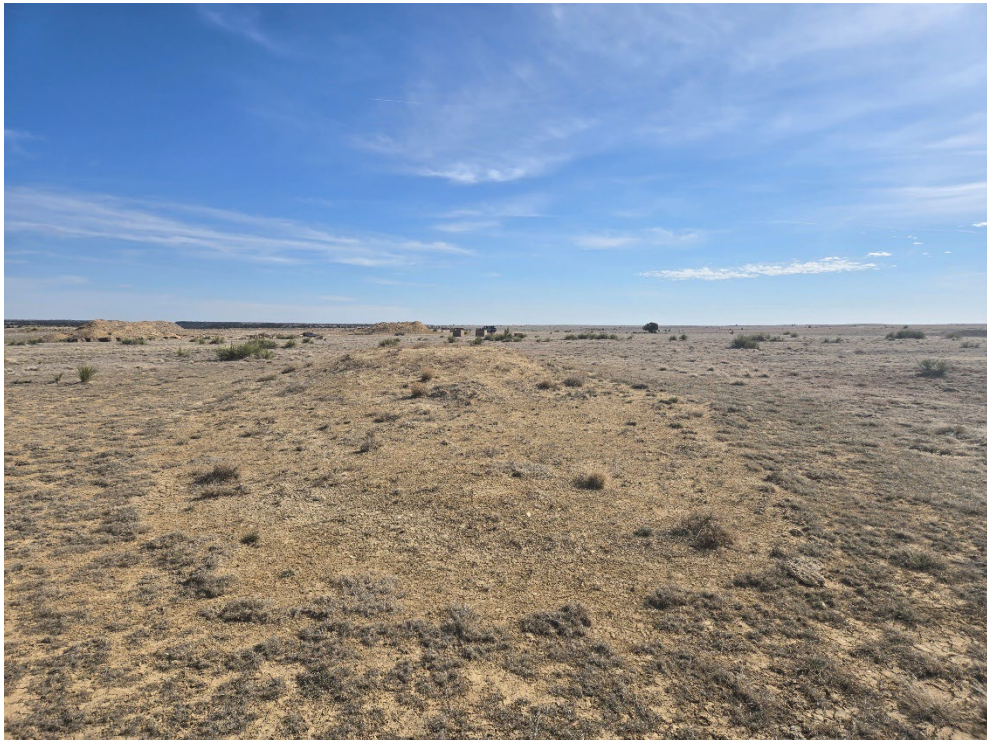
**Photo 8:** Looking east at the backside of the disturbance in Photo 6.

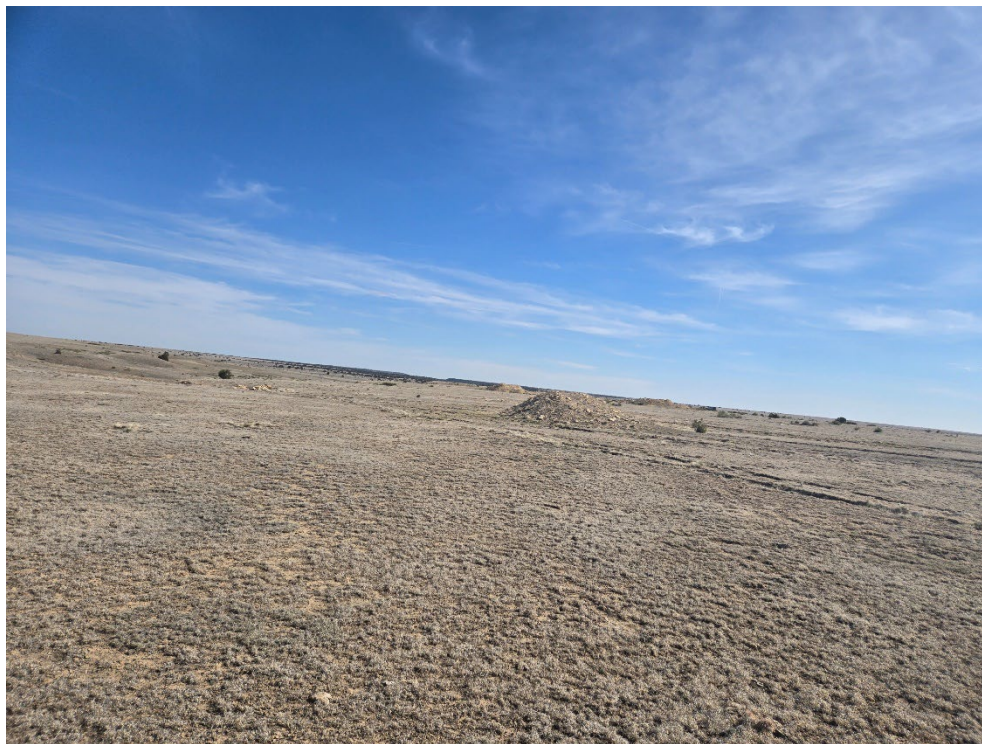
**Photo 9:** Looking east at the backside of the disturbance in Photo 7. Erosion is seen cutting through the permit area, but it starts outside of the permit area.

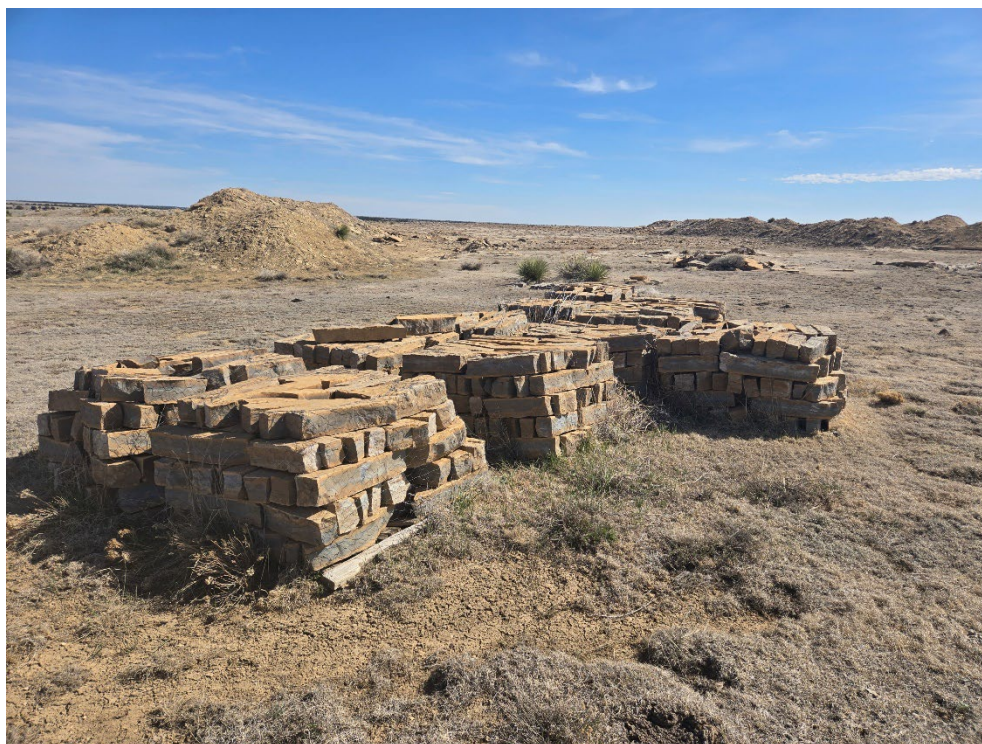
On the west side of the pit, there are bundles of product (Photo 10), a couple structures (Photo 11), wooden pallets (Photos 12), as well as various piles of product material around and within the pit (Photos 1 and 13). Vegetation has grown over most of the pre-existing ranch road leading to the permit area (Photo 14). From aerial imagery, the extent of the disturbance onsite does not appear to have changed since at least 2011 (See Figure 2). The Operator has indicated on annual reports that some activity has occurred at the site within the past few years. Because the nature of this operation appears to be minimal, but consistent, the Operator may need to update the mining plan with a Technical Revision (TR) and request an intermittent operator status, as it does not appear that this site operates greater than 180 days per year.

**Photo 10:** Blocks of stockpiled product.

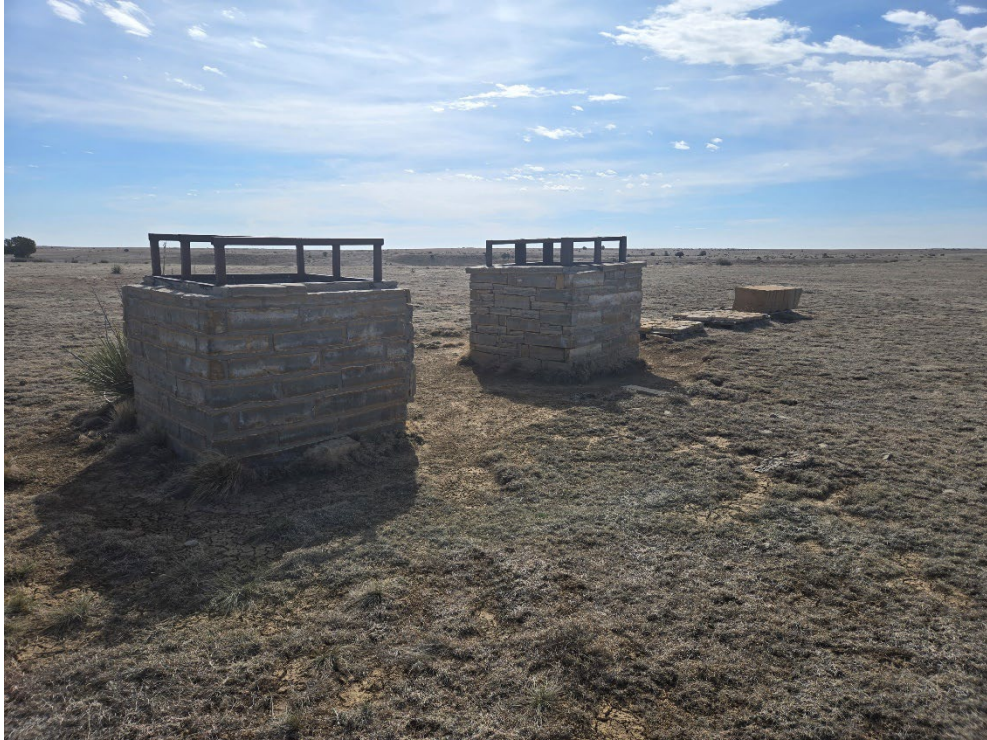
**Photo 11:** Structures near where product had been stored.

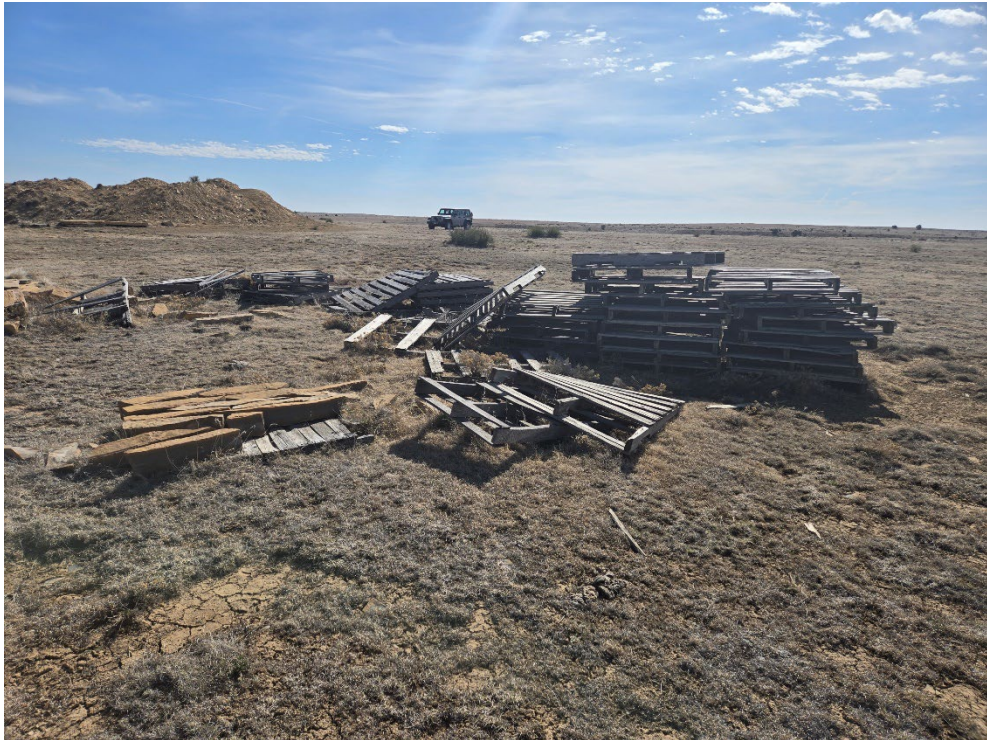
**Photo 12:** Wood pallets.

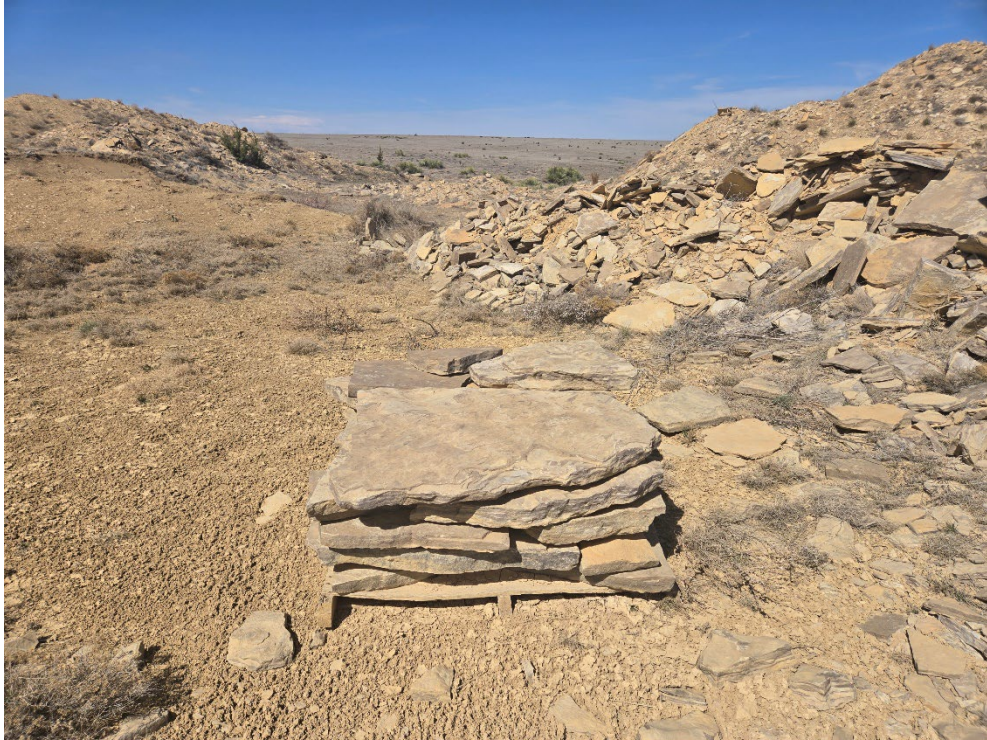
**Photo 13:** Stockpiled stone within the pit.

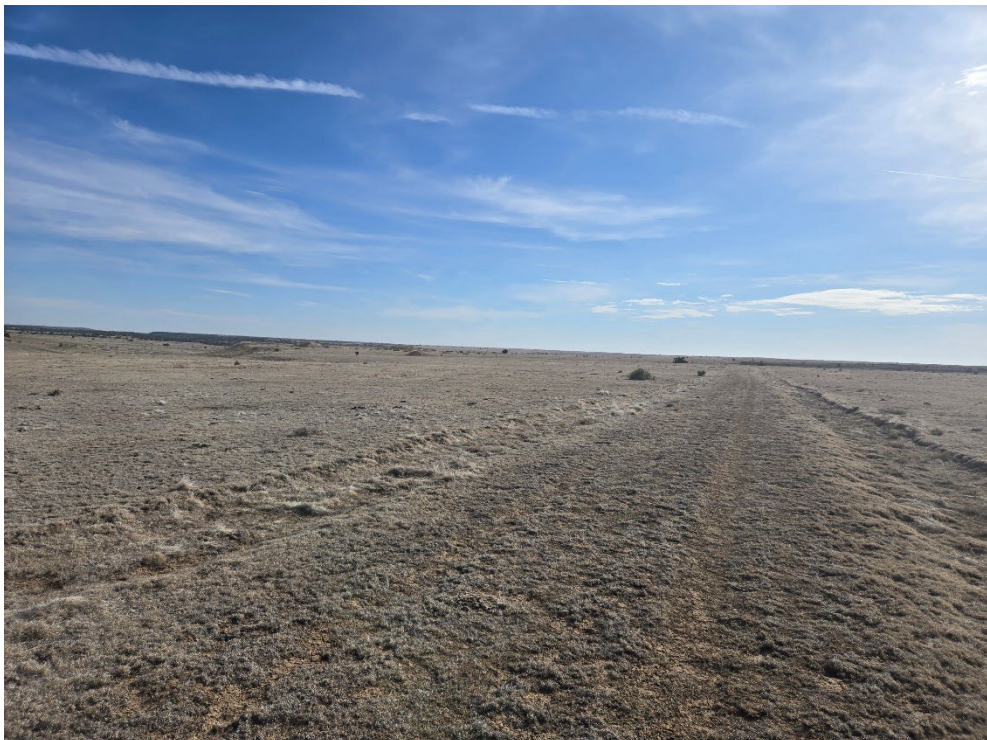
**Photo 14:** Looking east along the ranch road leading to the pit.

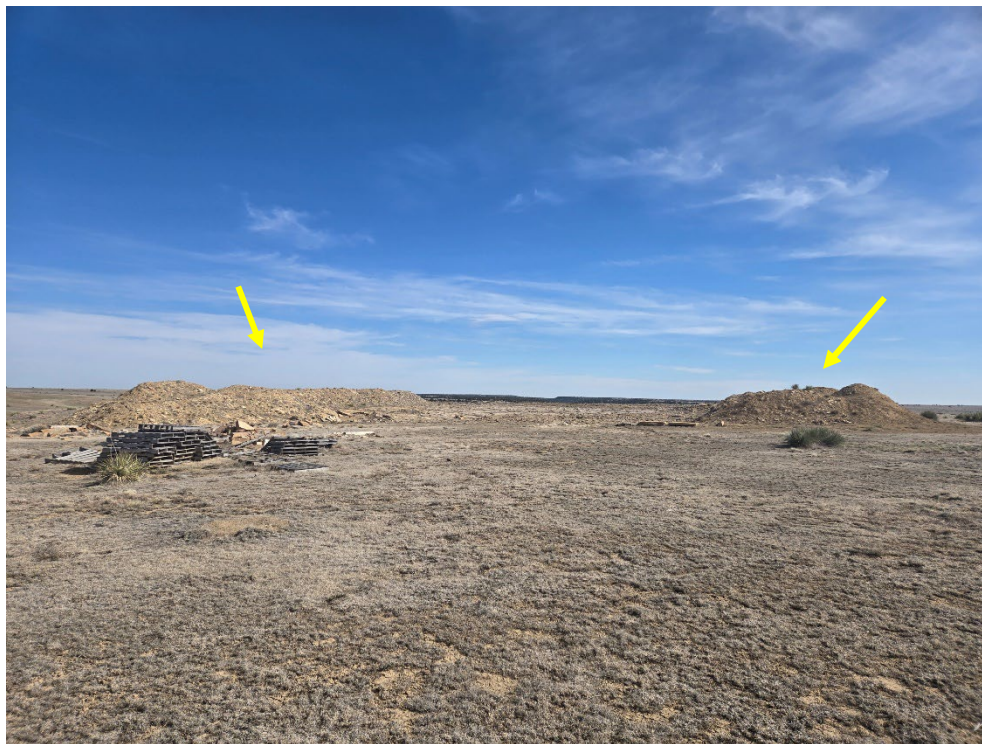
**Photo 15:** Looking east at the pit. The arrows point to the north and south topsoil piles as shown on the Operator's 2024 annual report map (Figure 3).

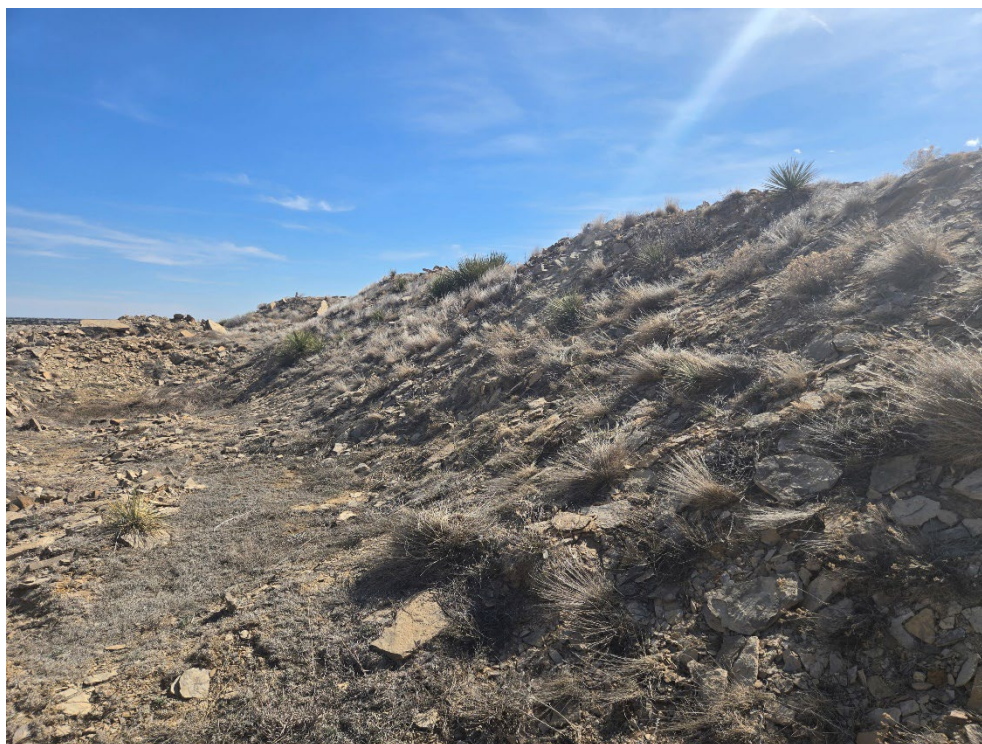
**Photo 16:** Looking along the backside of one of the topsoil piles where vegetation has helped stabilize the piles.

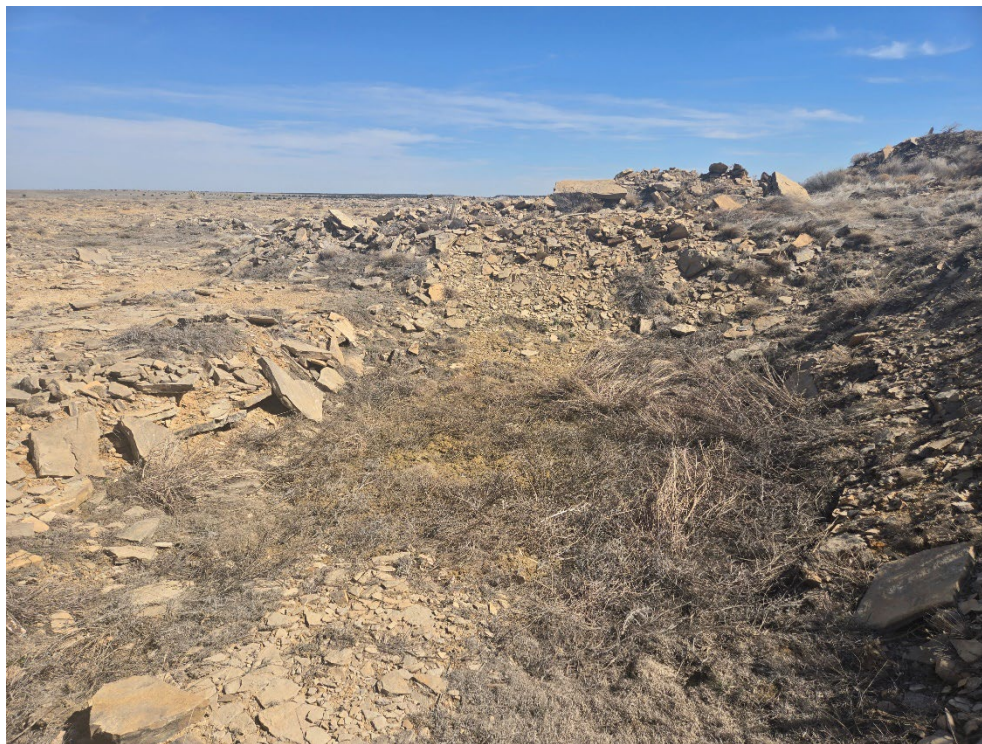
The Mining Plan Map shows that topsoil would be piled in the southeast corner of the site (see Figure 1). However, topsoil is stockpiled on the north and south sides of the main pit area, as indicted on the Operator’s 2024 Annual Report Map (Photos 15-16, Figure 3). The pile on the southside appears to have more vegetative growth on it, but both piles appear stable. There also is crushed/overburden material along both sides of the topsoil piles that will be replaced in the pit upon reclamation (Photo 17).

**Photo 17:** Looking at some unconsolidated material that will need to be backfilled into the pit before it is topsoiled.

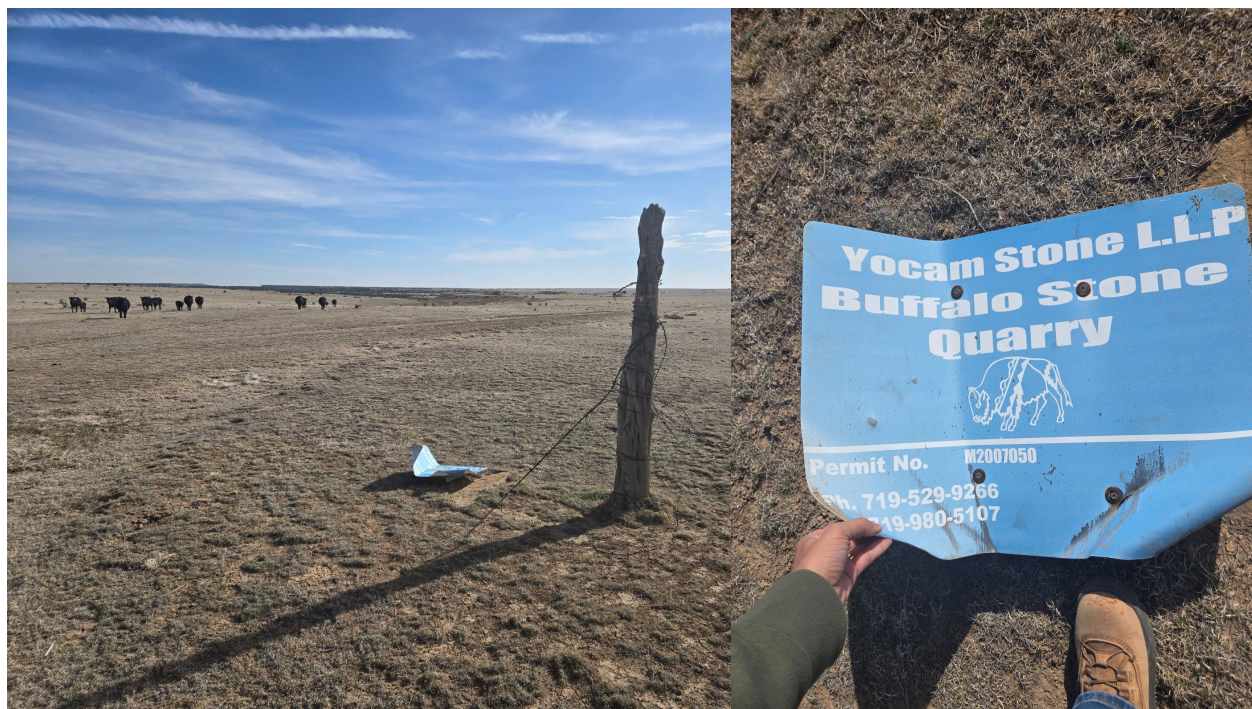
**PROBLEM:** The mine identification sign and affected area boundary markers were not observed per the requirements of Rule 3.1.12. The Operator shall, at the entrance of the mine site post a sign, which shall be clearly visible from the access road, with a minimum size equaling one hundred and eighty-seven (187) square inches, such as eleven (11) inches in height and seventeen (17) inches in width, with appropriate font size, with the following: the name of the Operator, a statement that a reclamation permit for the operation has been issued by the Colorado Mined Land Reclamation Board; and the permit number.

A post located on the south side of the ranch road leading to the permit area appears to have previously had the mine sign posted on it. During the inspection, the mine sign was observed damaged and on the ground (Photo 18). This **has been cited as a problem above**. The Operator shall re-post the sign and send a photo to the Division by the corrective actions date.

**Photo 18:** Looking east at the post where the sign had been posted.

- The Operator must post a sign at the entrance to the mine site which shall be clearly visible from the access road and specify the following; the name of the Operator, indicate that a reclamation permit for the operation has been issued by the Colorado Mined Land Reclamation Board, and the permit number.
- The boundaries of the affected area must be marked by monuments or other markers that are clearly visible and adequate to delineate such boundaries.

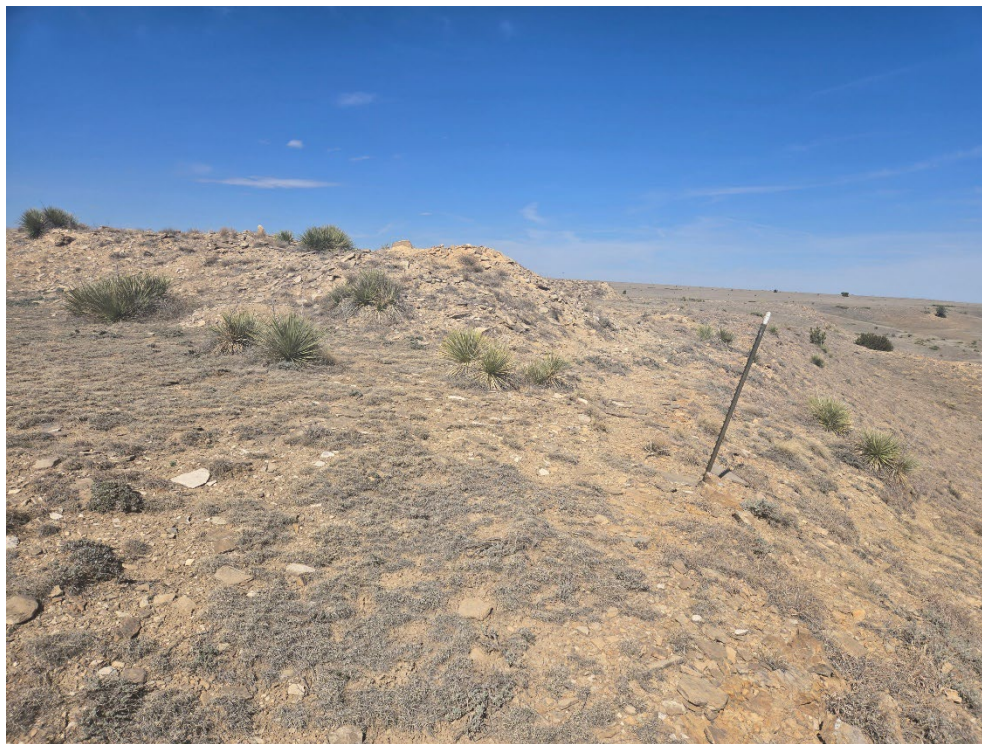
There are t-posts posted at the northeast, southeast, and northwest corners (Photos 19-20). It appears that the t-posts in the northeast and southeast corners are close to the correct locations. The t-post in the northwest corner does not seem related to the permit boundary, as it is approximately 160 feet northwest of the location of the northwest corner of the boundary (see the photo capture location #20 on Map 1). The northwest and southwest corner markers depicted on the Operator's 2024 annual report map (Figure 3) also appear to be in the incorrect locations, as the size of the permit would be too small. Map 1 included in this report depicts what the Division believes is the approximate permit boundary location, based off the dimensions provided in the approved Mining and Reclamation plan maps (See Figure 1). Due to these discrepancies, and the apparent absence of the northwest and southwest markers in the field, this **has been cited as a problem above**.

**Photo 19:** Looking north along the east side of the permit boundary at the southeast permit boundary marker. There was also another t-post marking the northeast side.

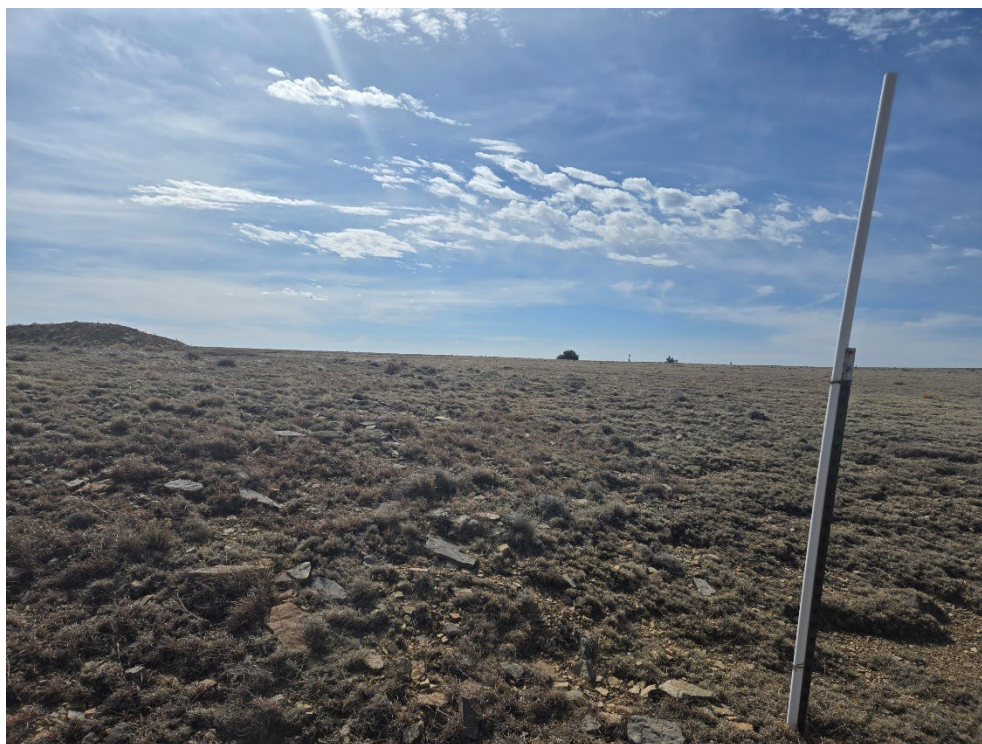
**Photo 20:** Looking south at what appeared to be a misplaced northwest permit boundary marker.

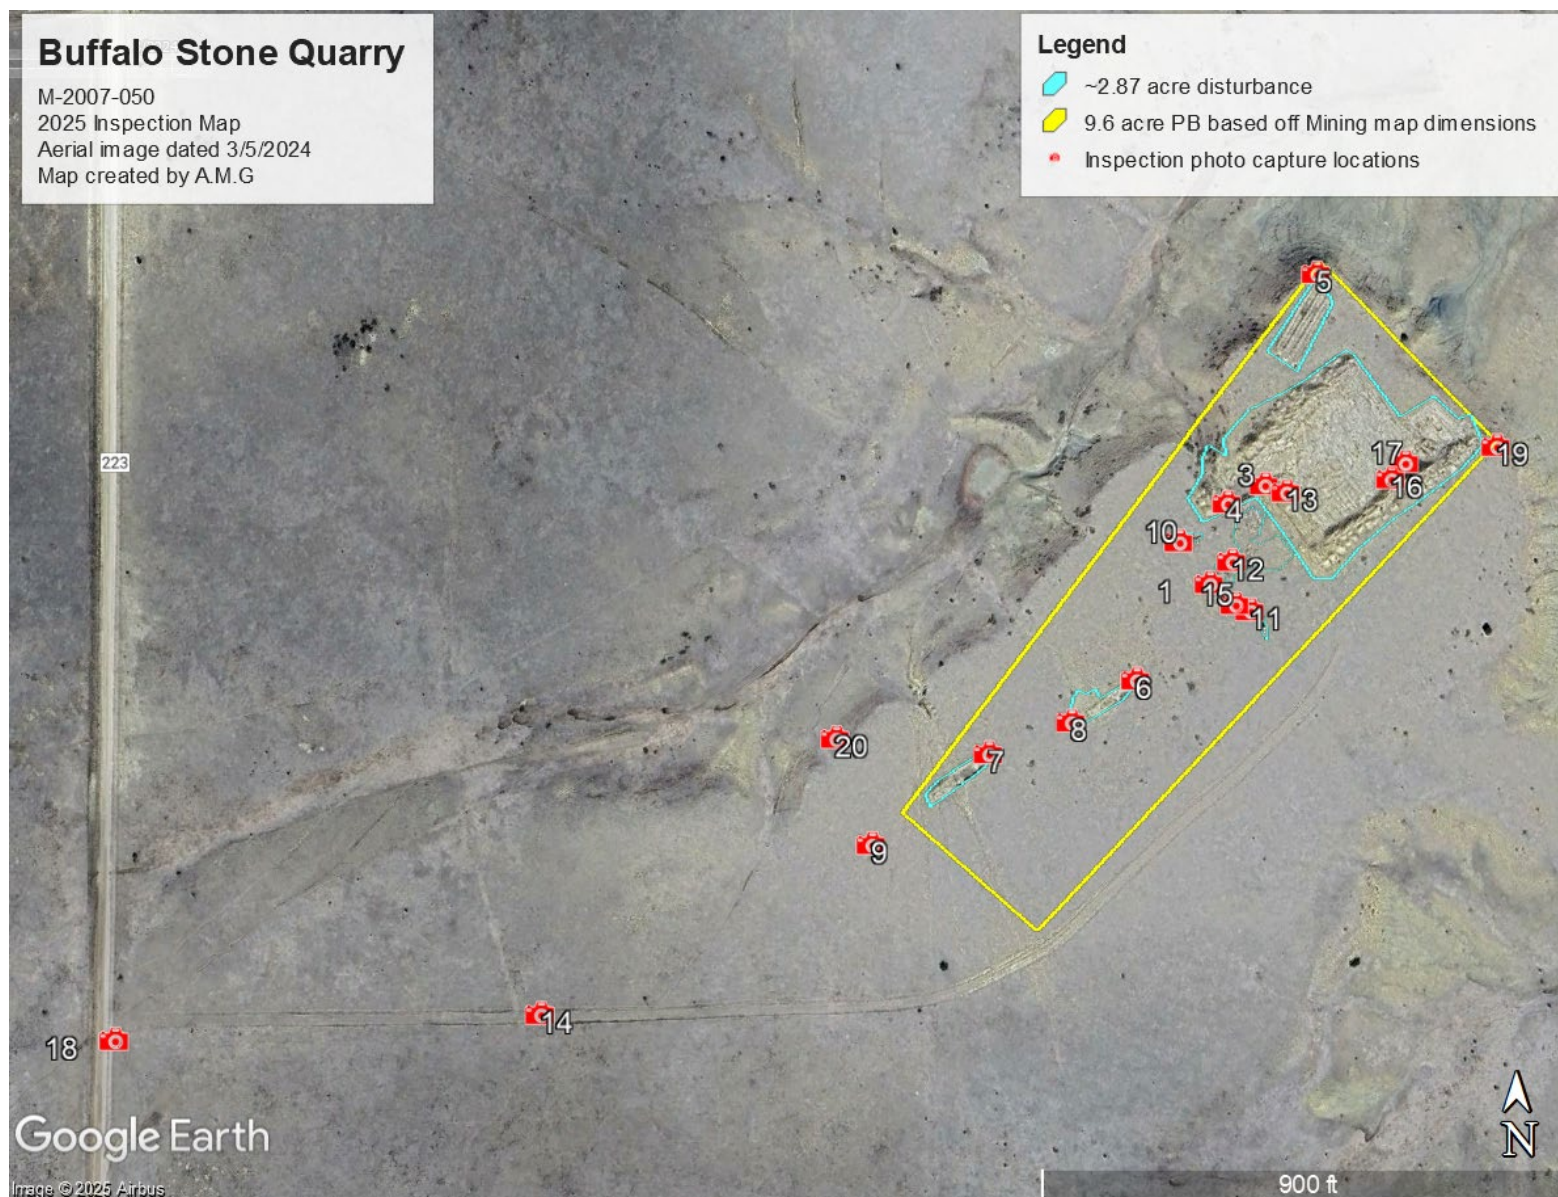
**Map 1:** 2025 Inspection Map generated in Google Earth Pro. The yellow polygon indicates the approximate permit boundary, based off the dimensions provided in the approved Mining Plan Map (see Figure 1 below). The numbers correspond with the inspection report photos. Icon #20 indicates the location of a t-post in the field that appears to be incorrectly marking the northwest corner of the permit boundary.

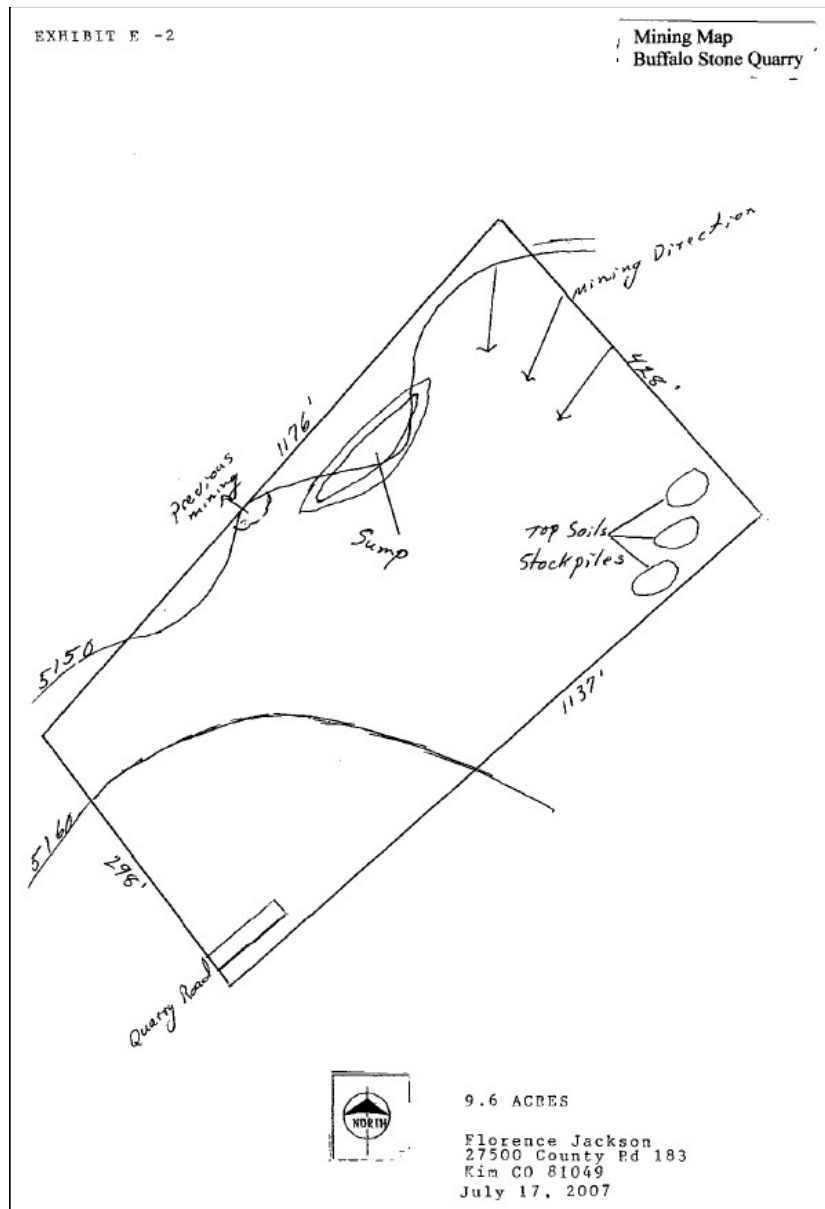
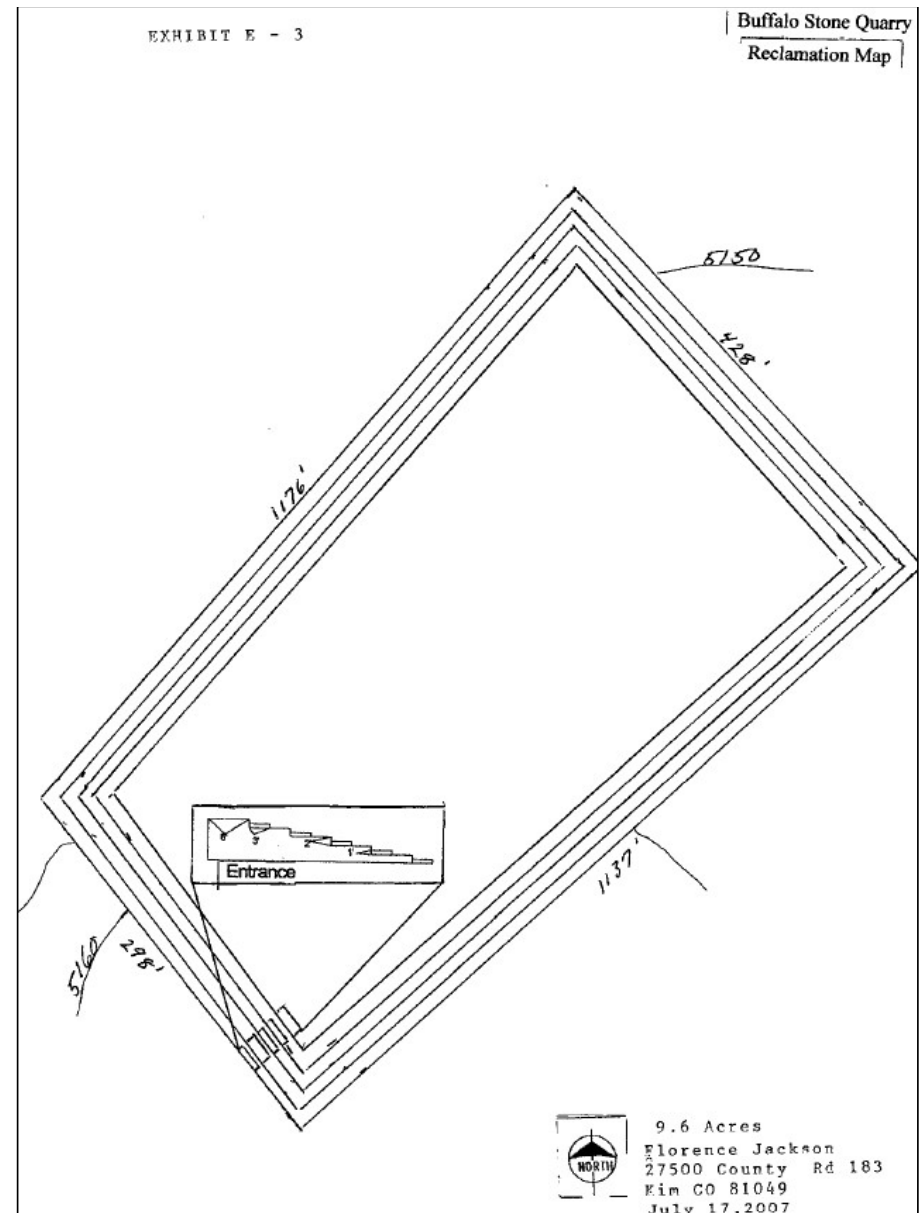
Figure 1: (Left) Picture of the approved Mining Plan Map. (Right) Picture of the approved Reclamation Plan Map.

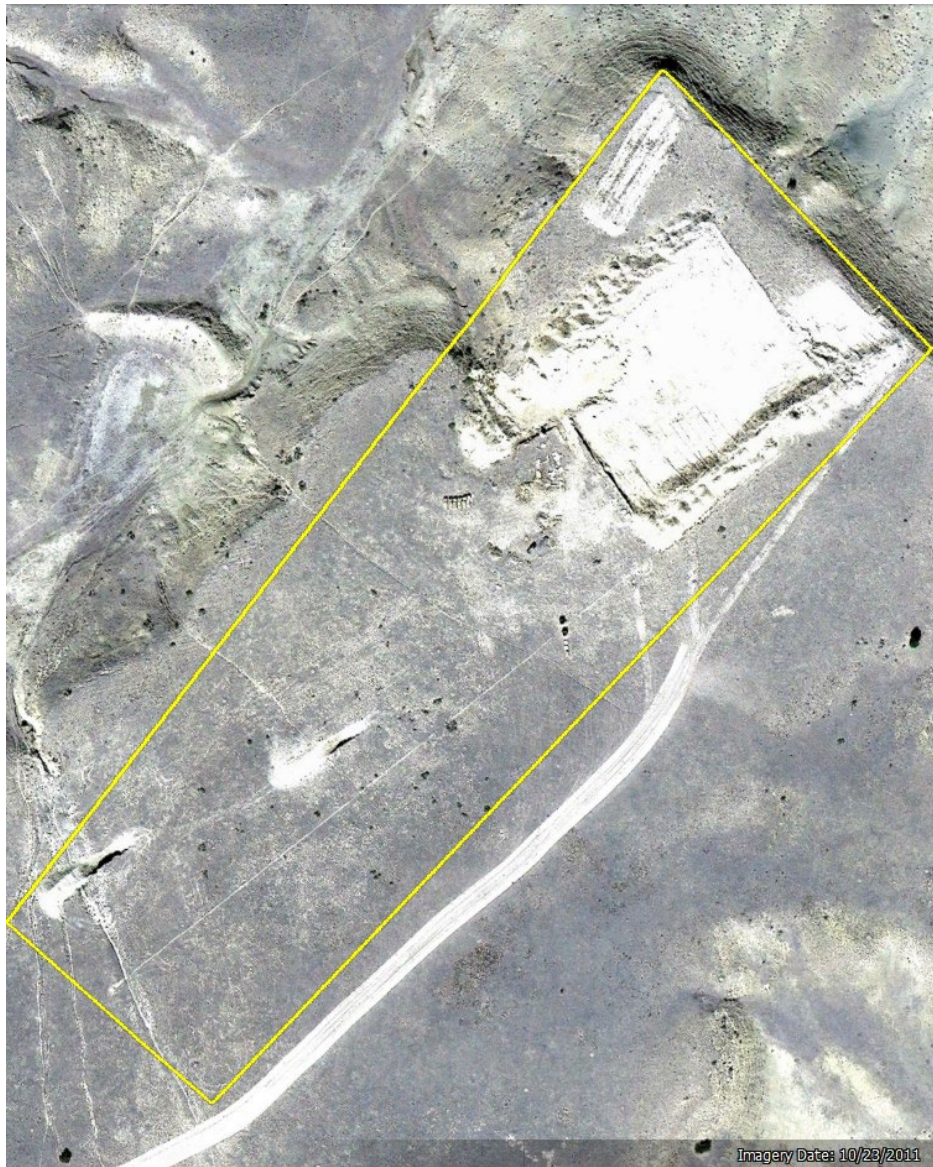
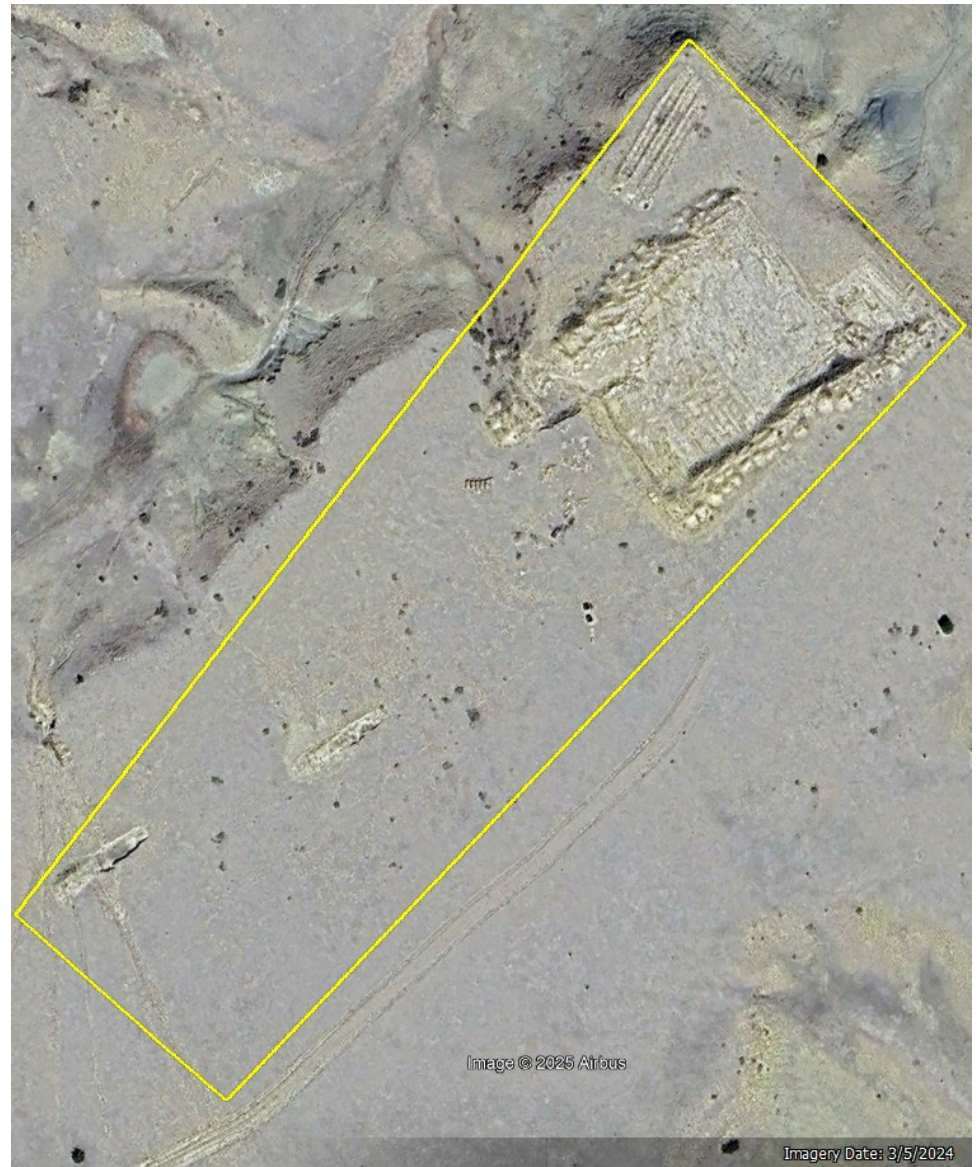
**Figure 2:** (Left) Earliest aerial imagery available in Google Earth Pro, dated 10/23/2011. (Right) Most recent aerial imagery available in Google Earth Pro, dated 3/5/2024.
