### MINERALS PROGRAM INSPECTION REPORT

<b>MINE NAME:</b> Buffalo Stone Quarry	<b>MINE/PROSPECTING ID#:</b> M-2007-050	<b>MINERAL:</b> Stone	<b>COUNTY:</b> Las Animas
<b>INSPECTION TYPE:</b> Monitoring	<b>WEATHER:</b> Cloudy	<b>INSP. DATE:</b> March 27, 2025	<b>INSP. TIME:</b> 10:05
<b>OPERATOR:</b> Yocam Stone LLP	<b>OPERATOR REPRESENTATIVE:</b> None	<b>TYPE OF OPERATION:</b> 110c - Construction Limited Impact

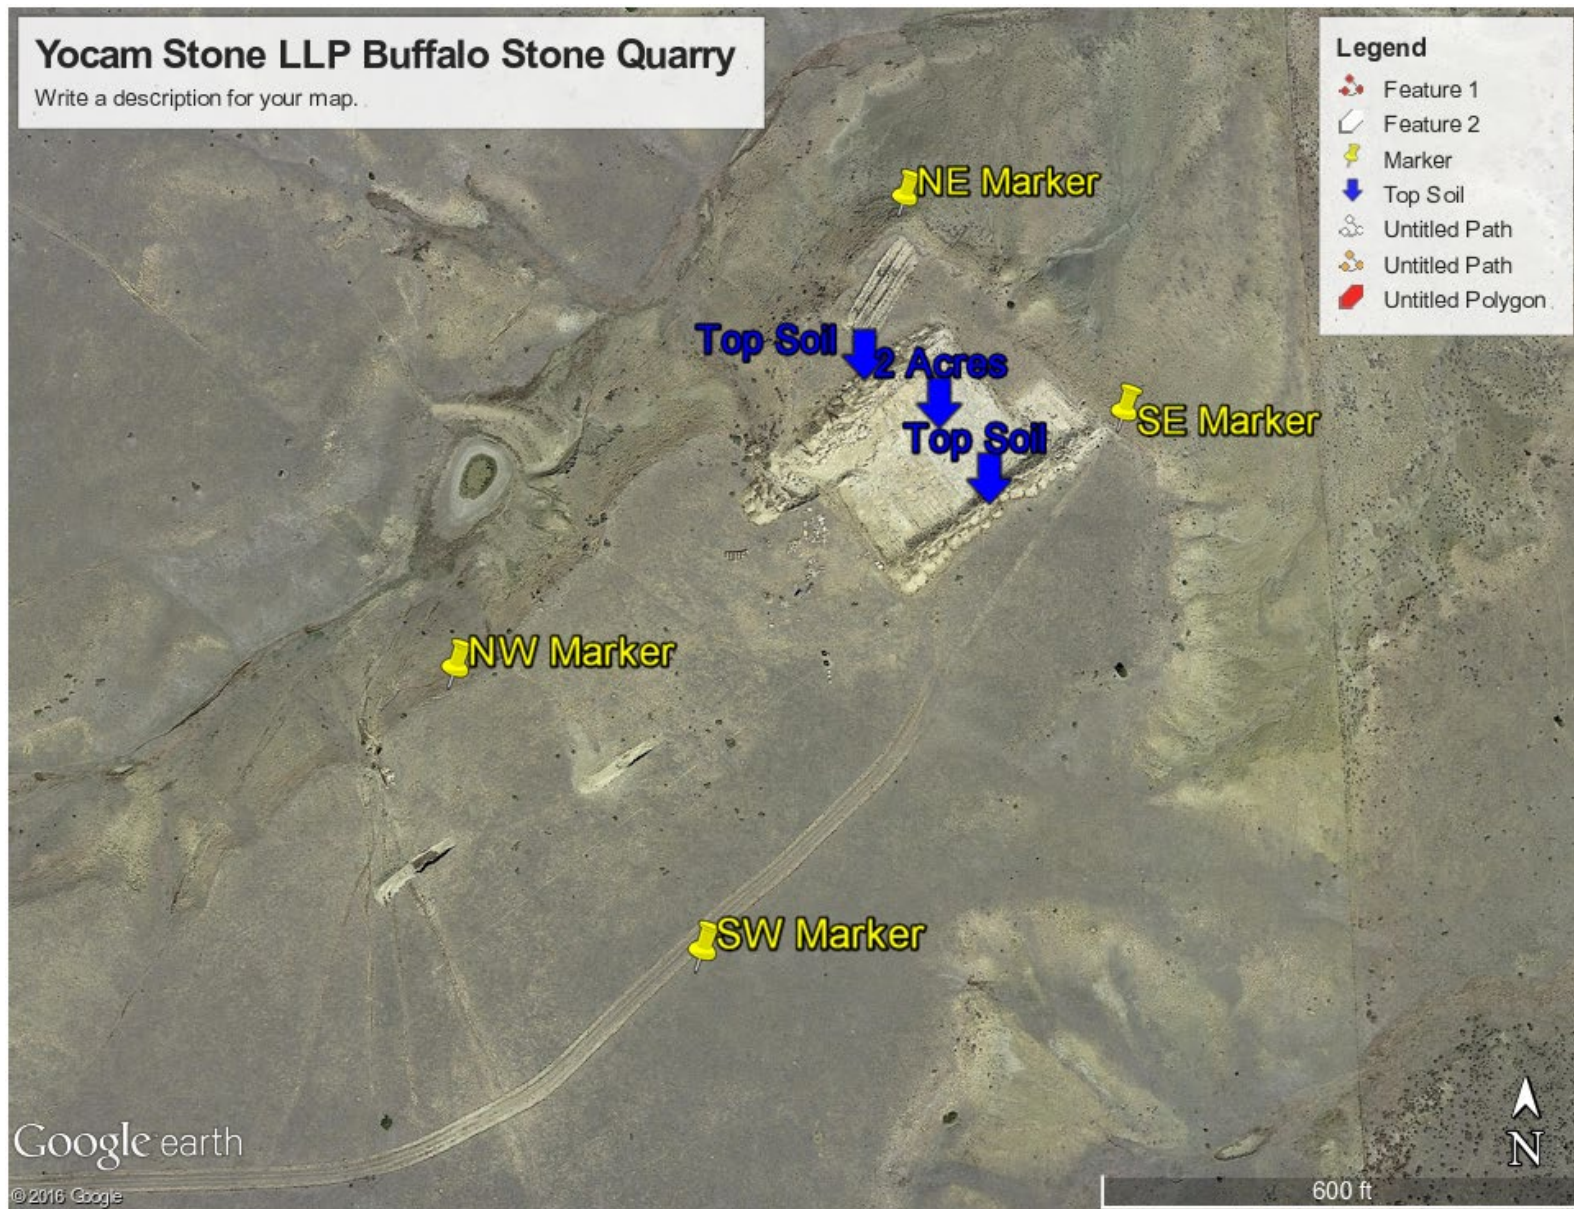
The Division found that the recent **annual report maps were inadequate**.

**Figure 3:** The Operator's 2024 annual report map. The markers indicated on the report map do not appear to match the orientation on the approved map, nor the dimensions provided on the approved map.

1. For the 2025 submittal of the annual report map please refer to the Annual Report Form. The Annual Report Form states that as required by the Colorado Land Reclamation Act for the Extraction of Construction Materials (C.R.S. 34-32.5-116), the Permittee shall attach a map to the report that accurately depicts:
  - i. the permit boundary,
  - ii. the current affected area boundary and;
  - iii. the location of the acreages specified in Items no. 8-12 and 15.

2. Please also include the following features:
  - A google earth background image
  - A north arrow and scale
  - A legend indicating the polygons and/or lines for the features identified in items 8-12 and 15 on the form OR include clear labels for each feature.
