MINERALS PROGRAM INSPECTION REPORT
PHONE: (303) 866-3567

MINE NAME: Boettcher Limestone Quarry	MINE/PROSPECTING ID#: M-1977-348	MINERAL: Limestone (general)	COUNTY: Larimer
INSPECTION TYPE: Surety Release Inspection	WEATHER: Cloudy	INSP. DATE: April 2, 2025	INSP. TIME: 09:30
OPERATOR: Holcim (US) Inc.	OPERATOR REPRESENTATIVE: Mr. Michale Toole	TYPE OF OPERATION: 112c - Construction Regular Operation	
REASON FOR INSPECTION: Surety Release Requested	BOND CALCULATION TYPE: None	BOND AMOUNT: \$2,518,261.30	
DATE OF COMPLAINT: NA	POST INSP. CONTACTS: None	JOINT INSP. AGENCY: None	
INSPECTOR(S): Jocelyn Carter	INSPECTOR'S SIGNATURE:

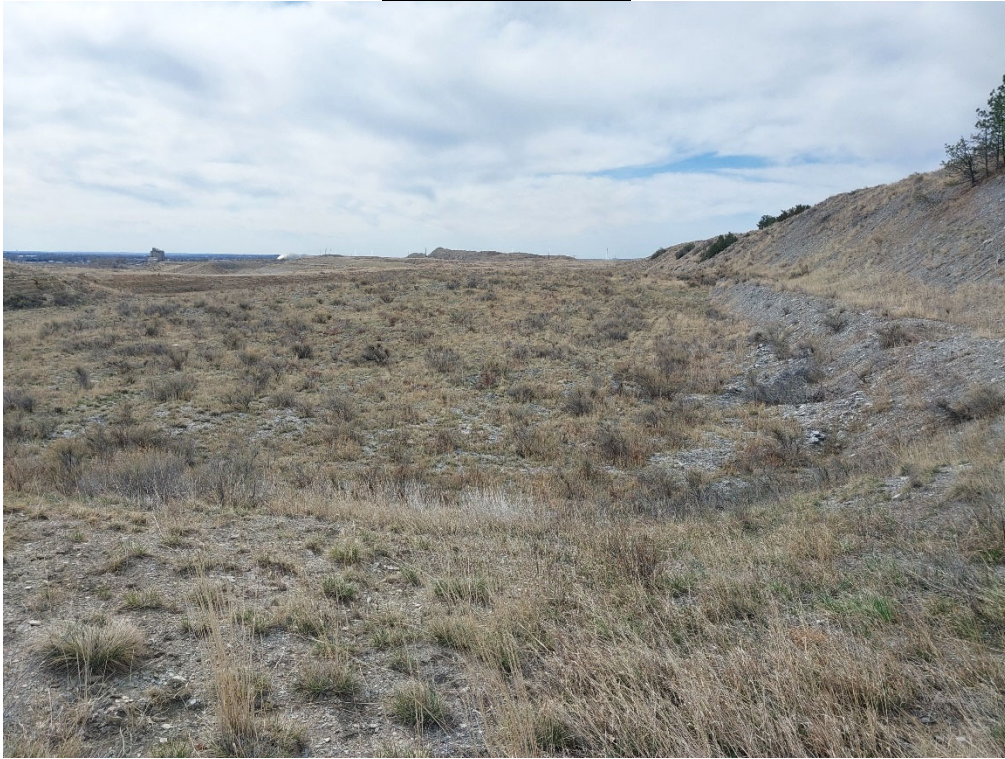
Photo #1: View of the permit area, looking to the south from the north boundary line.

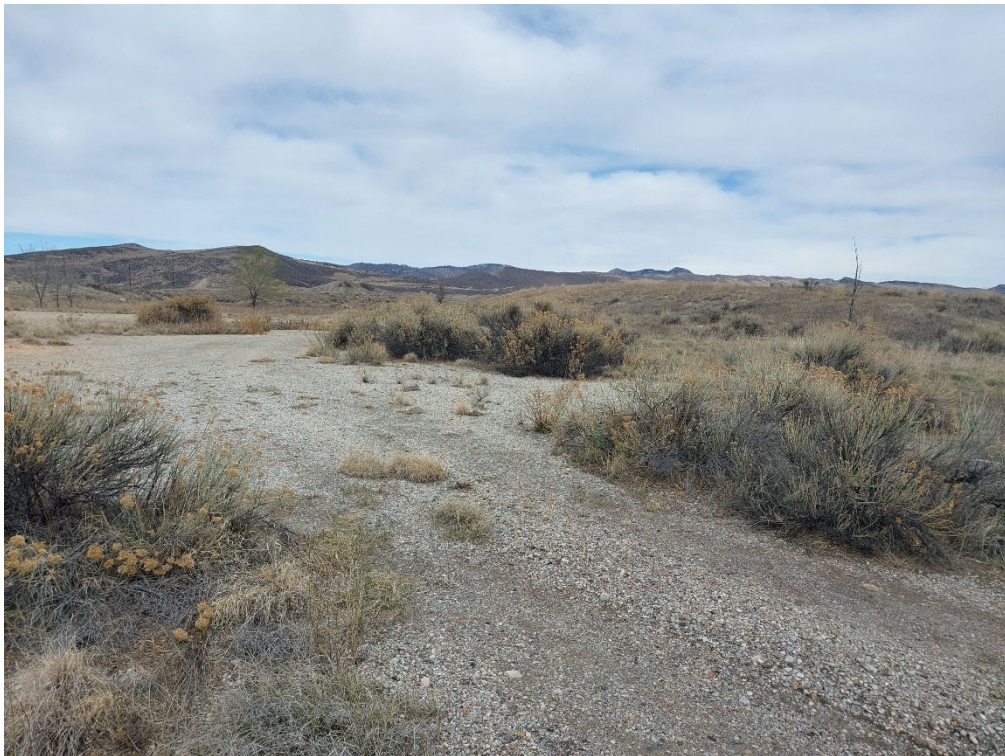
The backfill and grading were adequate according to the approved reclamation plan; slopes appear to be 2H:1V or less, are stable, and well vegetated.

Photo #2: View of the affected area, looking to the north from the southern portion of the permitted area.

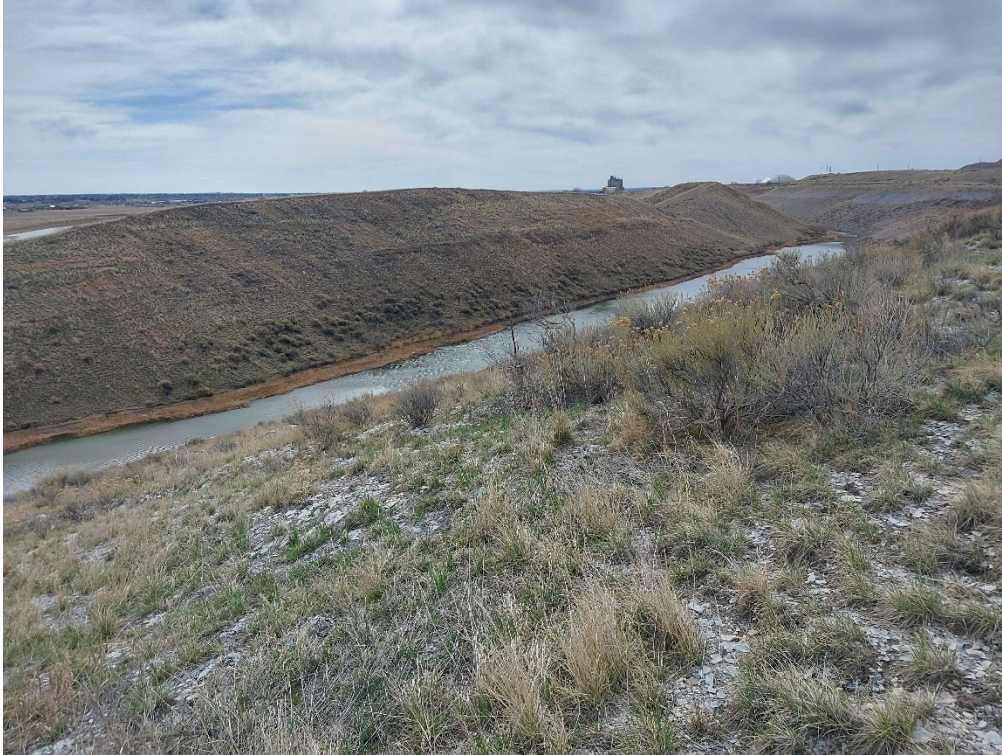
Photo #3: View of Pond C, situated along the southeast of the permitted area, looking to the southeast.

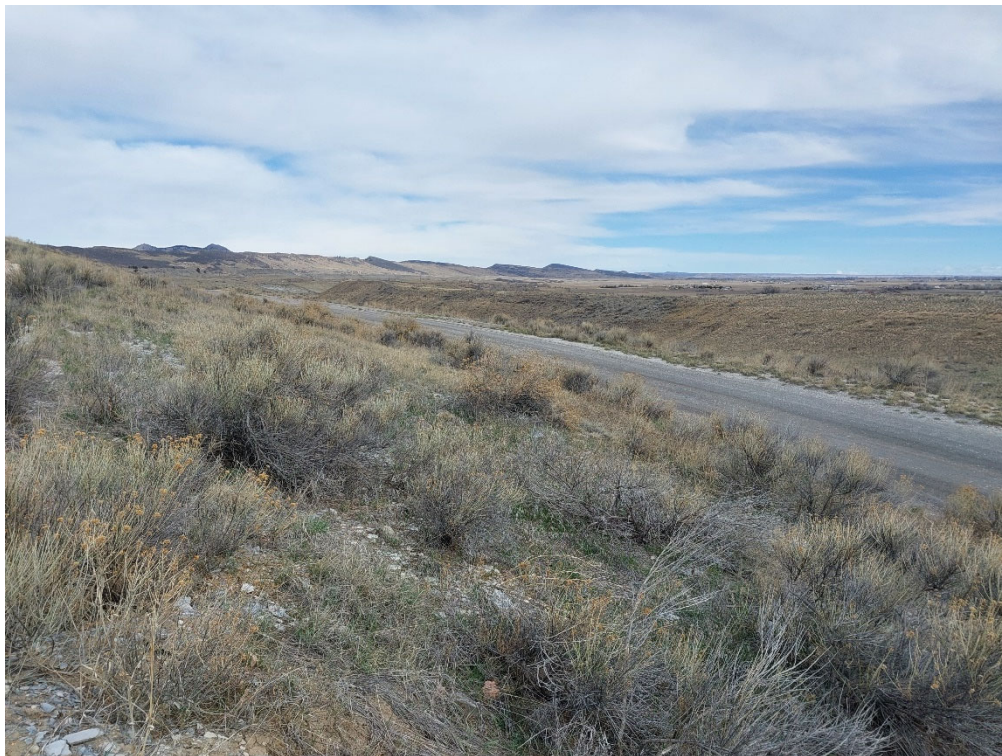
The road appeared to be in good condition, stable, and not a source of sedimentary or erosion issues. The road was approved to stay in place after mining activities. The technical revision TR-5, approved on July 12, 2005, allowed the road to remain at a width of 24 feet. In general, the width of the road is about 20 feet in width and lies within the accepted parameters.

Photo #4: View of the road running north-south through the approximate center of the permitted area, looking to the northeast.

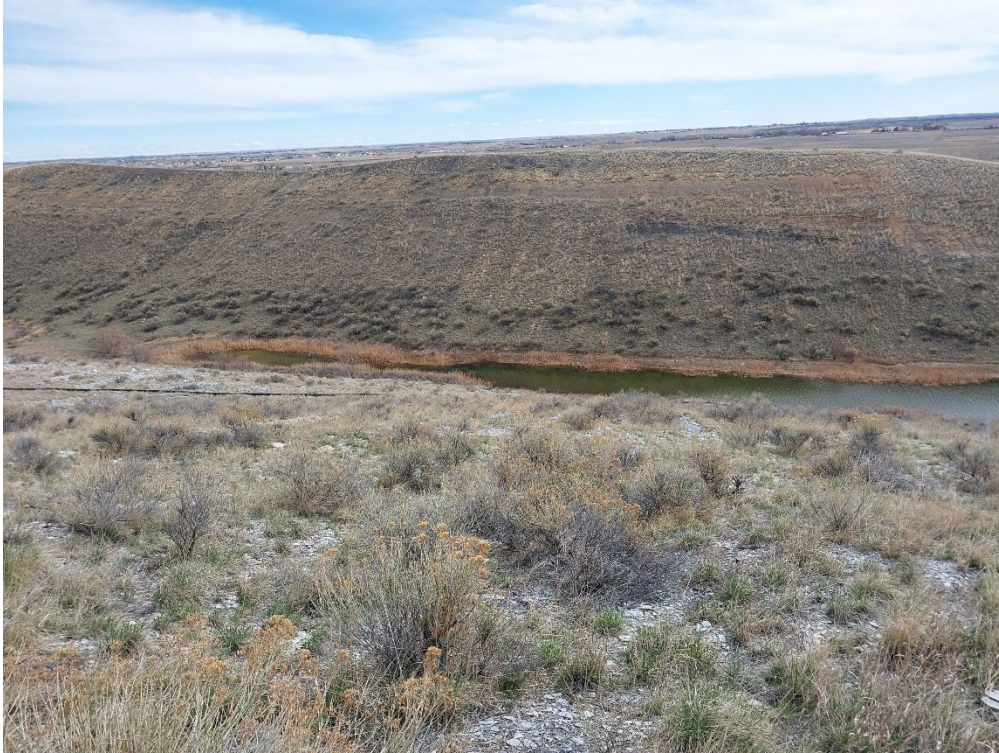
There is a pipeline between the north end of Pond C to a canal to the north. The pipeline is in place in accordance with an augmentation plan between Holcim (US), Inc. and the City of Greeley.

Photo #5: View of the pipeline, circled in red, at Pond C.

The Division intends to approve the Full/Final Release request after resolving issues with a pipeline and fence and gate that were viewed on the permitted area. These items are discussed further below and were addressed in the Division's adequacy review letter dated April 10, 2025.

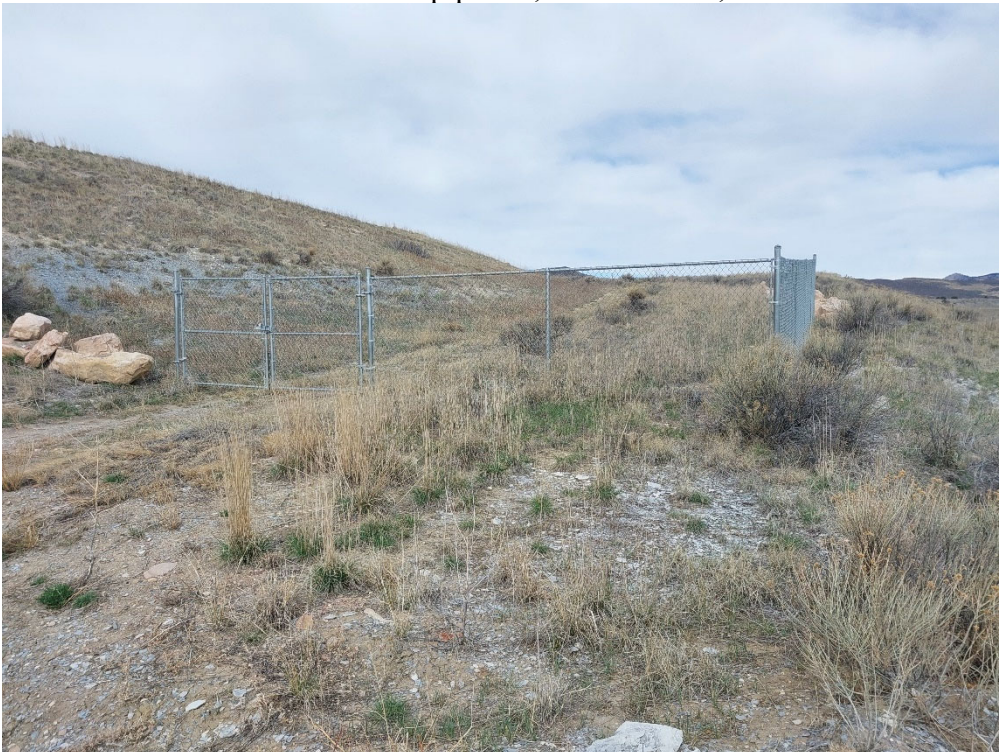
There is a gate and fence installed on the property used to discourage trespassing onto a small two track trail. Holcim (US) Inc. would like to leave the fence and gate in place for the same purpose; to discourage trespassing onto the property.

Photo #6: View of the fence and gate blocking the two-track trail on the property, looking north.
