MINERALS PROGRAM INSPECTION REPORT

MINE NAME: New Hay Camp Pit	MINE/PROSPECTING ID#: M-2013-031	MINERAL: Sand and gravel	COUNTY: Montezuma
INSPECTION TYPE: Monitoring	WEATHER: Clear	INSP. DATE: March 26, 2025	INSP. TIME: 10:45
OPERATOR: McStone Aggregates, LLC	OPERATOR REPRESENTATIVE: Casey McClellan	TYPE OF OPERATION: 112c - Construction Regular Operation

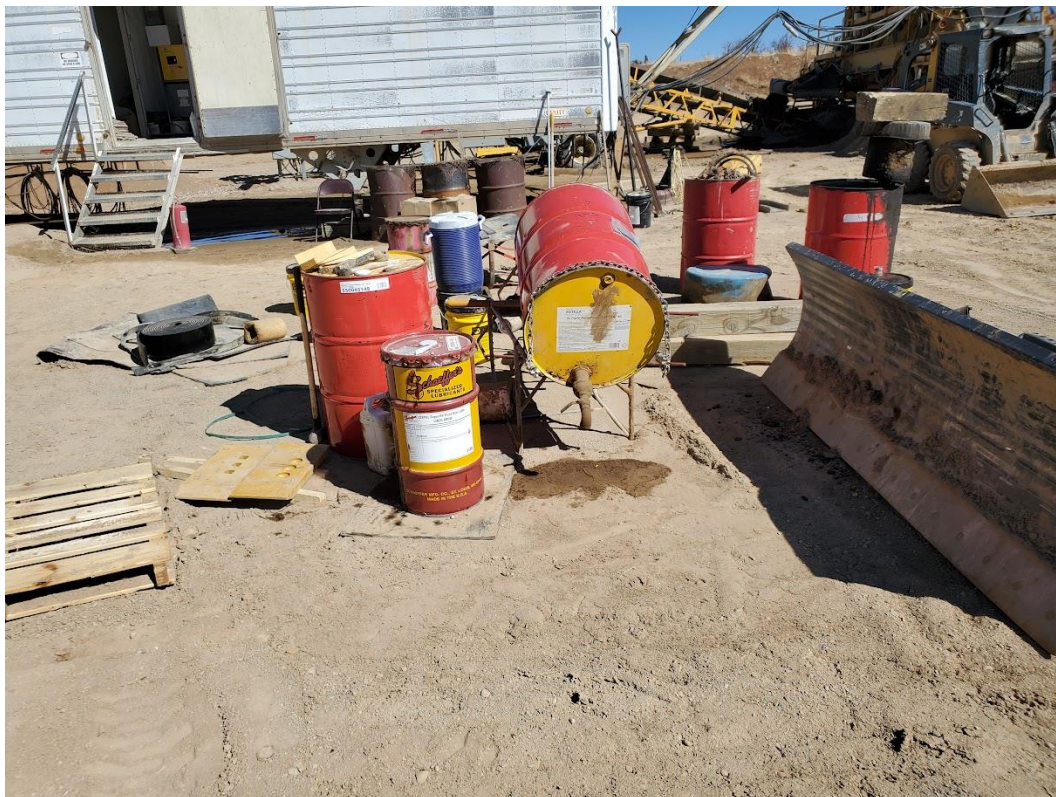
PROBLEM/POSSIBLE VIOLATION: Problem: Improper storage and containment of fuels and/or other hazardous materials was present on site.

55-gallon barrels of hydrocarbons was observed outside of secondary containment with a small lead under one of them. Please store hydrocarbons in secondary containment in accordance with best practices or remove the hydrocarbons from site. Please submit documentation or secondary containment or removal of hydrocarbons by May 23, 2025. If additional time is needed the operator may request an extension.

Photo 1: View to the north of 55-gallon barrels outside of secondary containment with a small drip under one of them.

CORRECTIVE ACTIONS: All storage tanks, petroleum and any hazardous materials on site for any period of time shall have appropriate secondary containment. The site will also have to comply with all applicable SPCC requirements. Please supply photo documentation that any fuel or hazardous materials containers are stored properly - including applicable secondary containment structures by the corrective action date. Note that secondary containment structures shall consist of an impermeable containment which could contain all contents of the tanks and various containers (when full) plus 10% of the total capacity. The operator may also provide photo documentation that all containers have been removed from the site on or before the corrective action date.

CORRECTIVE ACTION DUE DATE: 5/23/25

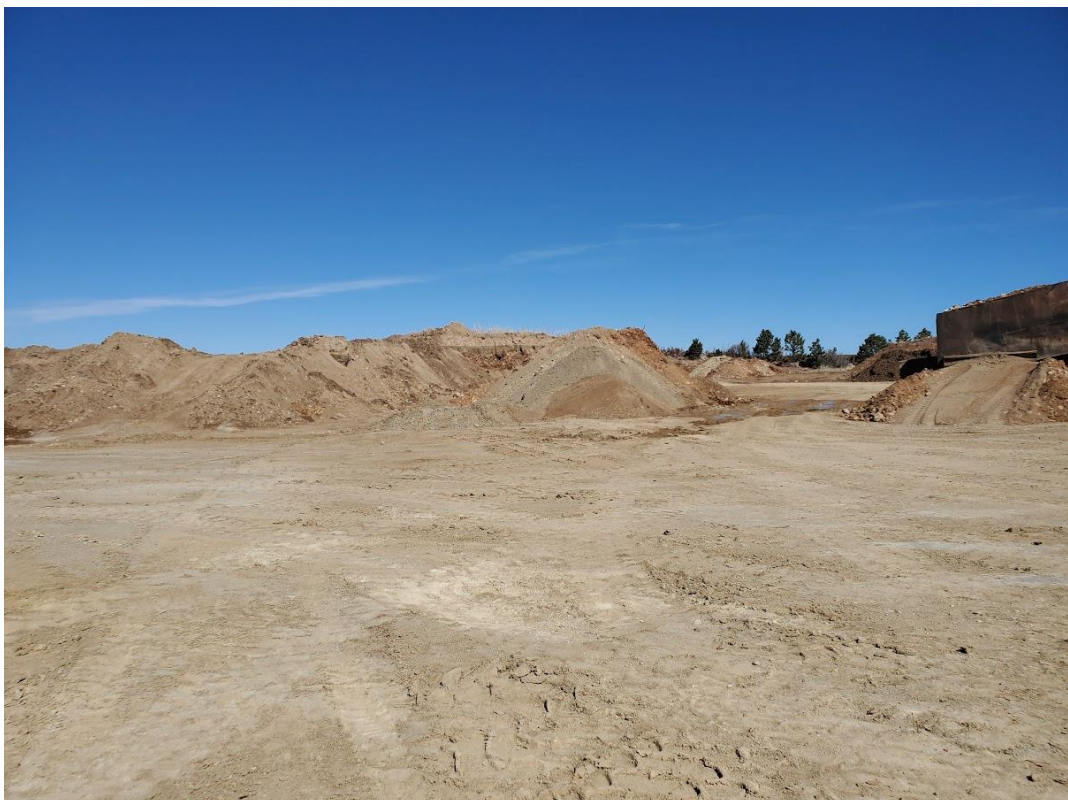
Mining is occurring from east to west in accordance with the approved mine plan. The mining area is on the western end of the permit area. Product stockpiles and processing area are located adjacent to the mining area to the east. A scale is located near the entrance to the permit.

Photo 2: View to the west of the mining area.

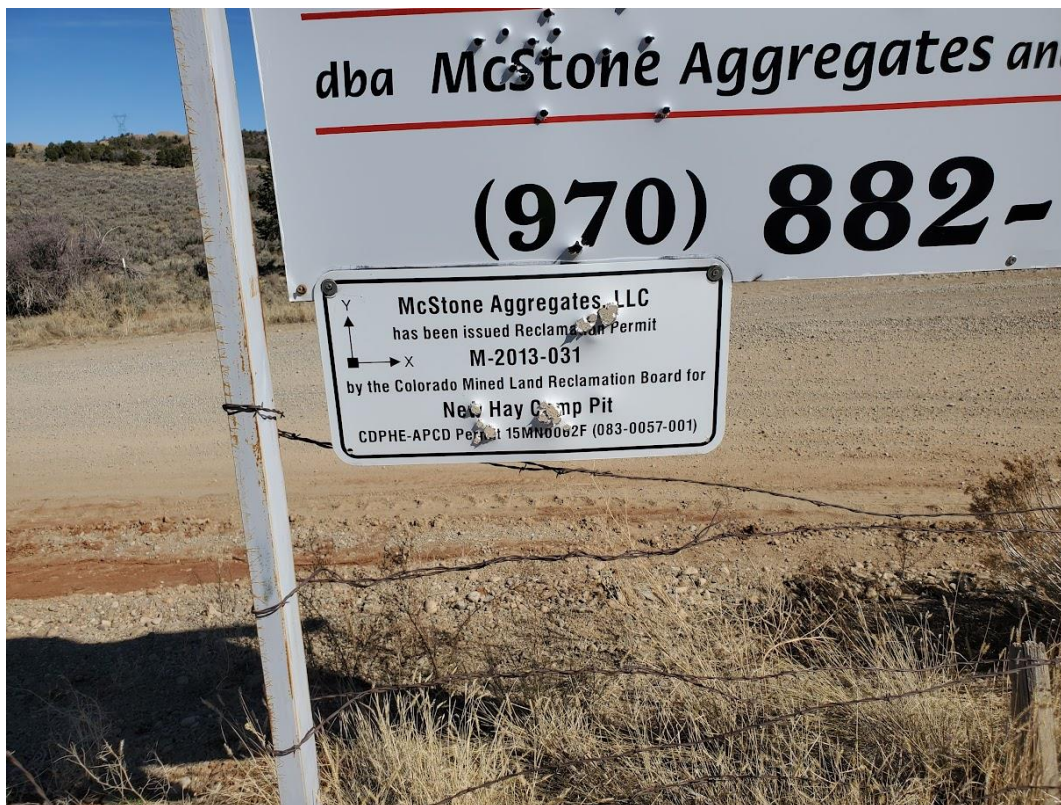
The mine identification sign and the affected area boundary markers are in place and in compliance with Rule 3.1.12. The mine ID sign is posted at the entrance to the permit area. It has bullet holes but still legible. The boundary is marked with berms and fence line that are easily identifiable.

Photo 3: View to the north of proper mine ID sign.

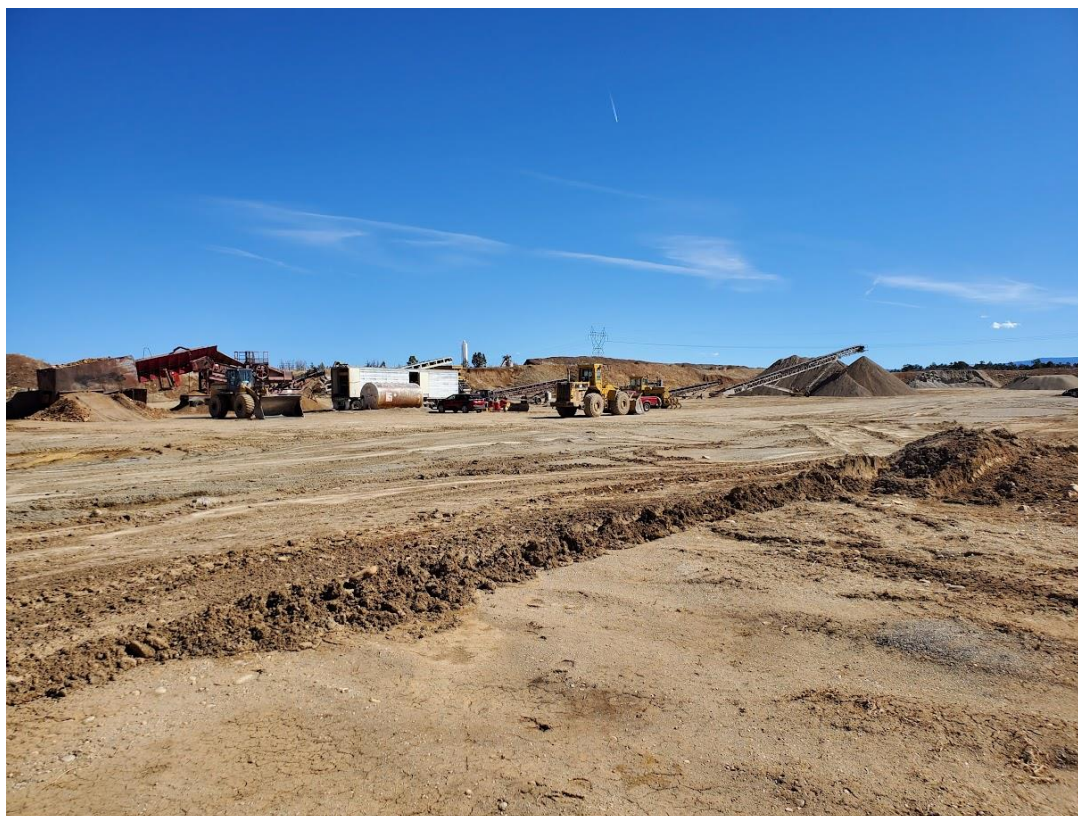
Photo 4: View to the north of processing area

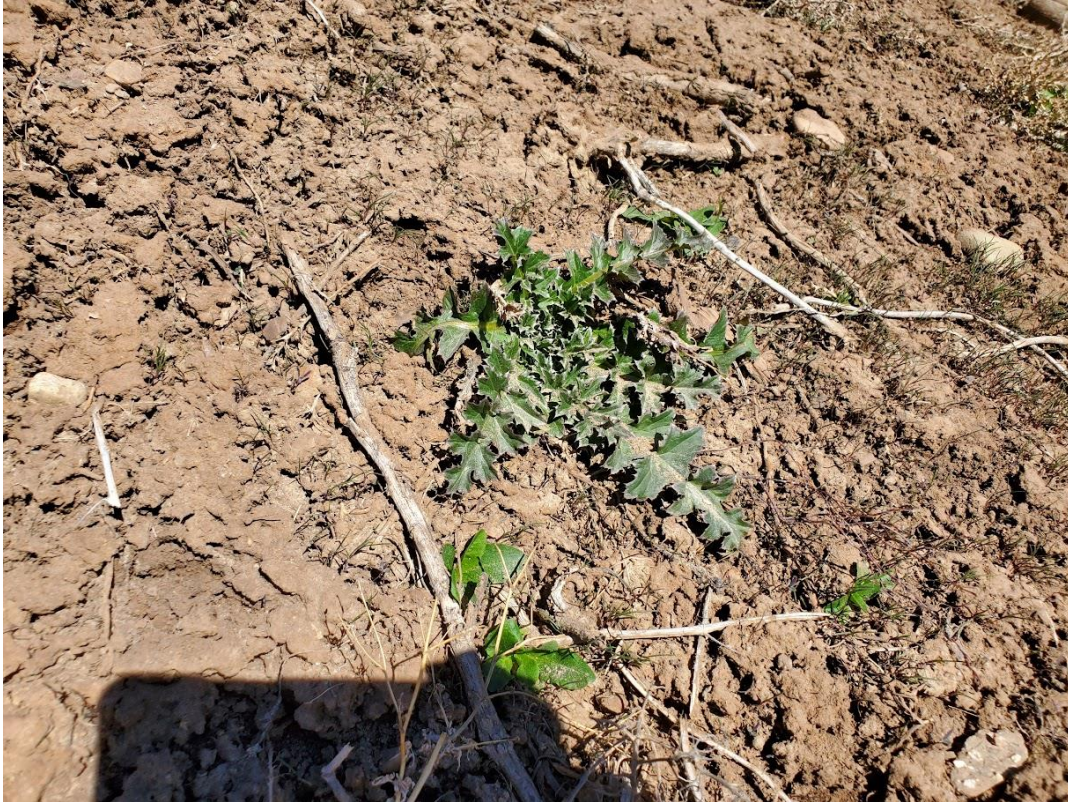
A small patch of thistle was observed to the north of the processing area. Please work with Montezuma County Noxious Weeds Program to implement a weed management plan.

Photo 5: View to the north thistle on site.

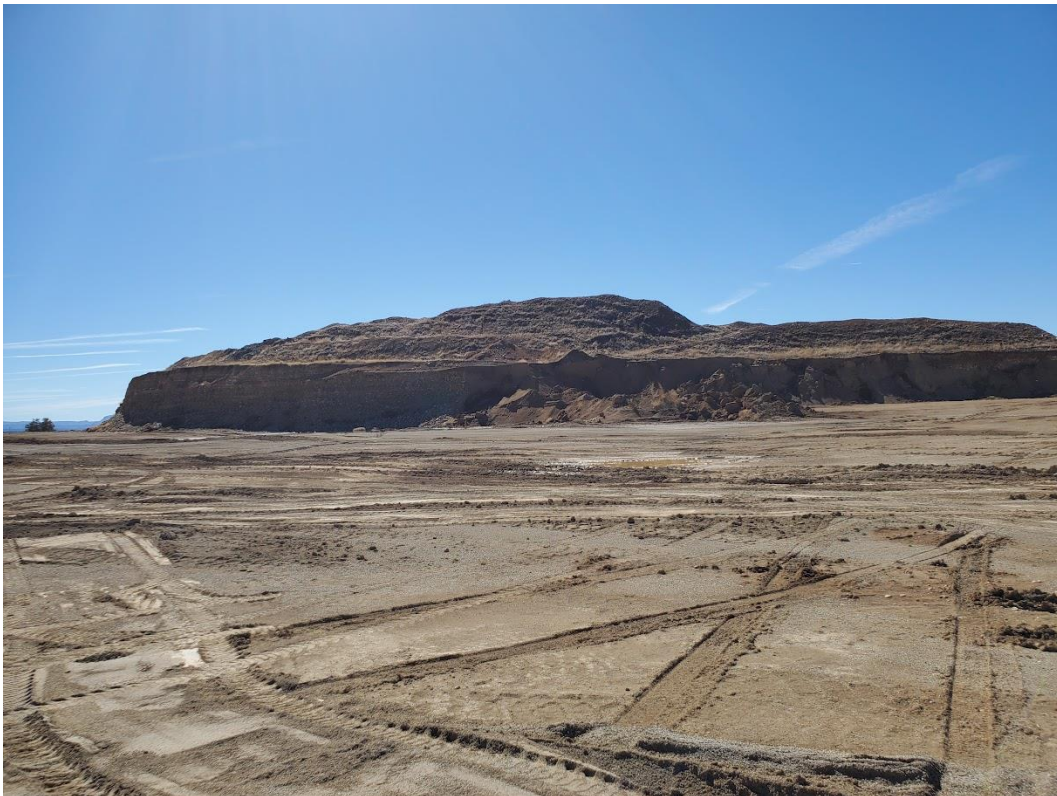
Topsoil is stored above a highwall in the southcentral area of the permit. Topsoil is protected by vegetative cover and there appears to be sufficient topsoil to complete reclamation.

Photo 6: View to the south of topsoil pile.
