MINERALS PROGRAM INSPECTION REPORT
PHONE: (303) 866-3567

MINE NAME: Never Summer Landscaping	MINE/PROSPECTING ID#: M-2025-020	MINERAL: Constuction Material	COUNTY: Saguache
INSPECTION TYPE: Illegal(Unpermitted Operation)	WEATHER: Clear	INSP. DATE: April 17, 2025	INSP. TIME: 11:00
OPERATOR: Never Summer Landscaping	OPERATOR REPRESENTATIVE: Justin Bunting	TYPE OF OPERATION: ILL - Illegal	
REASON FOR INSPECTION: Citizen Complaint	BOND CALCULATION TYPE:	BOND AMOUNT: \$0.00	
DATE OF COMPLAINT: April 8, 2025	POST INSP. CONTACTS: None	JOINT INSP. AGENCY: None	
INSPECTOR(S): Todd Jesse	INSPECTOR'S SIGNATURE:

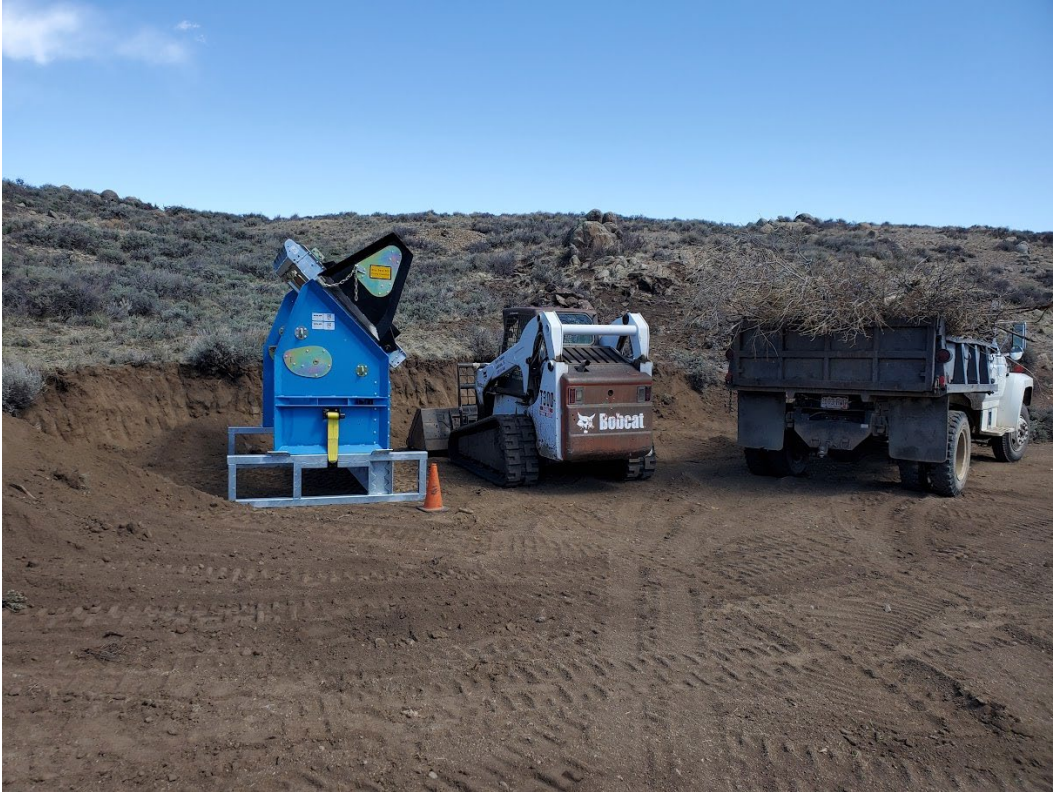
The landowner is utilizing a skid loader to create flat areas for infrastructure. There was also a haul truck with grubbed vegetation and screen on site. The screen appears unused and the operator states that it is staged there temporarily before being moved to a work site. Topsoil and some small boulders are being generated as a result of creating pads for agricultural infrastructure.

Photo 1: View to the north of excavation along roadway with screen, skidloader, and truck. To be location of shelter for horses.

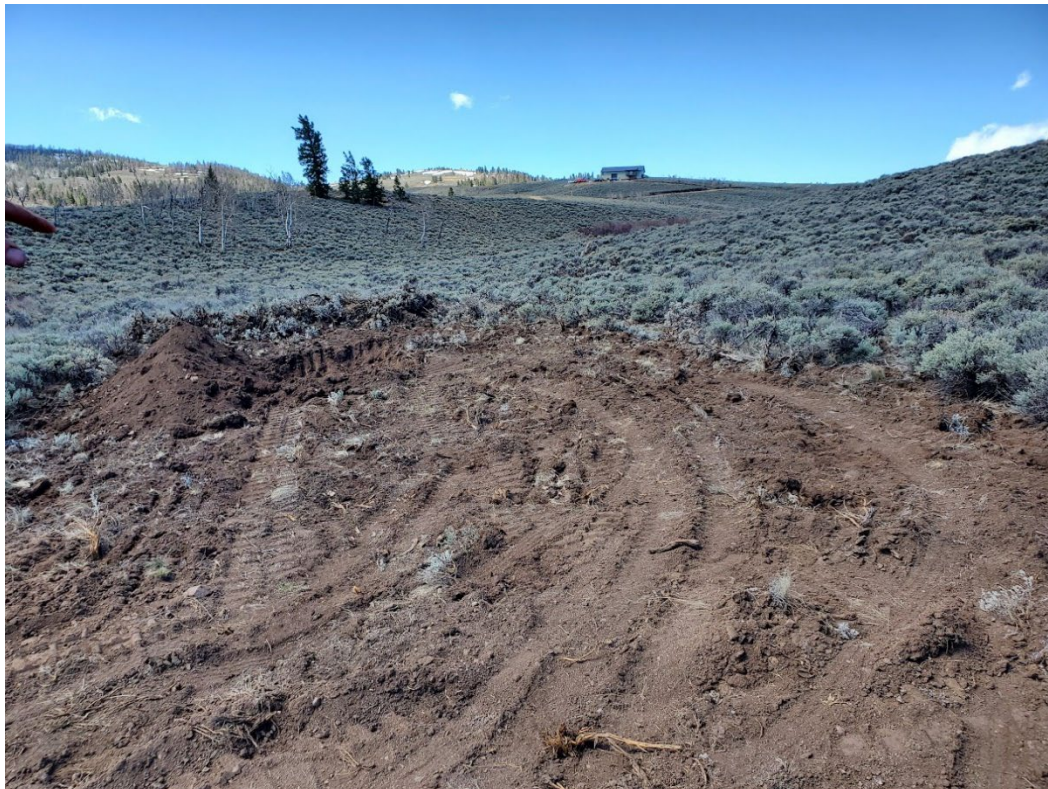
Photo 2: View to the west of grading done near roadway to create horse corral.

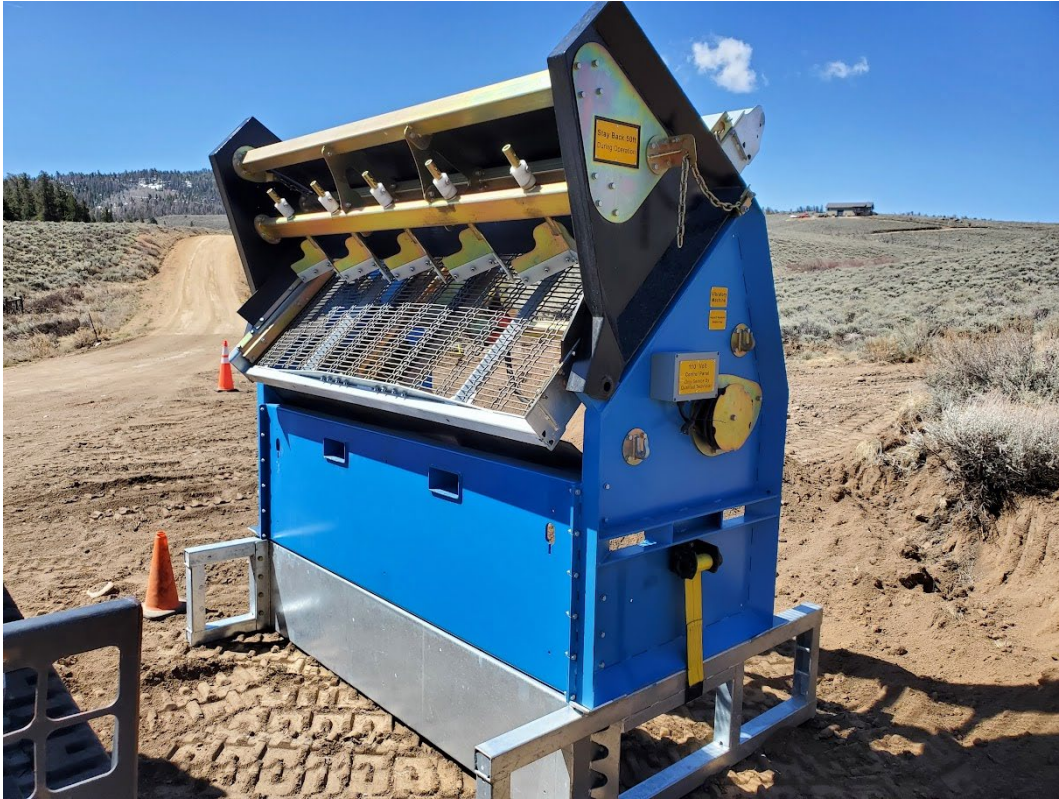
Photo 3: View to the north of screen. Screen looks new with no evidence of that it has been used.

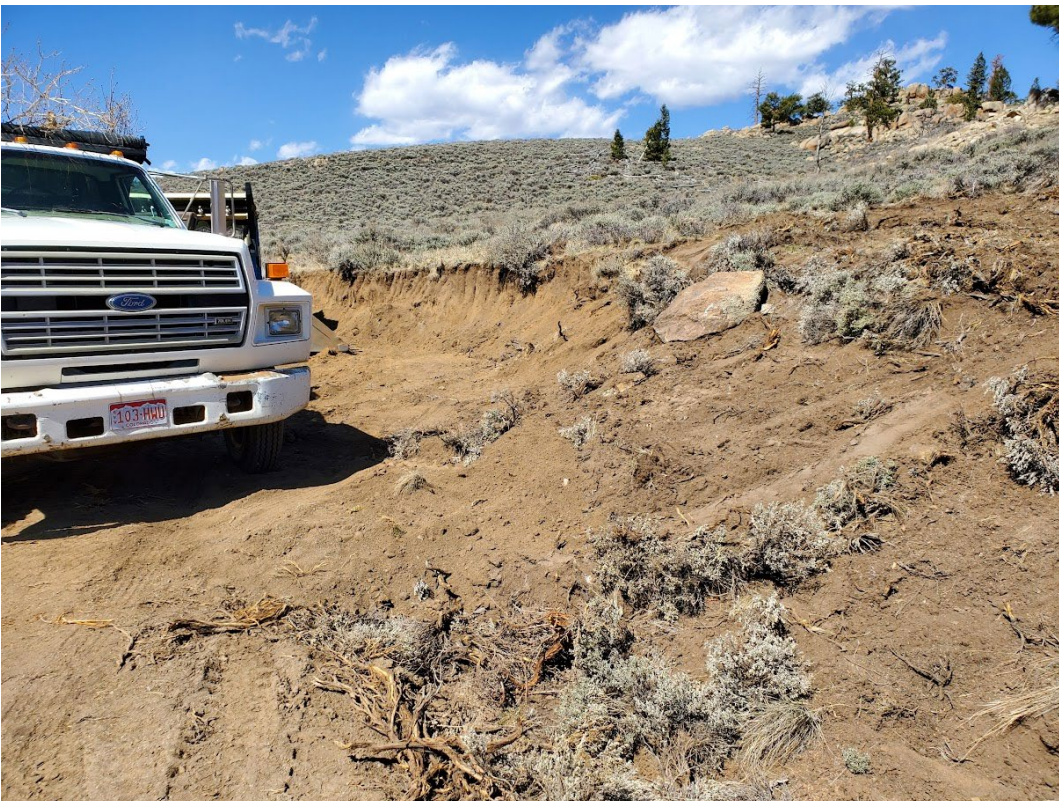
Photo 4: View to the west of excavation for horse shelter. Excavation will continue to the north.

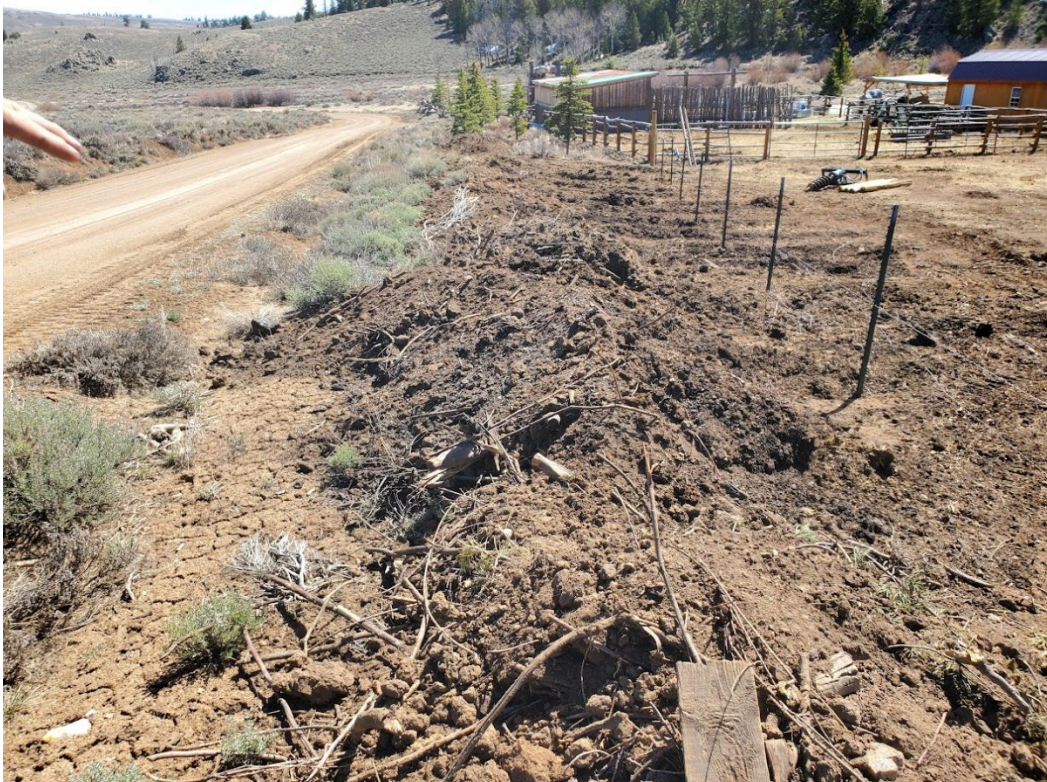
Topsoil is being generated in two adjacent locations on the property. Operator states that the shallow excavations which are generating topsoil are for infrastructure related to agriculture – specifically a horse barn and corral with access to a pasture. The Operator states that topsoil that is being generated at the site and being placed on the property as berm material or given away to neighbors – no topsoil is being sold.

Photo 5: View to the east of topsoil placement on the property.

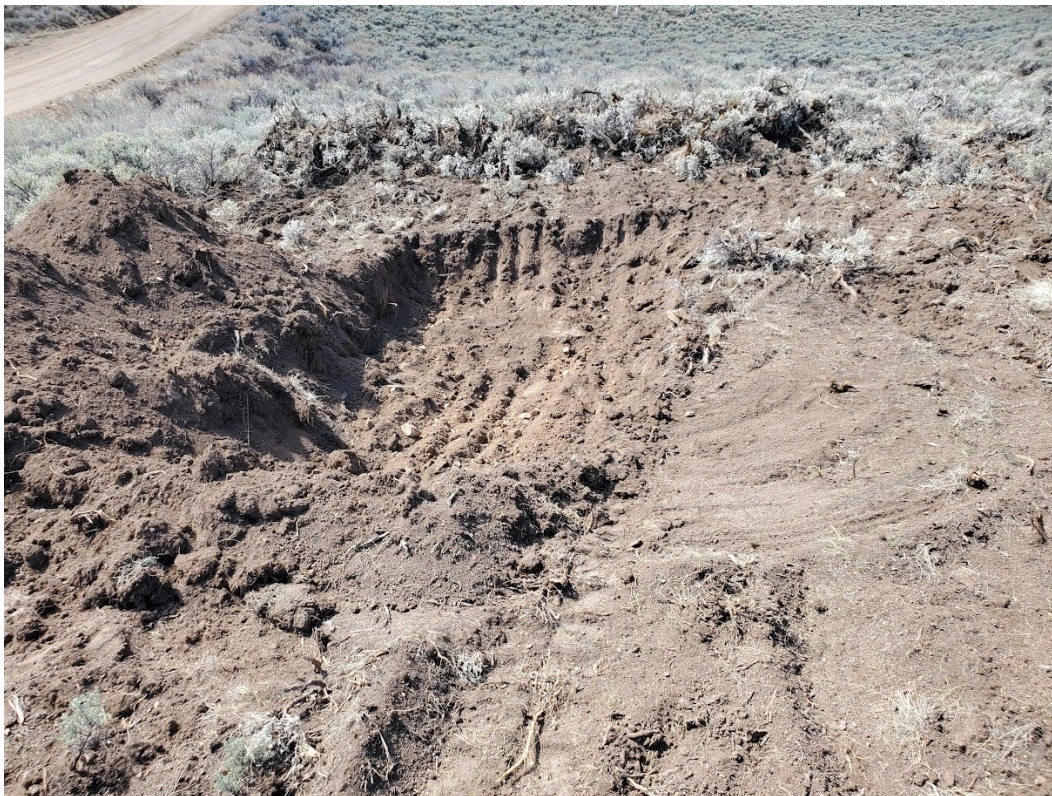
Photo 6: View to the west of excavation for well to water livestock.
