DRMS 2025 April inspection

COLORADO
 Division of Reclamation,
 Mining and Safety
 Department of Natural Resources

16 April 2025

Permit Number: C1981010 Mine Name: Trapper Mine Operator: Trapper Mining, Inc. Operator Address: Mr. Graham Roberts P.O. Box 187 Craig, CO 81626	County: Moffat Operation Type: Surface Permit Status: Active Ownership: Federal Operator Representative Present: Graham Roberts
This report was issued electronically from the Divisions' Denver Office.

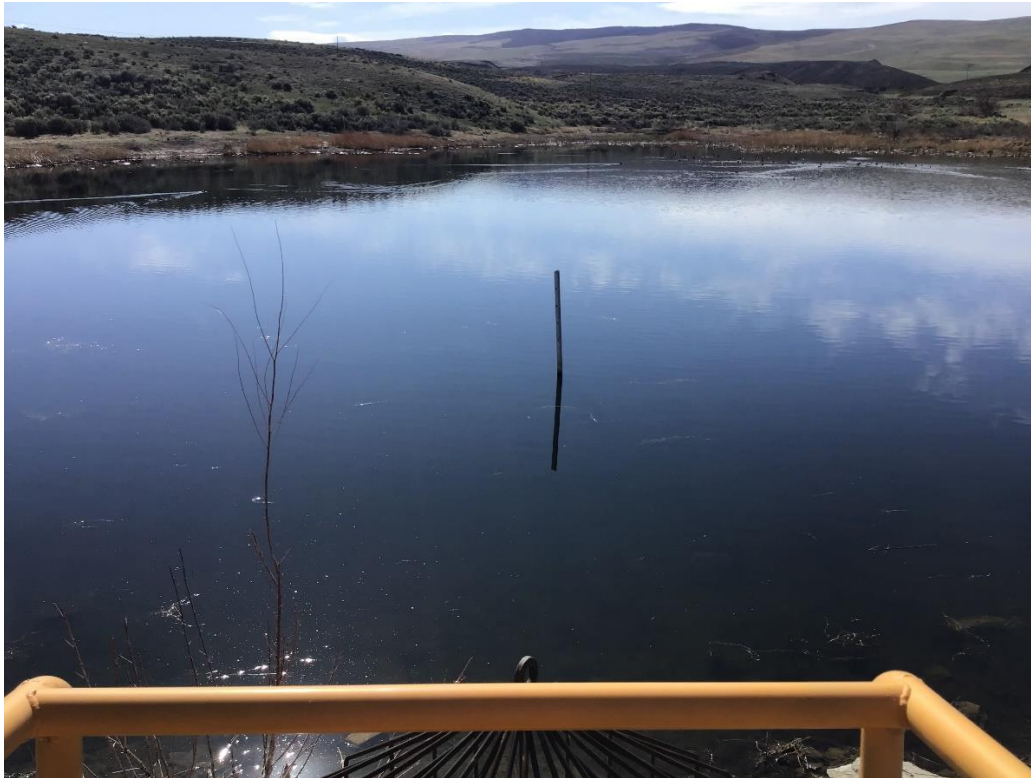
Photo 1: Coyote Pond and the decant structure looking east.

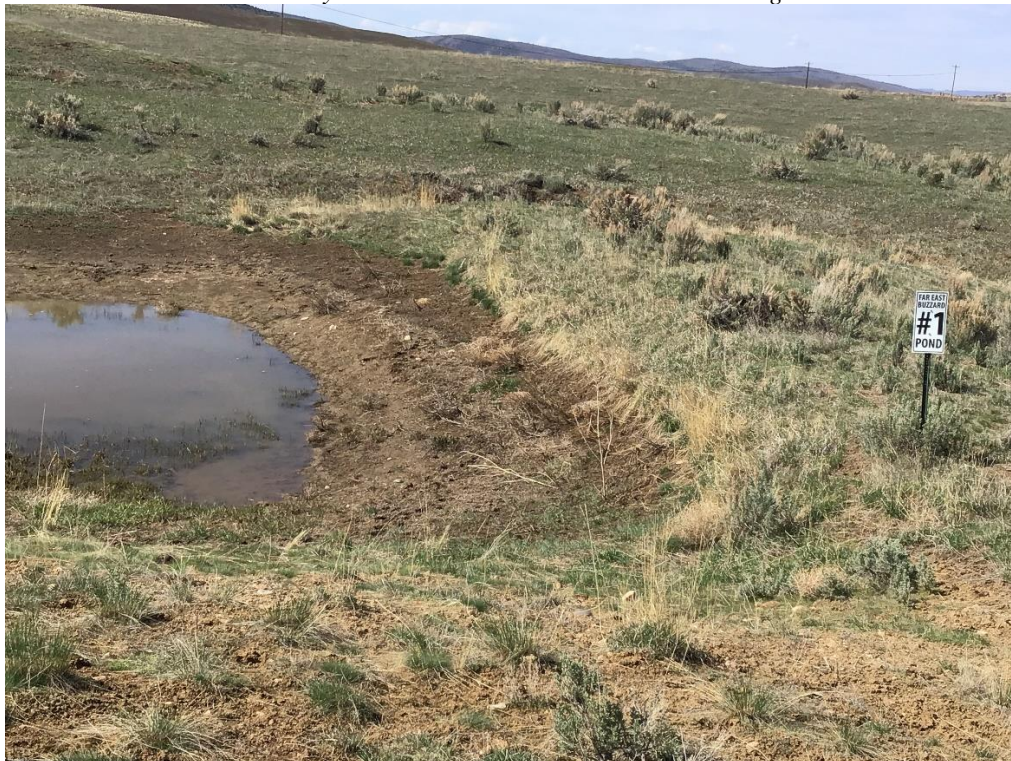
- Far East Buzzard #1: Holding a small amount of water.
- Ute #1: Holding water at the time of inspection and not discharging.
- East Flume #1: Dry at the time of inspection.

Photo 2: Far East Buzzard #1 Pond holding a small amount of water and not discharging.

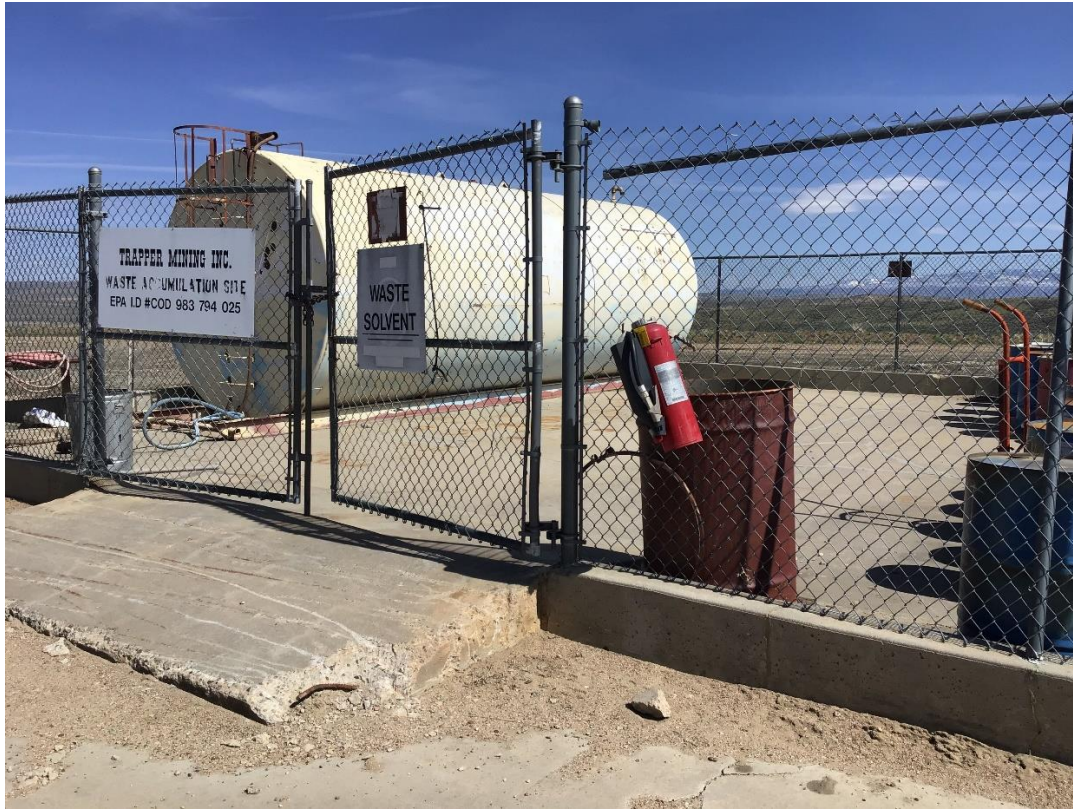
Photo 3: Waste solvent accumulation site, secured with adequate containment.

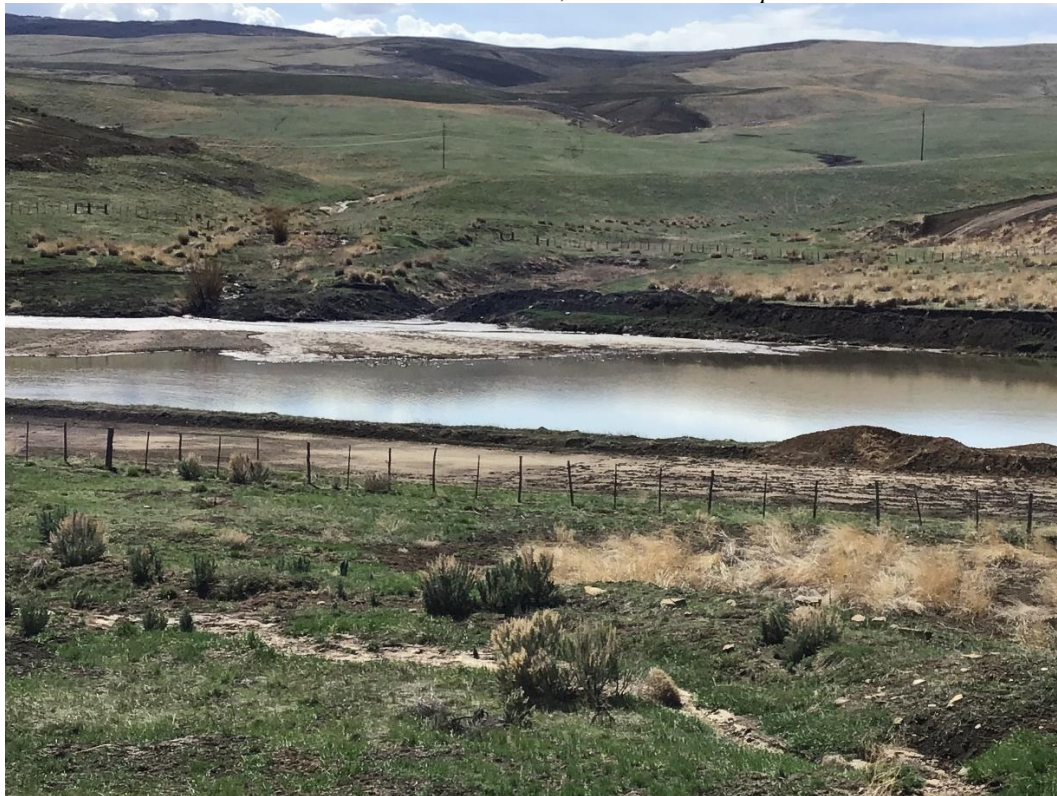
- No Name #2 shows significant sedimentation and will be dredged this summer. The pond is scheduled for dredging this summer. The pond was discharging at the time of inspection.

Photo 4: No Name Pond #2 with sediment fan from D Pit drainage looking south.
The pond was discharging at the time of inspection.

Pond dredging

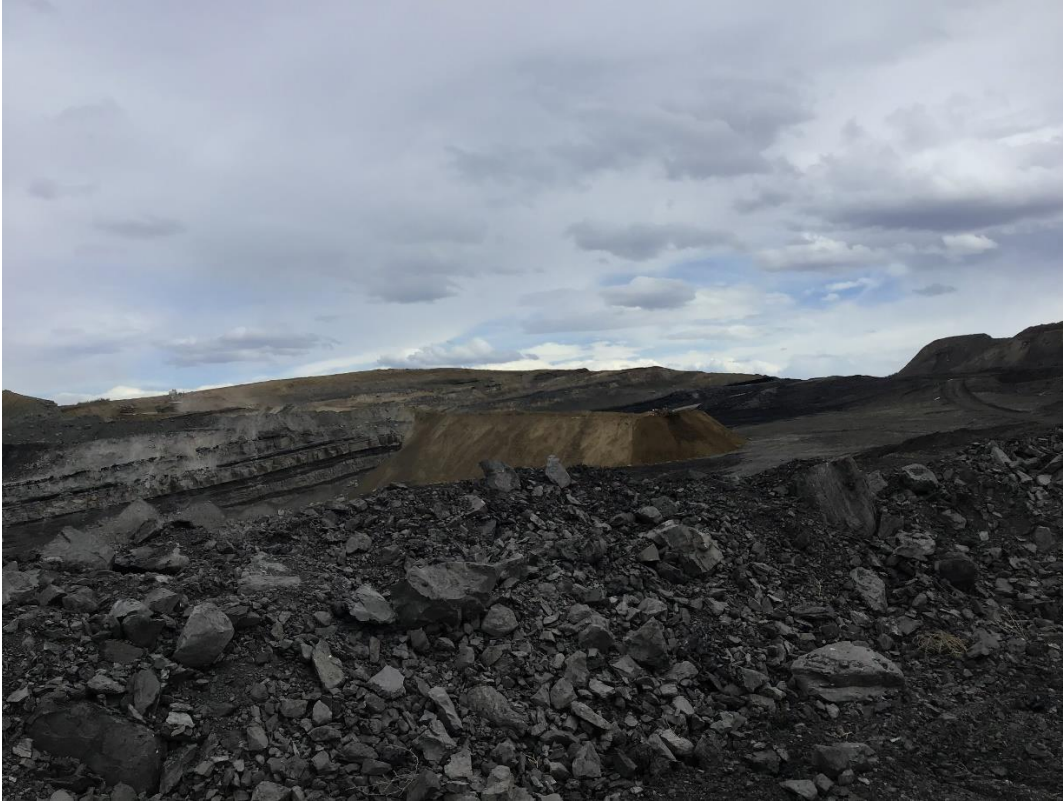
L Pit: The Baby Doe was stationed in north end of the pit and Molly Brown at the south end of the pit. Mining is occurring in the K and L seams. Overburden was being loaded and hauled.

Photo 5: View of L Pit activities looking southeast.

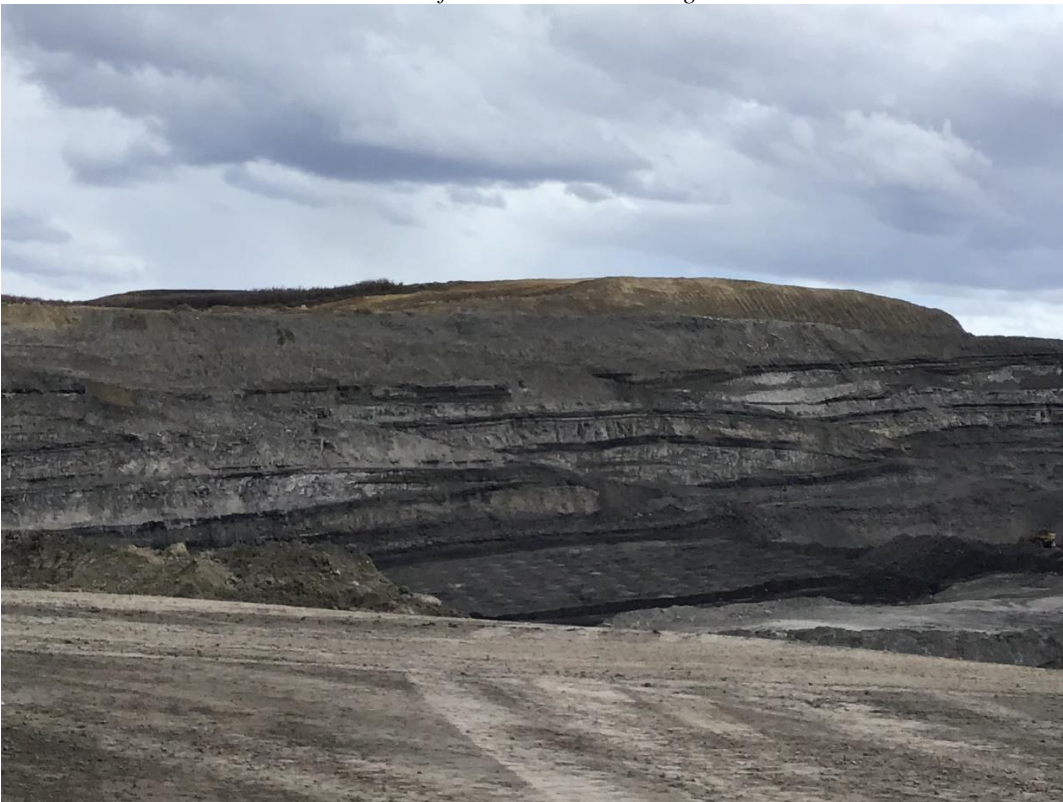
- Blasts were being developed in N and L Pits.

Photo 6: Blast prepared in L Pit looking southeast.

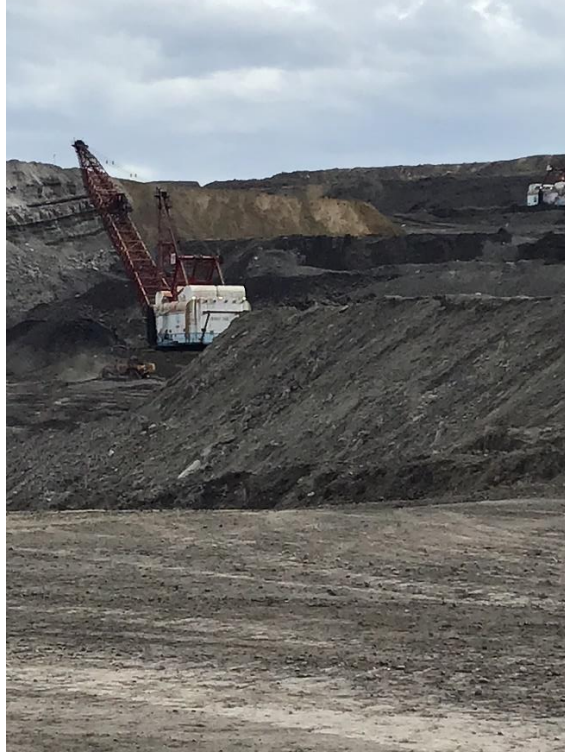
Photo 7: Drag Line working in L Pit, looking south.

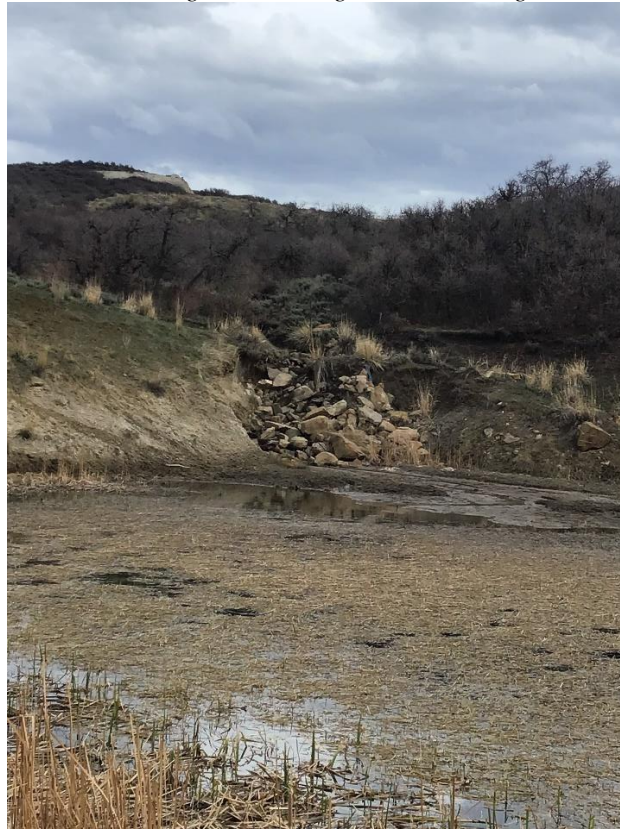
- East Middle Flume #1 is scheduled for dredging this field season. The Pond was holding water with a crop of emerging cattails covering the pond. The inlet is being eroded by clear pit water that is pumped at head of inlet.

Photo 8: East Middle Flume #1 with a crop of emerging cattails and a delta slated for dredging this field season.

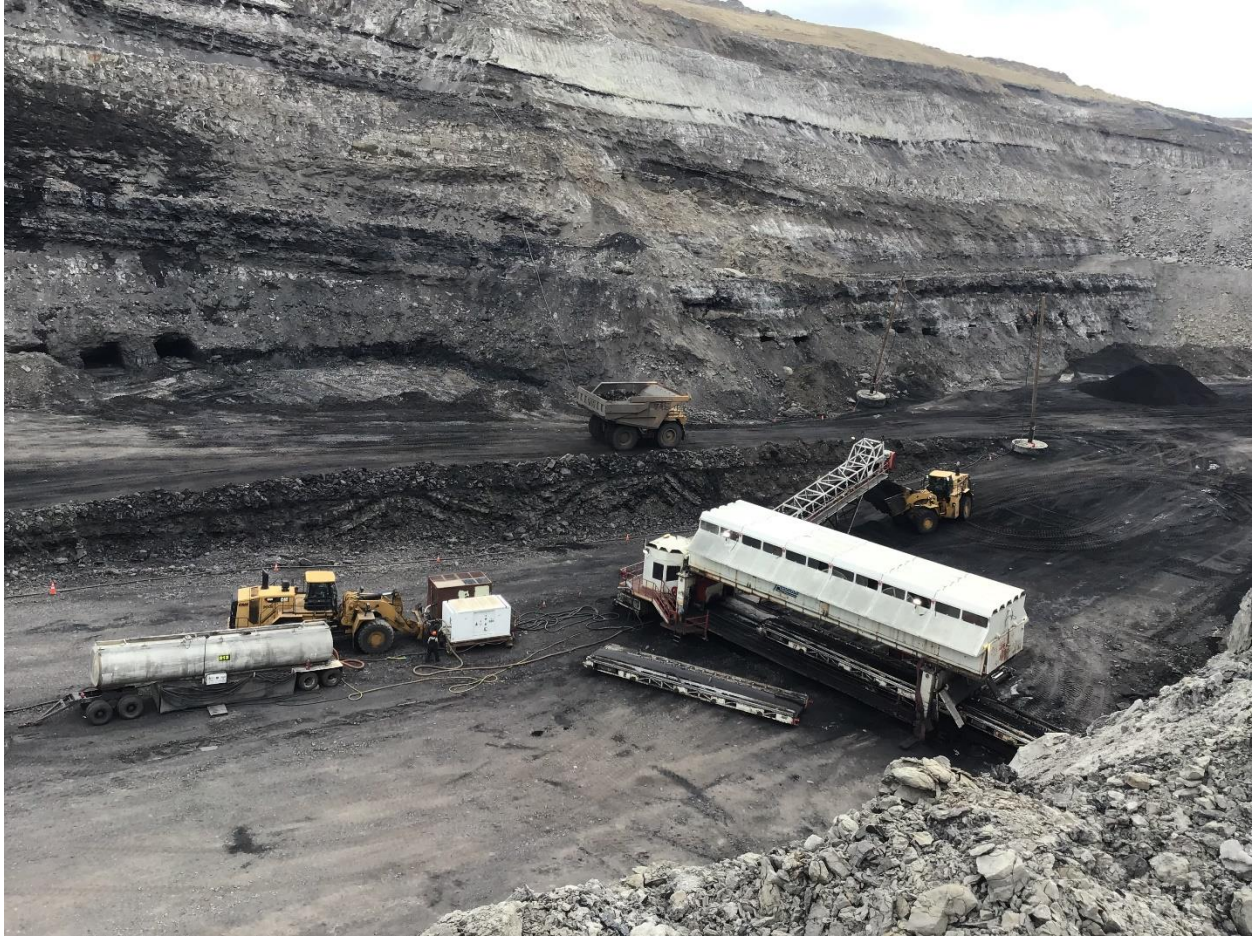
N Pit: Loading and hauling overburden from east end of N Pit. A blast was being developed at the east end of N Pit. The highwall miner was active at the time of inspection in the M seam of Panel 2 and coal was being produced.

Photo 9: View of N Pit from above looking south. Coal is being produced by the highwall miner.
