**MINERALS PROGRAM INSPECTION REPORT**  
**PHONE: (303) 866-3567**

<b>MINE NAME:</b> The Pride of America Mine	<b>MINE/PROSPECTING ID#:</b> M-1999-058	<b>MINERAL:</b> Marble	<b>COUNTY:</b> Gunnison
<b>INSPECTION TYPE:</b> Monitoring	<b>WEATHER:</b> Clear	<b>INSP. DATE:</b> April 17, 2025	<b>INSP. TIME:</b> 11:30
<b>OPERATOR:</b> Colorado Stone Quarries, Inc.	<b>OPERATOR REPRESENTATIVE:</b> Daniel Penfield	<b>TYPE OF OPERATION:</b> 112c - Construction Regular Operation	
<b>REASON FOR INSPECTION:</b> Normal I&E Program	<b>BOND CALCULATION TYPE:</b> None	<b>BOND AMOUNT:</b> \$629,887.00	
<b>DATE OF COMPLAINT:</b> NA	<b>POST INSP. CONTACTS:</b> None	<b>JOINT INSP. AGENCY:</b> None	
<b>INSPECTOR(S):</b> Dustin Czapla	<b>INSPECTOR'S SIGNATURE:</b>

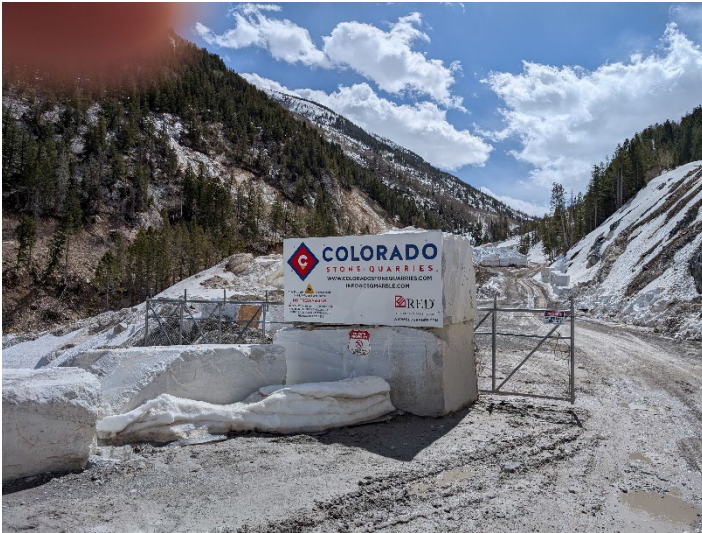
Adequate mine identification signage was noted at the entrance to the site.

Site entrance secured by locked gate

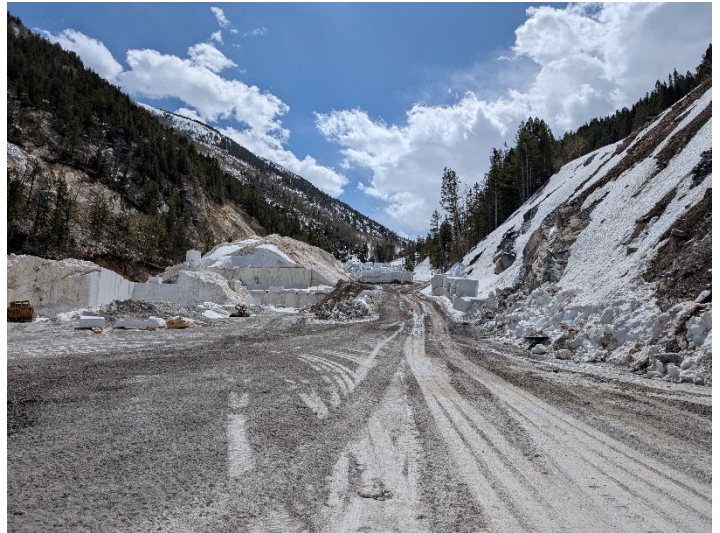
Franklin Quarry area

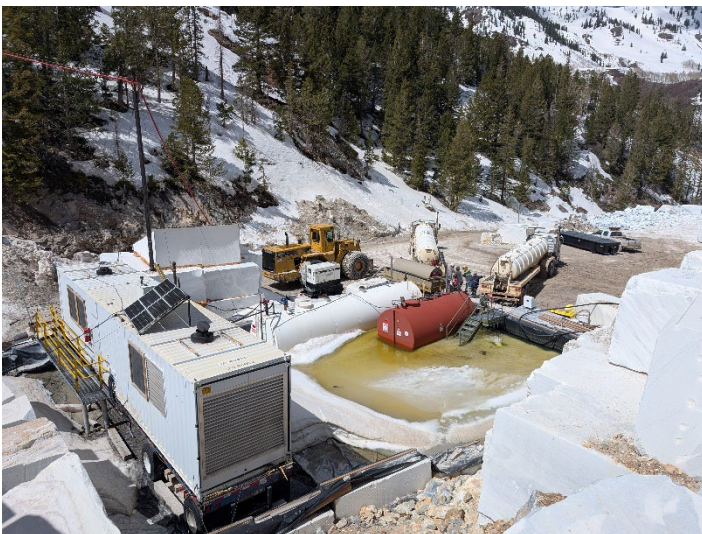
Fuel for the site is stored in the Franklin Quarry. This location was authorized through approval of TR-06. The two site gensets and associated fuel containers and fuel containment for equipment are located in a lined containment structure. Fuel tanks > 1,000 gallons are double walled. When snow melts in the spring, water collects in the containment area. Personnel were dewatering the containment during this inspection. No problems with the containment facility were noted.

Gensets and fuel storage in Franklin area

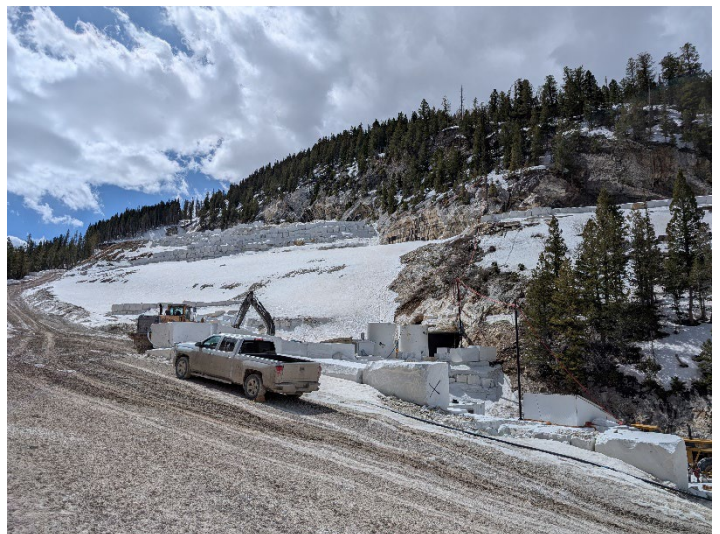
Mining observed at the site appeared to be in accordance with the approved mining plan. Waste rock piles appeared stable.

Wasterock landform above Franklin Quarry

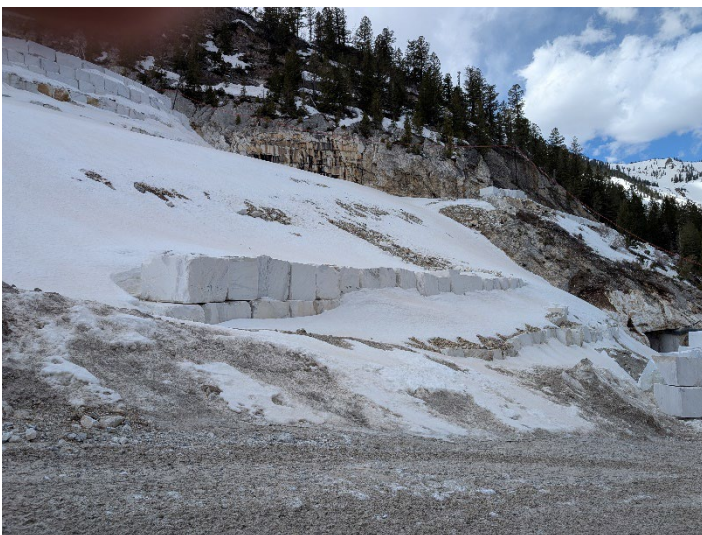
Wasterock landform above Franklin Quarry

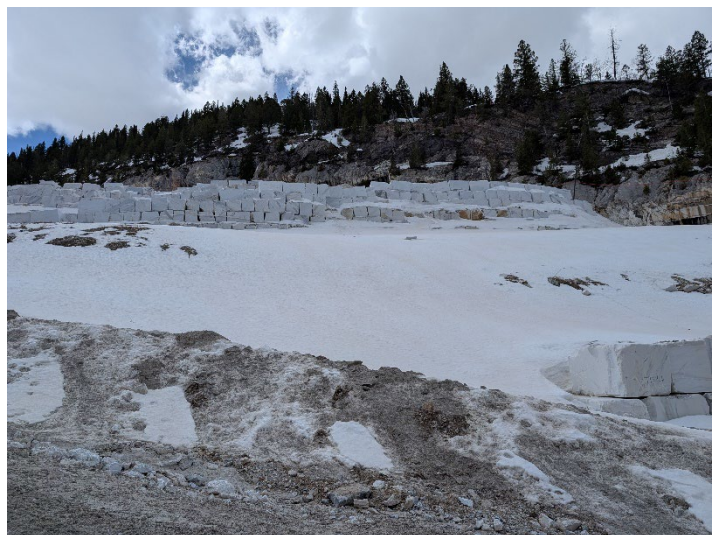
Wasterock landform above Franklin Quarry

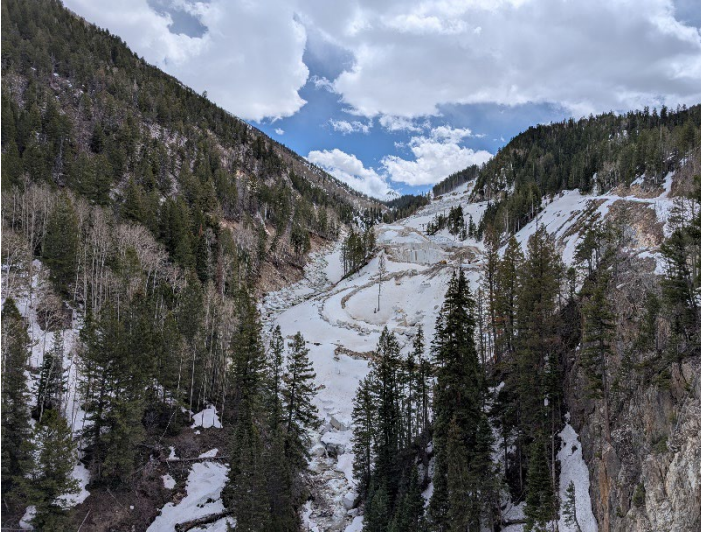
In March 2022 the U.S. Army Corp of Engineers (USACE) issued CSQ a permit authorizing the diversion of Yule Creek to its current eastern channel along with associated mitigation work to Yule Creek. This work was incorporated into the DRMS permit through TR10 in 2022. The operator has completed construction of the eastern channel of Yule Creek. The new channel appears to have been constructed in accordance with the approved plans and appears stable. Transplanted willows are beginning to take hold on the banks. No problems were noted in this area.

View of Yule Creek eastern channel

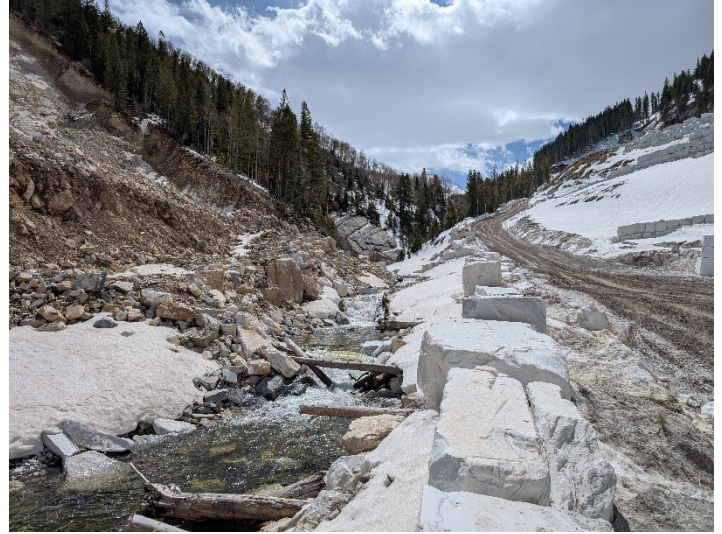
Yule Creek constructed eastern channel

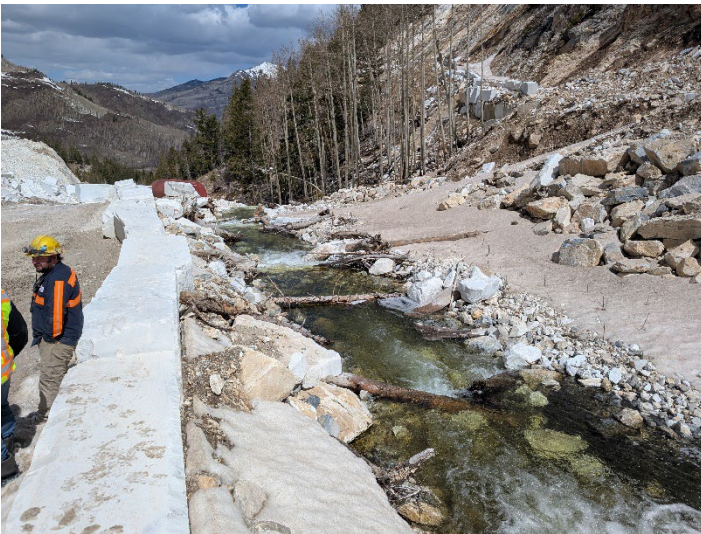
Yule Creek constructed eastern channel

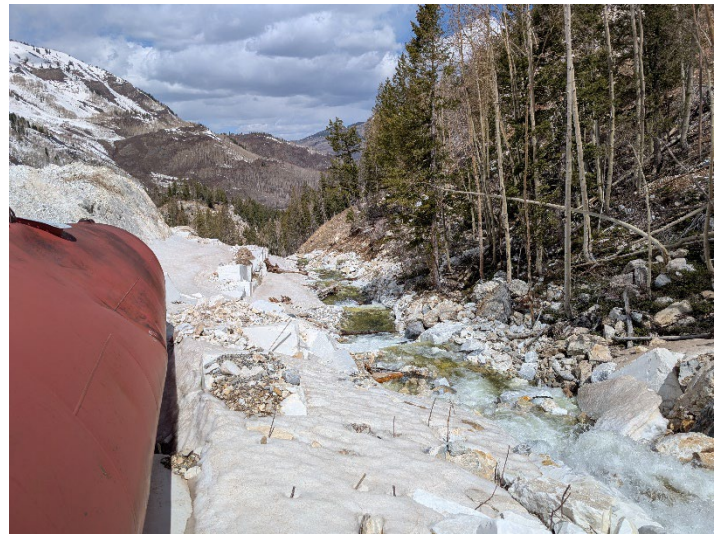
Yule Creek constructed eastern channel

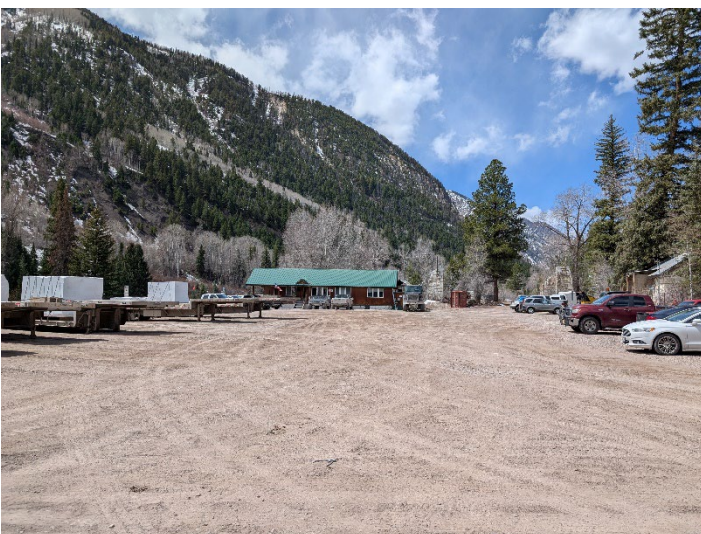
The staging area appears orderly and well maintained.

Staging area
