**MINERALS PROGRAM INSPECTION REPORT**  
**PHONE: (303) 866-3567**

<b>MINE NAME:</b> Two Sheep for One Brick Mine	<b>MINE/PROSPECTING ID#:</b> M-2020-047	<b>MINERAL:</b> Clay (general), gravel and sand	<b>COUNTY:</b> Gunnison
<b>INSPECTION TYPE:</b> Monitoring	<b>WEATHER:</b> Clear	<b>INSP. DATE:</b> April 17, 2025	<b>INSP. TIME:</b> 13:45
<b>OPERATOR:</b> Delta Brick & Climate Company Ltd	<b>OPERATOR REPRESENTATIVE:</b> None	<b>TYPE OF OPERATION:</b> 110c - Construction Limited Impact	
<b>REASON FOR INSPECTION:</b> Normal I&E Program	<b>BOND CALCULATION TYPE:</b>	<b>BOND AMOUNT:</b> \$2,500.00	
<b>DATE OF COMPLAINT:</b> NA	<b>POST INSP. CONTACTS:</b> None	<b>JOINT INSP. AGENCY:</b> None	
<b>INSPECTOR(S):</b> Dustin Czapla	<b>INSPECTOR'S SIGNATURE:</b>

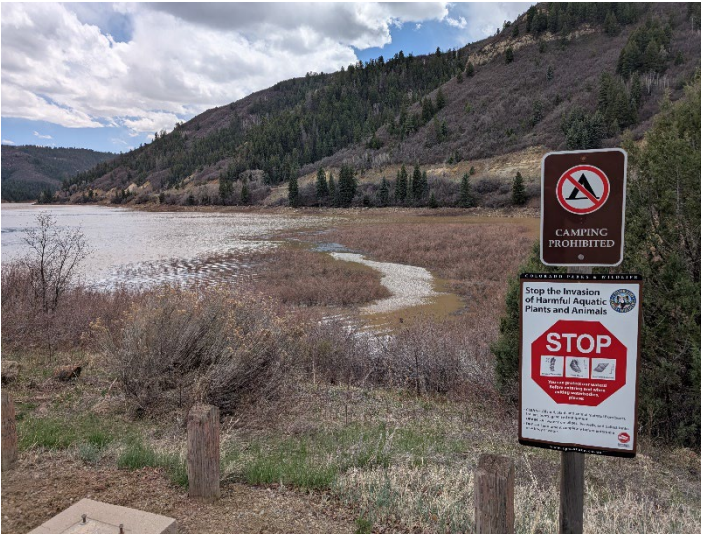
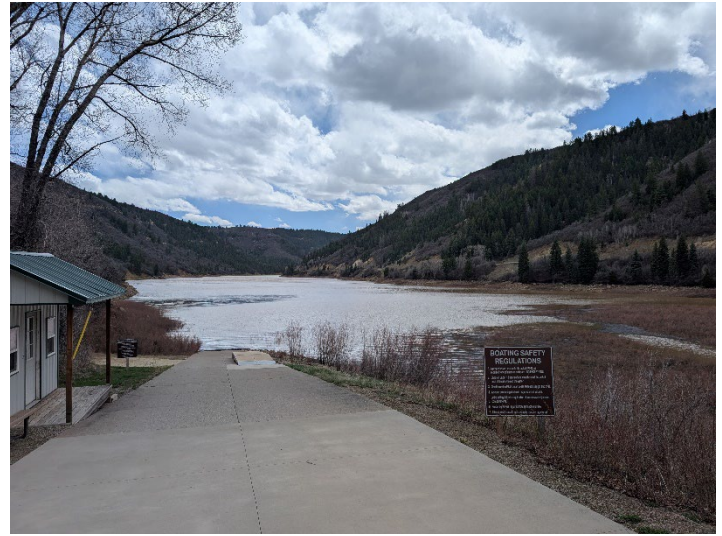
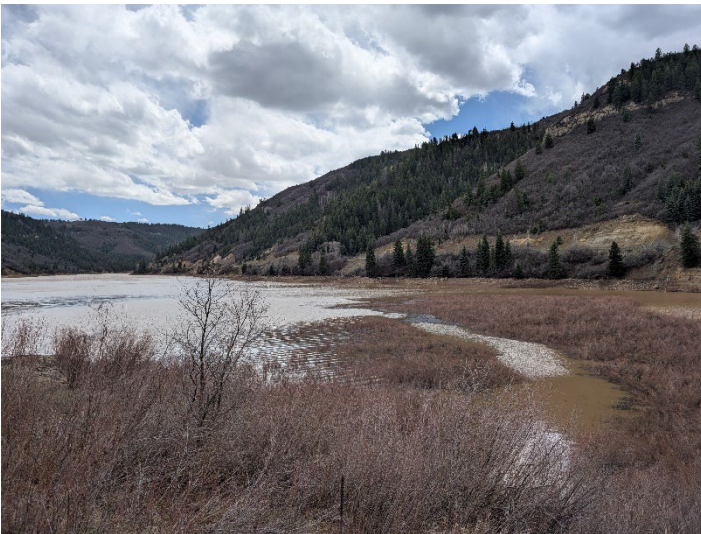
This is an intermittent operation that removes sediment that has accumulated in the reservoir, for use in ceramics manufacturing. Excavation was not occurring during this inspection. Mining equipment is not stored on site. The excavation area is inundated seasonally and self-reclaims as it refills with sediment. The excavation area was under water during this inspection. The excavation area is indiscernible from the surrounding area.
