MINERALS PROGRAM INSPECTION REPORT PHONE: (303) 866-3567

M-2006-021	Sandstone (silica,	Larimer
	stone, quartzite)	
WEATHER:	INSP. DATE:	INSP. TIME:
Cloudy	April 2, 2025	11:00
OPERATOR REPRESENTATIVE:	TYPE OF OPERATION:	
Mr. Justyn Hamilton	112c - Construction Regular Operation	
BOND CALCULATION TYPE:	BOND AMOUNT:	
Complete Bond	\$39,059.00	
POST INSP. CONTACTS:	JOINT INSP. AGENCY:	
None	None	
INSPECTOR'S SIGNATURE:	SIGNATURE DAT	E:
Jon Rath	April 25, 2025	
	Cloudy OPERATOR REPRESENTATIVE: Mr. Justyn Hamilton BOND CALCULATION TYPE: Complete Bond POST INSP. CONTACTS: None	Cloudy April 2, 2025 OPERATOR REPRESENTATIVE: TYPE OF OPERAT Mr. Justyn Hamilton 112c - Construction I BOND CALCULATION TYPE: BOND AMOUNT: Complete Bond \$39,059.00 POST INSP. CONTACTS: JOINT INSP. AGEN None None INSPECTOR'S SIGNATURE: SIGNATURE DATE

The Glade Quarry, Permit No. M-2006-021, was inspected by me, Jocelyn Carter, on behalf of the Division of Reclamation, Mining, and Safety (Division/DRMS). Mr. Justyn Hamilton was present for the inspection on behalf of the operator, Glade, LLC. The weather at the time of the inspection was partially cloudy and windy with cold temperatures.

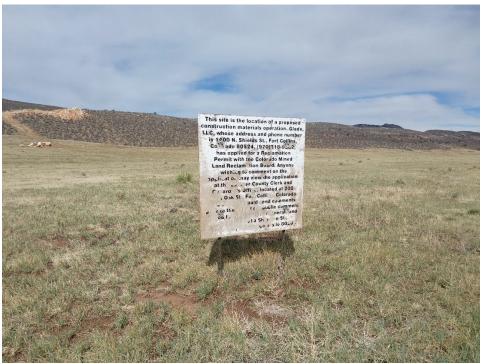
The posted mine sign is the original sign posted for the purpose of applying for an MLRB permit and needs to be updated, see Photo #1. According to the last inspection report, dated June 13, 2023, the operator was advised to post an updated and legible sign in accordance with Rule 3.1.12(1). Problem #1, given above, is in regard to the mine sign not being eligible and needing to be updated. According to Rule 3.1.12(1), the posted mine sign should be clearly visible from the access road, a minimum size of 187 square inches (11" h x 17" w), with appropriate font size and the following information:

Photo #1: The posted mine sign. It is worn and illegible and needs to be replaced. The recent disturbance can be seen in the background to the left of the sign.

- Operation name
- Operator's name
- Permit Number
- A statement that a reclamation permit for the operation has been issued by the Colorado Mined Land Reclamation Board (MLRB)

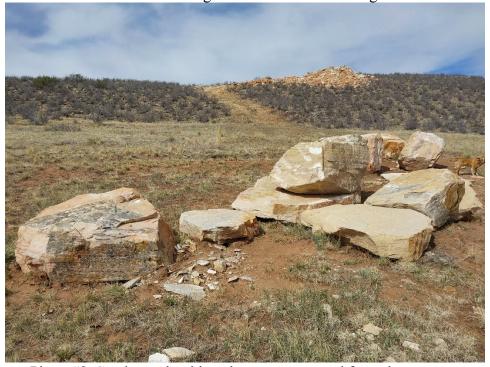
Glade Quarry is located about 4.5 miles north of the town of Laporte in Larimer County, Colorado. Access to the site is on the west side of U.S. Highway 287. The operation is a 112c with 46.49 acres permitted and extracts sandstone. Mining activity started in July of 2024 according to the most recent annual report and about 0.5 acres have been disturbed along an outcrop of sandstone that runs north-south through the area. A few sandstone boulders had been removed and placed along the internal road, see Photo #2.

Photo #2: Sandstone boulders that were removed from the outcrop.

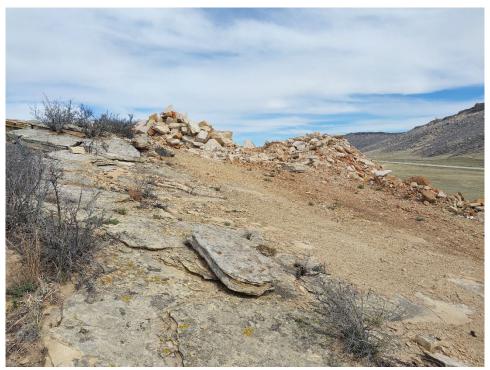
Photo #3: Disturbance along the top of the sandstone outcrop, looking north.

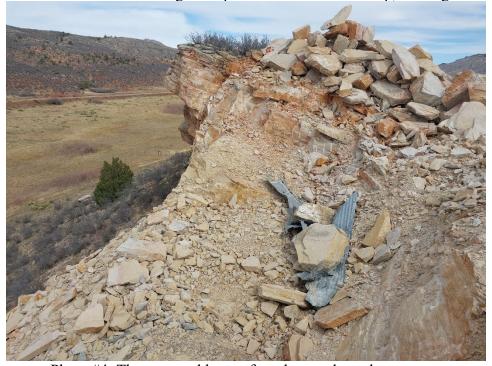
No equipment was on site and mining activities were not taking place at the time of the site visit. According to My. Hamilton, the exposed sandstone is not stratified as was expected and the operator is reassessing how the material will be removed and processed, see Photo #4. Additionally, the county is still moving forward with the development of Glade Reservoir which will result in the site to be submerged. The reservoir project will require U.S. Highway 287 to be re-routed. The operator was advised that as the reservoir project progresses, and changes to how the site is accessed, technical revisions will need to be submitted to keep the Division informed and the permit file up to date and accurate.

Photo #4: The removed layer of sandstone along the outcrop.
