MINERALS PROGRAM INSPECTION REPORT
PHONE: (303) 866-3567

MINE NAME: Climax Mine	MINE/PROSPECTING ID#: M-1977-493	MINERAL: Molybdenum	COUNTY: Lake
INSPECTION TYPE: Monitoring	WEATHER: Clear	INSP. DATE: April 16, 2025	INSP. TIME: 10:30
OPERATOR: Climax Molybdenum Company, Climax Mine	OPERATOR REPRESENTATIVE:	TYPE OF OPERATION: 112d-3 - Designated Mining Operation	
REASON FOR INSPECTION: Normal I&E Program	BOND CALCULATION TYPE:	BOND AMOUNT: \$284,783,656.00	
DATE OF COMPLAINT: NA	POST INSP. CONTACTS: None	JOINT INSP. AGENCY: None	
INSPECTOR(S): Todd Jesse	INSPECTOR'S SIGNATURE:

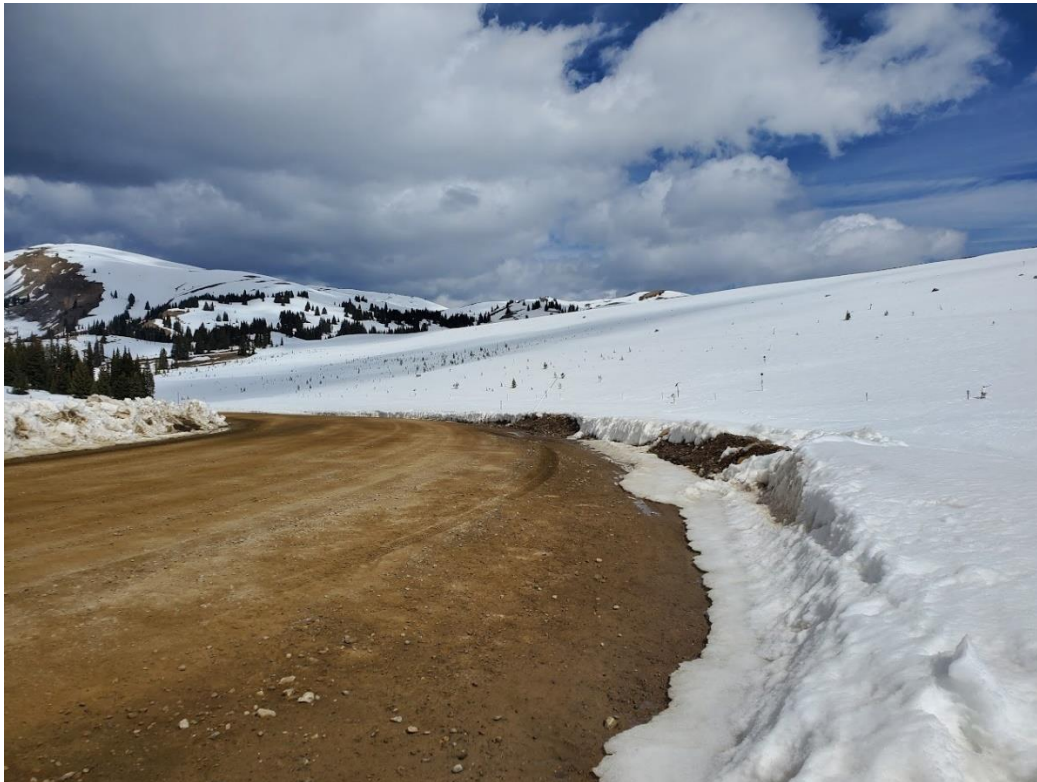
The Robinson TSF and pond are an EPF and function as the primary process water storage facility for the site. The reservoir stores process water that is collected from the Tenmile and Mayflower TSFs and delivered through the Tenmile Tunnel. 1 Dam (Photo 1) forms the eastern embankment of the Robinson TSF. The operator will be creating a reclamation plot on the southern end of the dam in the near future. No excessive erosion or displacement was observed on 1 Dam. 4 Dam (Photo2) is below the TSF in Eagle Park. The dam appeared stable at the time of the inspection with no signs of excessive erosion from stormwater. 2 Dam on the northern end of the Robinson TSF is partially inundated by the upstream portion of the Tenmile TSF in the Tenmile Creek drainage. The road that crosses the top of 2 Dam was clear of snow but had deep mud (Photo 3). No excessive erosion or displacement was observed on the dam. The area was covered by snow during this inspection.

Photo 1: View to the northwest of 1 Dam.

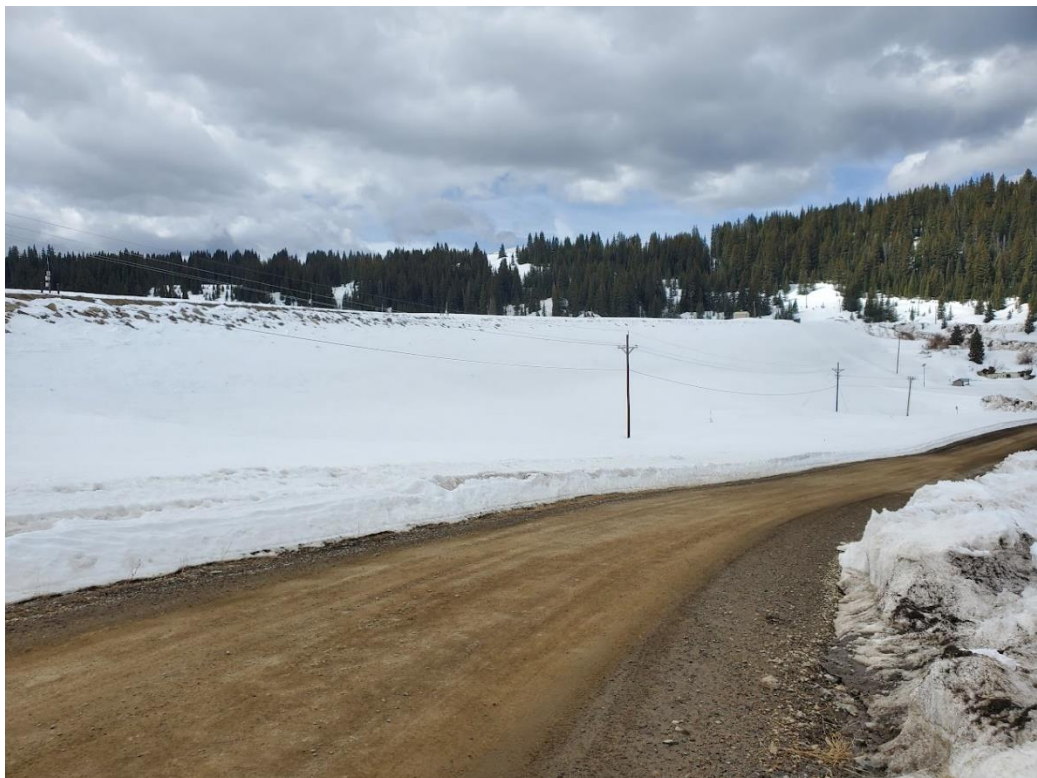
Photo 2: View to the south of 4 Dam.

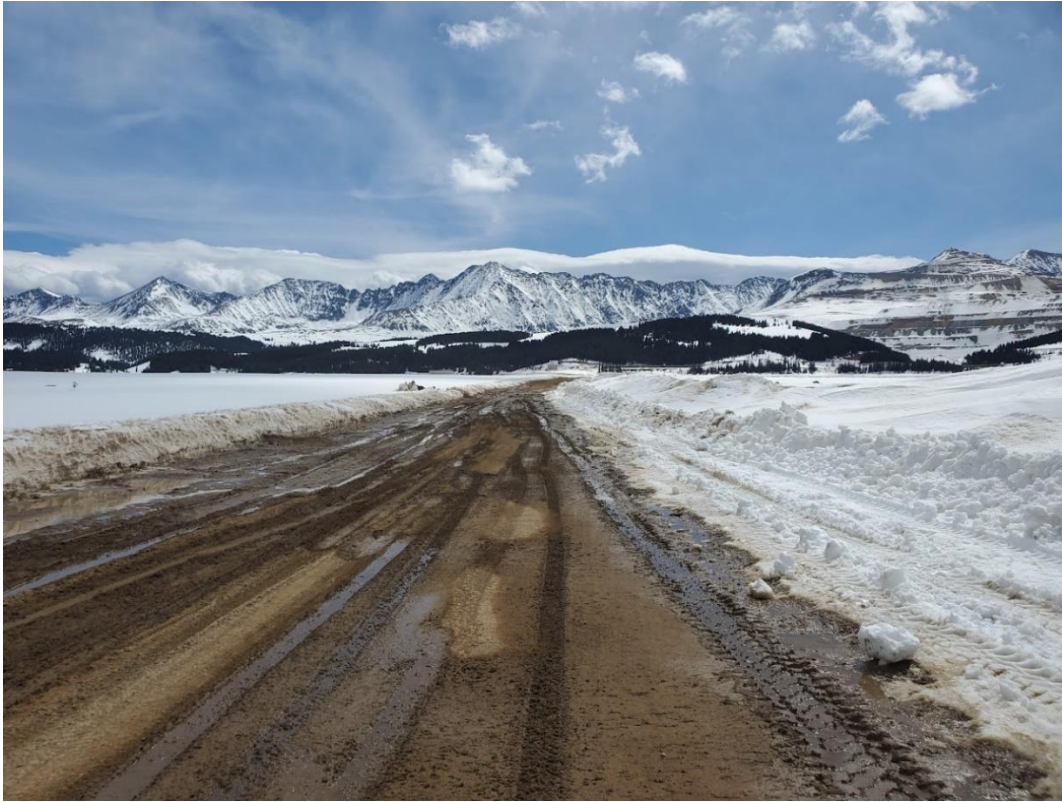
Photo 3: View to the east of road across 2 Dam.

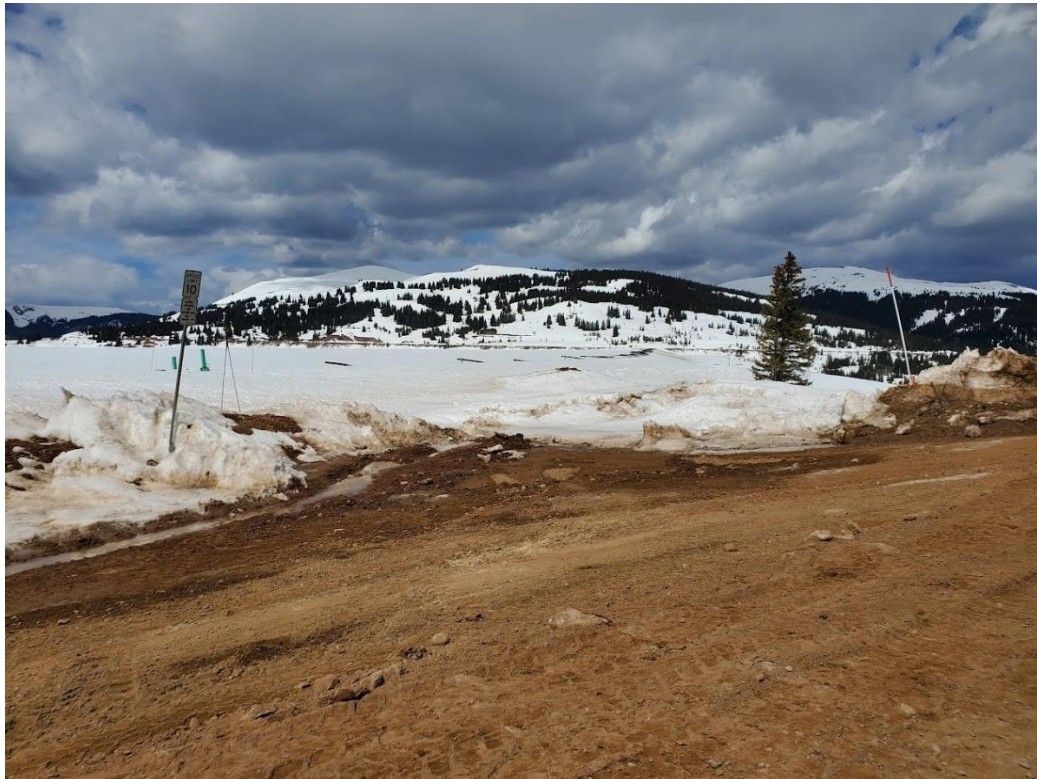
The Tenmile TSF (Photo 4) and 3 Dam (Photo 5) are downstream of the Robinson TSF and 2 Dam in the Tenmile Creek Watershed. The Tenmile TSF contains acid-generating material. Mill tailings are delivered to the TSF through the tailings delivery line. A water pool is maintained at the upstream end of the Tenmile TSF for process water storage, storm water management, and as the first stage in the water treatment system. Seepage from 3 Dam is routed to a collection pond and pumped back by vertical turbine pumps to the Sludge Densification Plant or diverted to the water pool on the Mayflower TSF. The pumping system is located within the 3 Dam Pump Station below the Tenmile TSF. The area was covered by snow during this inspection. There was no excessive stormwater erosion noted on the dam face and berms along the benching of the dam appear to be functioning as designed. No slumping or displacement was observed.

Photo 4: View to the west of Tenmile Tailings Storage Facility and top of 3 Dam.

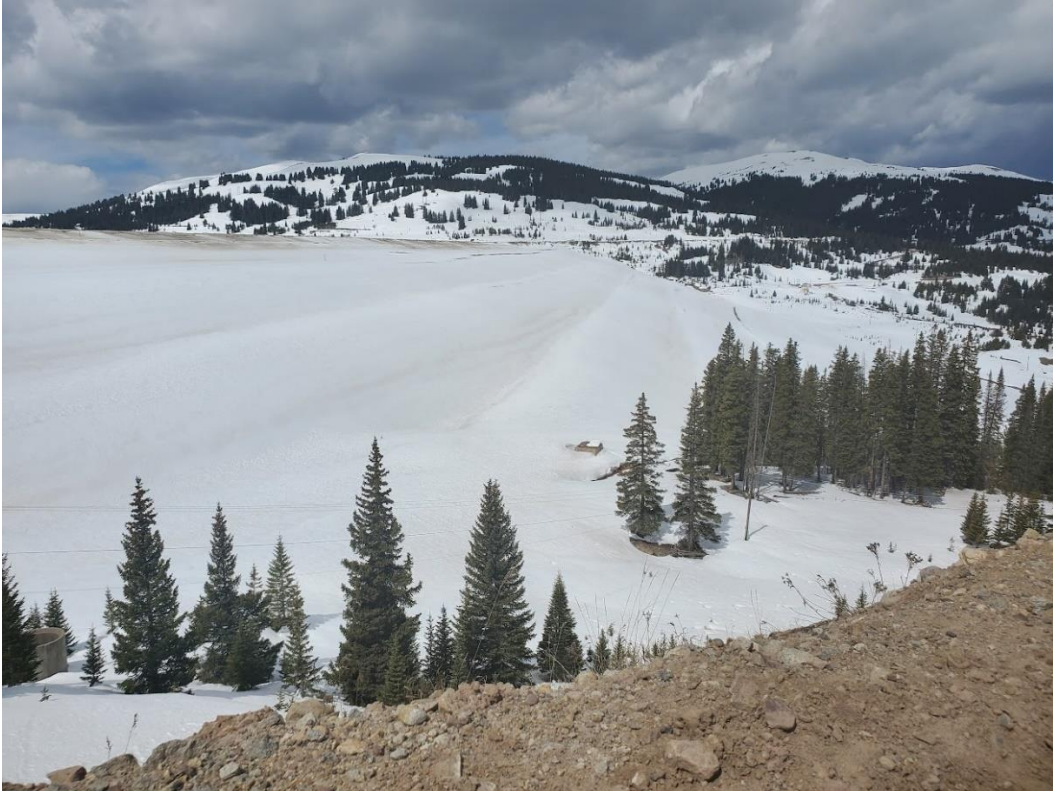
Photo 5: View to the west of 3 Dam.

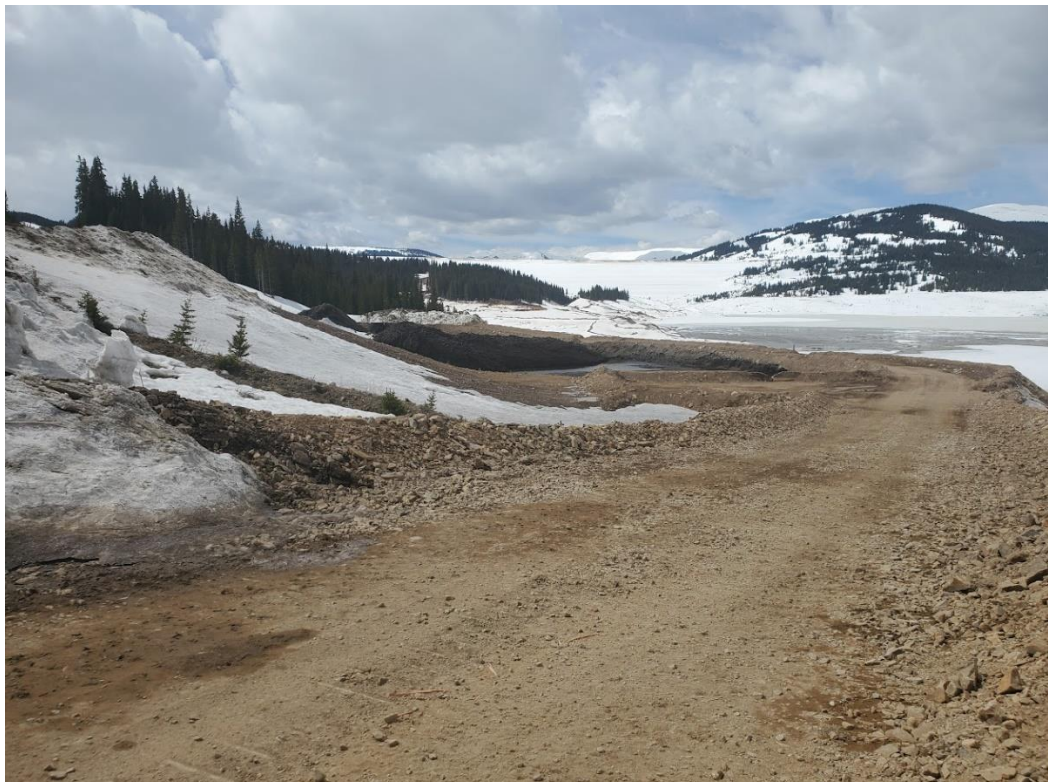
TENORM waste generated in the water purification process before it is shipped off site (Photo 7). Below 5 Dam, collected seepage is pumped back by vertical turbine pumps to the 3 Dam Pump Station or the water pool on the Mayflower TSF. The 5 Dam face was covered by snow during this inspection (Photo 8). There was no excessive stormwater erosion noted on the dam face and berms along the benching of the dam appear to be functioning as designed. No slumping or displacement was observed.

Photo 6: View to the south of TENORM sludge cell.

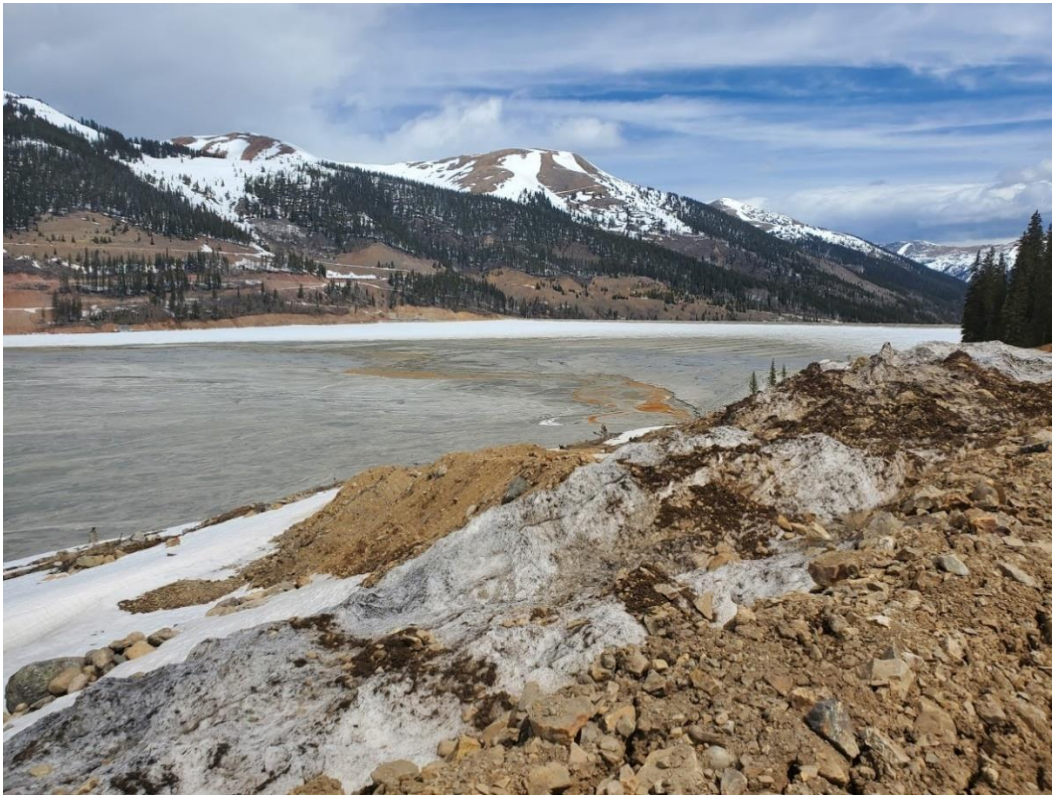
The Mayflower TSF (Photo 6) and 5 Dam are the last downstream TSF in the Tenmile Creek Watershed. The TSF contains acid-generating material. To prevent dam failure, the Mayflower TSF includes an emergency flood bypass tunnel. Along with tailings storage, the Mayflower TSF also provides containment of contaminated materials or designated chemicals that might be accidentally released up-gradient of the TSF. There is also a sludge cell located adjacent to the east of the Mayflower TSF. The sludge cell is to store

Photo 7: View to the north of Mayflower TSF.

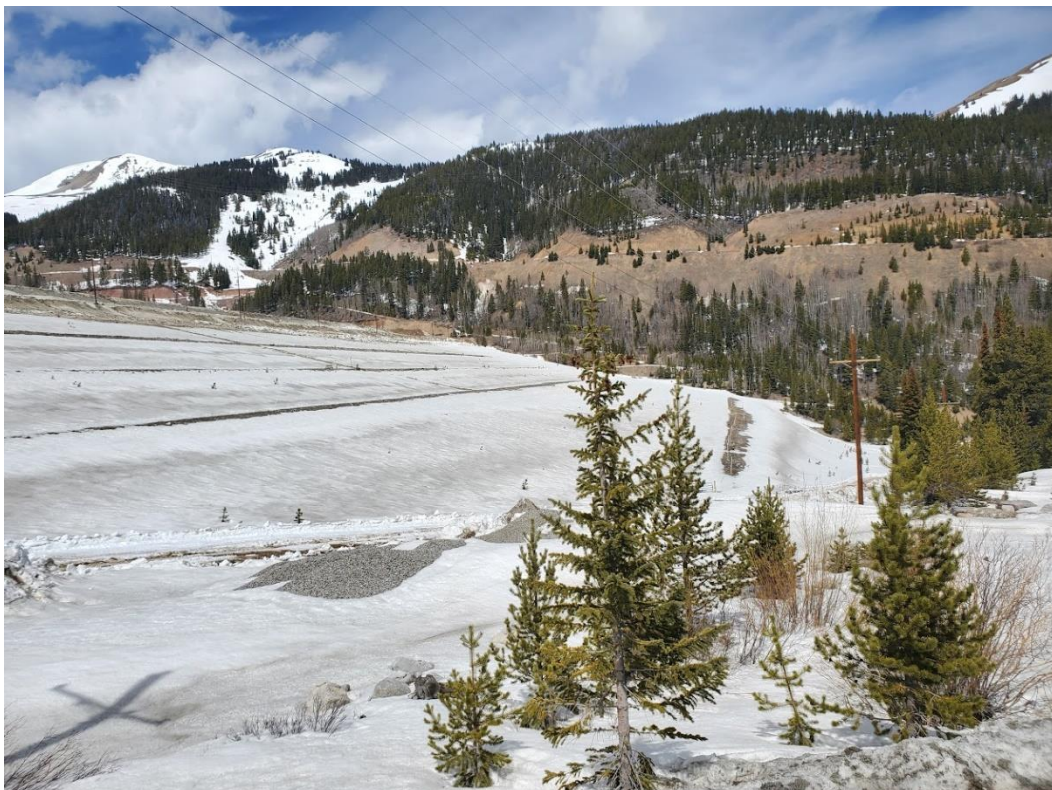
Photo 8: View to the west of 5 dam.

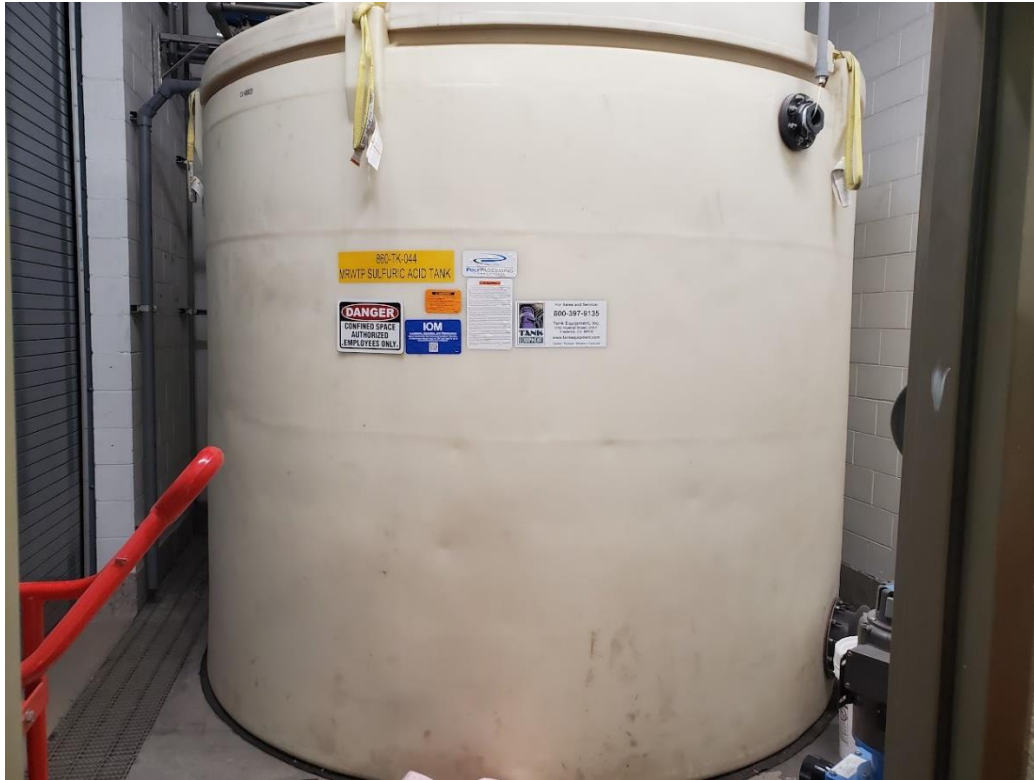
The operator is in the process of commissioning the recently completed MRWTP. The MRWTP provides supplementary water treatment for removal of molybdenum from the effluent in order to meet discharge requirements. The sulfuric acid is stored in a dual-contained polyethylene tank in an isolated room on the southeast side of the MRWTP building (Photo 9). The tank is located within an epoxy-coated concrete secondary containment area. The sulfuric acid storage area appeared to be in good working condition. No evidence of spills or loss of containment were noted during the inspection. Granular ferric sulfate is stored in a silo (Photo 10) which sits on a concrete apron what contains a sump to capture spilled materials. The silo appears in good conditions with no evidence of loss of containment. Liquid ferric sulfate is stored in a isolated area in the southeast corner of the MRWTP. The polyethylene tanks sit above containment sumps to capture any spilled material (Photo 11). There was no evidence of loss of containment.

Photo 9: View to the east of sulfuric acid storage.

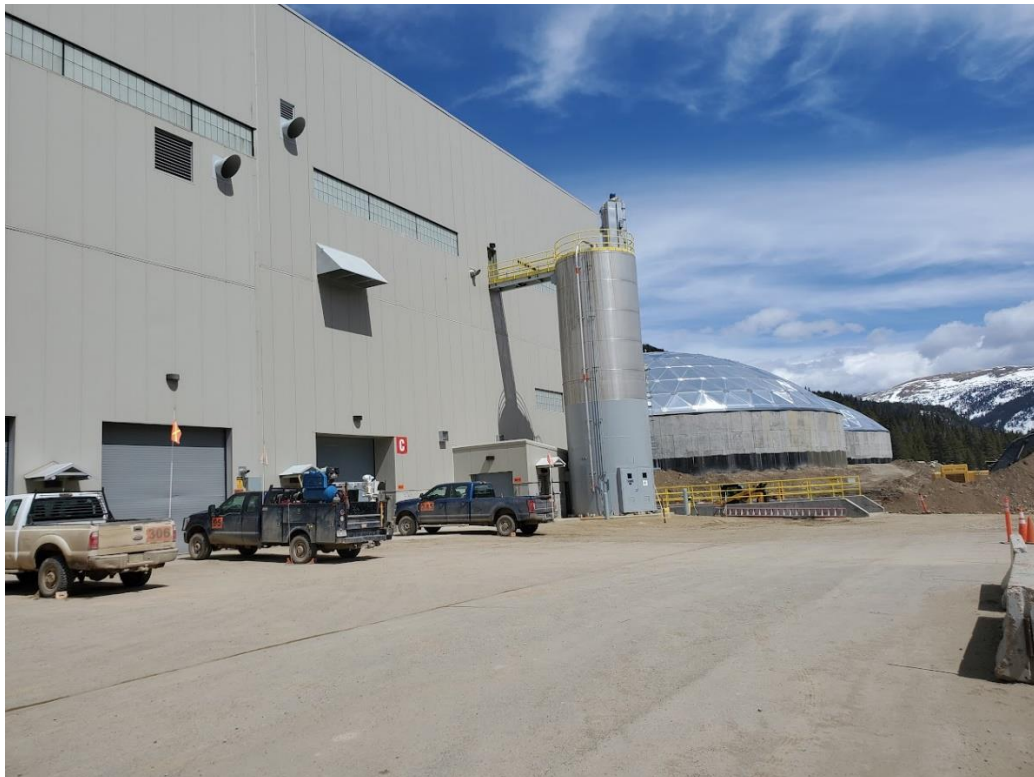
Photo 10: View to the north of ferric sulfate silo.

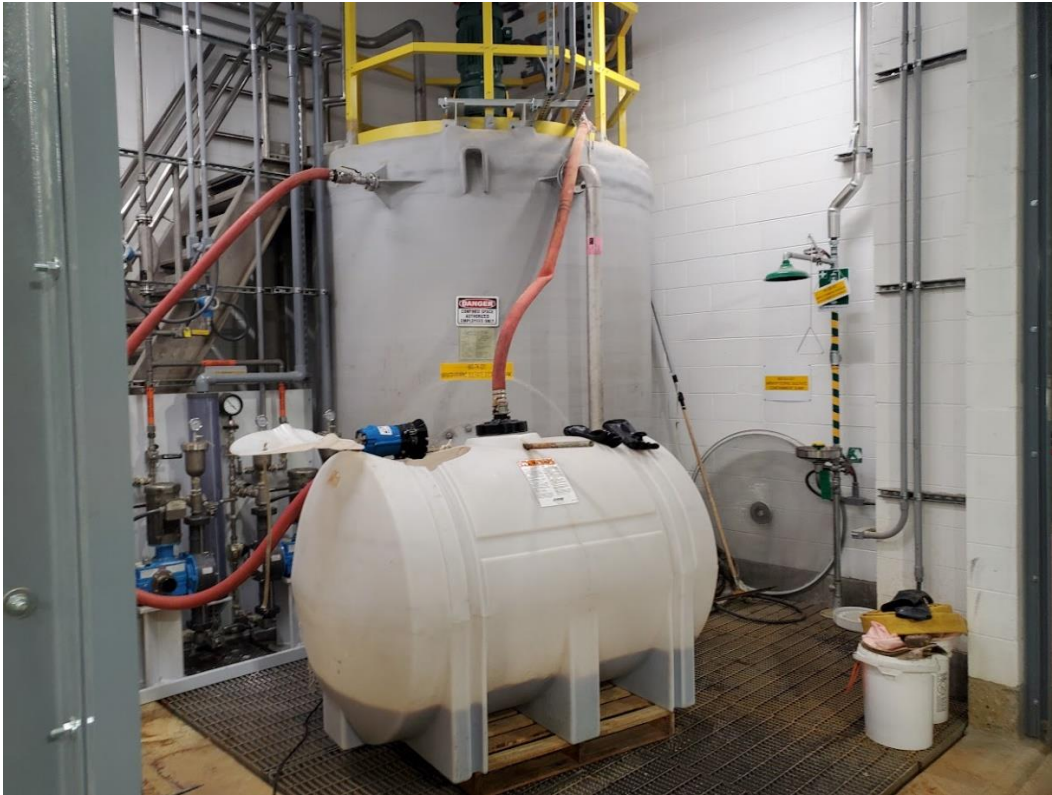
Photo 11: View to the northeast of ferric sulfate storage.
