Fall 2024 Subsidence and Geologic Field Observations

Southern Panels, Sunset Trail, and
Apache Rocks West Mining Areas

Mountain Coal Company, LLC
West Elk Mine
P.O. Box 591
Somerset, CO 81434

April 2025

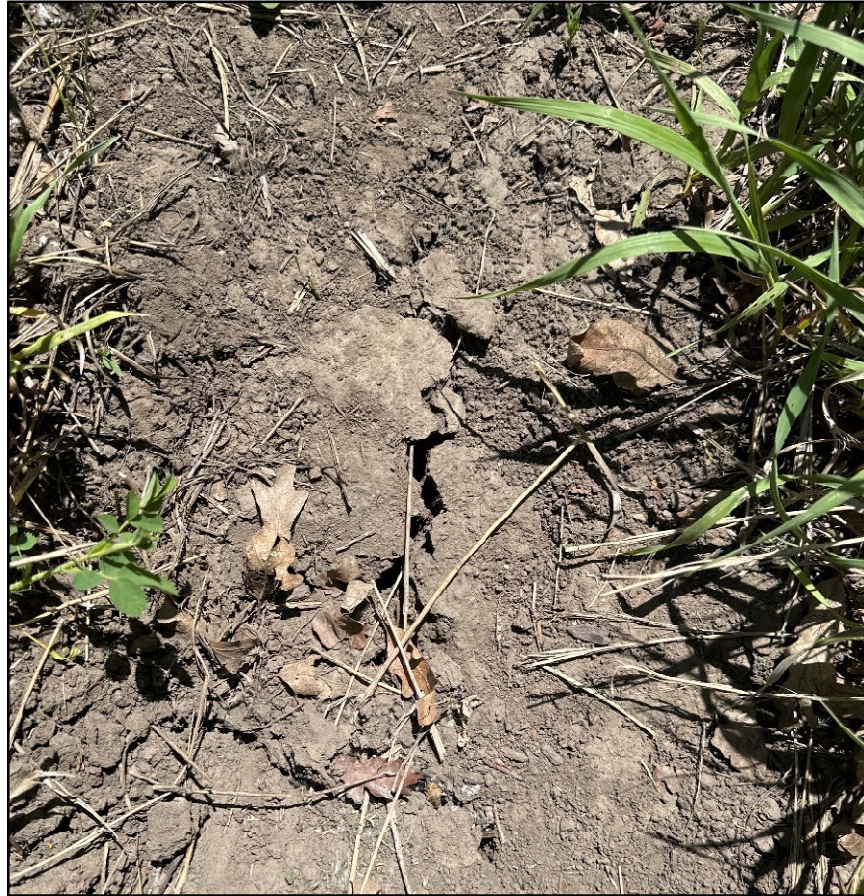
Figure 1 shows one of the larger cracks observed in spring 2024 along this traverse. Most of the cracks had no discernible width and were very shallow. This crack was no longer evident in fall 2024 (Figure 2).

Figure 1: Small subsidence crack on the trail along Horse Gulch overlying Longwall Panel E12 during spring 2024. These cracks were no longer evident in fall 2024.

WWE has observed similar cracks at locations recently mined under in the E-seam longwall mining panels. Typically, these cracks are due to dynamic subsidence processes and heal/seal within a short timeframe. Observations during fall 2024 showed these cracks followed a similar pattern and were likely tension cracks that closed after the mining face had moved through the area.

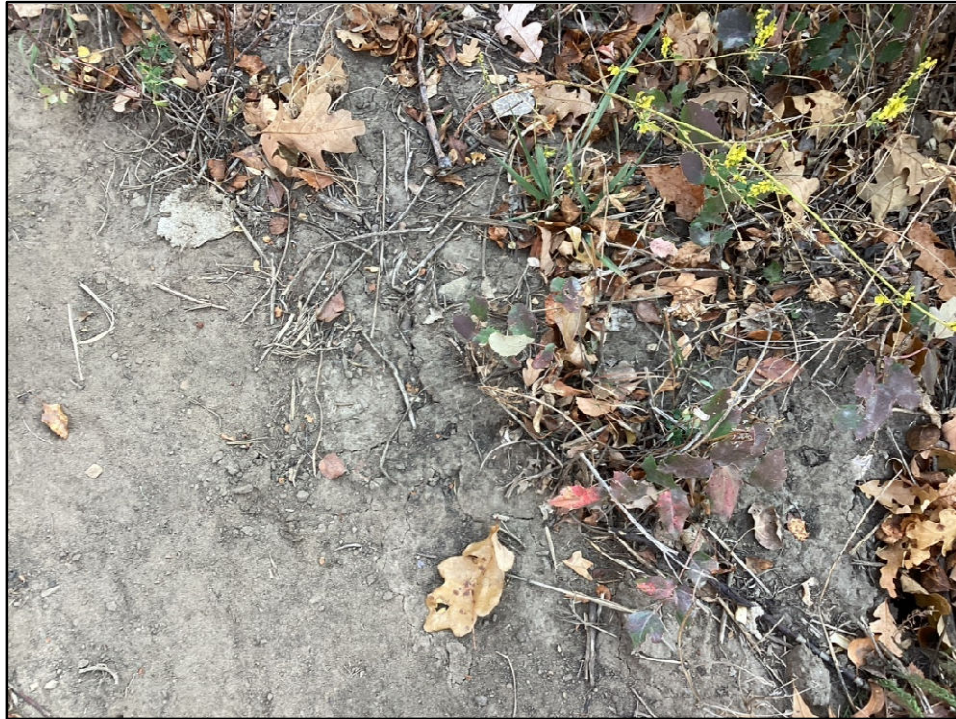
Figure 2: Sealing of tension cracks was observed along Traverse A-A'.

Given the shallow overburden and the presence of two-seam mining, it was surprising that there was not more surficial evidence of the mining activity. The small tension cracks that were observed in spring 2024—shortly after mining had occurred beneath the traverse—were difficult to discern, indicating that they were likely short-term tension cracks that had sealed once the adjacent ground subsided.

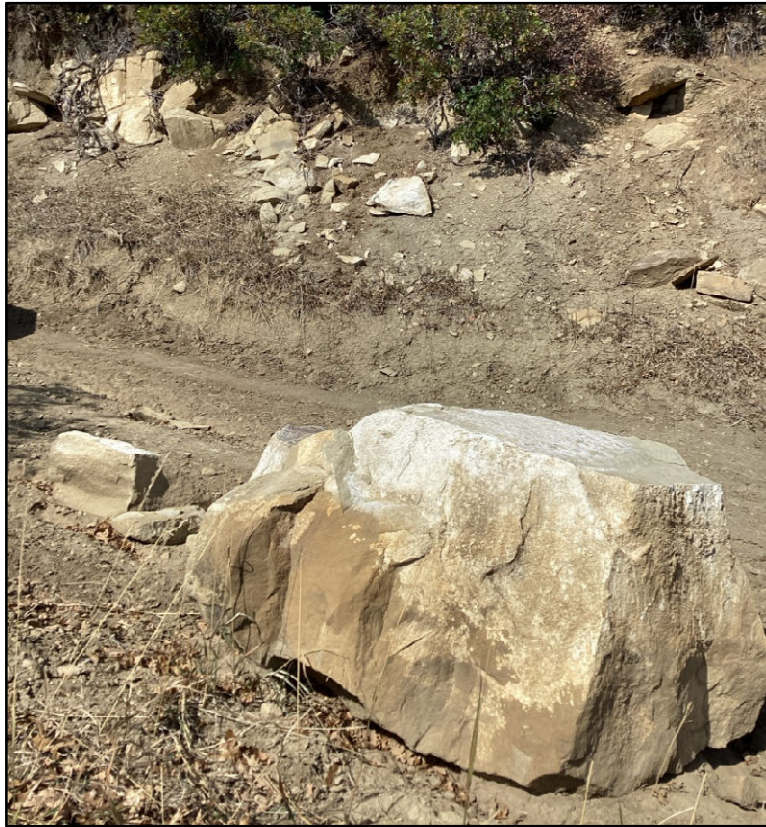
Location 1 was a new rockfall that was observed along the access road at the eastern edge of Longwall Panel E14. Figure 3 shows the large boulder that was observed for the first time during the fall 2024 site visit. There was no evidence that the rockfall was related to mining activity,

especially since mining of Longwall Panel E14 concluded in 2022. The rockfall may have been related to ongoing road maintenance activities that could have destabilized the boulder from the hillside above the road.

Figure 3: New rockfall observed along access road, though the cause is unclear.

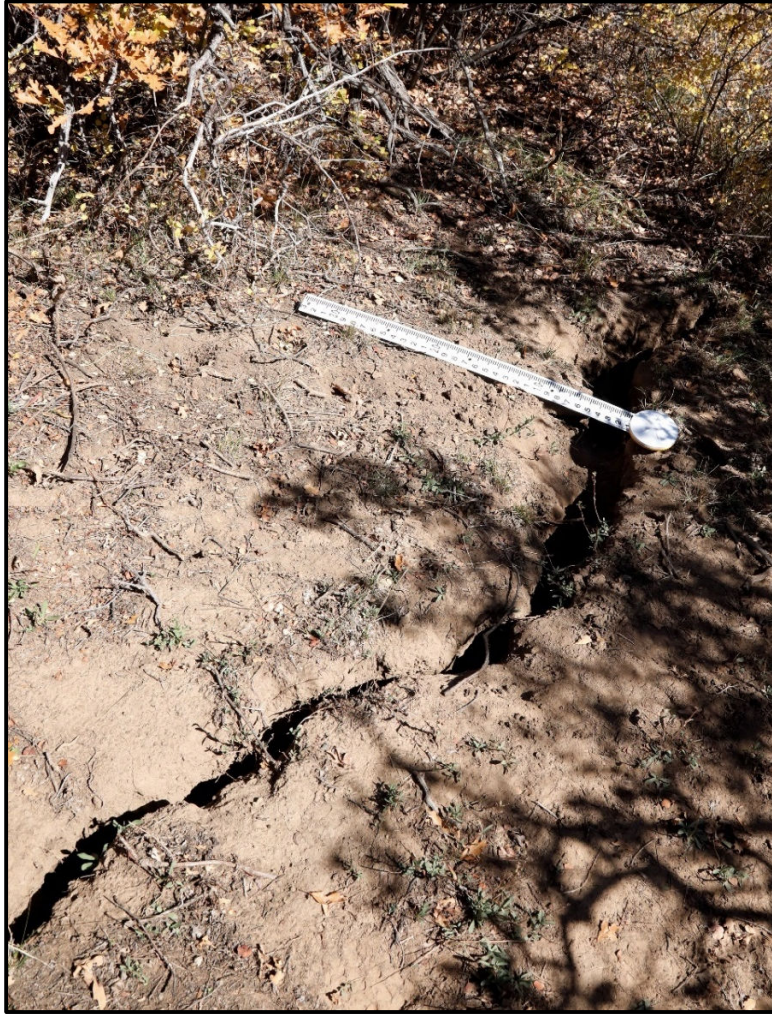
New cracks were first observed south of the access road overlying the north end of E-seam Longwall Panel E14 during the fall 2022 site visit. As shown on Map 1, the cracks were observed at Location 2 adjacent to cross cut 17 of the E14 Headgate. A series of parallel cracks were observed roughly parallel to the E14 Headgate with an orientation of South 40° East. The largest of the observed cracks followed the topographic contour for approximately 100 feet (Figure 4).

Figure 4: The largest of the cracks observed at Location 2 in fall 2022, south of the access road on Traverse C-C'.

The location of these cracks is consistent with locations where the tilt and horizontal displacement are largest near the edge of the panel as shown in Figure 3 of Exhibit 60E (WWE 2018). The existence of the series of parallel cracks was likely a combination of these horizontal strains in combination with the natural sloped hillside. In total, there were 5 cracks observed with the dimensions of the cracks generally decreasing in the downhill direction towards the center of the longwall panel.

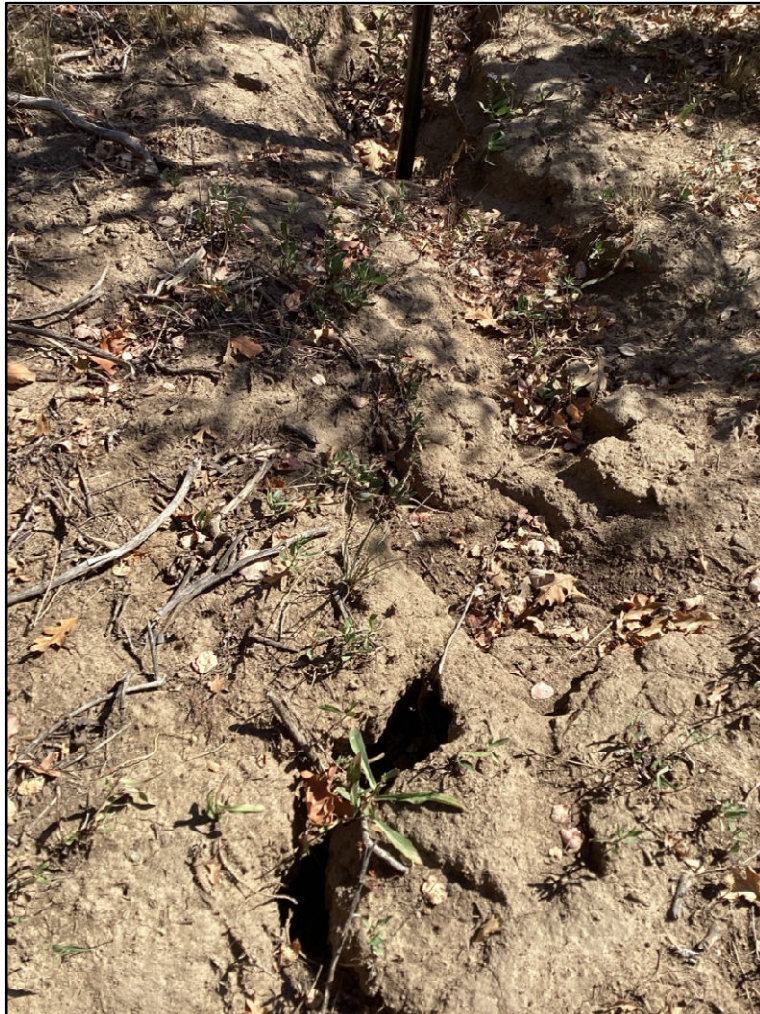
During the fall 2024 site visit, these cracks were still evident but were much less prominent. The smaller cracks had largely healed/sealed, especially where cattle or large game trails occurred. The

larger cracks continue to heal; however, the sealing process appears to have stopped as some of the largest cracks remain open (Figure 5).

Figure 5: Continued healing of subsidence cracks overlying Longwall Panel E14 on Traverse C-C'.

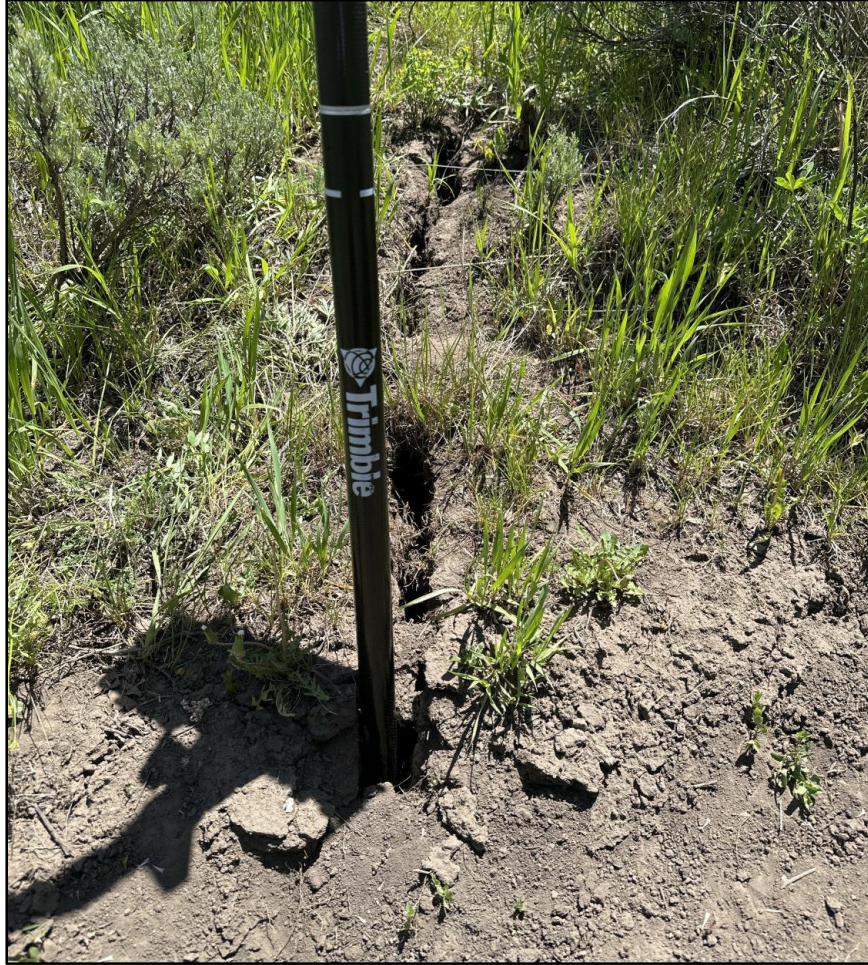
A newly-observed crack was documented along the path overlying E-seam Longwall Panel E15 as shown in Figure 6.

Figure 6: New crack observed over Longwall Panel E15 during spring 2024 site visit.

The crack was at a location that indicates mining occurred shortly after the fall 2023 site visit, at which time no subsidence features were observed. The crack appeared fresh, consistent with the timing of mining occurring beneath the location. The crack was approximately 15 to 20 feet in length with an east-west orientation. The maximum width of the crack was 2 to 3 inches with a maximum observed depth of 1.5 feet.

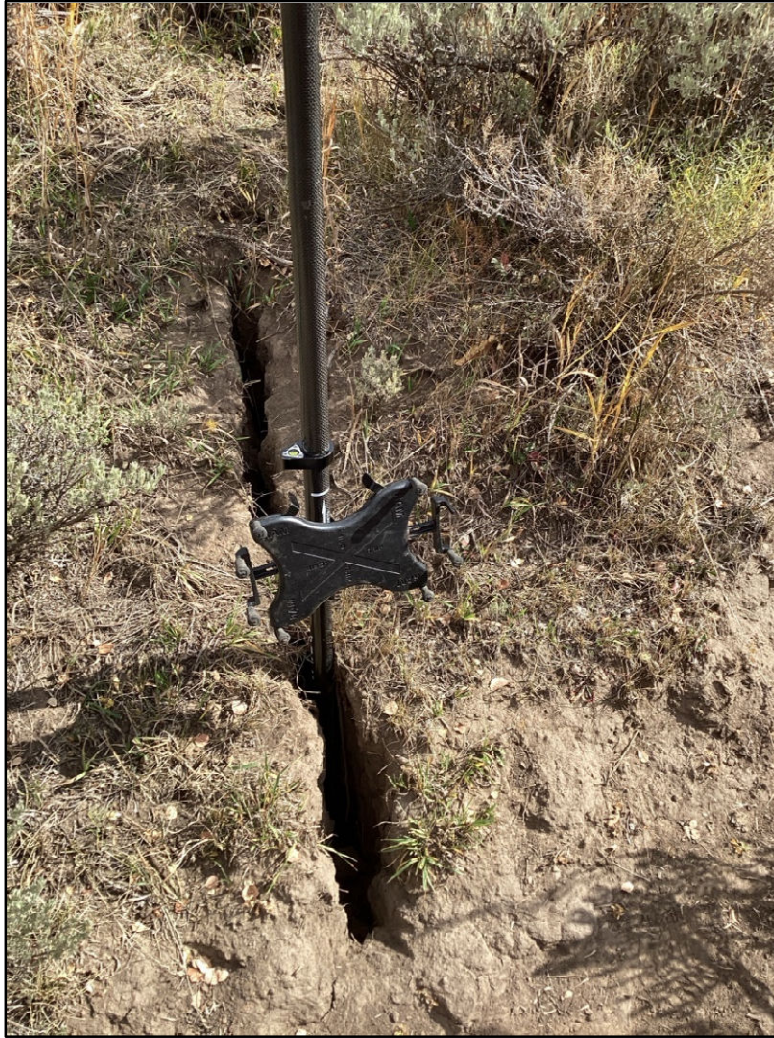
During the fall 2024 visit, the crack was still clearly evident; however, the crack was shorter in length as it appeared that it had begun to heal/seal in locations where the original width was smaller. As shown in Figure 7 at the maximum observed location, the crack was still of similar dimensions as it was originally observed in spring 2024 at the widest location.

Figure 7: Crack observed along Traverse C-C' over Longwall Panel E15.

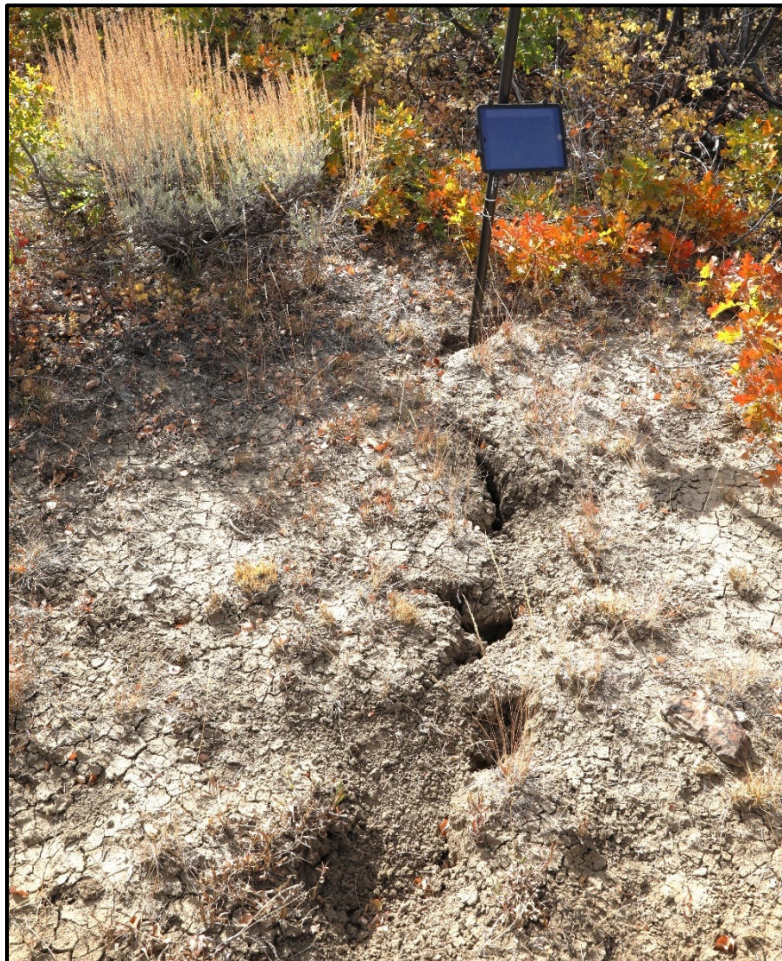
The newly observed cracks were located on both sides of the access road but were not seen on the road itself. This fact may indicate that the cracks were present, but not observed, prior to the fall 2023 site visit. The majority of the observed cracks were located on the eastern side of the road with E-seam overburden depth of roughly 500 to 600 feet. In general, the orientation of the cracks was north-south along the downslope of the topography away from the road that follows a ridgeline over Panel E14. The maximum depth of the cracks was 1.5 to 2.0 feet with a maximum width of approximately 4 inches. Figure 8 shows the largest of the cracks observed at Location 4 in the fall 2023.

Figure 8: Crack observed along D-D' over Longwall Panel E14 during the fall 2023 site visit.

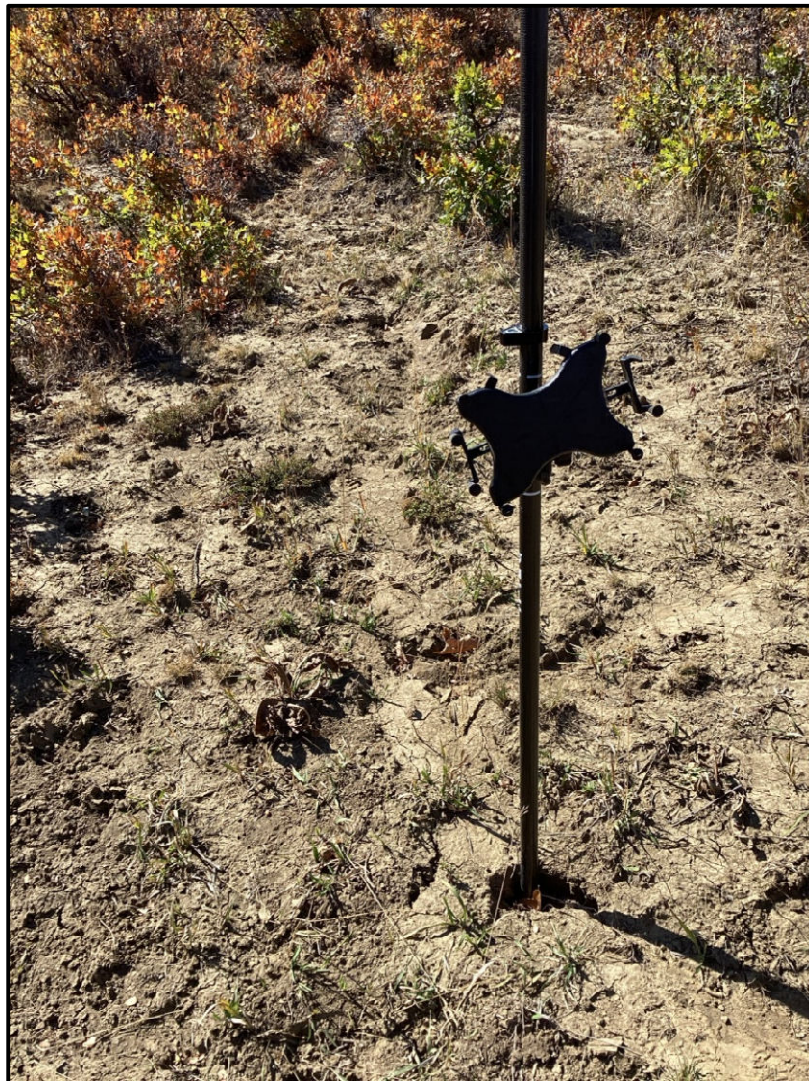
During the fall 2024 visit, the cracks were hardly discernible as cattle activity appears to have accelerated the healing process. While there were numerous desiccation cracks, surface evidence of the observed subsidence cracks was nonexistent. Figure 9 shows Location 4a during the fall 2024 visit with little surface expression of the subsidence feature.

Figure 9: Cattle activity accelerating healing of subsidence cracks over Longwall Panel E14 on Traverse D-D'.

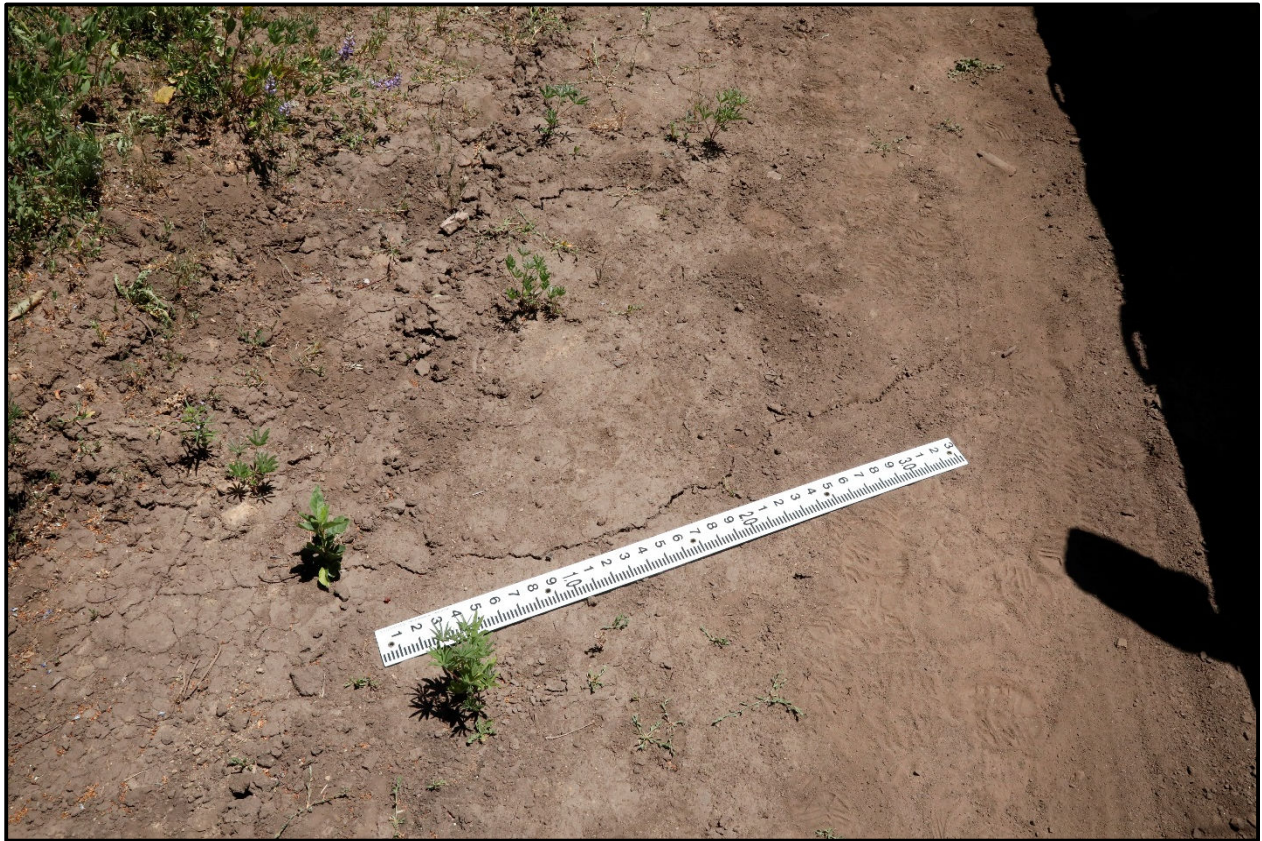
Cracks were observed along the north side of the access road overlying the north end of E-seam Longwall Panel SS3 during the spring 2023 site visit. As shown on Map 1, the cracks were observed near Location 3. A series of cracks were observed roughly parallel to each other with an orientation of South 37° East. The cracks had no discernable depth or width and were not perpendicular to the road (Figure 10). It is unclear whether these observed cracks were related to mining subsidence; however, their consistent orientation was noteworthy and merited documentation. Longwall mining occurred under Location 3 during the months of December 2022 and January 2023.

Figure 10: Example of an observed crack along the north side of E-seam Longwall Panel SS3 during spring 2023 site visit

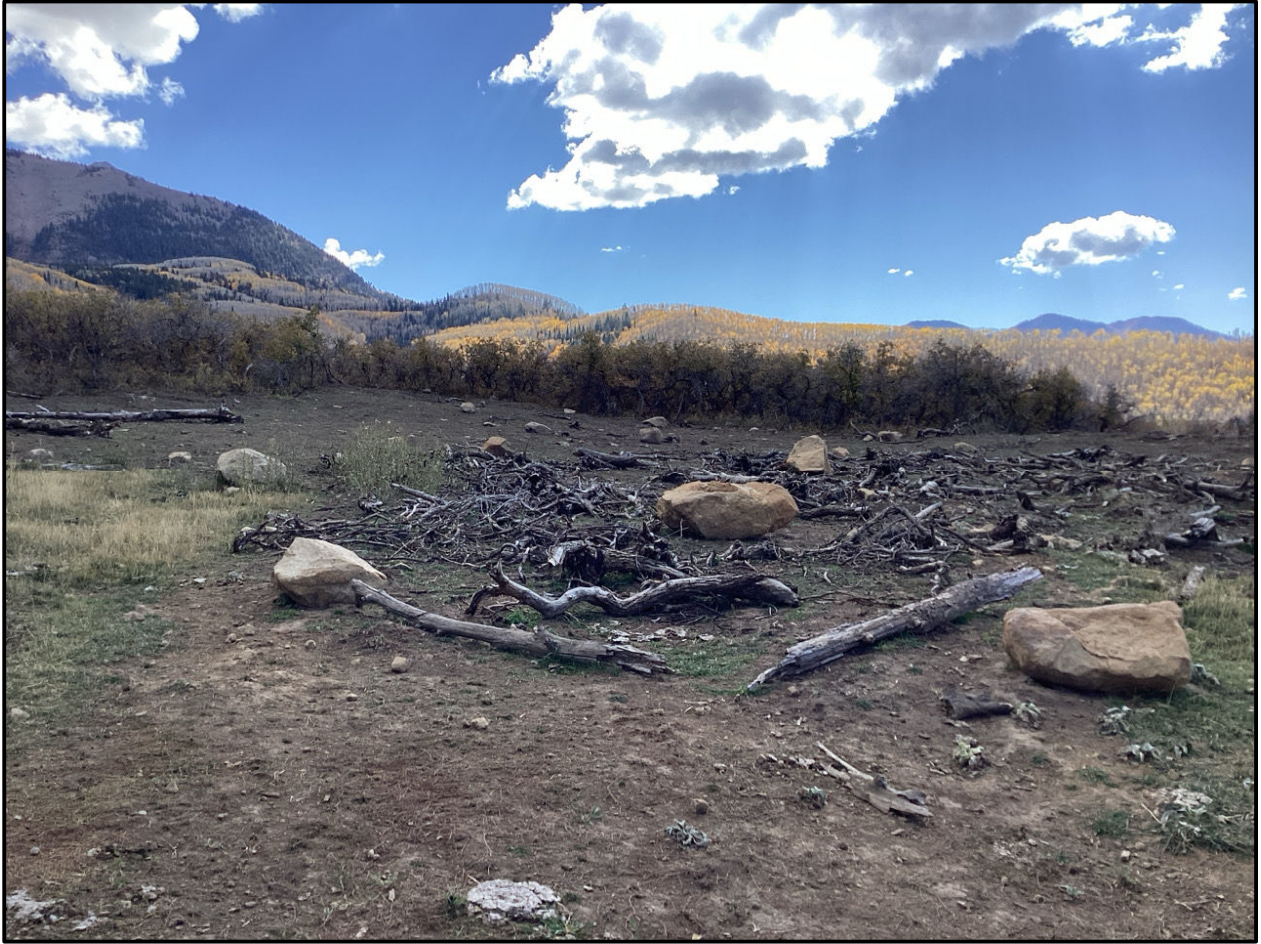
No cracks were observed during the fall 2024 site visit and the pad for MVB SS3-2 had been reclaimed (Figure 11). Traverse E-E' will no longer be included in the subsidence observations.

Figure 11: Reclaimed Pad MVB SS3-2 at end of E-E' Traverse.
