MINERALS PROGRAM INSPECTION REPORT
PHONE: (303) 866-3567

MINE NAME: Laster Pit	MINE/PROSPECTING ID#: M-2024-005	MINERAL: Gravel	COUNTY: Sedgwick
INSPECTION TYPE: Monitoring	WEATHER: Clear	INSP. DATE: March 25, 2025	INSP. TIME: 11:50
OPERATOR: Sedgwick County	OPERATOR REPRESENTATIVE: Kacey Campbell, Bob Coty	TYPE OF OPERATION: 112c - Construction Regular Operation	
REASON FOR INSPECTION: Normal I&E Program	BOND CALCULATION TYPE: None	BOND AMOUNT: \$0.00	
DATE OF COMPLAINT: NA	POST INSP. CONTACTS: None	JOINT INSP. AGENCY: None	
INSPECTOR(S): Joel Renfro	INSPECTOR'S SIGNATURE:

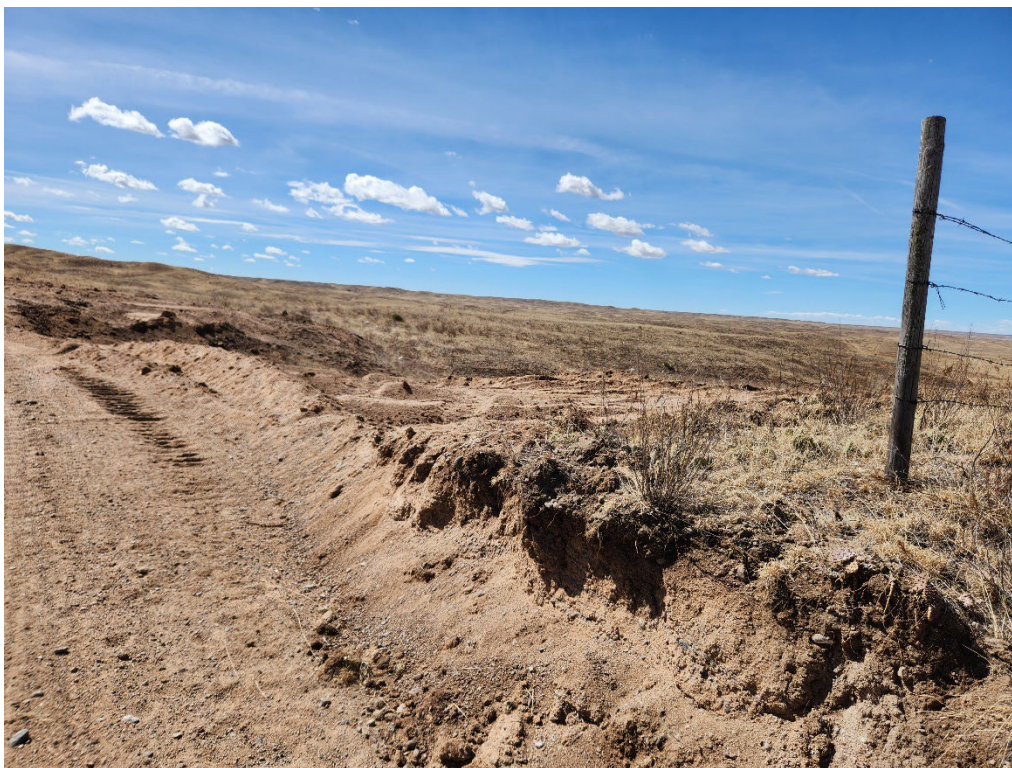
Photo 1. Mine entrance, looking south.

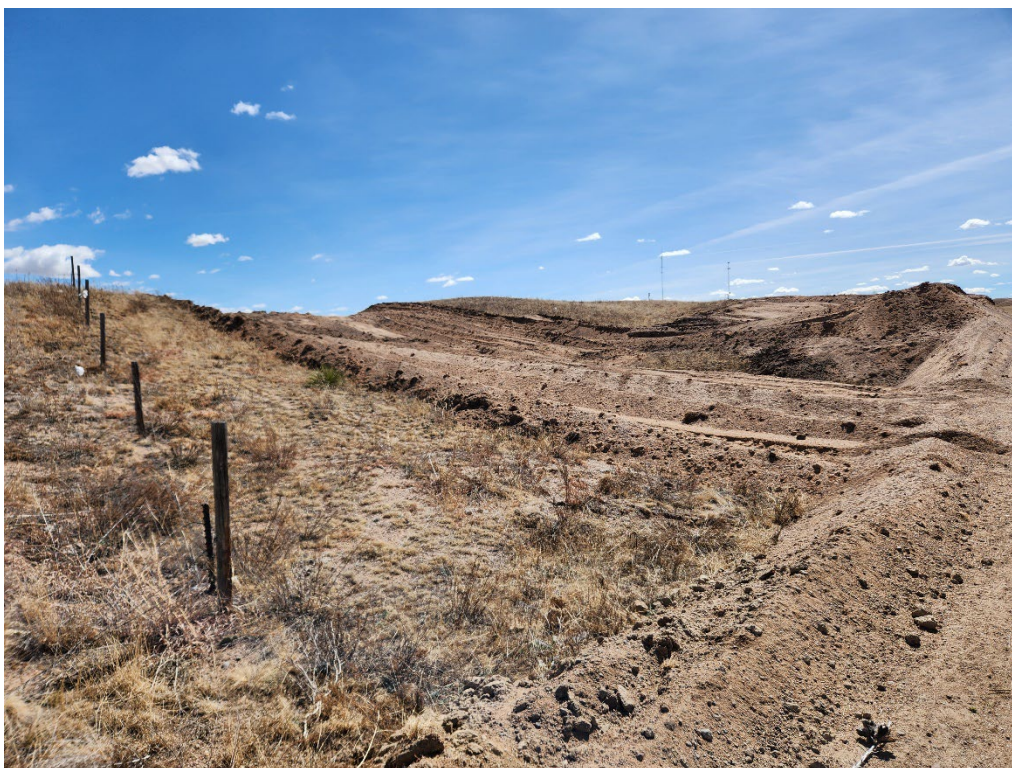
Photo 2. Moved material near the site entrance, looking south.

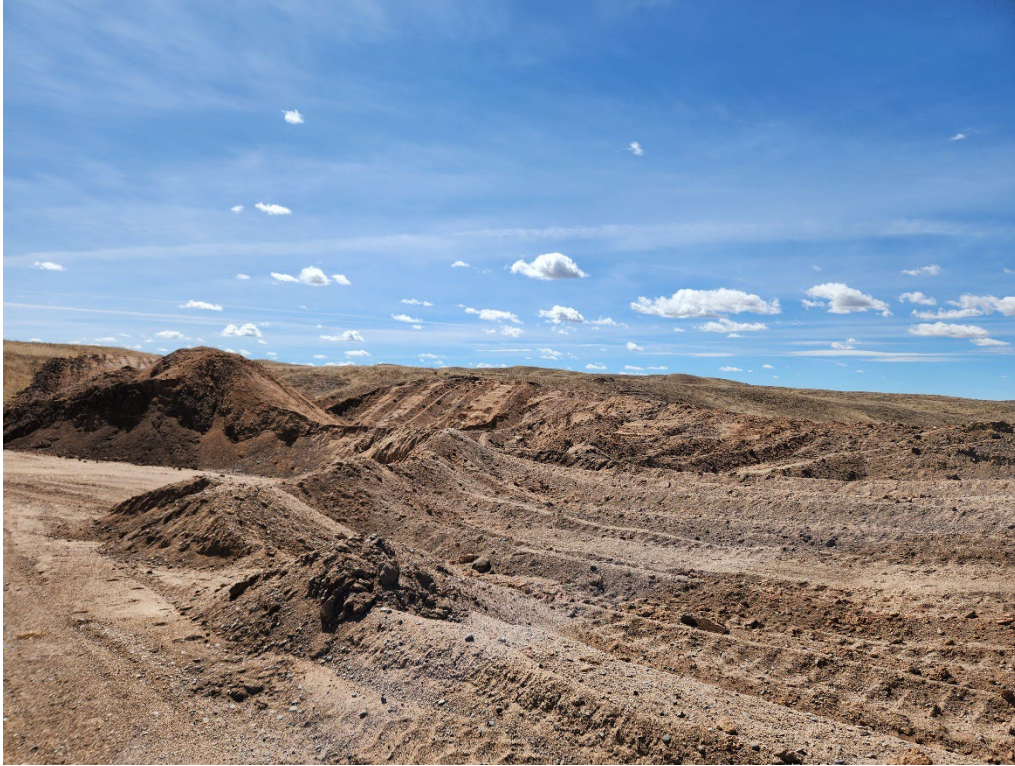
During the inspection, the site was not active, however, significant progress has been made. The beginnings of a pit floor were observed, with substantial overburden material pushed to the sides of the area. According to the operator, material extraction has yet to begin as they are currently in the process of locating gravel.

Photo 3. Recent disturbance on site, looking southwest.

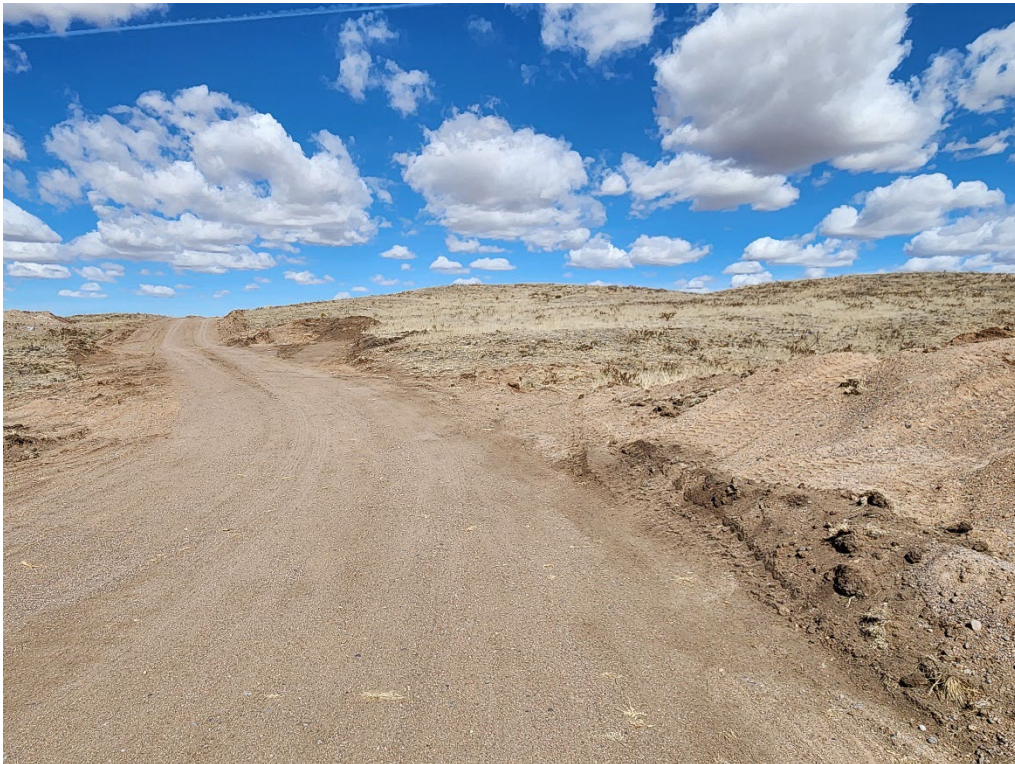
A well-managed dirt road provides access to the site, with the entrance located to the north, just past the county landfill. The road appeared to be in good condition.

Photo 4. Dirt road that leads in/out of the site, looking north.

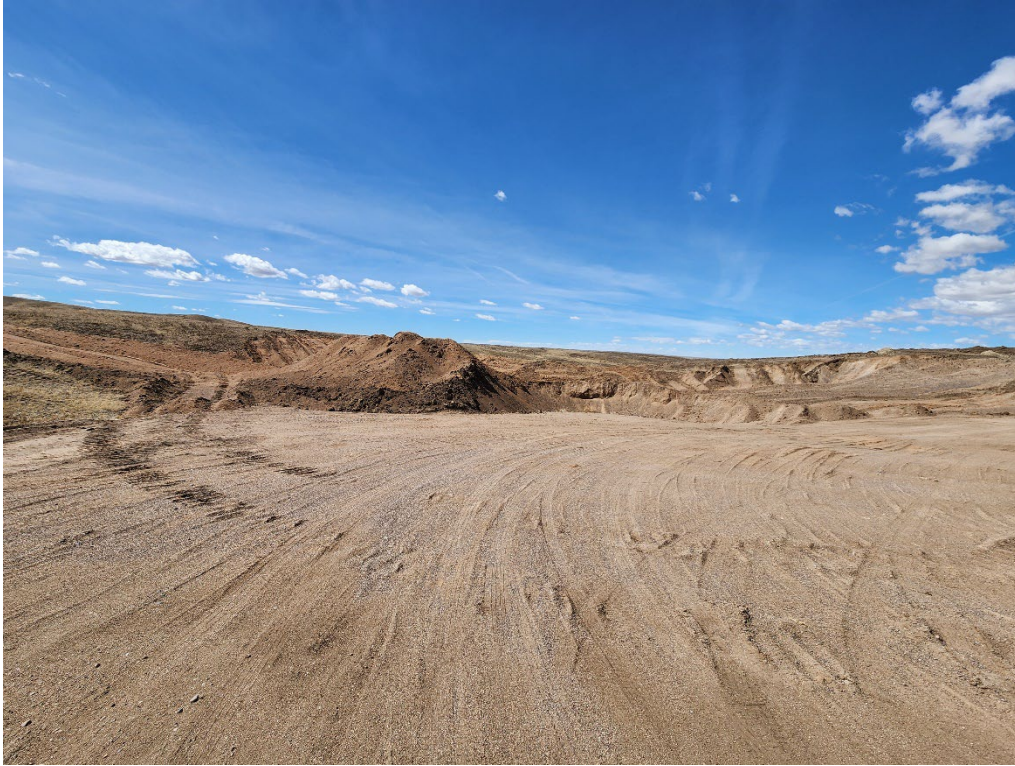
Photo 5. Beginnings of the pit floor, looking west.
