MINERALS PROGRAM INSPECTION REPORT
PHONE: (303) 866-3567

MINE NAME: Dolezal Gravel Pit	MINE/PROSPECTING ID#: M-1996-073	MINERAL: Gravel	COUNTY: Sedgwick
INSPECTION TYPE: Monitoring	WEATHER: Clear	INSP. DATE: March 25, 2025	INSP. TIME: 10:30
OPERATOR: Sedgwick County	OPERATOR REPRESENTATIVE: Kacey Campbell, Bob Coty	TYPE OF OPERATION: 110c - Construction Limited Impact	
REASON FOR INSPECTION: Normal I&E Program	BOND CALCULATION TYPE: None	BOND AMOUNT: \$0.00	
DATE OF COMPLAINT: NA	POST INSP. CONTACTS: None	JOINT INSP. AGENCY: None	
INSPECTOR(S): Joel Renfro	INSPECTOR'S SIGNATURE:

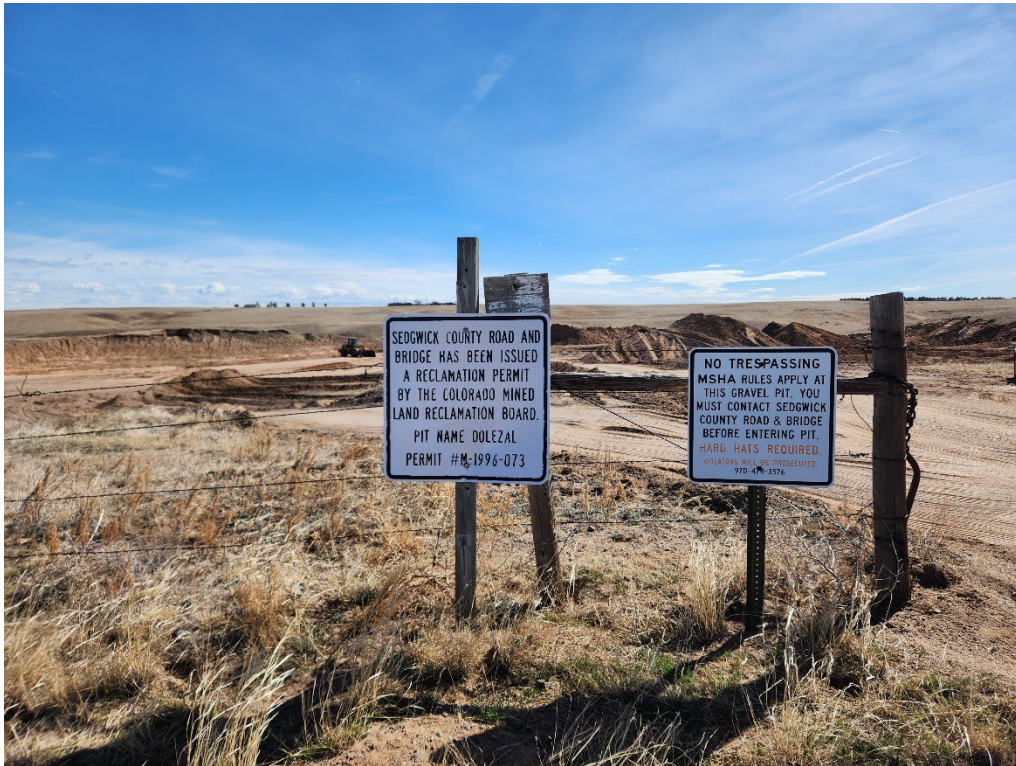
Photo 1. Mine entrance sign, looking east.

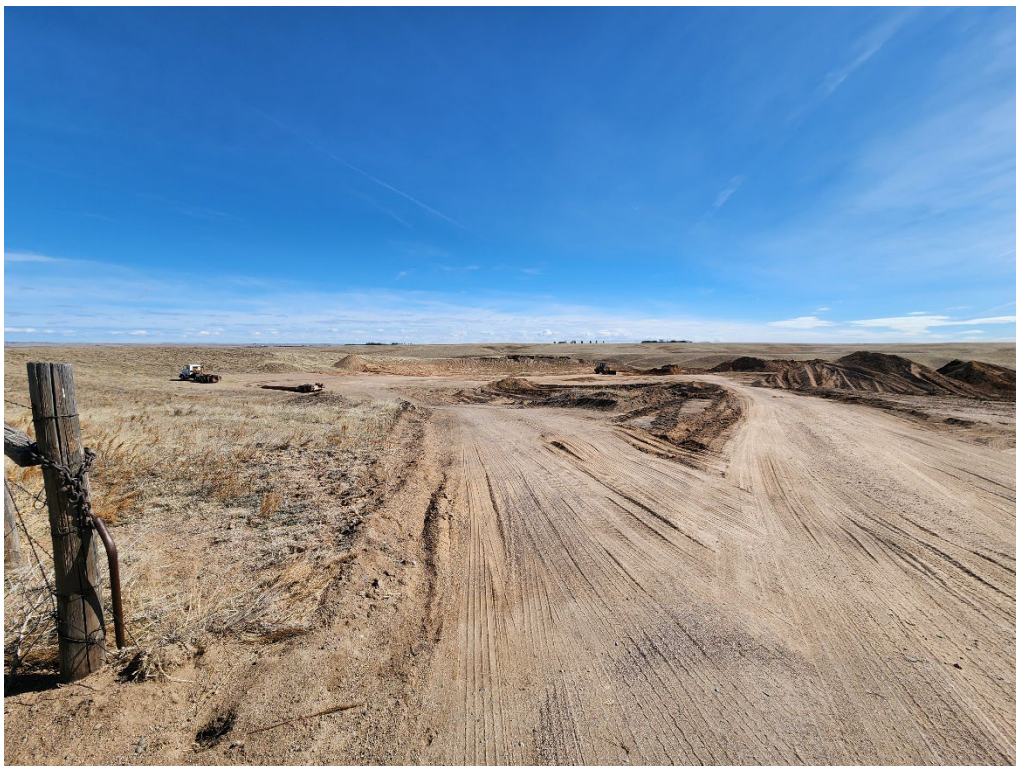
Photo 2. Mine entrance, looking east.

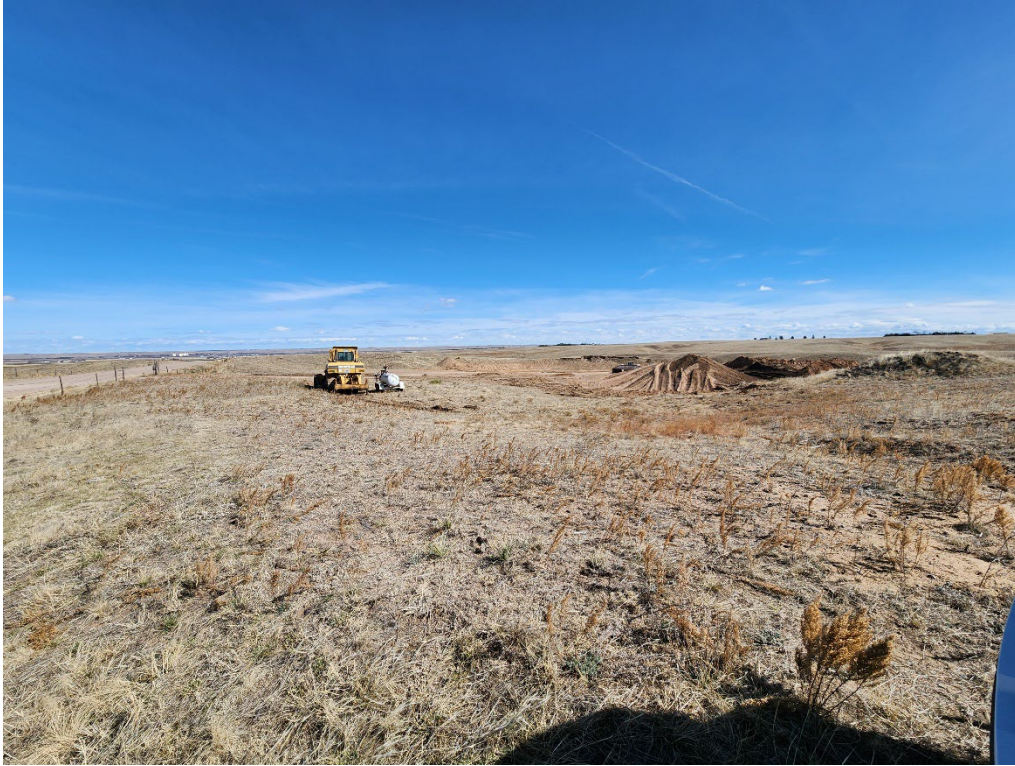
Photo 3. Undisturbed land just south of the pit, looking north.

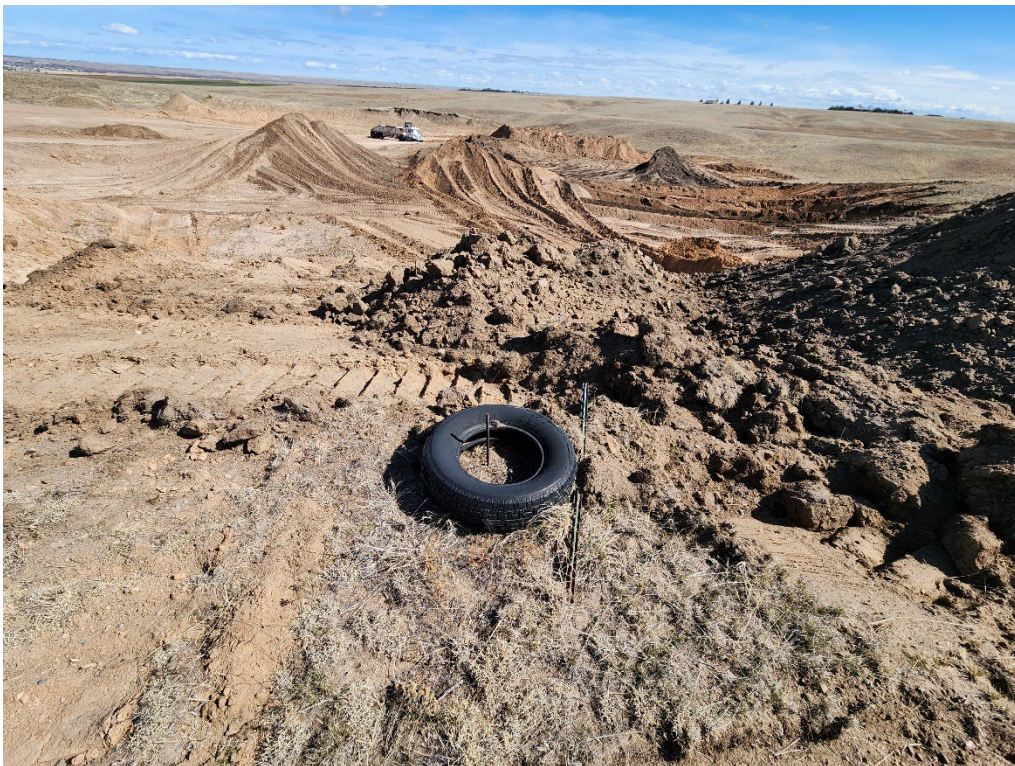
Permit boundary markers were checked during the inspection. All the markers are comprised of metal posts with a tire at the base. Each of these markers are placed in the corners of the permit boundary. Each permit boundary marker appeared to be well-maintained and accurately placed.

Photo 4. Corner permit boundary marker south of the pit, looking north.

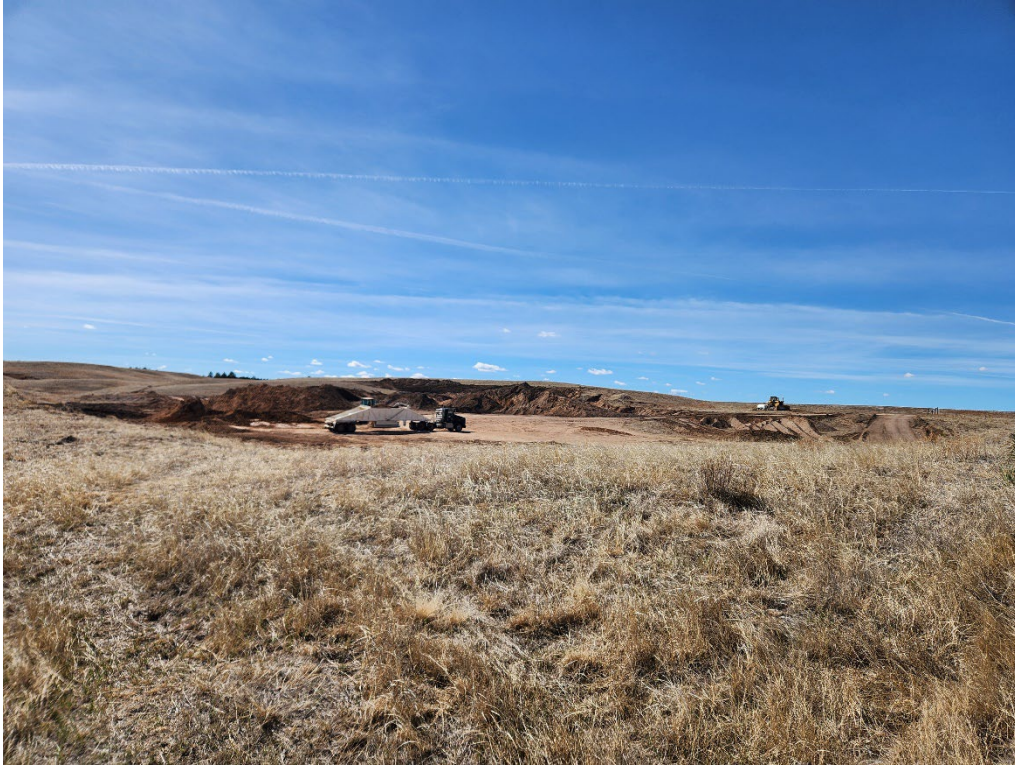
The Division observed construction equipment moving around mined material and a haul truck taking material off-site. The site is comprised of one main pit, and it appears that mining is moving to the south. Topsoil is stockpiled along the northern edge of the pit.

Photo 5. Mined pit, looking east.

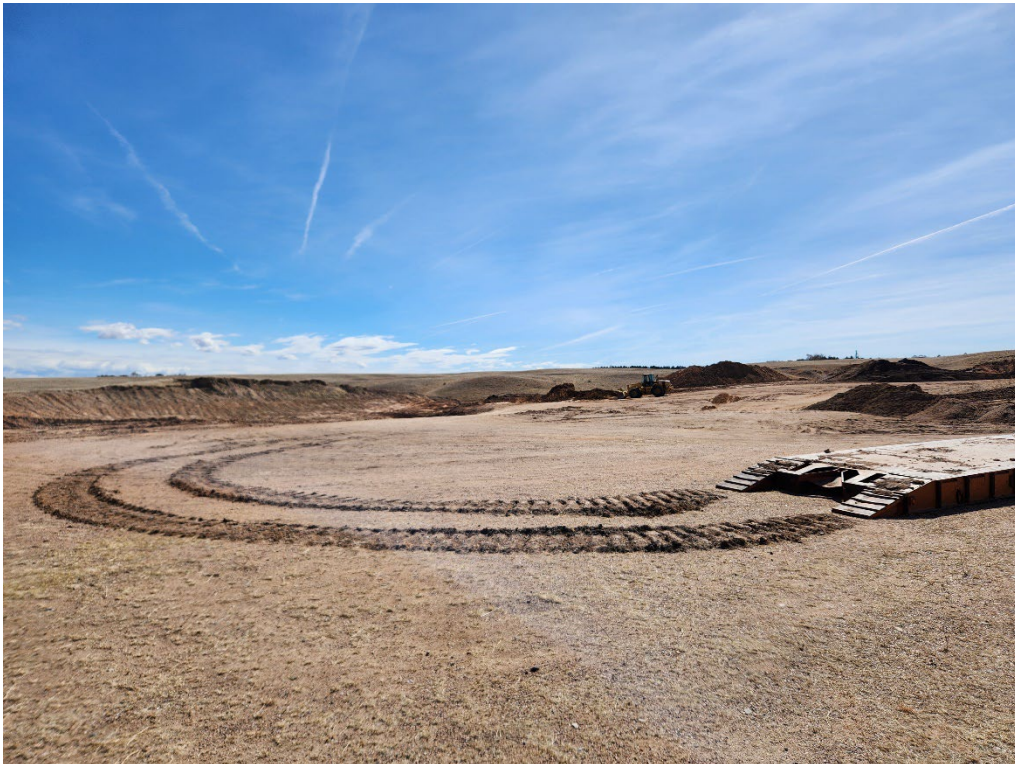
Photo 6. Mined pit, looking north.
