**MINERALS PROGRAM INSPECTION REPORT**  
**PHONE: (303) 866-3567**

<b>MINE NAME:</b> Kinnie Gravel Pit	<b>MINE/PROSPECTING ID#:</b> M-1997-061	<b>MINERAL:</b> Gravel	<b>COUNTY:</b> Sedgwick
<b>INSPECTION TYPE:</b> Monitoring	<b>WEATHER:</b> Clear	<b>INSP. DATE:</b> March 25, 2025	<b>INSP. TIME:</b> 11:10
<b>OPERATOR:</b> Sedgwick County	<b>OPERATOR REPRESENTATIVE:</b> Kacey Campbell, Bob Coty	<b>TYPE OF OPERATION:</b> 110c - Construction Limited Impact	
<b>REASON FOR INSPECTION:</b> Normal I&E Program	<b>BOND CALCULATION TYPE:</b> None	<b>BOND AMOUNT:</b> \$0.00	
<b>DATE OF COMPLAINT:</b> NA	<b>POST INSP. CONTACTS:</b> None	<b>JOINT INSP. AGENCY:</b> None	
<b>INSPECTOR(S):</b> Joel Renfro	<b>INSPECTOR'S SIGNATURE:</b>

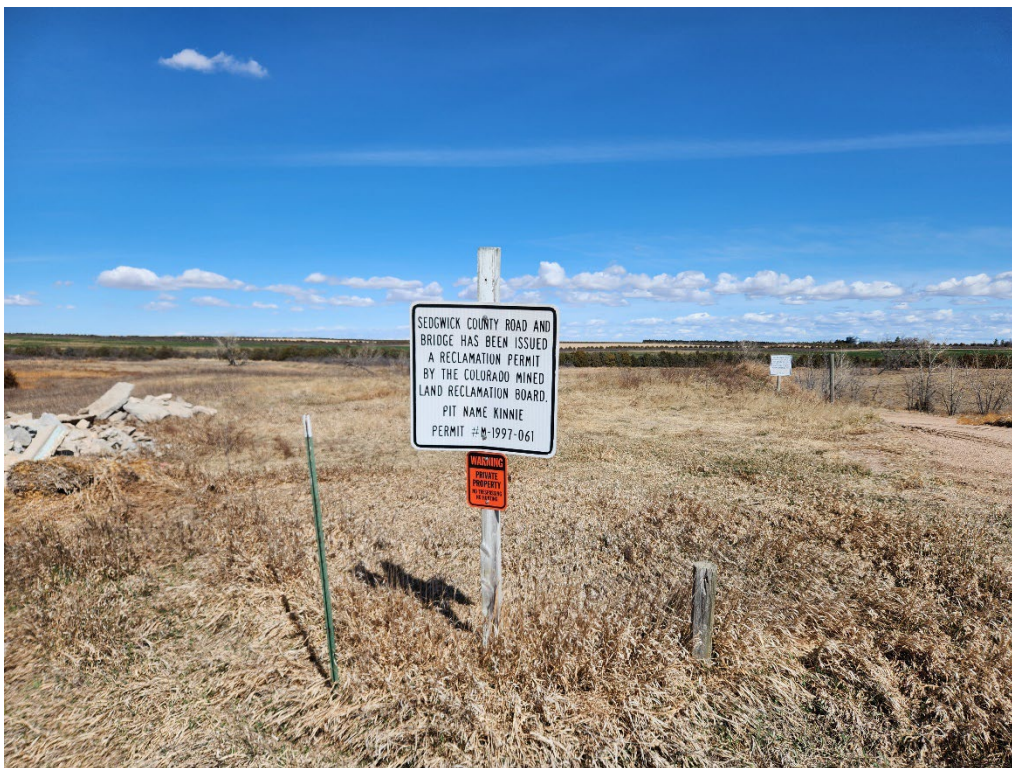
**Photo 1.** Mine entrance sign, looking north.

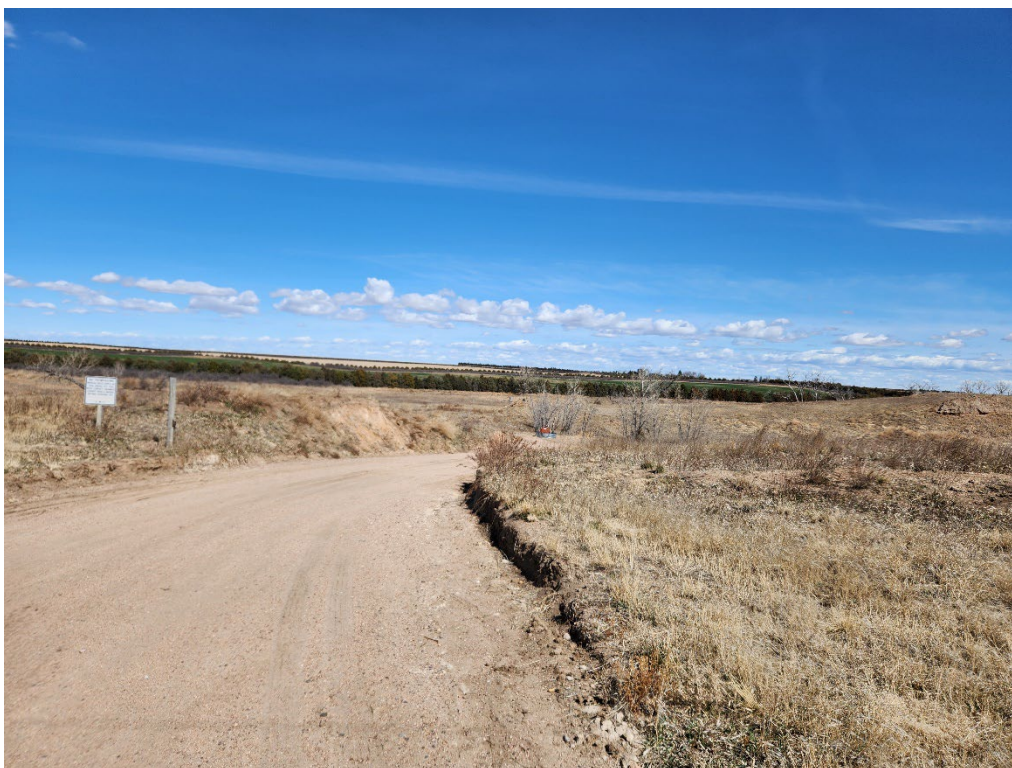
**Photo 2.** Mine entrance, looking north.

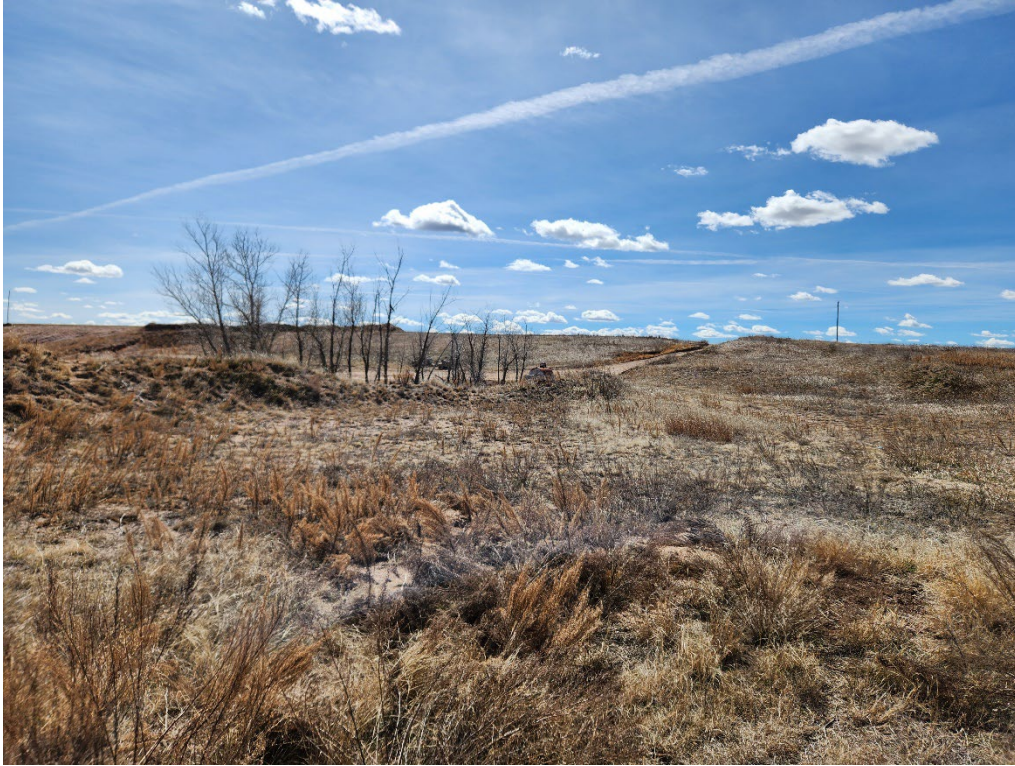
**Photo 3.** Northwest corner of the site, looking southeast.

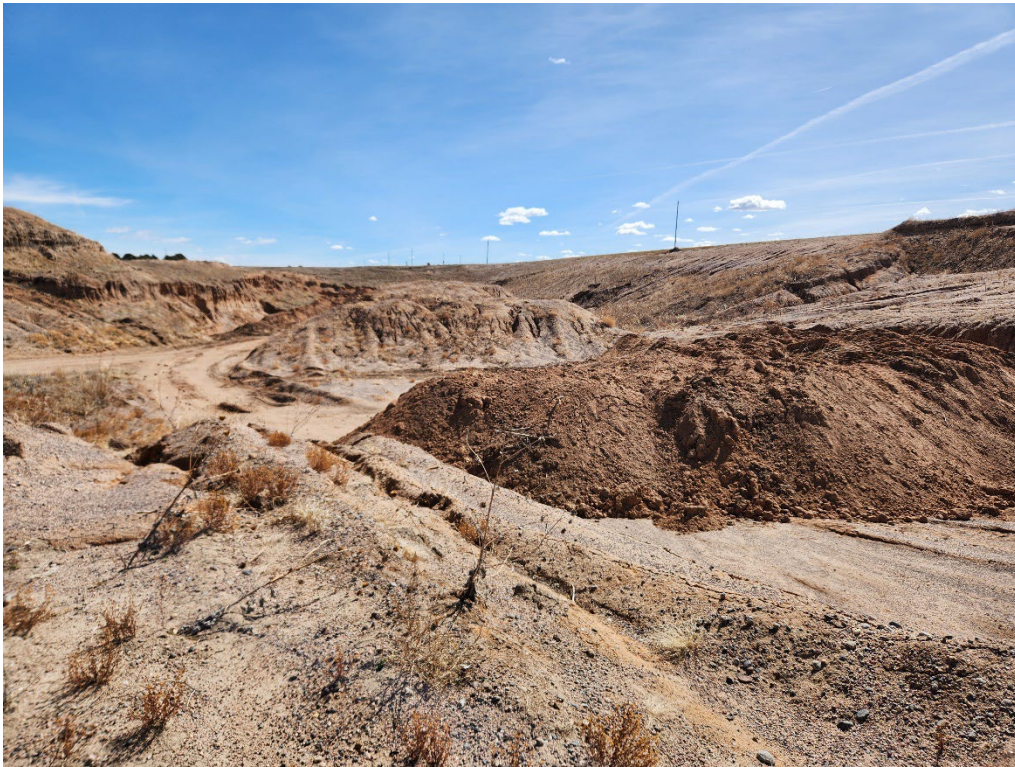
The gravel material is used in county road maintenance. Some material stockpiles were observed on the pit floor. Mined slopes surround the pit with some topsoil stockpiles located to the northwest of the pit.

**Photo 4.** Pit floor with material stockpiles, looking east.

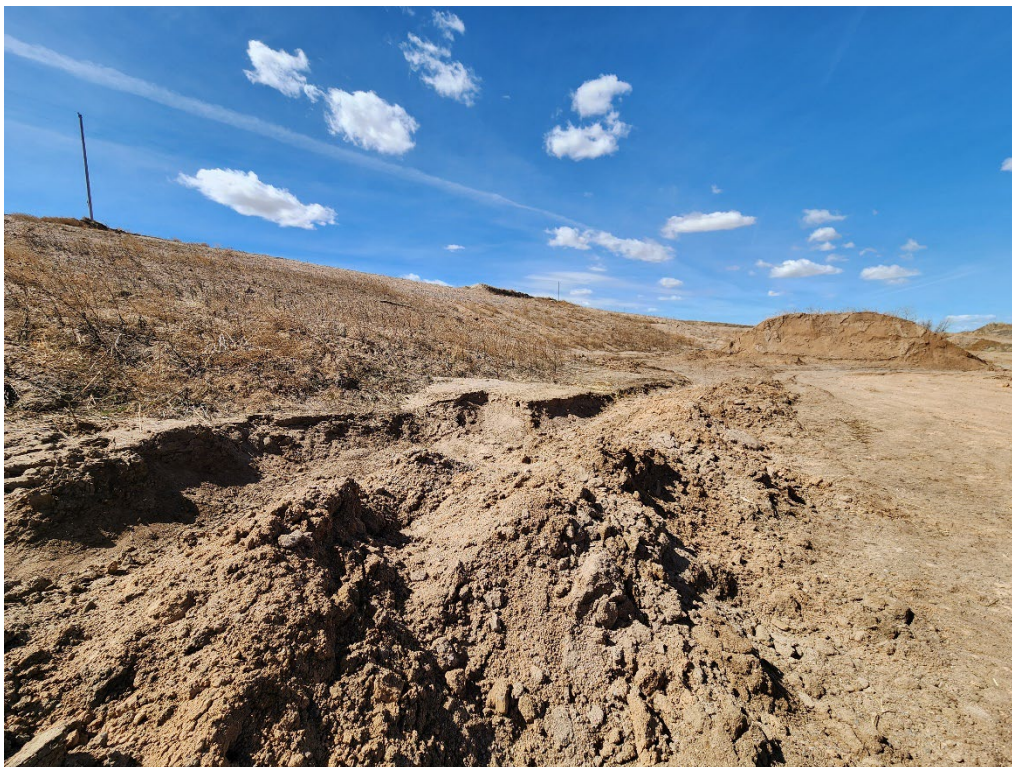
It appears that this site may have had issues with water pooling in the pit, but the operator has dug out the pit floor and mitigated most of those issues. No water was observed in the pit floor during the inspection.

**Photo 5.** Pit floor, looking west.

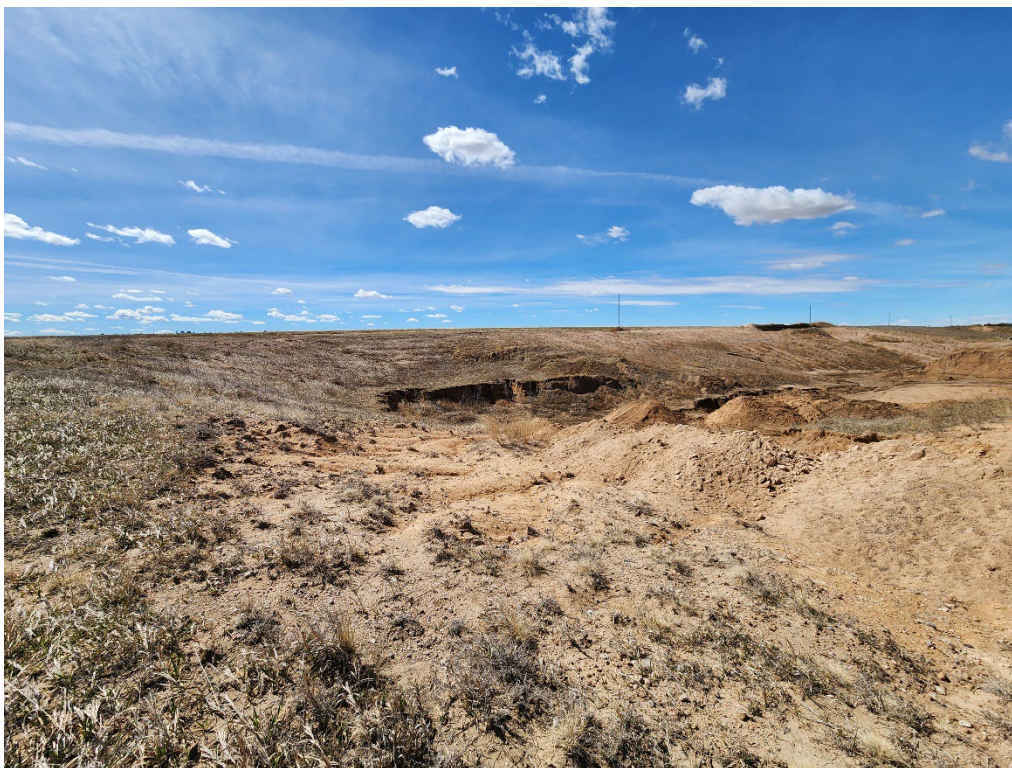
**Photo 6.** Mined pit, looking west.
