MINERALS PROGRAM INSPECTION REPORT
PHONE: (303) 866-3567

MINE NAME: O'Dwyer	MINE/PROSPECTING ID#: M-2002-017	MINERAL: Sand and gravel	COUNTY: Lincoln
INSPECTION TYPE: Surety Release Inspection	WEATHER: Clear	INSP. DATE: April 22, 2025	INSP. TIME: 01:30
OPERATOR: Lincoln County	OPERATOR REPRESENTATIVE:	TYPE OF OPERATION: 110c - Construction Limited Impact	
REASON FOR INSPECTION: Surety Release Requested	BOND CALCULATION TYPE:	BOND AMOUNT: \$0.00	
DATE OF COMPLAINT: NA	POST INSP. CONTACTS: None	JOINT INSP. AGENCY: None	
INSPECTOR(S): Ben Hammar Zach Trujillo	INSPECTOR'S SIGNATURE:

OBSERVATIONS

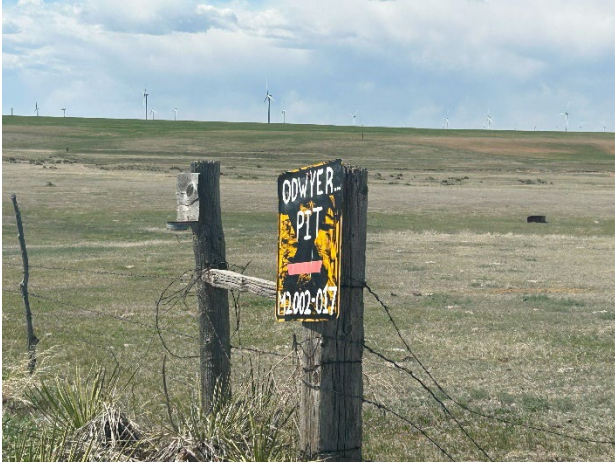
Photo 1: Posted mine ID sign.

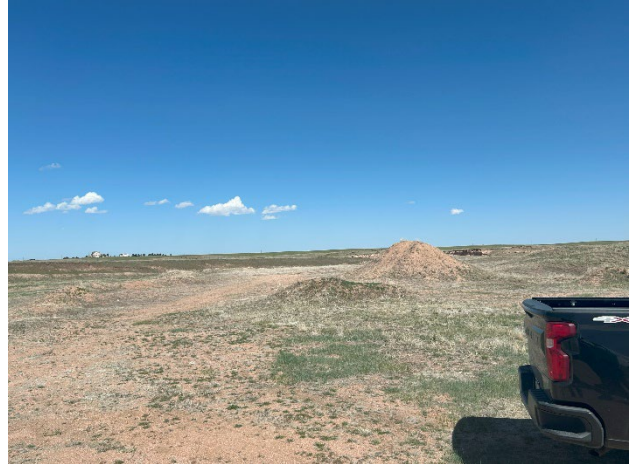
Overall, the grading of the site appears to be adequate and adheres to the 3:1 slope requirement of the rangeland post-mining land use. Vegetation appears to be well established, with the exception of a small area outside of the stream bed which was stripped to act as a product stockpile. This area had been reseeded but is relatively bare compared to the surrounding area. A single mounded product stockpile is also present within this area, however per a conversation with the landowner and the operator this area has been stated by the landowner to be acceptable as is. The existing roadway has also been stated to be acceptable as is.

Photo 2: Less vegetated area and remaining stockpile. Owner states area is in acceptable condition.

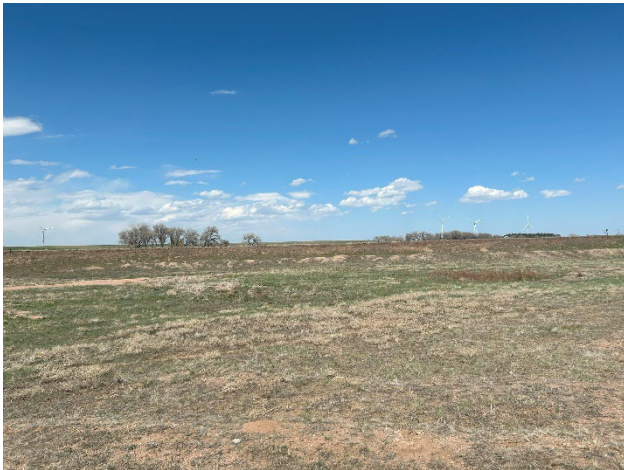
Photo 3: Reclaimed area within streambed. Facing northern portion of permit.

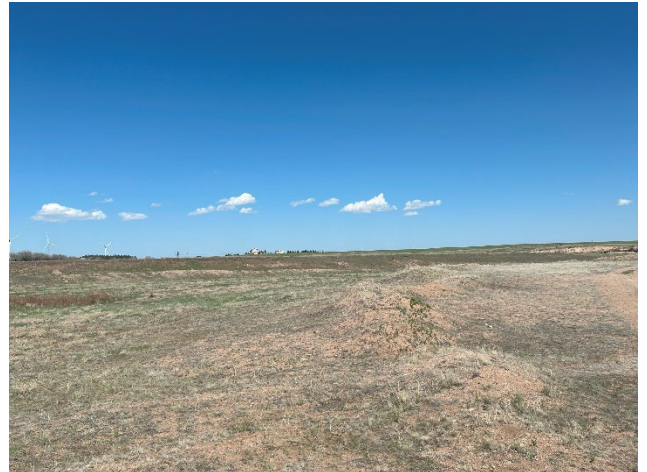
Photo 4: Reclaimed area of streambed, facing east.

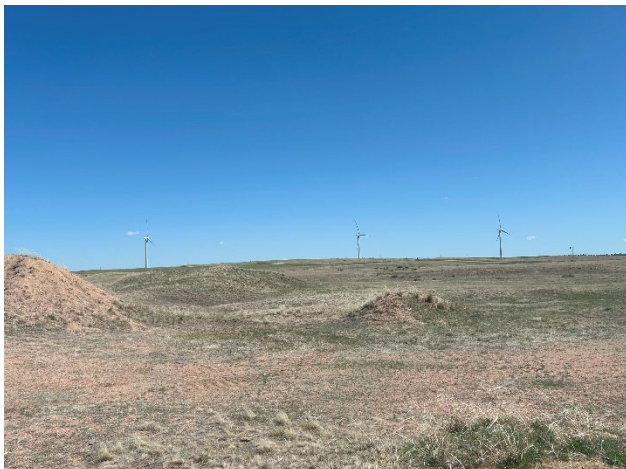
Photo 5: Reclaimed berms and additional documentation of the stockpile. Facing south.
