## Roadside Portals Mine, C-1981-041, April Inspection Report

**Roadside Portals Mine, C-1981-041, April Partial Inspection Report\_CCW.pdf**

**PERMIT INFORMATION**

**INSPECTION INFORMATION**

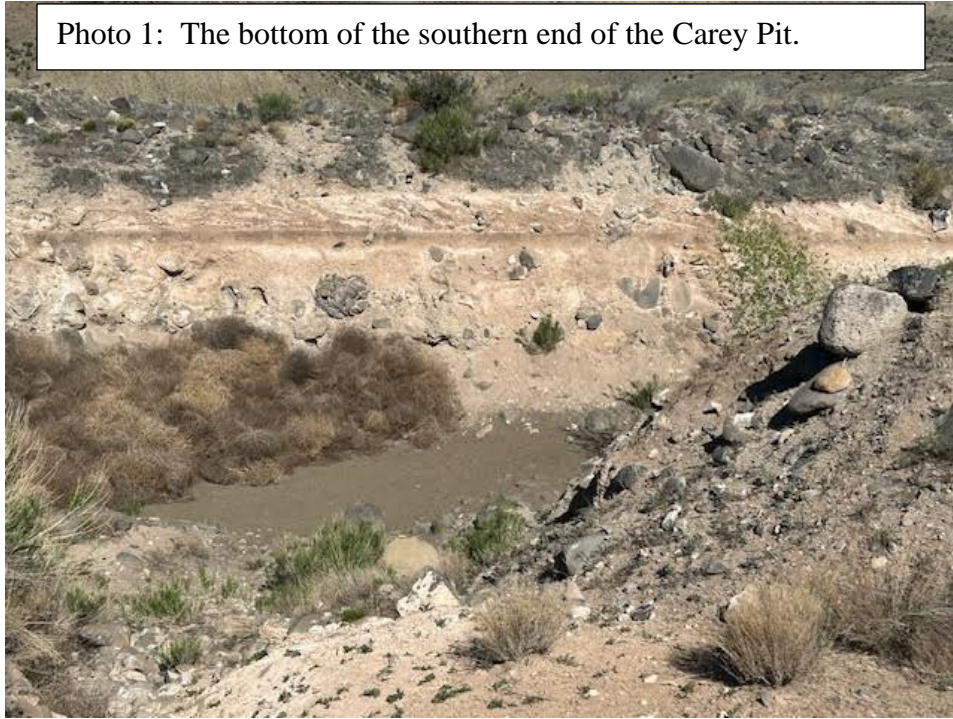
During the inspection, the landowner's trenches located on the north and eastern portions of Tract 71 were dry. There was no indication of the recent application of water in the trenches. The Carey Pit is located adjacent to the southwest corner of the permit area. The pit was observed from the permit boundary to be muddy but not holding any water (Photo 1). The landowner's buried pipeline on the southern part of Tract 71, connects to the pit via an open trench. The trench was wet near the exit of the pipe (Photo 2). However, there was no evidence that water had flowed through the trench and into the pit.

Photo 1: The bottom of the southern end of the Carey Pit.

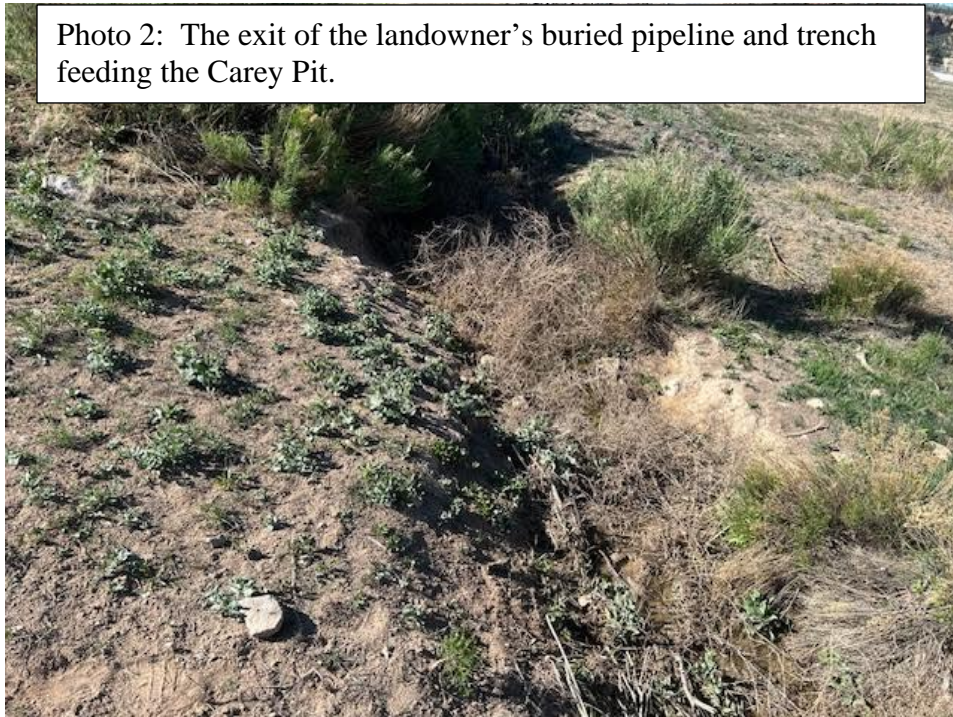
Photo 2: The exit of the landowner's buried pipeline and trench feeding the Carey Pit.

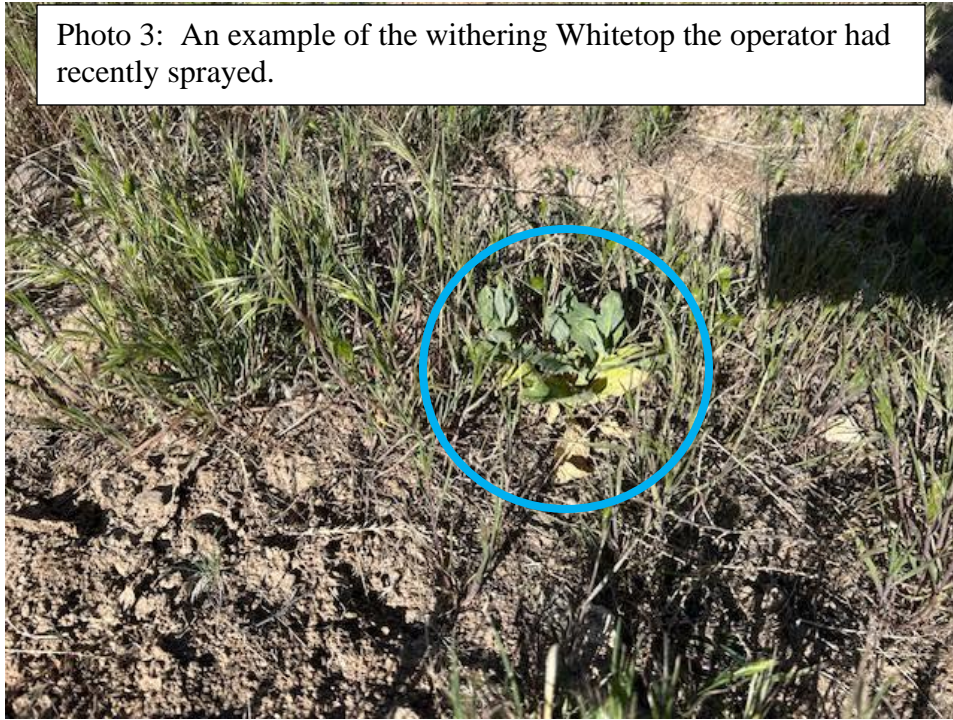
beginning to grow. During the inspection the Whitetop was observed to be withering from the weed spray (Photo 3). The site was stable and there were no erosional features identified (Photo 4, 5 and 6). The straw waddles placed at the boundary of the downgradient reclamation were observed to be in good condition. No off-site impacts were observed.

Photo 3: An example of the withering Whitetop the operator had recently sprayed.

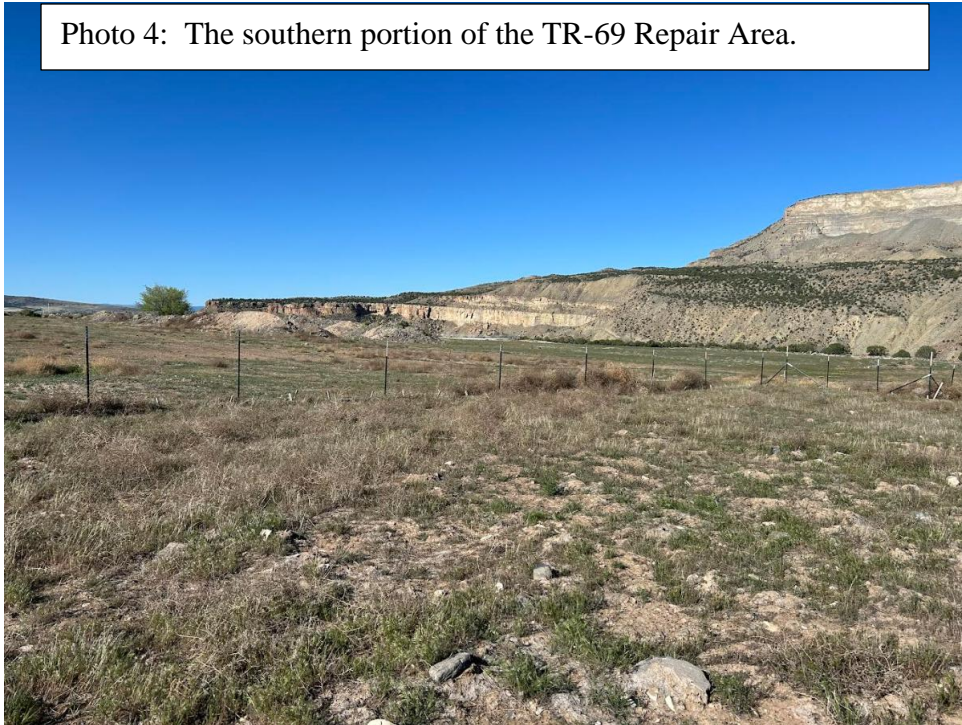
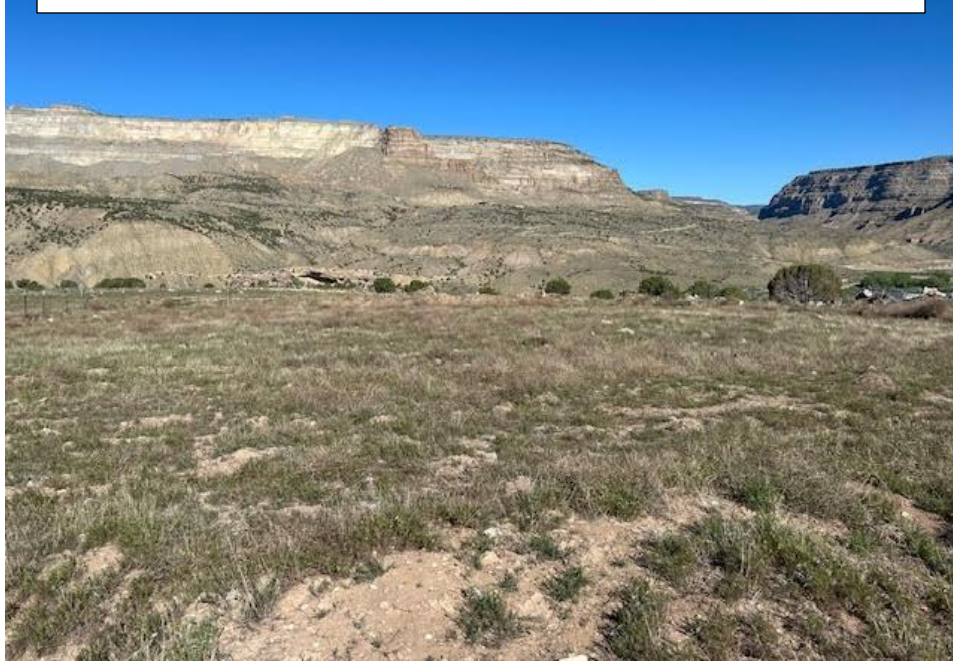
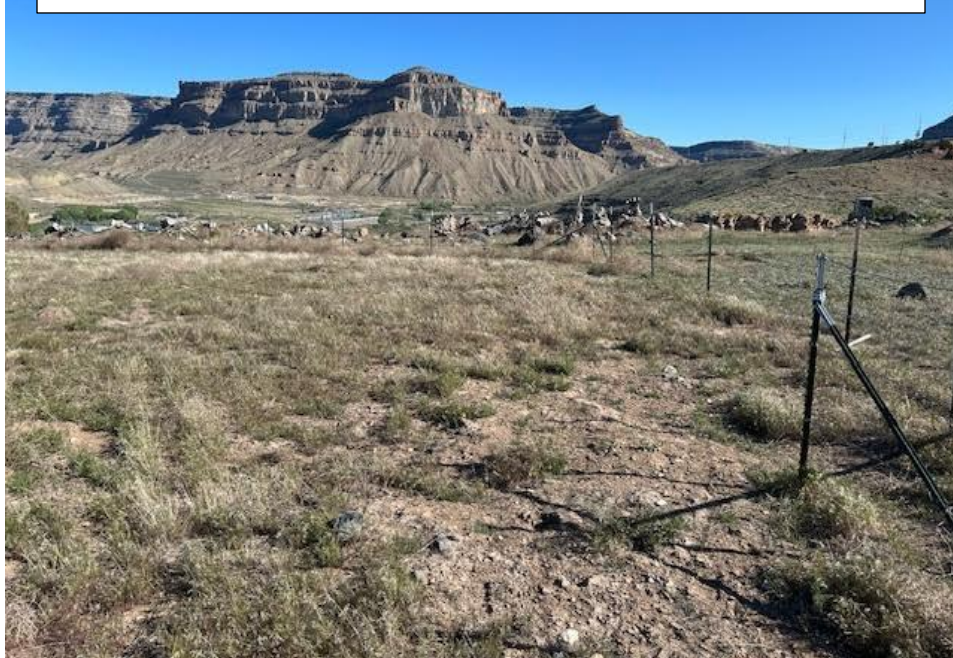
Photo 4: The southern portion of the TR-69 Repair Area.

Photo 5: The middle portion of the TR-69 Repair Area.

Photo 6: The northern portion of the TR-69 Repair Area.
