Permit Number: C-1982-056 Mine Name: Foidel Creek Mine Operator: Twentymile Coal, LLC Operator Address: Ms. Miranda Kawcak 29515 Routt County Road No. 27 Oak Creek, CO 80467	County: Routt Operation Type: Underground Permit Status: Active Ownership: Private
	Operator Representative Present: Mike Howard
Operator Representative Signature: (Field Issuance Only)

Inspection Start Date: April 23, 2025 Inspection Start Time: 13:00 Inspection End Date: April 24, 2025 Inspection End Time: 12:00		Inspection Type: Coal Partial Inspection Inspection Reason: Normal I&E Program Weather: Clear	
Joint Inspection Agency: None		Joint Inspection Contacts: 	
Post Inspection Agency: None		Post Inspection Contacts: 	
Inspector(s): Brock Bowles	Inspector's Signature:

The focus of this inspection is to review and inspect the Small Area Exemptions (SAE) listed in Section 2.05-82.1 through 2.05-84.12 of the permit application. Each SAE description describes the location and method of sediment control for each site. The first part of this inspection was spent in the office locating all the SAE on maps as not all the SAEs are shown on the same map.

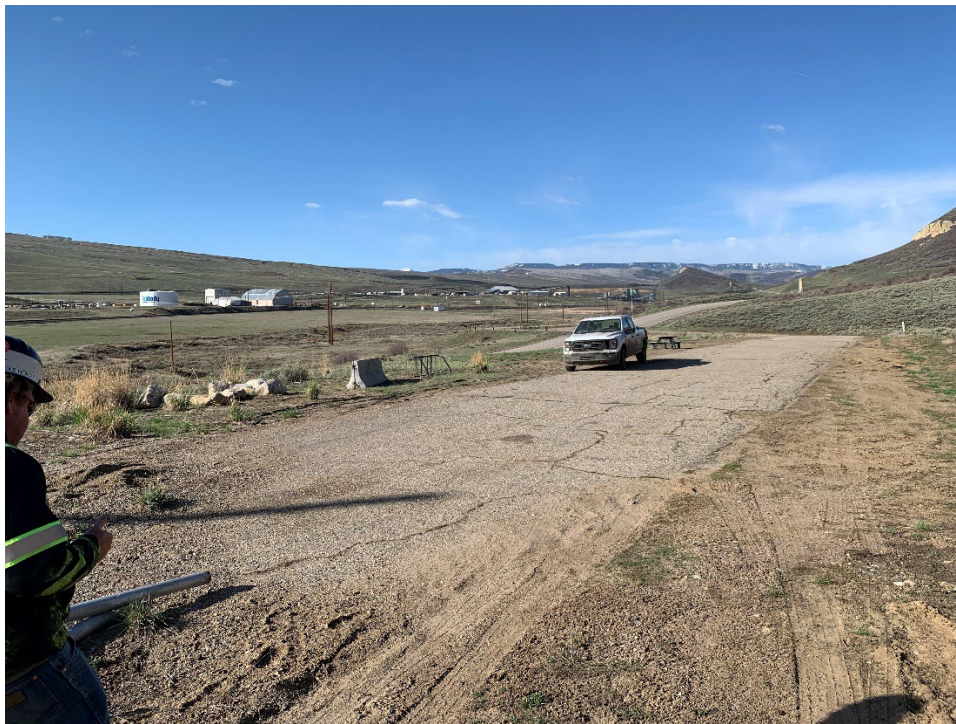
Trout Creek Sandstone Test Site- The site is located northwest of the Hwy 27 and Hwy 33 intersection. The site is no longer used by TC and has become a parking area for cyclists. The road is paved, which TC did not do. There is a picnic table, bike rack and jersey barrier (photo 1). The area is also littered with non-mine related waste such as bath towels, pieces of carpet and plastic bottles. The land is owned by Routt County as part of the Hwy 27 right-of-way, according to the Routt County Assessor website. TC will look into how to have this area removed as an SAE.

Photo 1– Trout Creek Sandstone Test Site. The area is now used by cyclists.

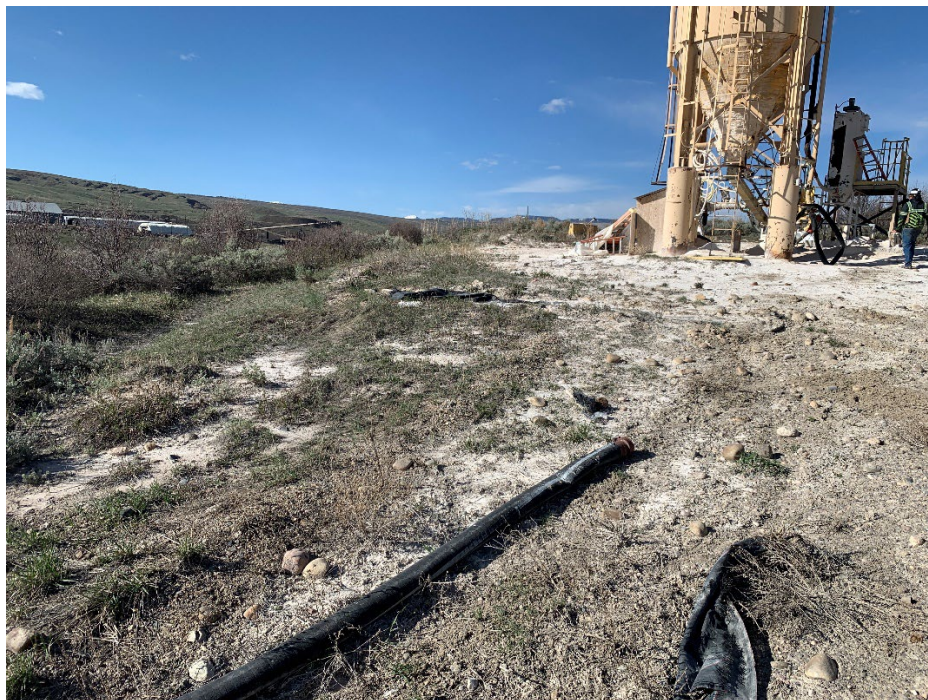
Rock Dust Tank- This area is adjacent to Hwy 27, west of the Hwy 33 intersection. Rock dust is scattered all over the area and is especially thick directly underneath the storage bins (photo 2 & 3). The sediment control ditch that runs along the south side is full of sediment. The rock dust is carried by water over the ditch beyond the sediment control structure. The excessive amount of rock dust on the ground needs to be cleaned up, the sediment ditch needs to be cleaned, and the gravel infiltration screens need to be reestablished. The topsoil stockpile was marked with a sign and well vegetated.

Photo 2- Rock dust tank area. Sediment ditch on left.

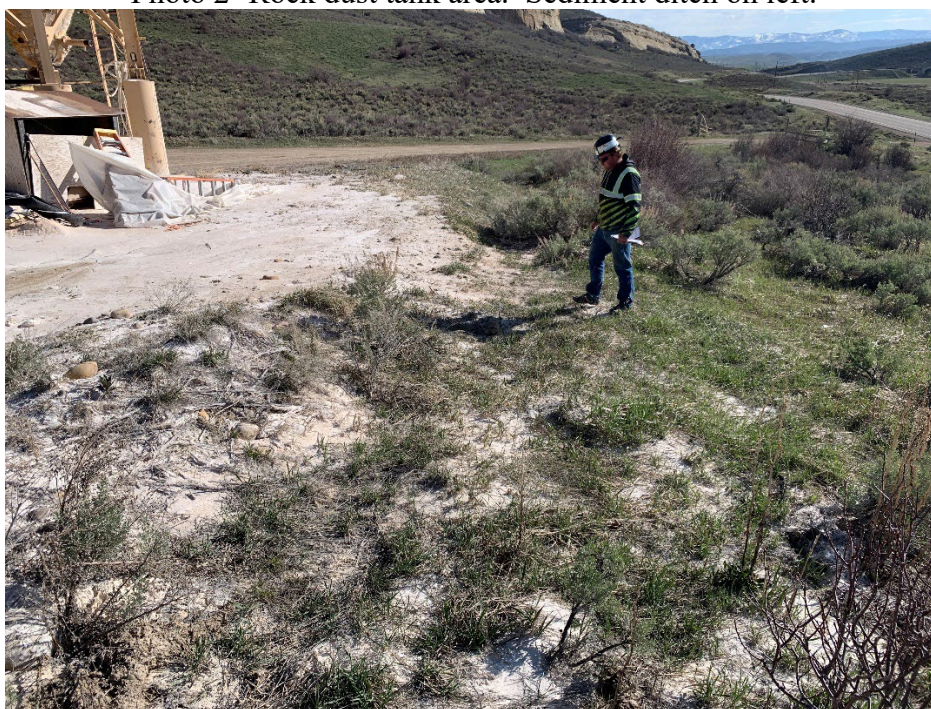
Photo 3- Upper end of sediment control ditch filled with sediment.

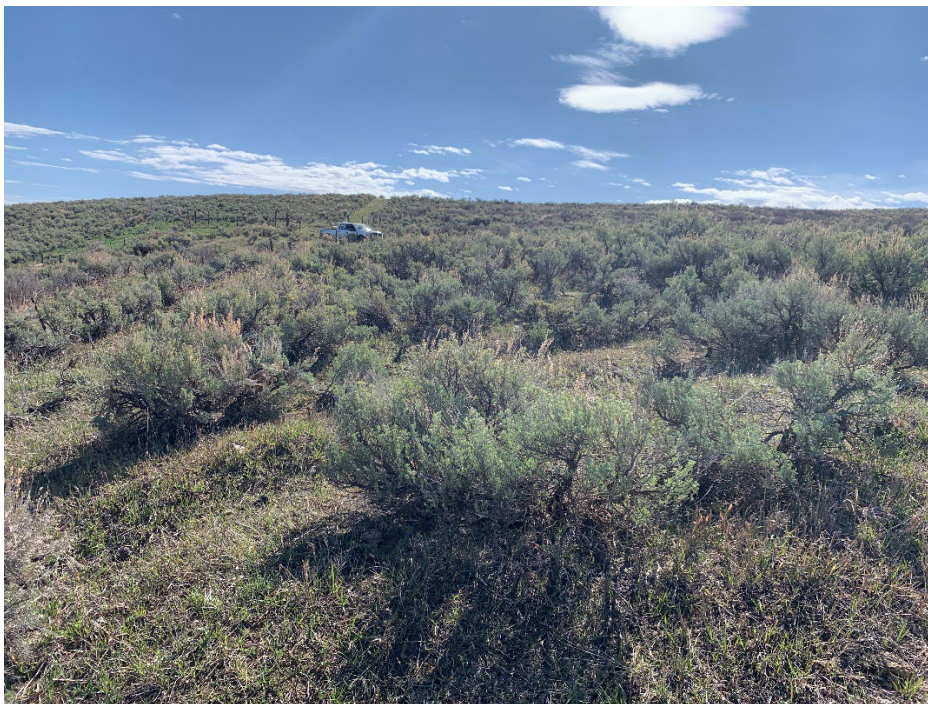
Southwest Mining District Ventilation Borehole and Substation- This site is located 0.5 miles southeast of the Hwy 27 and CR 37 intersection. The site is very well vegetated with grasses and sagebrush (photo 4). The soil is very stable and no erosion features were seen. The vent shaft was reported to have been sealed, but a piece of metal is sticking out of the ground that resembles the top of a shaft (photo 5). This needs to be investigated to ensure the integrity of the shaft. No sediment control devices were noted and none are needed.

Photo 4- The shaft disturbance area is well vegetated with grasses and sagebrush

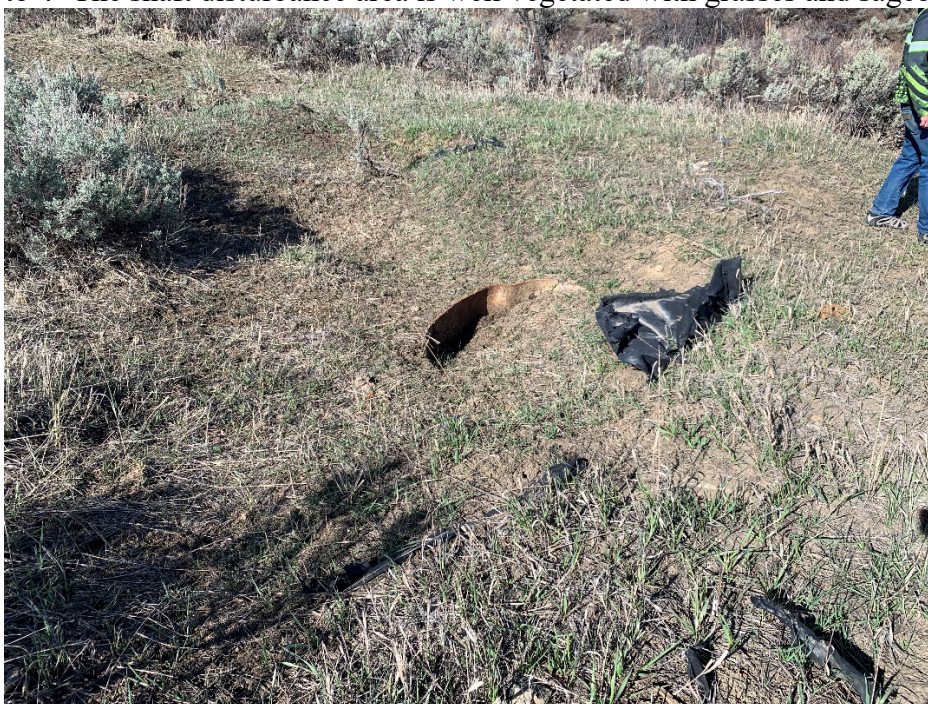
Photo 5- This piece of metal needs to be investigated if it is part of the sealed shaft

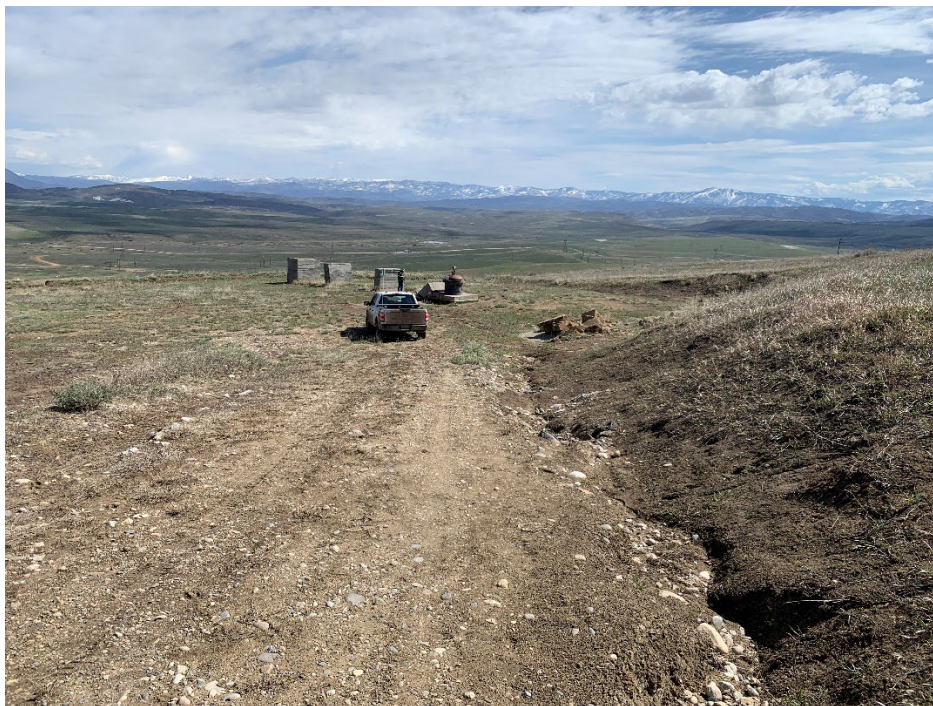
No. 7 North Escape Shaft- located 1.2 miles due south of the 6 MN Reservoir. The site is a 1.82 acre pad. The topsoil stockpile on the north side is well vegetated. The roadside sediment traps are full and need cleaning (photo 6). The sediment trap on the east side is in good condition (photo 7). The sediment trap on the west side needs repair.

Photo 6- Road side sediment traps need cleaning.
