PERMIT INFORMATION

Permit Number: C-1992-081 Mine Name: Hayden Gulch Loadout Operator: Hayden Gulch Terminal, LLC Operator Address: Ms. Miranda Kawcak 29515 Routt County Road 27 Oak Creek, CO 80467	County: Routt Operation Type: Loadout Permit Status: Active Ownership: Private
	Operator Representative Present: N/a
Operator Representative Signature: (Field Issuance Only)

INSPECTION INFORMATION

Inspection Start Date: April 22, 2025 Inspection Start Time: 15:00 Inspection End Date: April 22, 2025 Inspection End Time: 15:30	Inspection Type: OSM Partial Inspection Inspection Reason: Normal I&E Program Weather: Clear
Joint Inspection Agency: None	Joint Inspection Contacts:
Post Inspection Agency: None	Post Inspection Contacts:
Inspector(s): Brock Bowles	Inspector's Signature:

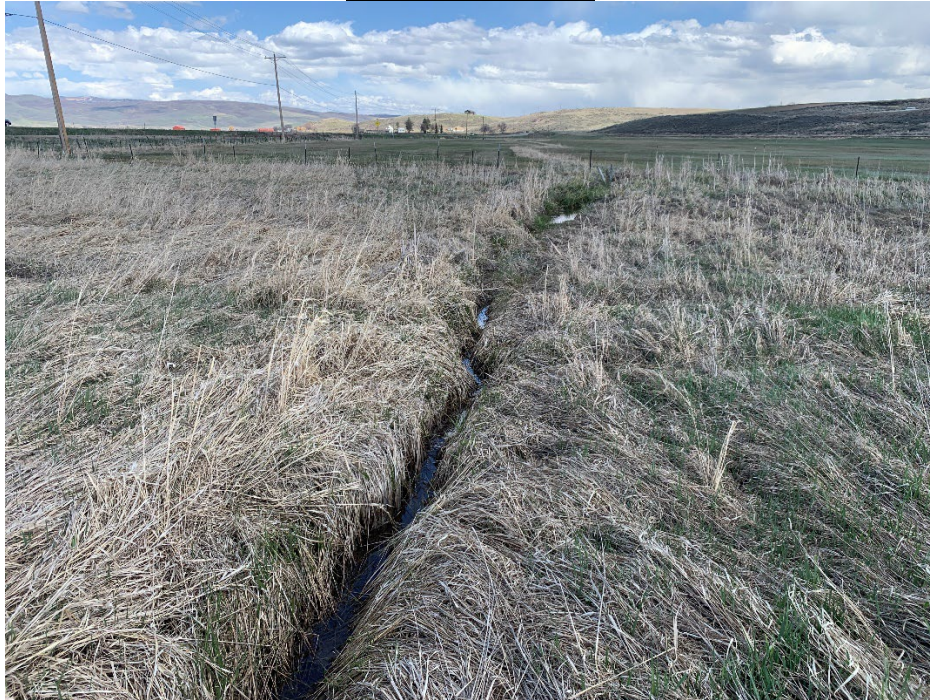
All the snow had melted, and all the snowmelt water was gone. The site was dry. Some water was in the ditches that traverse the site from east to west (photo 1). No erosion features were seen as the grasses are well established and are controlling erosion.

Photo 1 – A small amount of water was still in the ditches

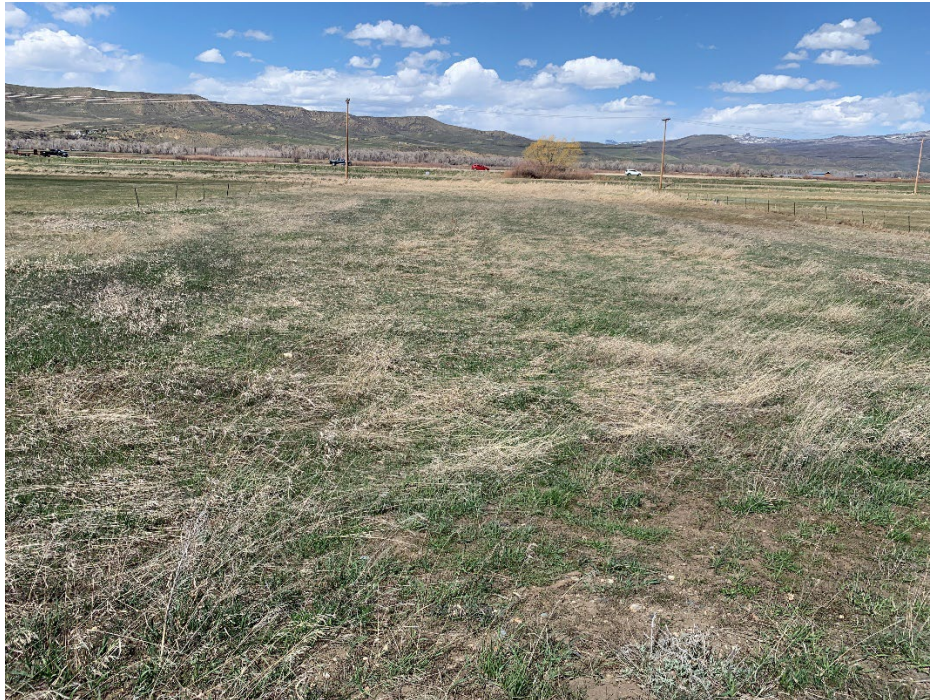
The grasses were starting to sprout on all parts of the site and adjacent areas (photo 2). The willows were not sprouting yet.

Photo 2- Grasses are starting to sprout for the season north of trailhead parking area.

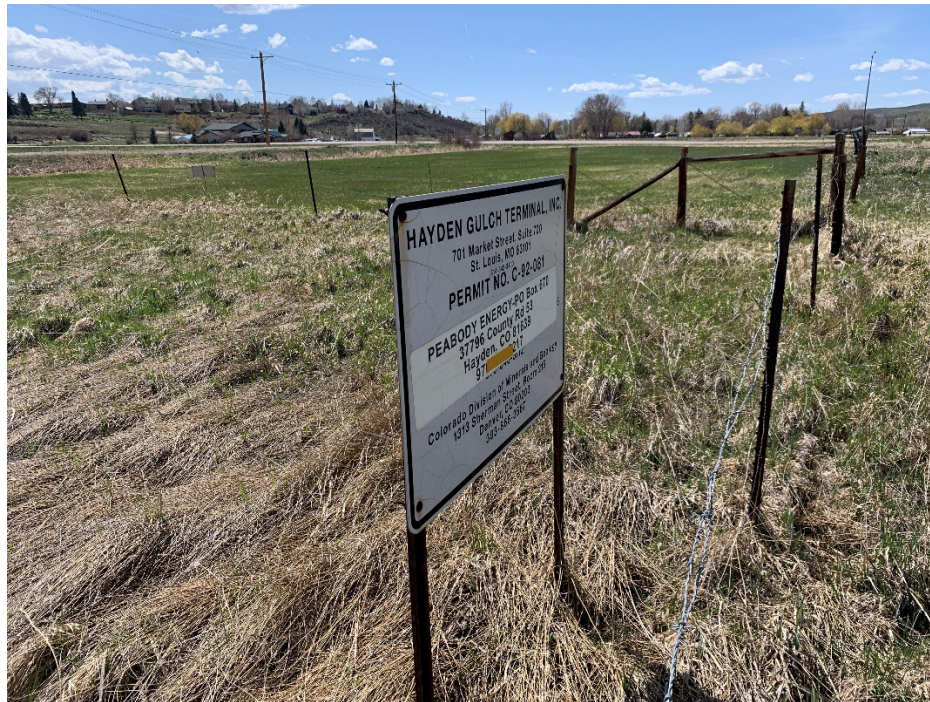
The mine identification signs were in place (photo 3).

Photo 3- Mine identification sign facing Hwy 40
