Subject: Summary of Instrumentation Monitoring

1<sup>st</sup> Quarter 2025

Bowie Coal Waste Disposal Area No. 2

Paonia, Colorado

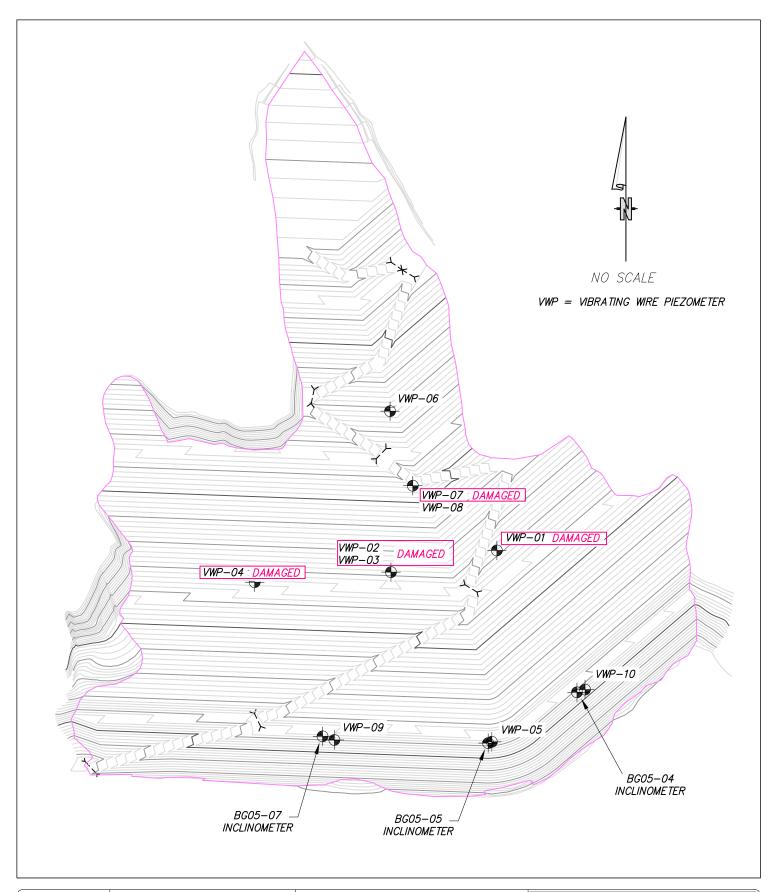
Attachments: Map 1 – Instrumentation Location Plan

The physical locations of the piezometers are shown on the attached Instrumentation Site Plan (Map 1). As seen on this map, five of the original piezometers were damaged, and some were replaced. Currently, there are five active VWP's, and three of them are adjacent to inclinometers. The graph of historical VWP data from May 16, 2005 through May 21, 2014, is presented in Figure 1. A graph of measured pore pressures of active piezometers is shown on the attached Figure 2 and is presented numerically in Table 1 below.

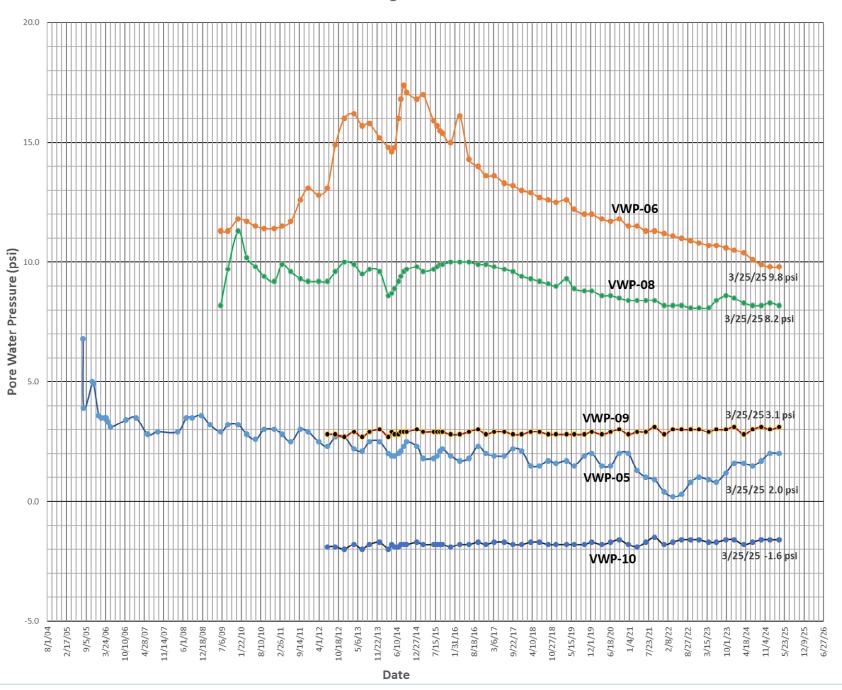
Figure 2 - Bowie Mine #2 - CWDA #2 Active Vibrating Wire Piezometer Data

As seen on Table 1 and Figure 2, the VWP readings and trends are consistent with recent and historic readings. When compared to a year ago (Q1 2024), pore pressure readings in all the VWP's changed by small amounts (-0.6 to 0.4 psi). When compared with last quarter (Q4 2024), pore pressures also changed by relatively small amounts (0 to +/-0.1 psi) for all five VWP's. Although four of the five VWP's remain steady or have general declining trends in pore pressure over the life of the VWP's, one of the piezometers (VWP-05) has exhibited pronounced seasonal cyclical behavior for its lifespan, except from mid-2021 to mid-2022 where there was a steady decline in pore pressures. This piezometer generally (but not always) shows low pore pressures for Q1 and Q2 and higher pressures for Q3 and Q4, with a net loss of -4.8 psi over the lifetime of that VWP. The other four VWP's have experienced net changes of 0 to -1.5 psi since installation, meaning current readings are very similar to initial readings. For VWP-09 and VWP-10, pressures have been consistent throughout the lifetime of the piezometers; however, for VWP-06 and VWP-08, they experienced wild fluctuations in pore water pressure in the first half of their lifetimes but have settled to pressures similar to the installation pressures in the past several years.

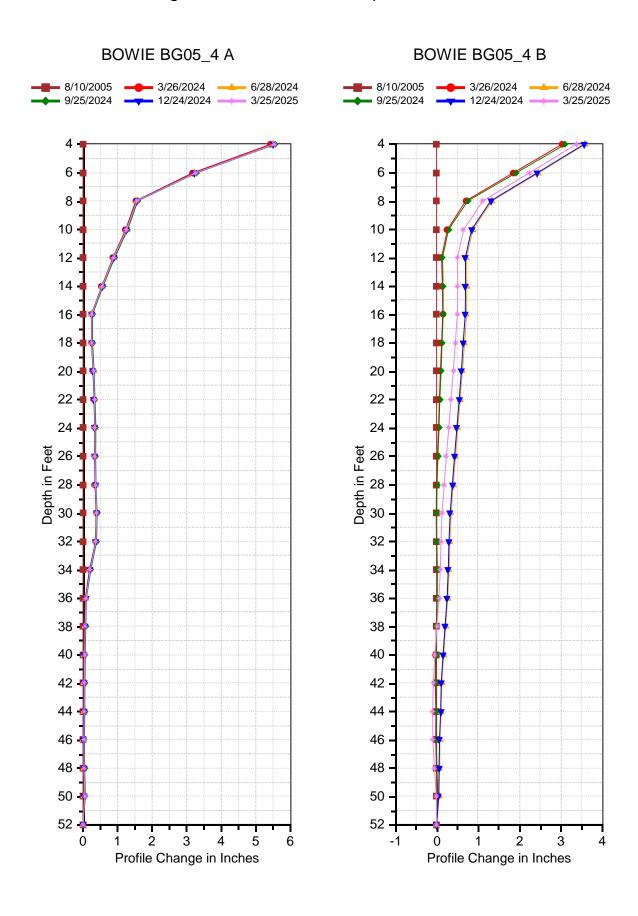
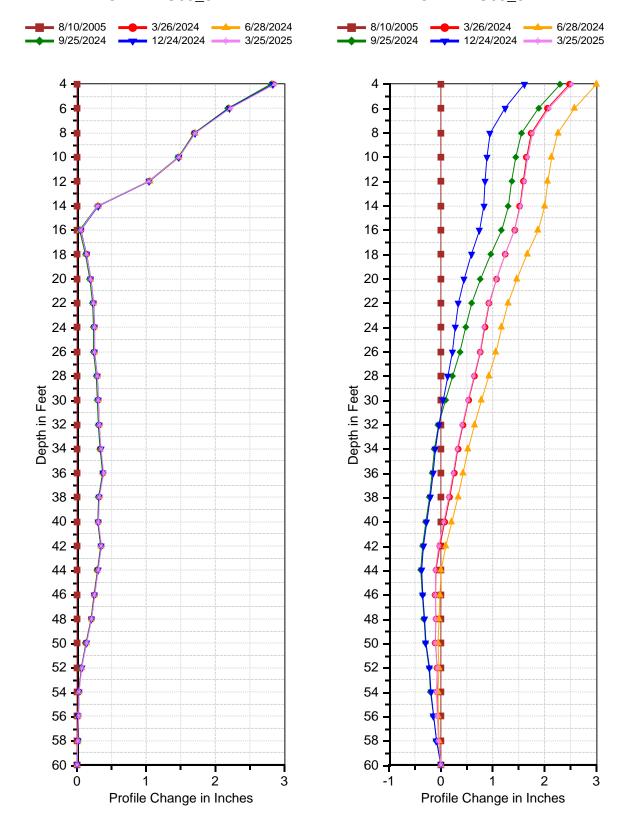
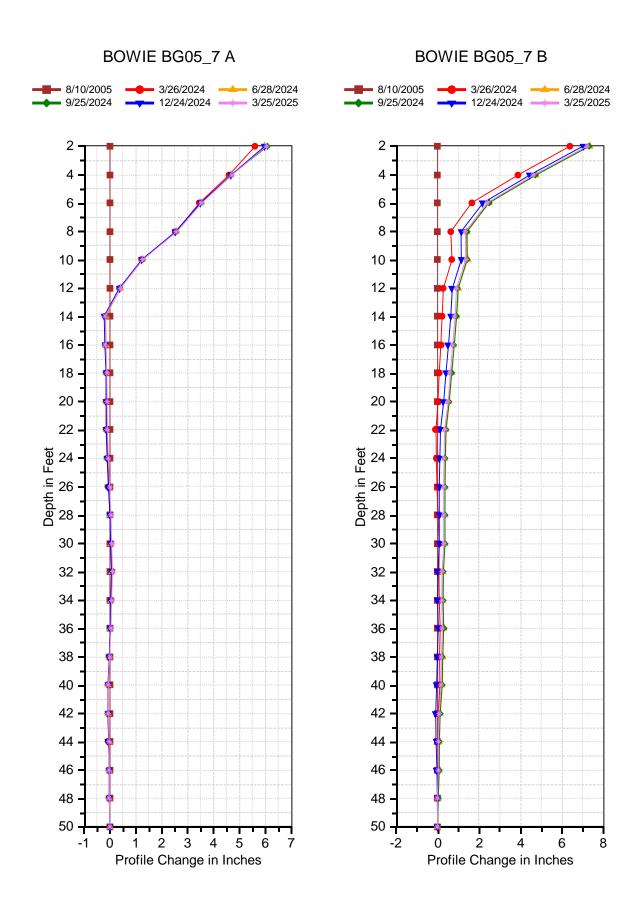
Figure 3 - Inclinometer Displacement Curves

As described in previous reports, historic displacements indicated on the plots for the approximate upper 14-16 feet of the inclinometers since installation in 2005 are due to placement of cover soil on the face of the waste pile during revegetation/regrading operations in late 2006 and early 2007. This man-caused displacement is documented in a report by Buckhorn Geotech dated December 22, 2008, to Bowie Resources called *Revised Stability Evaluations for Coal Mine Waste Disposal Area No. 2, Bowie No. 2 Mine.*

Based on the current inclinometer readings, BG05\_7 shows near perfect alignment (essentially identical readings for 20 years) with the initial reading in 2005 for the downslope direction (Axis A). Inclinometers BG05\_4 and BG05\_5, however, show a bulge of less than ½-inch in the inclinometer pipes (below the surface regrading). Based on our records, this bulge developed slowly from 2005 to 2010, but no movement has been recorded since then. This suggests there had been some gob pile settlement early in the lifetime of the inclinometers, but no recent or additional movement has occurred. Some "noise" which is understood to be relatively common in orthogonal direction (Axis B) readings, was observed over the past few years for all three inclinometers. This can be due to various mechanical or installation causes that are unrelated to slope movement. For example, grout voids, poor grout coverage, or soil settlement around the instrument can all contribute to vibrations and pipe movement that impacts inclinometer

readings. No software bias adjustments were applied to filter this noise. All readings were consistent with previous readings and the "displacement" error was within equipment tolerances and not deemed to be due to slope movement.
