## C-1981-035 King Mine April Partial Inspection Report

<b>Permit Number:</b> C-1981-035 <b>Mine Name:</b> King Coal Mine <b>Operator:</b> GCC Energy, LLC <b>Operator Address:</b> Mr Jordan McCourt 6473 County Road 120 Hesperus, CO 81326	<b>County:</b> La Plata <b>Operation Type:</b> Underground <b>Permit Status:</b> Active <b>Ownership:</b> Private
	<b>Operator Representative Present:</b>  Wade Wymore and Jordan McCourt
<b>Operator Representative Signature: (Field Issuance Only)</b>

<b>Inspection Start Date:</b> April 23, 2025 <b>Inspection Start Time:</b> 13:20 <b>Inspection End Date:</b> April 23, 2025 <b>Inspection End Time:</b> 15:34	<b>Inspection Type:</b> Coal Partial Inspection <b>Inspection Reason:</b> Surety Related <b>Weather:</b> Clear
<b>Joint Inspection Agency:</b>  None	<b>Joint Inspection Contacts:</b>
<b>Post Inspection Agency:</b>  None	<b>Post Inspection Contacts:</b>
<b>Inspector(s):</b>  Lucas West	<b>Inspector's Signature:</b>

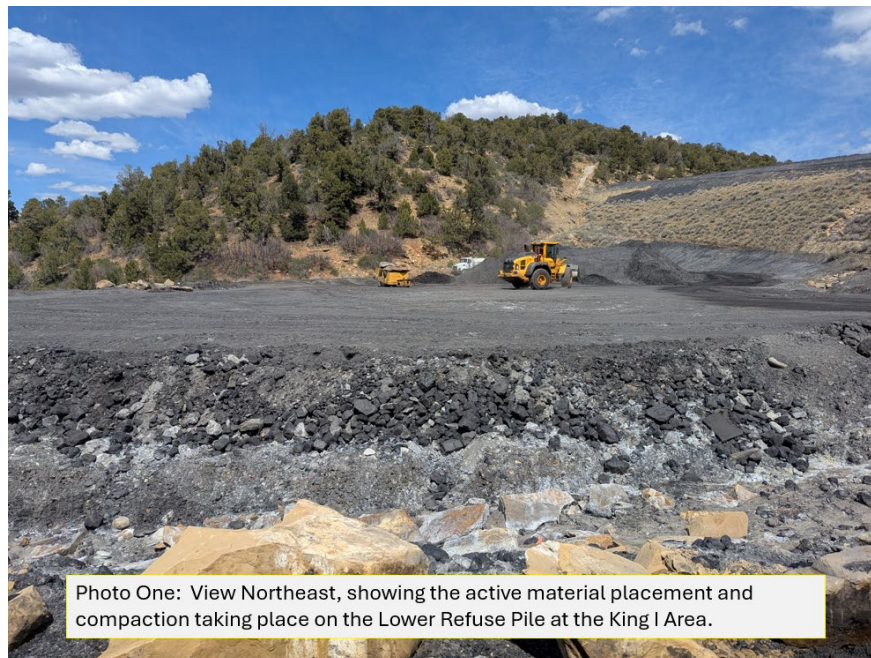
At the King I facility both the Upper and the Lower Refuse Piles were observed. The Upper Refuse Pile (URP) remains in similar condition to the Division's previous inspections. The stockpile of material at the East end of refuse pile shows no signs of recent placement, nor signs of erosion or sediment transport. The face of the pile is well compacted, and no evidence of erosion was noted. At the time of the inspection, material was actively being laid down in lifts and compacted on the Lower Refuse Pile (LRP) as seen in Photo One. The material being compacted appears to be in accordance with the design specifications.

Photo One: View Northeast, showing the active material placement and compaction taking place on the Lower Refuse Pile at the King I Area.

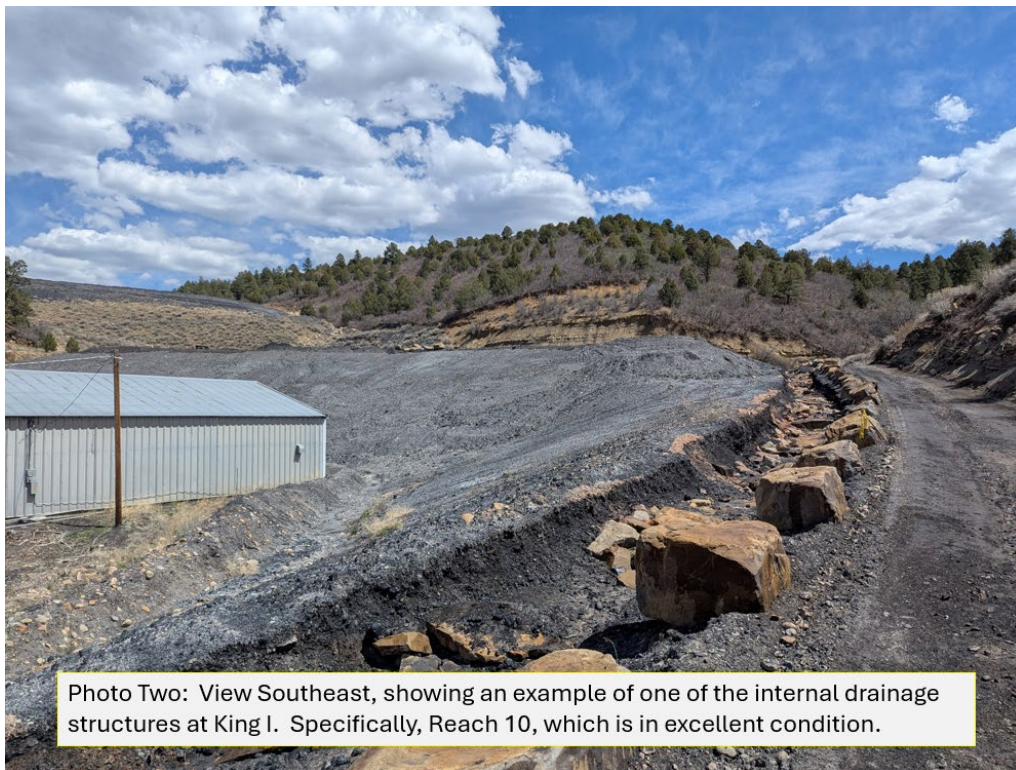
At the King I facility, many of the internal drainage control structures were observed. all of the observed structures were free from obstruction and able to function as designed. an example of one of the structures can be seen in Photo Two.

Photo Two: View Southeast, showing an example of one of the internal drainage structures at King I. Specifically, Reach 10, which is in excellent condition.

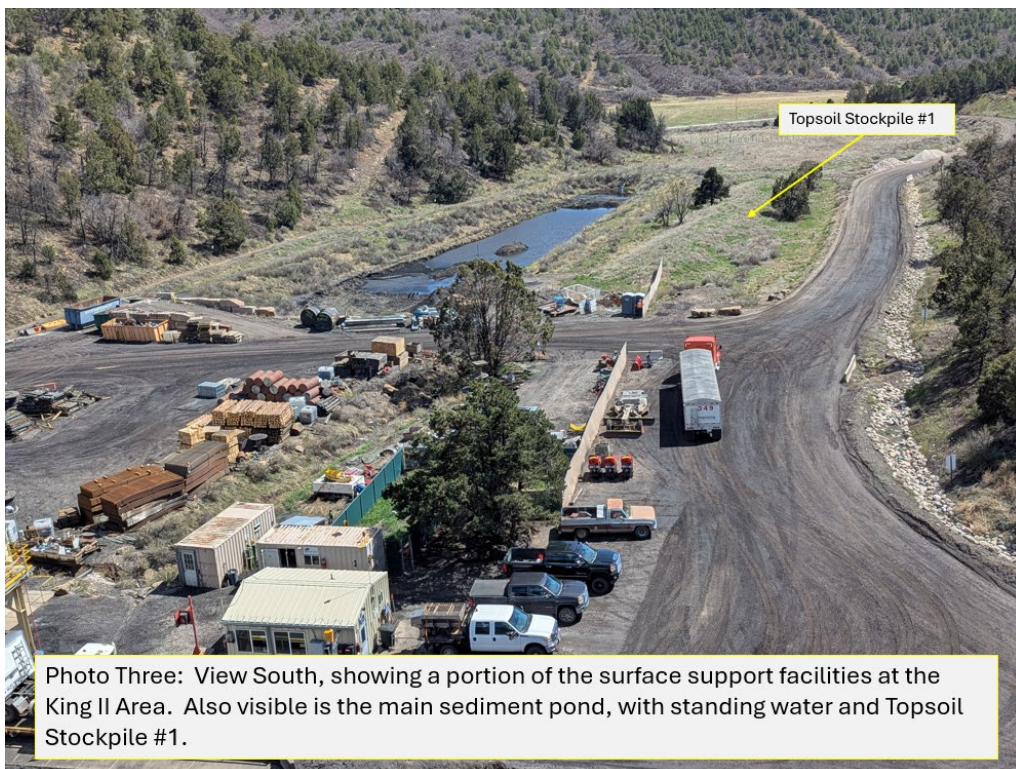
function as designed. The main sediment pond did contain standing water, however no evidence of discharge was noted. The banks of the pond appeared to stable at the time of the inspection, are well vegetated and in good condition. The pond can be seen in Photo Three.

During this inspection the surface facilities at the King II Area were observed from the top of the Number 1 Stacker. All elements of the surface facilities are in excellent condition and the Operator has done an exemplary job at keeping the area organized and well kept. The surface facilities can be seen in Photos Three and Four.

Photo Three: View South, showing a portion of the surface support facilities at the King II Area. Also visible is the main sediment pond, with standing water and Topsoil Stockpile #1.

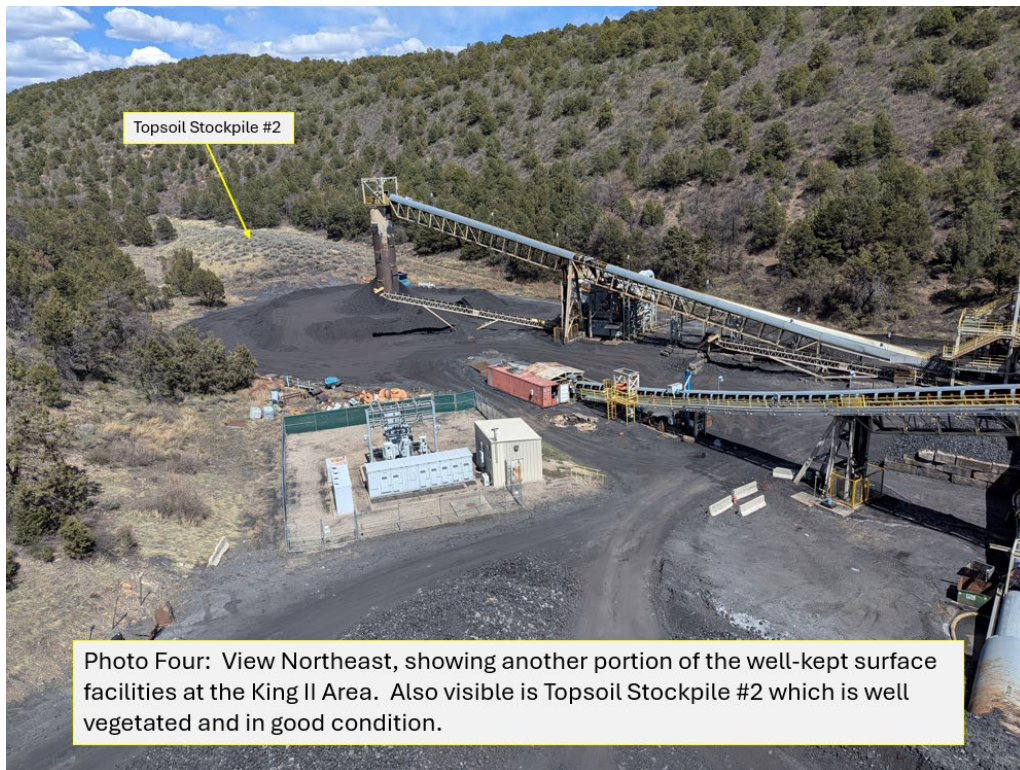
All topsoil stockpiles at both the King I and II Areas were observed. The piles have all been vegetated for stability and no evidence of erosion or sediment transport was noted. The topsoil stockpiles at the King II area can be seen in the overview photos, Photos Three and Four. The piles at the King I Area can be seen in Photos Five and Six.
