C1980007, West Elk Mine, April Inspection Report

PERMIT INFORMATION

Permit Number: C-1980-007 Mine Name: West Elk Mine Operator: Mountain Coal Company, LLC Operator Address: Robert Munz 5174 Highway 133 Somerset, CO 81434	County: Delta, Gunnison Operation Type: Underground Permit Status: Active Ownership: Private
	Operator Representative Present: Chase Hiatt
Operator Representative Signature: (Field Issuance Only)

Inspection Start Date: April 25, 2025 Inspection Start Time: 09:00 Inspection End Date: Inspection End Time:	Inspection Type: Coal Partial Inspection Inspection Reason: Normal I&E Program Weather: Clear
Joint Inspection Agency: None	Joint Inspection Contacts:
Post Inspection Agency: None	Post Inspection Contacts:
Inspector(s): Leigh Simmons	Inspector's Signature:

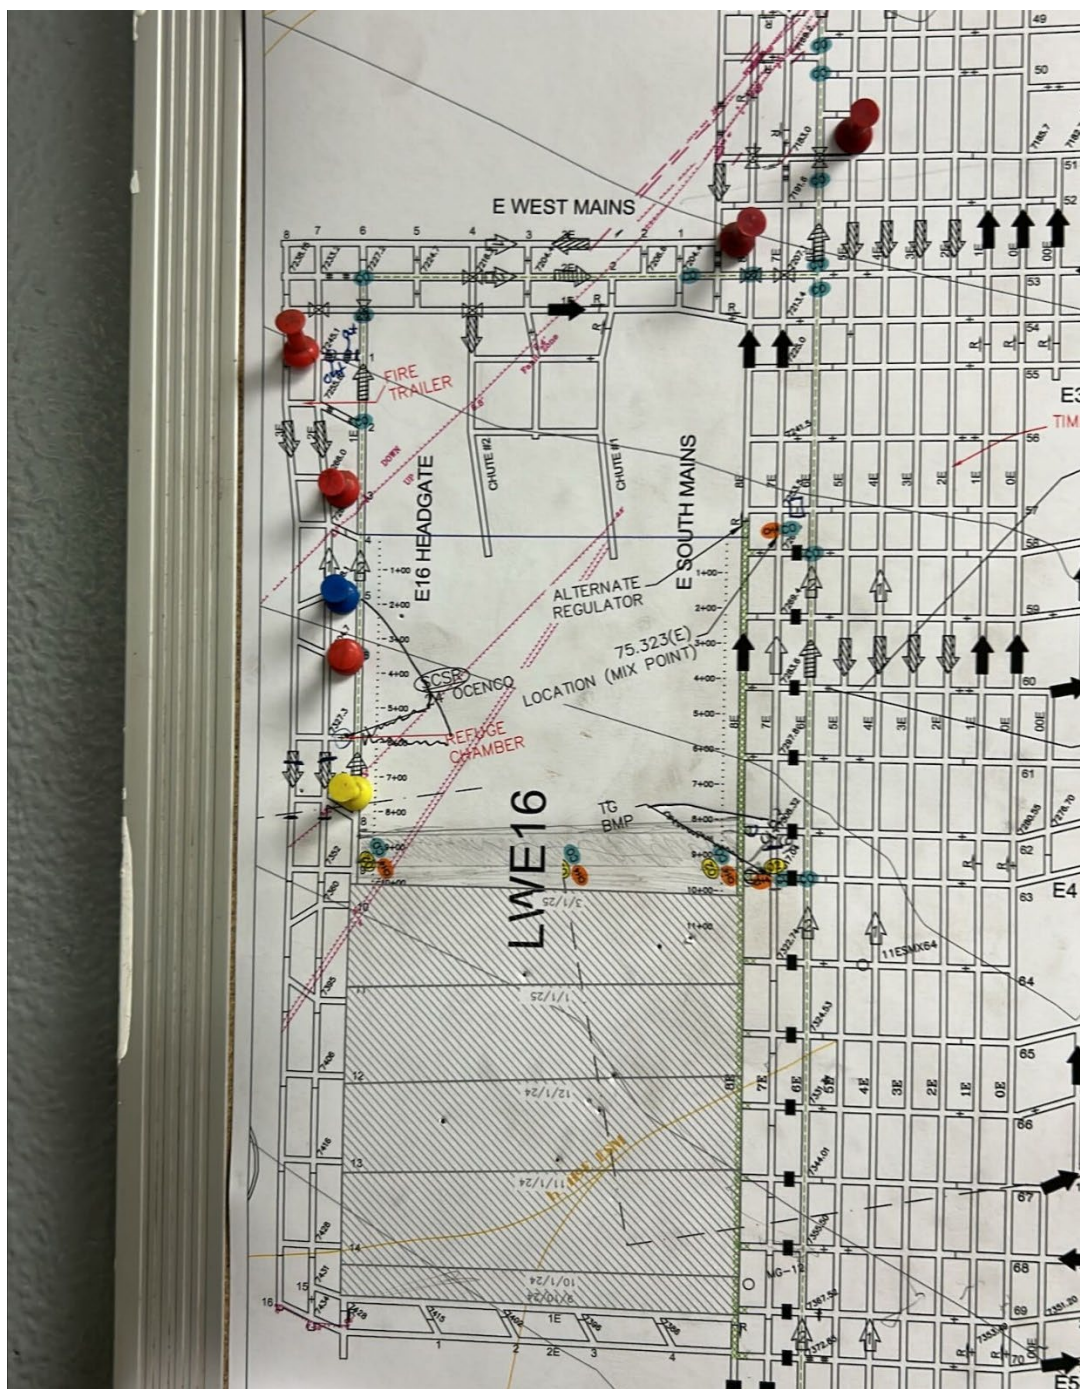
Longwall mining of the LWE16 panel was in progress, at around cross cut 8 on the head gate. Three development crews were working: in the B26 tail gate at around cross-cut 38, in the B26 head gate as far as the start line, and in the B27 head gate at around cross-cut 33. Contractors with Phoenix Mining continued to work on pillaring of the Sunset Mains, the job was nearing completion.

Figure 1: Mine map showing longwall progress in LWE16

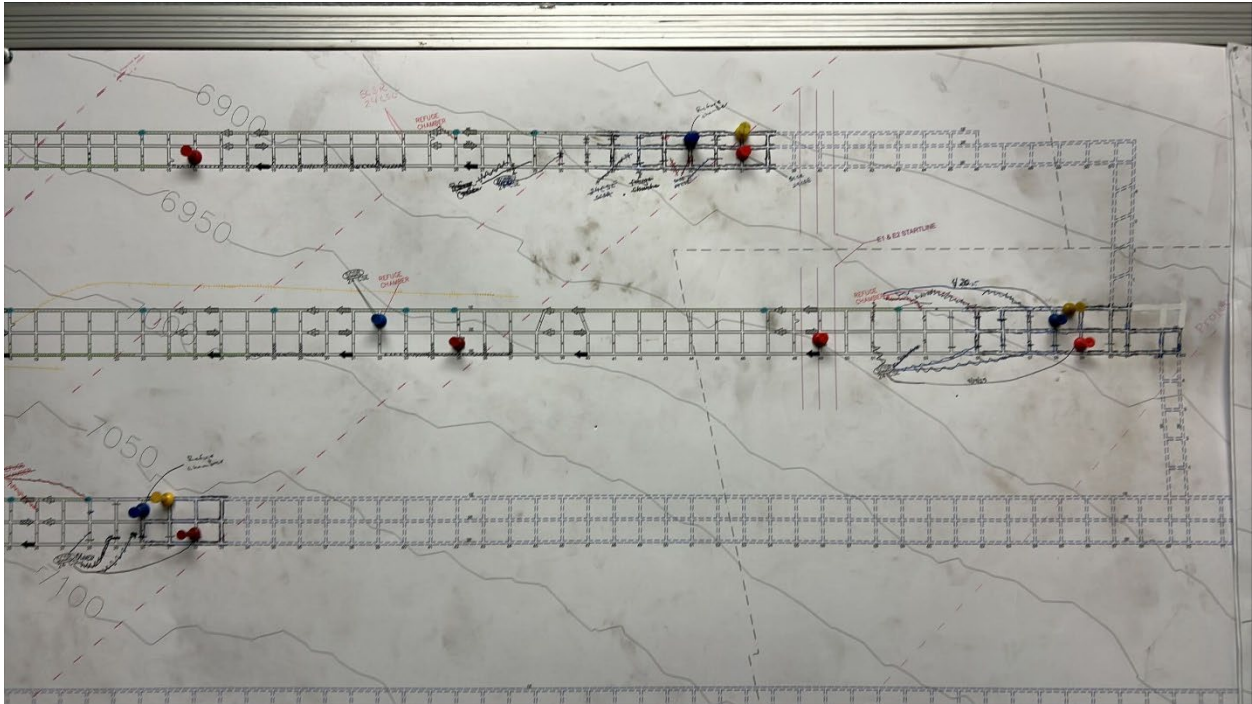
Figure 2: Mine map showing development progress in B-seam panels

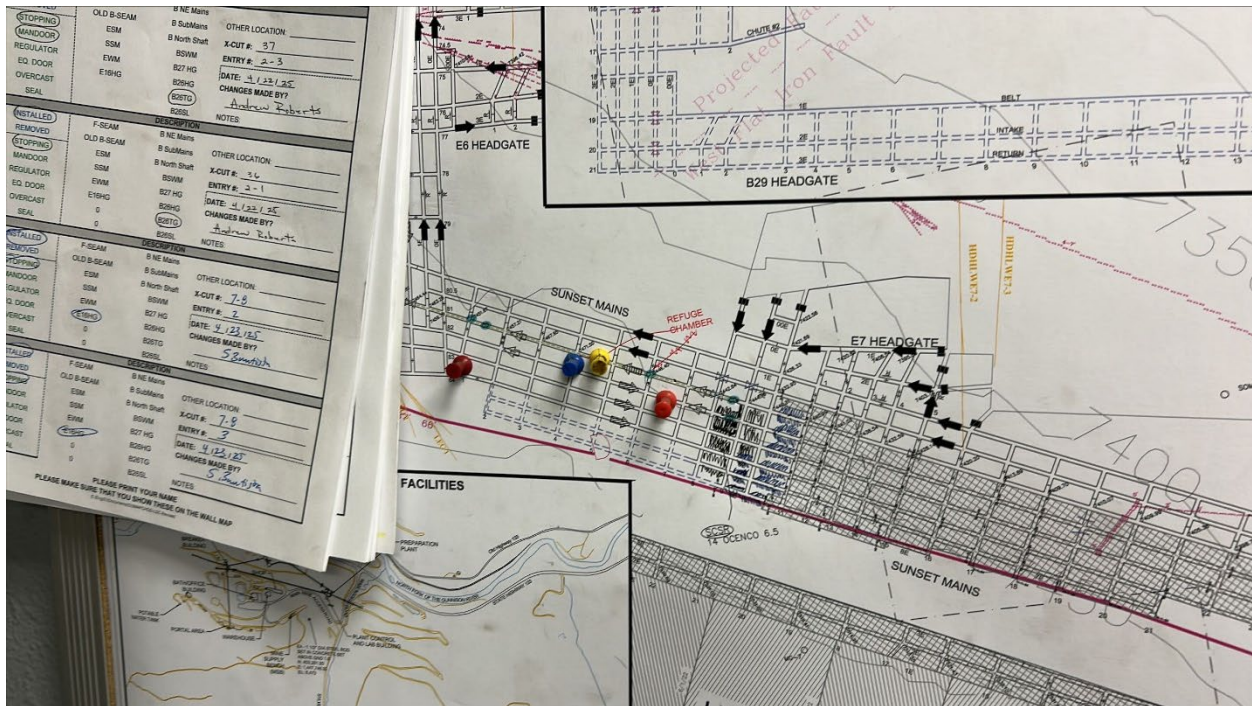
Figure 3: Mine map showing pillaring progress

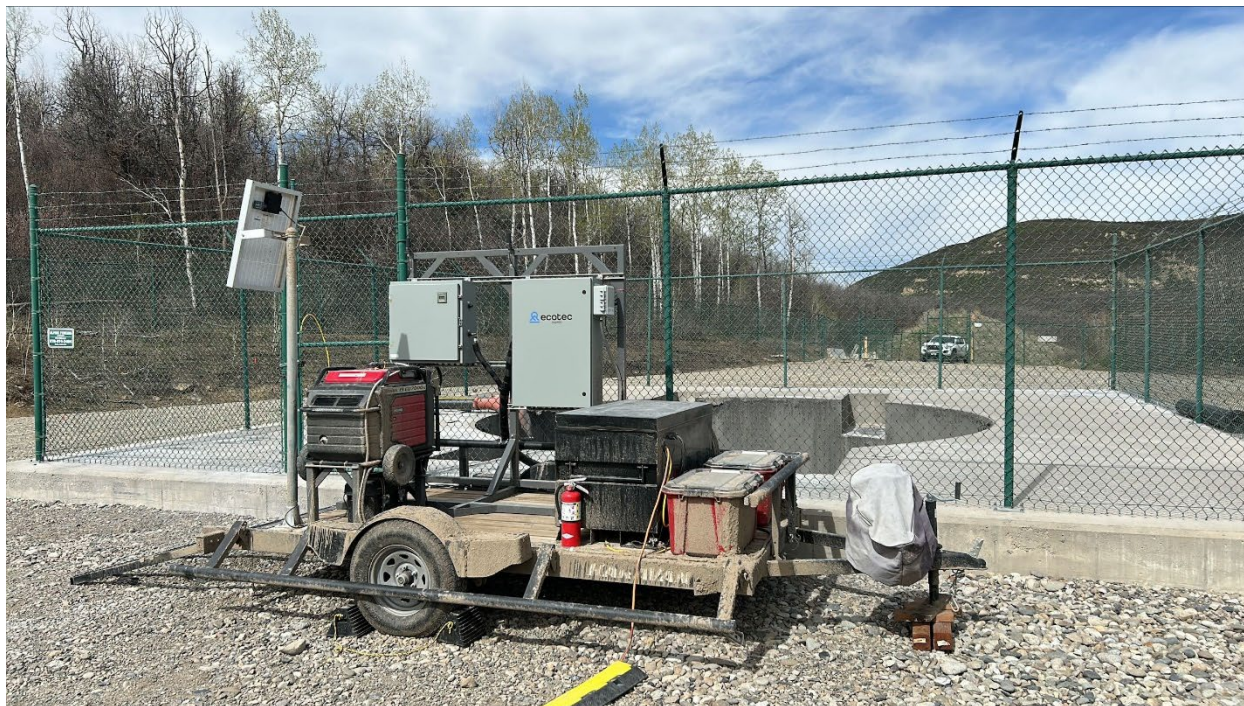
At the Deer Creek vent shaft a laser device had been installed in order to better characterize the gases emitted from the shaft and assess the potential for greenhouse gas mitigation. The pad was stable and in good condition behind two layers of chain link fence and locked gates.

Figure 4: Laser instrument installed at Deer Creek vent shaft

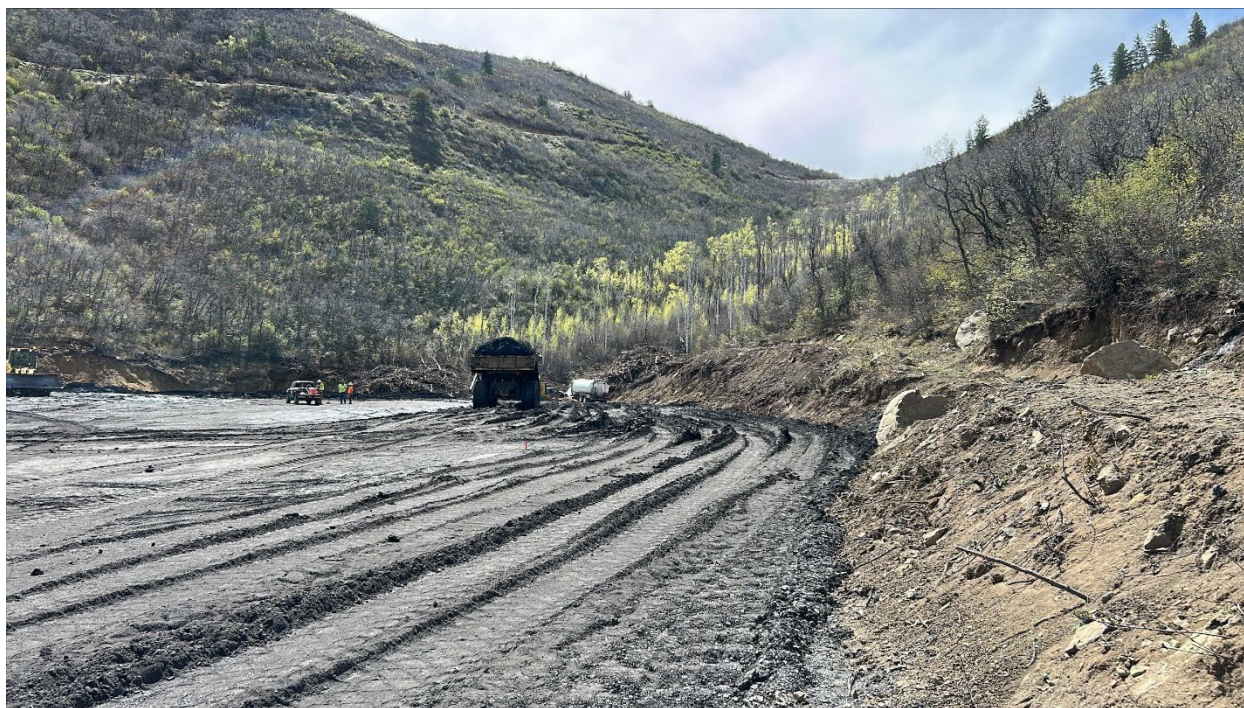
The surface of the RPEE was in good shape, with drainage to the north west corner. The reclaimed outcrops were also in good shape, however a few sections of straw wattle should be re-staked.

Figure 5: RPEE

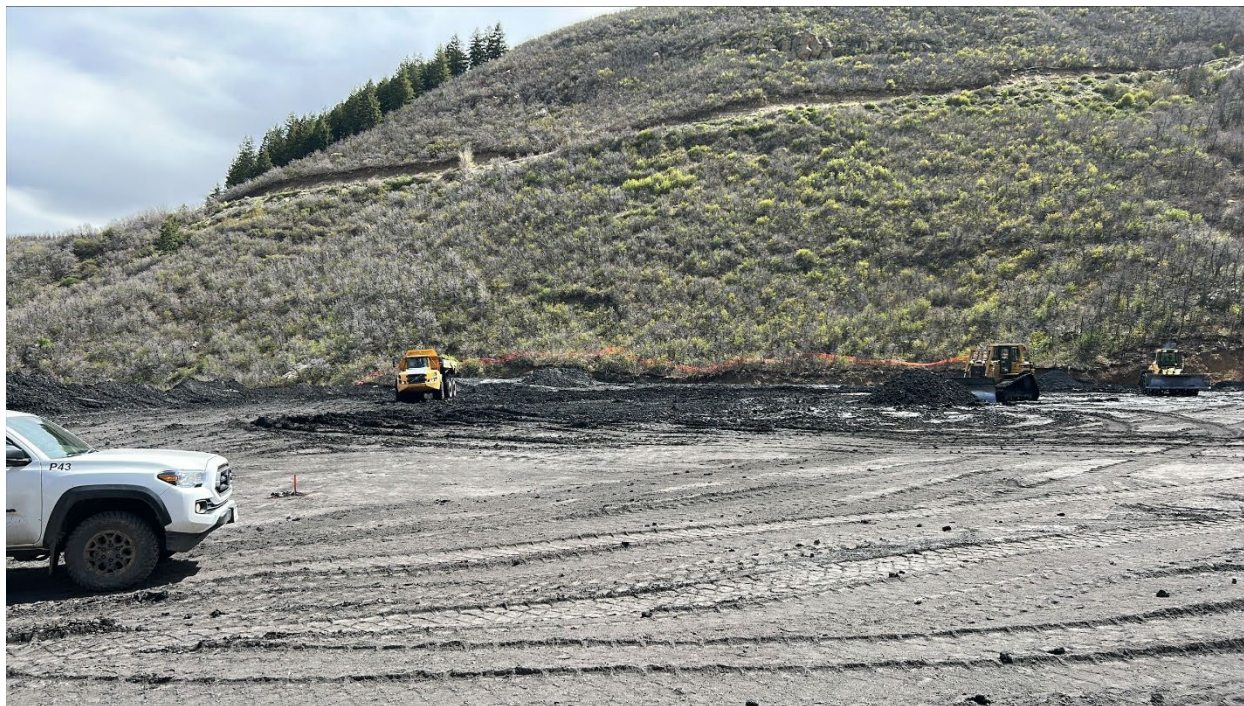
The wash plant had been running for about a week and a half to wash coal from the longwall, where a fault had been encountered in panel LWE16. Processing waste was being transported to the RPEE where it was spread with a dozer. Haul trucks were being used for preliminary compaction, and a sheep's foot compactor was also working.

Figure 6: RPEE, showing preliminary compaction with haul truck

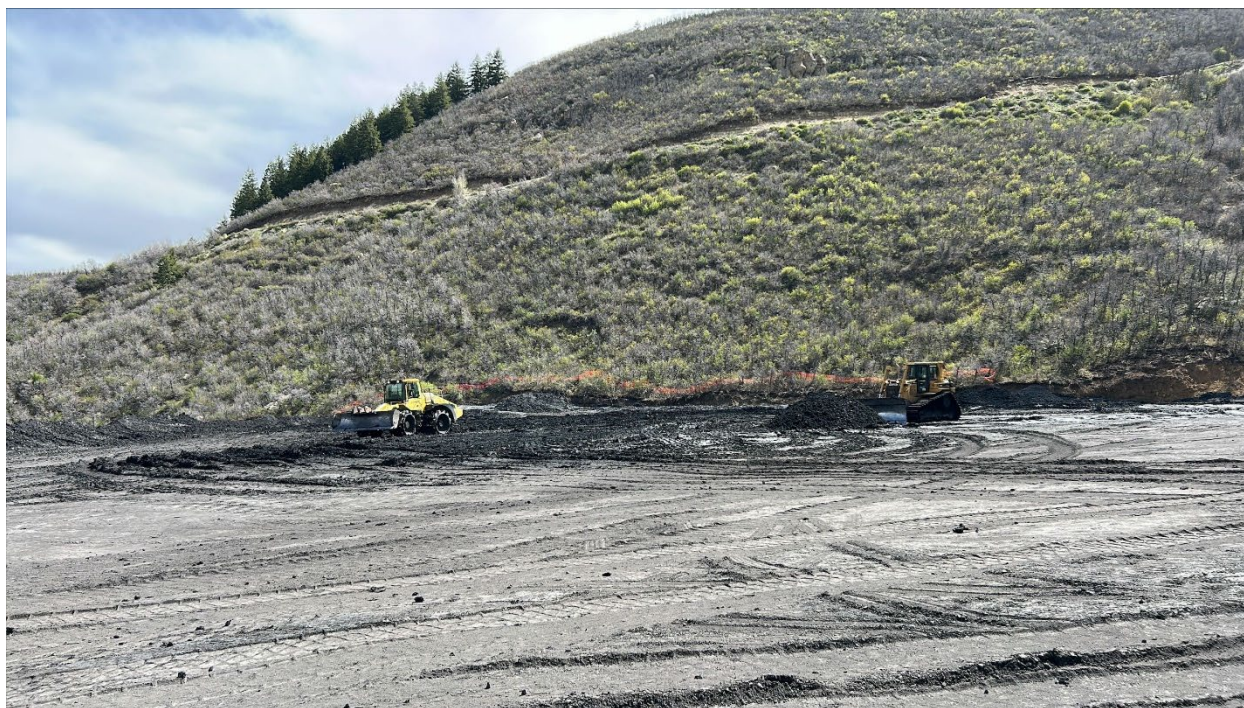
Figure 7: Sheep's foot compactor

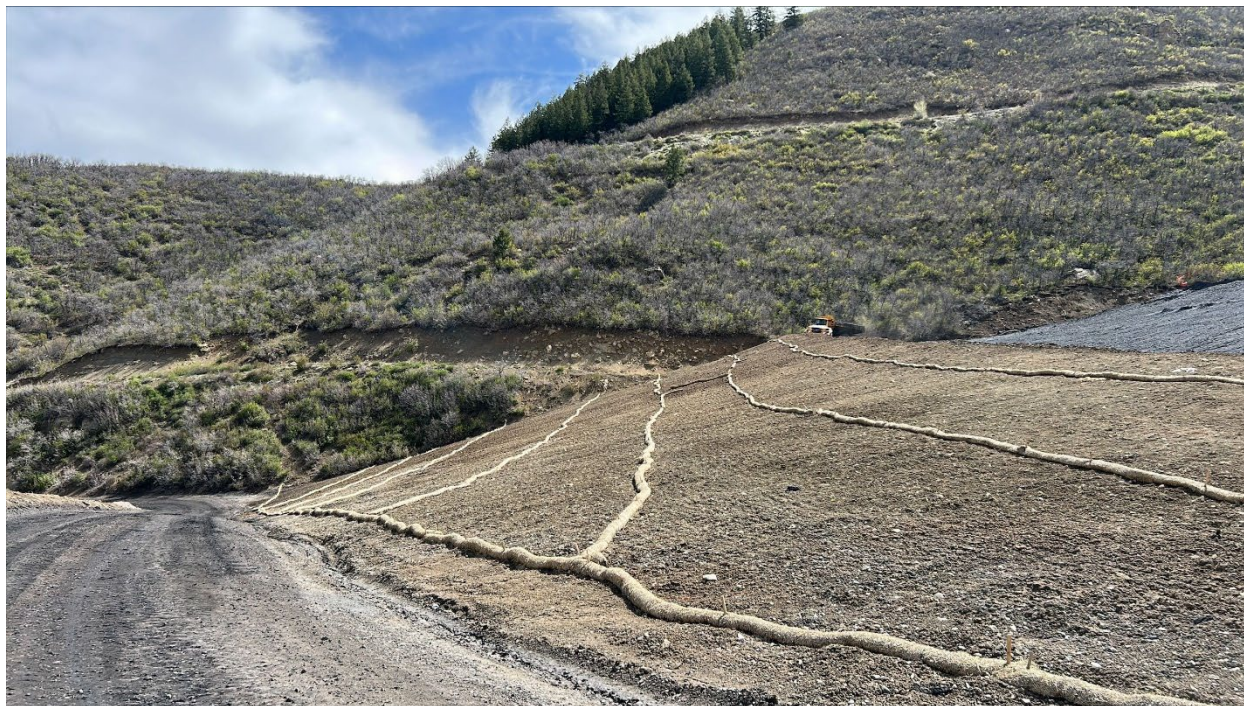
Figure 8: RPEE outslope, showing straw wattles

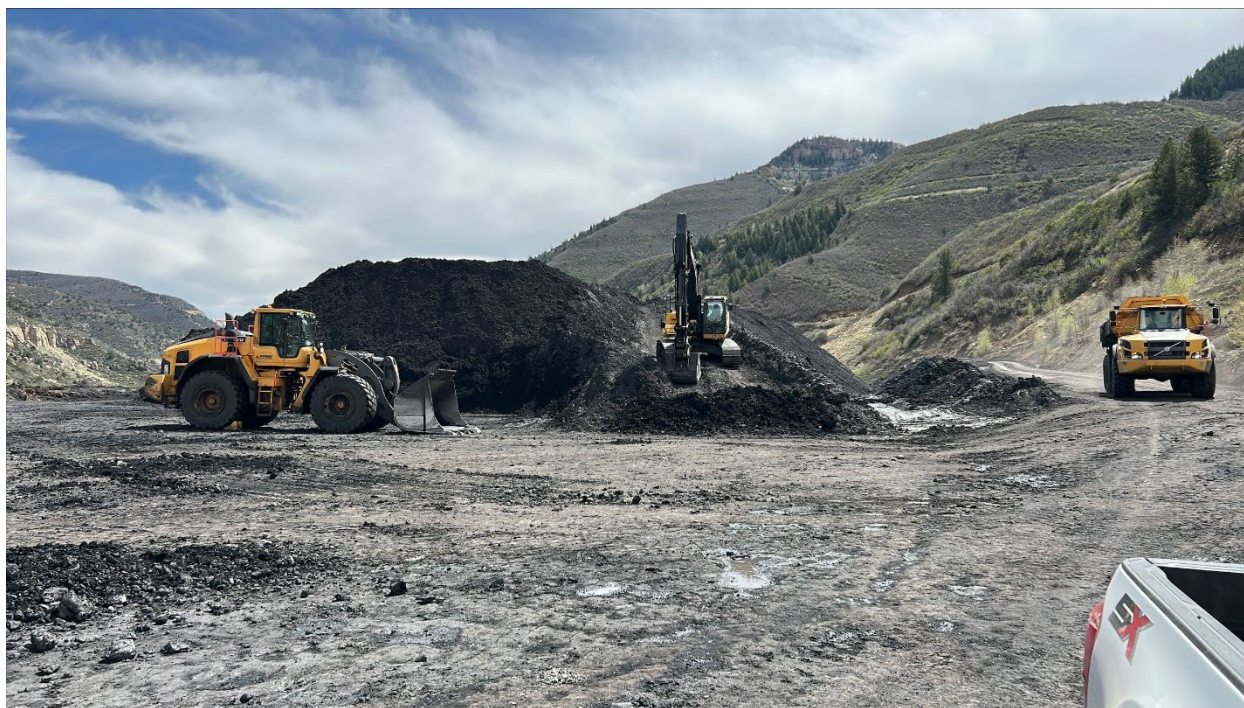
Waste from the temporary pile on the RPE was also being transported to the RPEE.

Figure 9: Temporary waste pile on RPE
