Permit Number: C-1981-037 Mine Name: GEC Strip Mine Operator: GEC Minerals, Inc. Operator Address: Dr W Corley 2605 Constellation Drive Colorado Springs, CO 80906	County: Fremont Operation Type: Surface Permit Status: Revoked Ownership: Private
	Operator Representative Present: None
Operator Representative Signature: (Field Issuance Only)

Inspection Start Date: May 1, 2025 Inspection Start Time: 10:30 Inspection End Date: May 1, 2025 Inspection End Time: 10:45		Inspection Type: Coal Complete Inspection Inspection Reason: Normal I&E Program Weather: Cloudy	
Joint Inspection Agency: None		Joint Inspection Contacts: 	
Post Inspection Agency: None		Post Inspection Contacts: 	
Inspector(s): Hunter Ridley	Inspector's Signature: <i>Hunter Ridley</i>		Signature Date: May 6, 2025

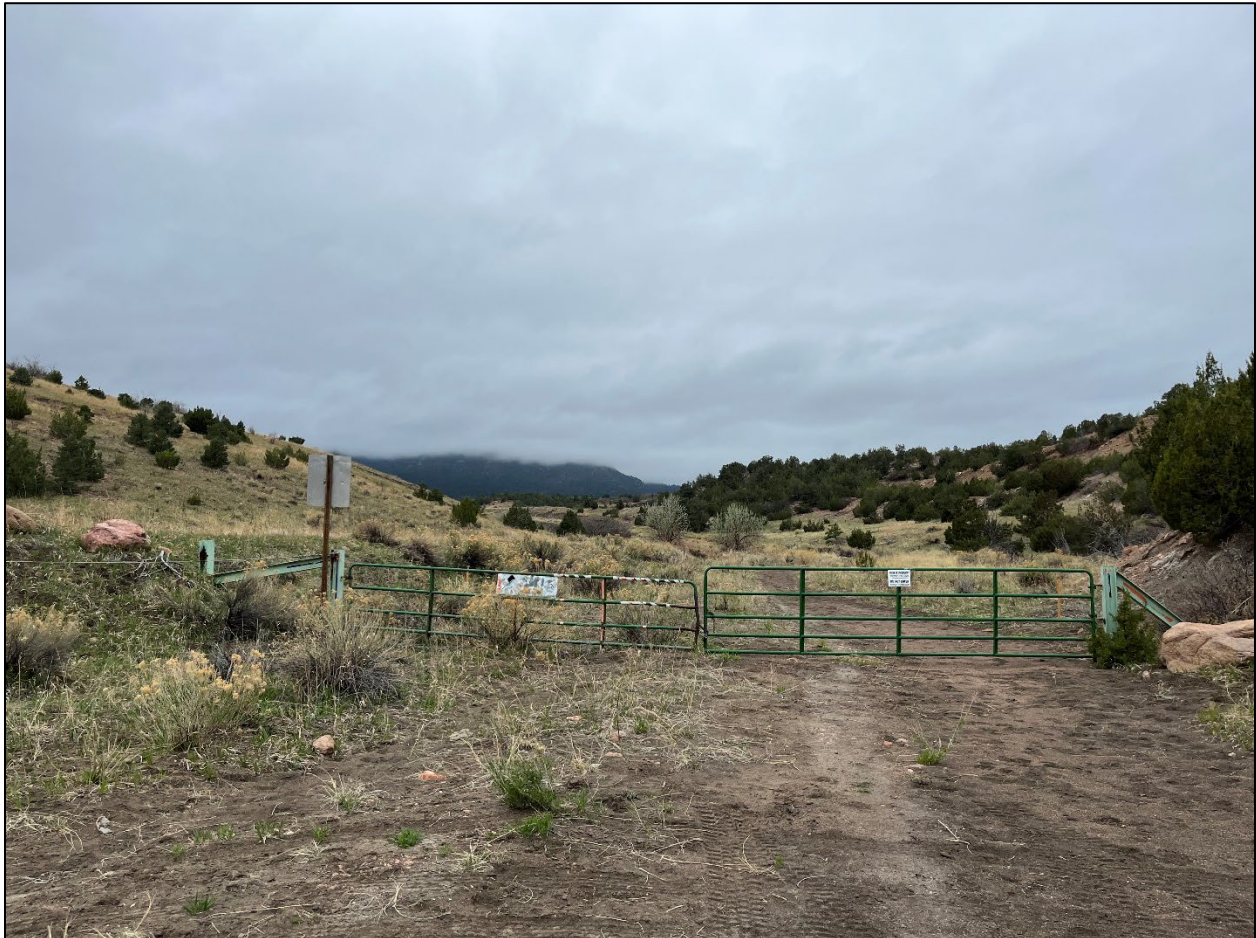
As a result of a meeting which occurred on November 13, 2018 between the Corley Company and the Division, only portions of the site which are able to be viewed from the gated county road were inspected (Photo 1), this area is adjacent to the Southfield Mine permit boundary. For more information on the 2018 meeting, please refer to previous inspection reports conducted by the Division.

Figure 1: Photo 1: View from behind the locked gate at the old county road entrance, Chen's Hill is located to the west and the filled in Pond A is located to the south.
