**MINERALS PROGRAM INSPECTION REPORT**  
**PHONE: (303) 866-3567**

<b>MINE NAME:</b> Dist No 2 Gravel Pit	<b>MINE/PROSPECTING ID#:</b> M-1979-216	<b>MINERAL:</b> Sand and gravel	<b>COUNTY:</b> Fremont
<b>INSPECTION TYPE:</b> Monitoring	<b>WEATHER:</b> Clear	<b>INSP. DATE:</b> April 16, 2025	<b>INSP. TIME:</b> 11:20
<b>OPERATOR:</b> Fremont County	<b>OPERATOR REPRESENTATIVE:</b> Michael Whitt & Scott Hileman	<b>TYPE OF OPERATION:</b> 110c - Construction Limited Impact	
<b>REASON FOR INSPECTION:</b> Normal I&E Program	<b>BOND CALCULATION TYPE:</b> None	<b>BOND AMOUNT:</b> \$0.00	
<b>DATE OF COMPLAINT:</b> NA	<b>POST INSP. CONTACTS:</b> None	<b>JOINT INSP. AGENCY:</b> None	
<b>INSPECTOR(S):</b> Jocelyn Carter	<b>INSPECTOR'S SIGNATURE:</b>

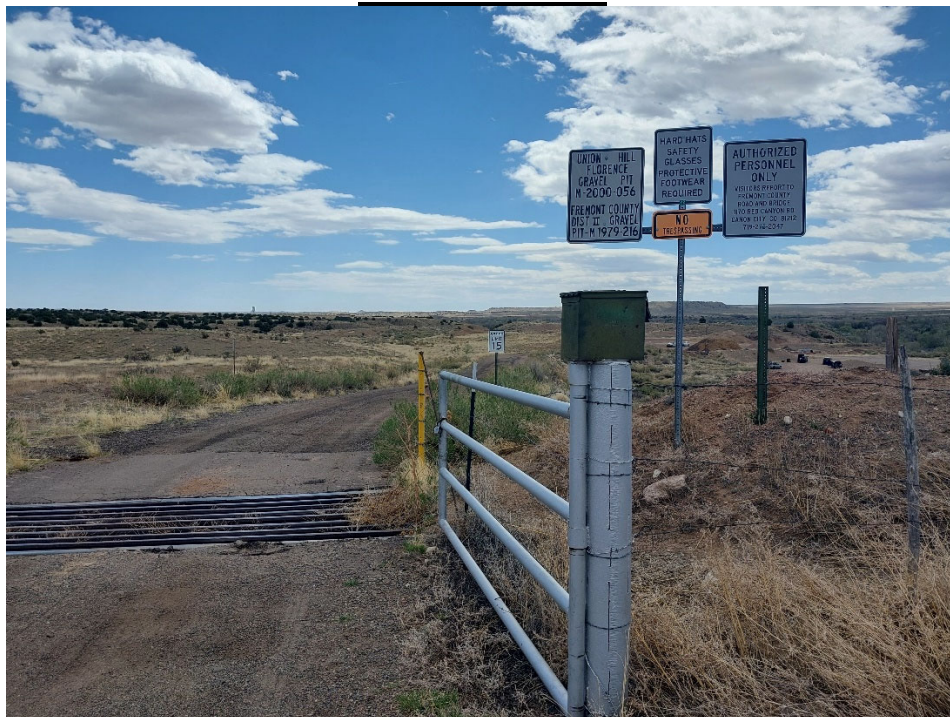
The mine sign is posted at the entrance of the site, see Photo #1. The permit is adjacent to the Union Hills Gravel Pit, also operated by Fremont County, and the entrance to the site is at the eastern end of the permit area, see Photo #4. There are also an old landfill and a shooting range in the vicinity, both require marking the area. The permit boundary markers used at the time of the site visit were white PVC pipes over T-posts. There was some confusion about which markers were being used for each land use area.

Photo #1: Mine sign posted at the entrance of the permit area.

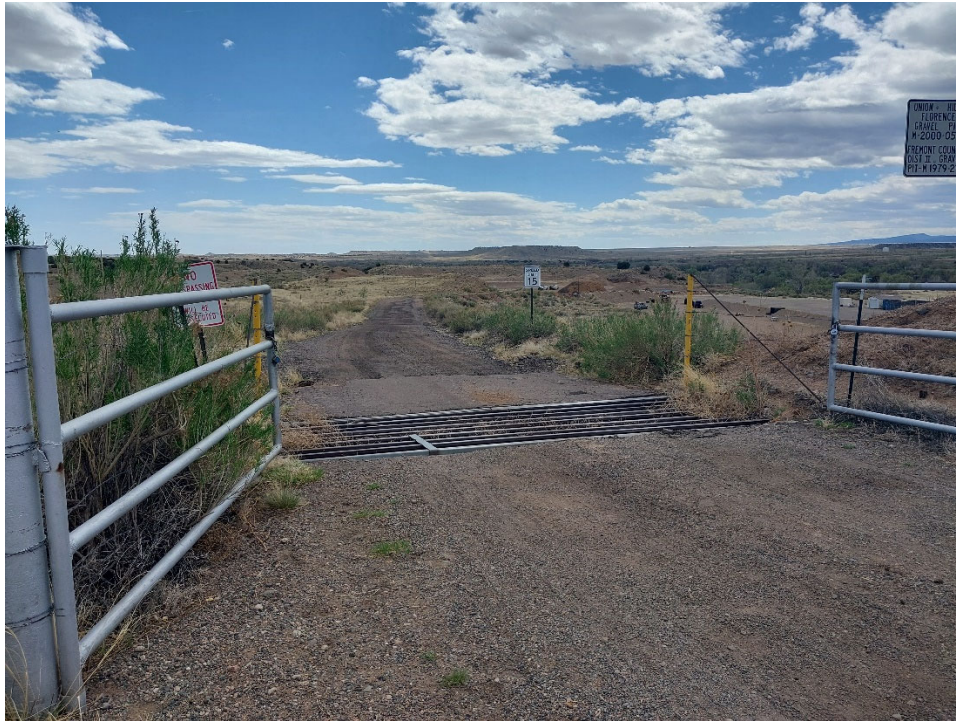
The access road was in good condition and stable, see Photo #2.

Photo #2: View of the access road, looking to the south.

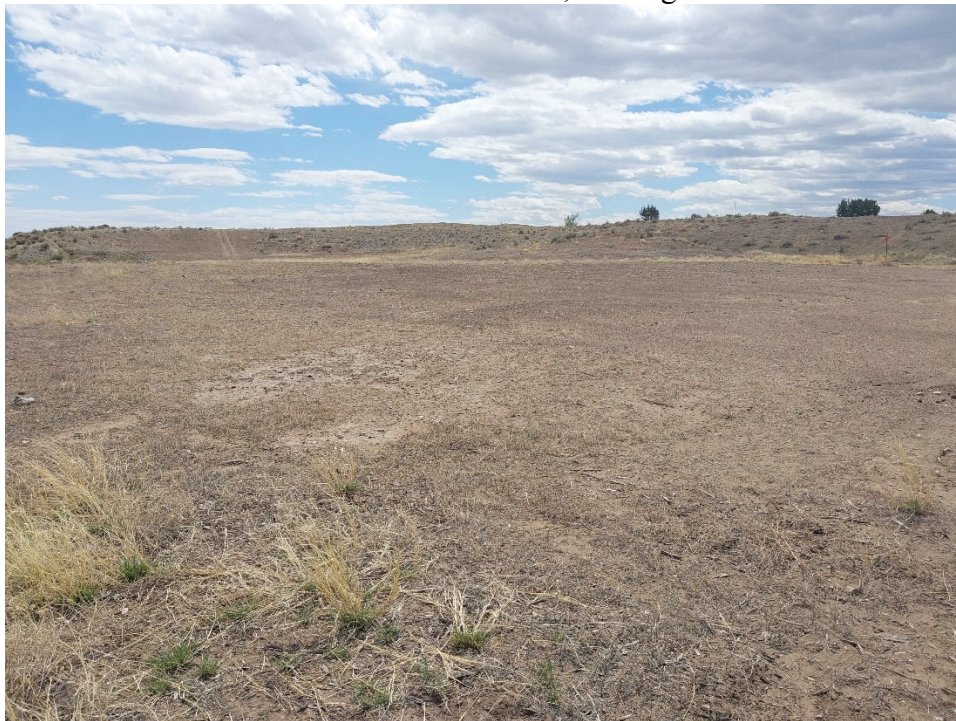
According to the mining plan, the topsoil is stored along the southern portion of the permit area, see Photo #3. The stockpile appears to be well graded, with a 2H:1V or less slope, stable and well vegetated.

Photo #3: View of the pit floor, looking to the south. The topsoil berm can be seen in the background.

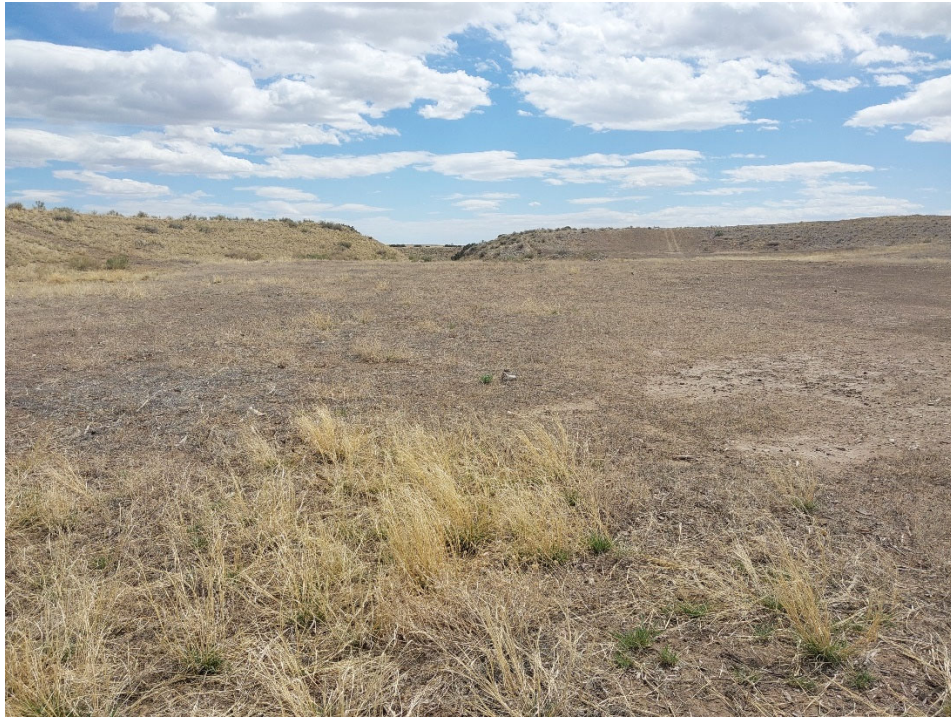
Photo #4: View of the pit floor, looking to the southeast. The entrance to the Union Hill Gravel Pit can be seen in the background at the break in the berm.

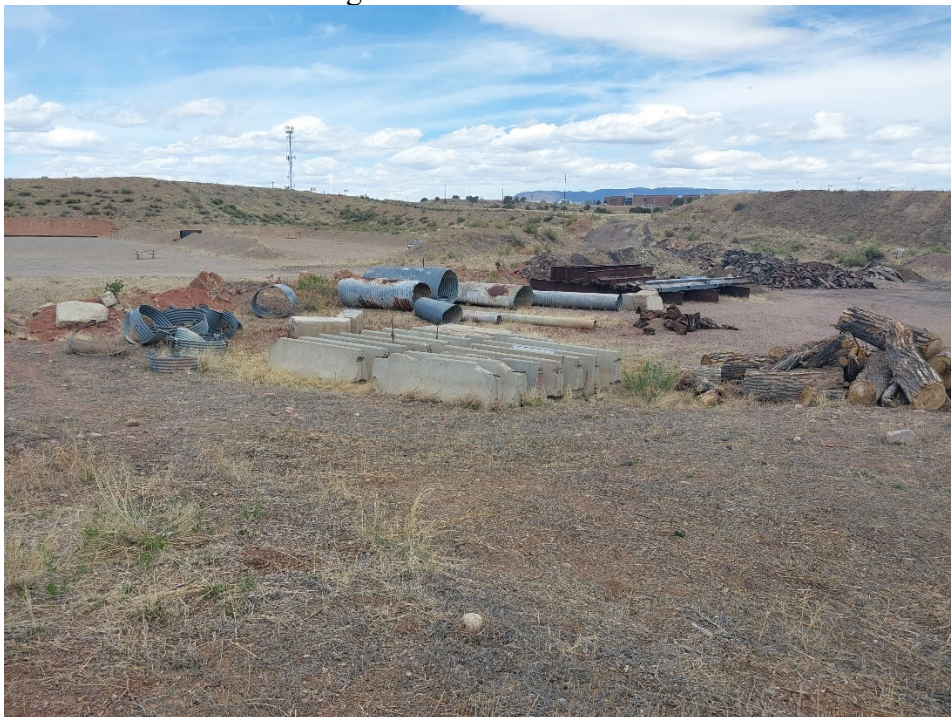
**PROBLEM:** The current mine plan needs to be updated and clarified pursuant to C.R.S. 34-32.5-112 (1)(c)(VI). There are imported materials stockpiled on the permitted area. The operator must provide sufficient information to describe or identify how the operator intends to conduct the operation.

There are several stockpiles of imported materials being stored on the site in the northwest area, see Photo #5. Various types of materials are stored on site including gravel, asphalt, concrete partitions, metal culverts, steel I-beams, and wood/mulch. The permit does not include using the site for storage of these materials. This is being cited as a problem in this report. See the problem above for the corrective action and the corrective action due date.

Photo #5: View of the various imported materials stockpiled on the site.

**CORRECTIVE ACTIONS:** The operator shall submit a Technical Revision, with the required \$216 revision fee, to update and clarify the current approved mine plan to reflect existing and proposed activities regarding the imported materials by the corrective action date.

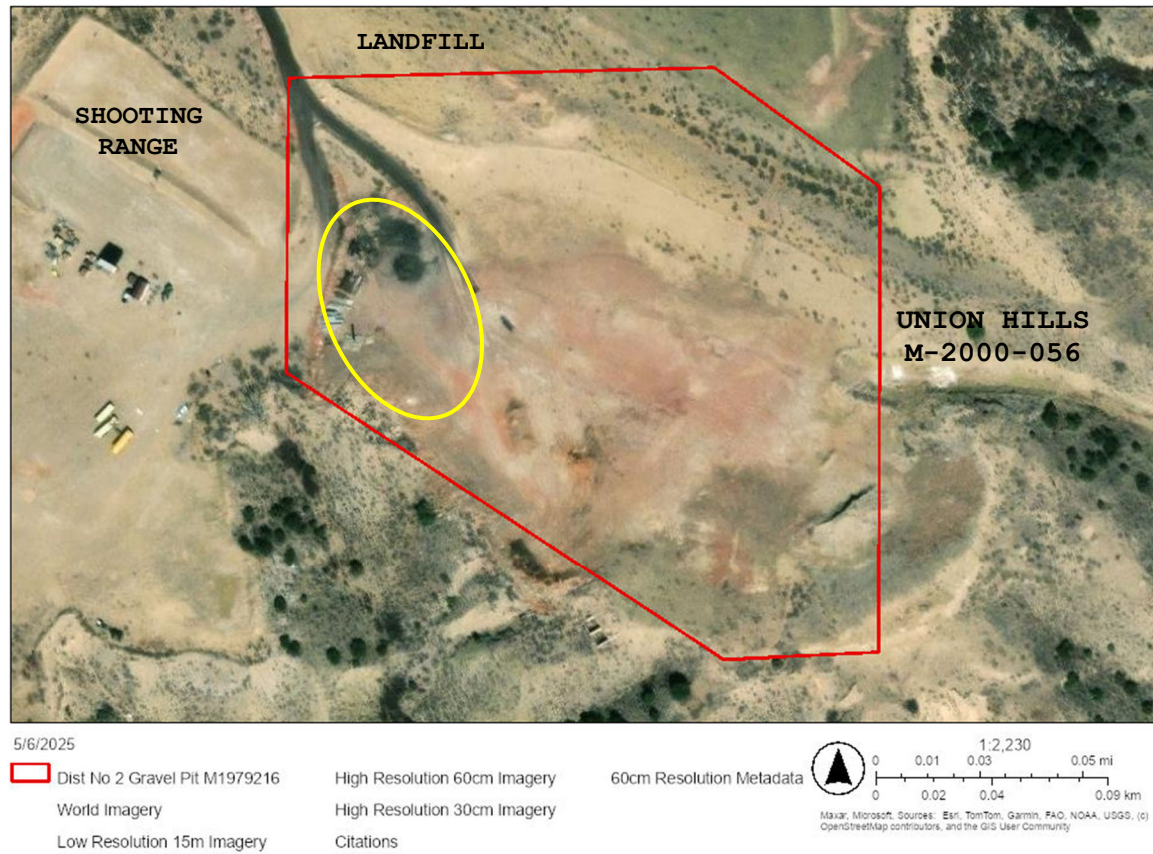
Figure 1: Map of the permit area showing where the imported materials are stored (circled in yellow) and the neighboring land uses.
