MINERALS PROGRAM INSPECTION REPORT
PHONE: (303) 866-3567

MINE NAME: Union Hill Gravel Pit	MINE/PROSPECTING ID#: M-2000-056	MINERAL: Gravel	COUNTY: Fremont
INSPECTION TYPE: Monitoring	WEATHER: Clear	INSP. DATE: April 16, 2025	INSP. TIME: 11:20
OPERATOR: Fremont County	OPERATOR REPRESENTATIVE: Mike Whitt & Scott Hileman	TYPE OF OPERATION: 112c - Construction Regular Operation	
REASON FOR INSPECTION: Normal I&E Program	BOND CALCULATION TYPE: None	BOND AMOUNT: \$0.00	
DATE OF COMPLAINT: NA	POST INSP. CONTACTS: None	JOINT INSP. AGENCY: None	
INSPECTOR(S): Jocelyn Carter	INSPECTOR'S SIGNATURE:

FREMONT COUNTY'S UNION HILL GRAVEL PIT

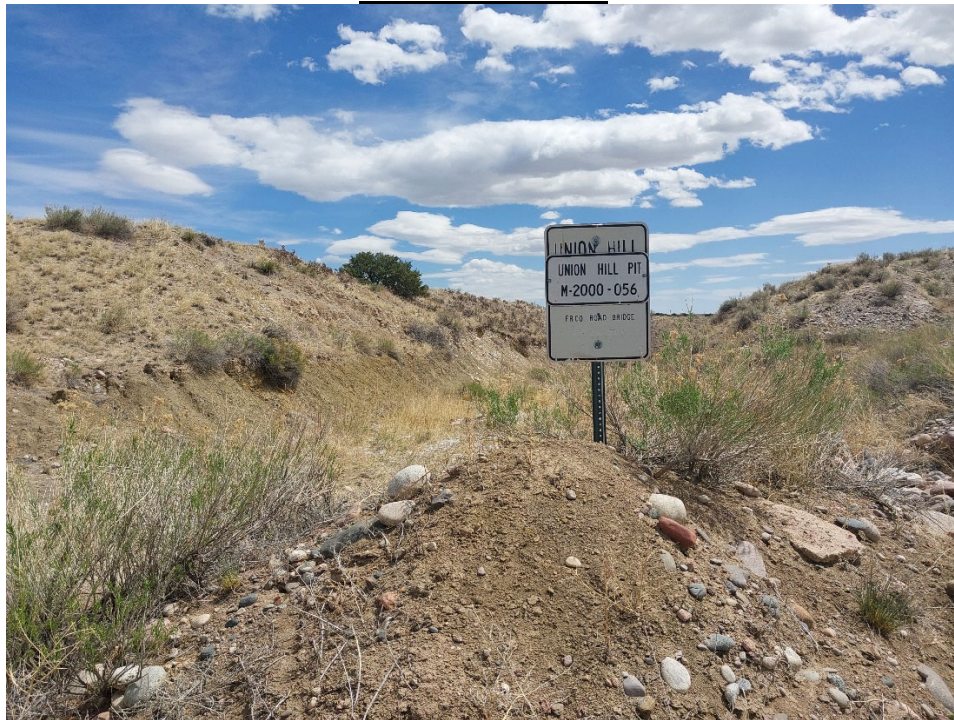
The mine sign is posted at the western entrance of the permit site, see Photo #1. There is another sign posted at the entrance of the Dist. No. 2 Gravel Pit, see Photo #7. The permit boundary corners are marked with white PVC pipes over T-posts. In addition to the Dist. No. 2 Pit being adjacent to the permit area, there is also a shooting range and landfill in the immediate area that require to be marked. There was some confusion about which markers were designated for each area, PVC piping over T-posts are used for multiple markers. The Operator was asked to delineate which marker was used to mark this site, Dist. No. 2, and which ones mark both permit boundaries.

Photo #1: Mine sign posted at the entrance, located along the west side of the permit area, accessed through the Dist. No. 2 Gravel Pit permit area.

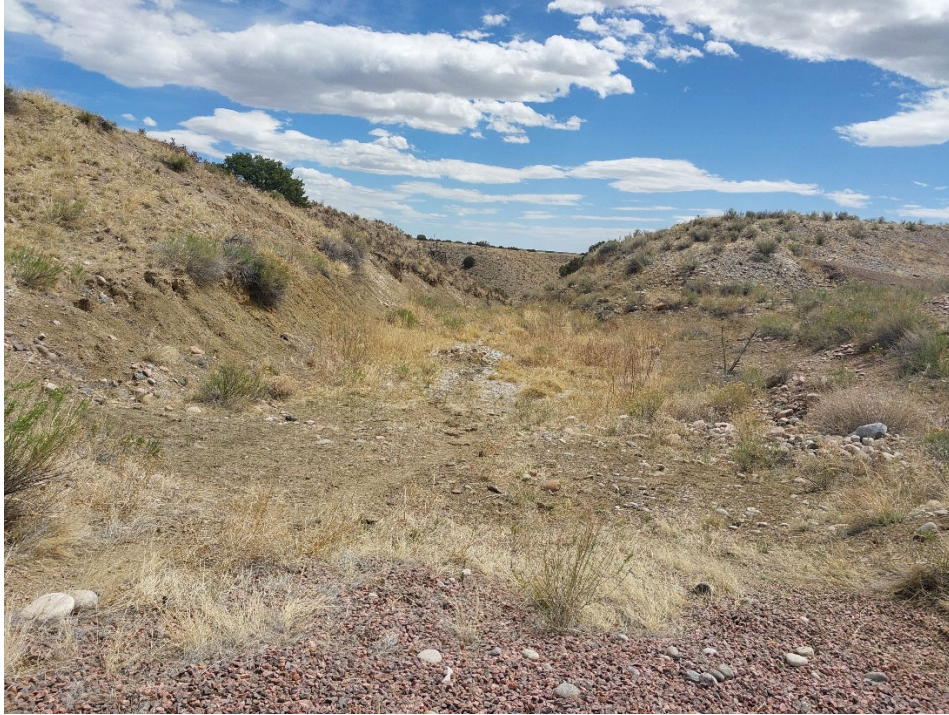
Photo #2: View of the trail used to access the permitted area, looking to the east.

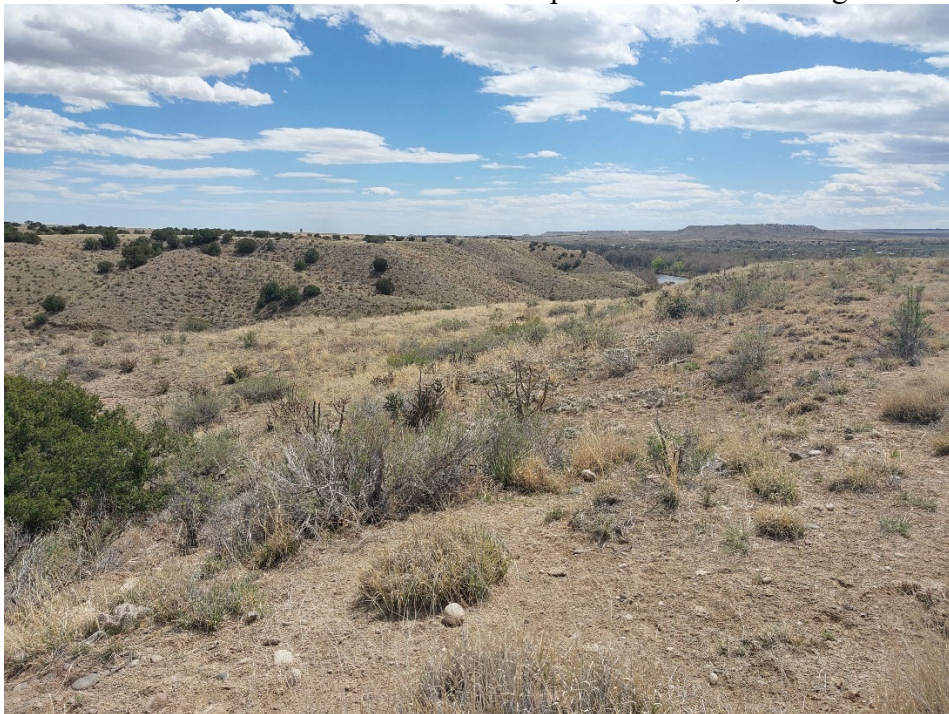
Photo #3: View of the southern portion of the permitted area, looking east.

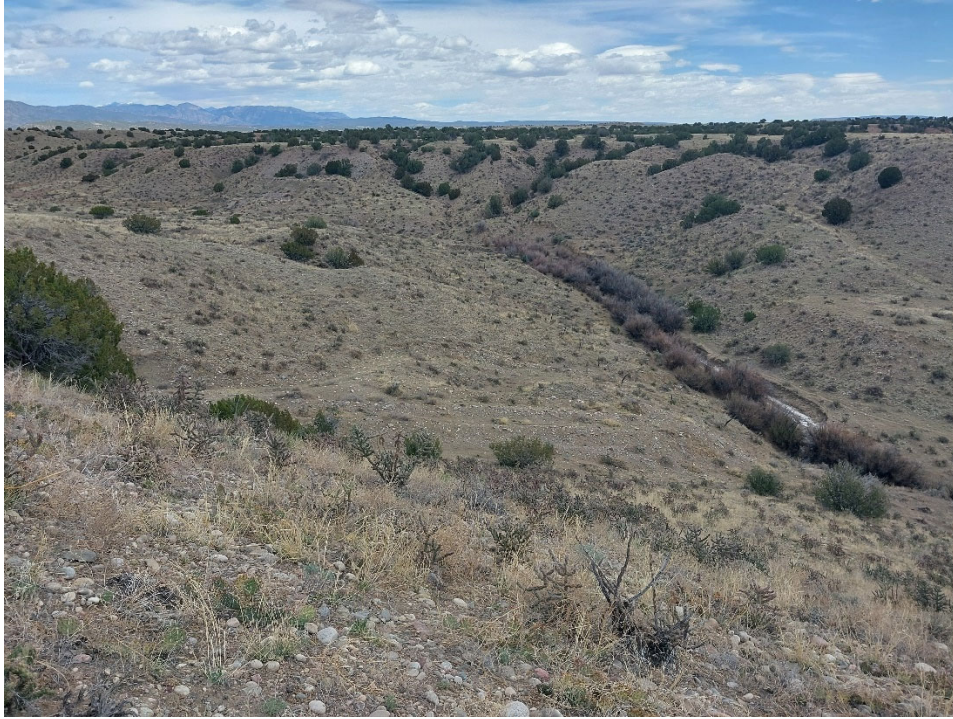
Photo #4: View of the permit area, looking northeast from the southwestern portion of the permit area.

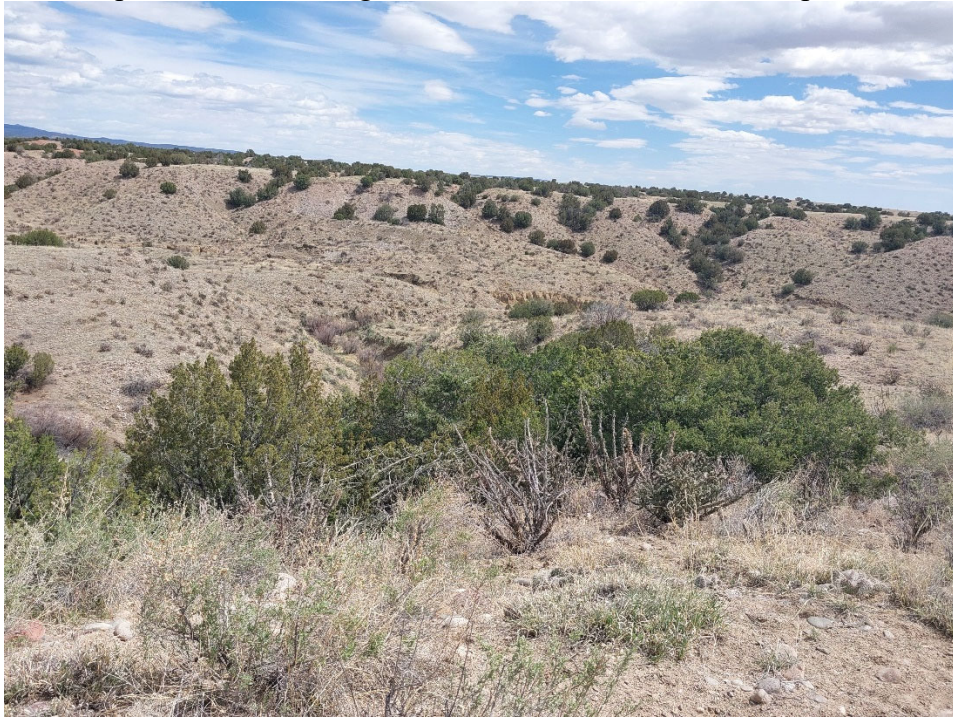
Photo #5: View of the northern area of the permit, looking to the east from the northwest of the permit area.

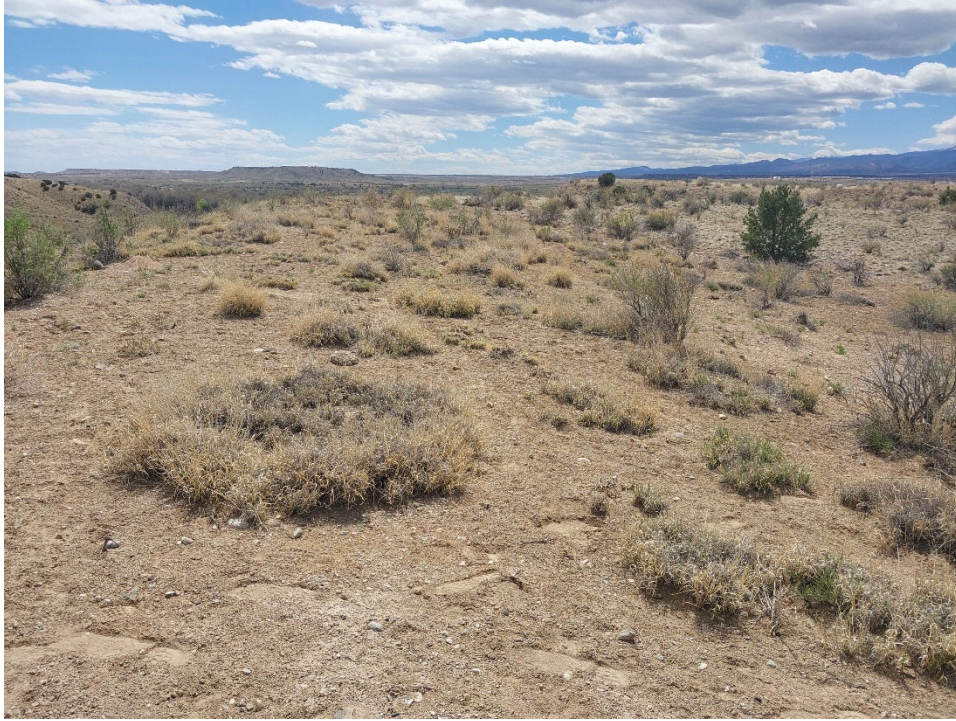
Photo #6: View of the western portion of the permit area, looking to the south.

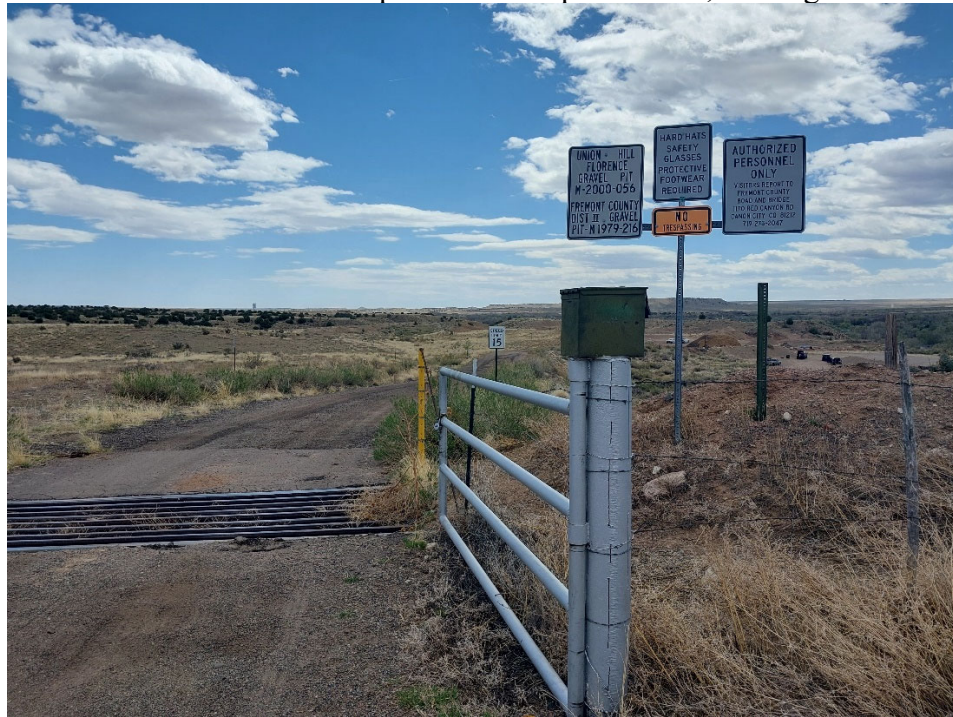
Photo #7: Additional permit sign posted at the entrance of the Dist. No. 2 Pit.

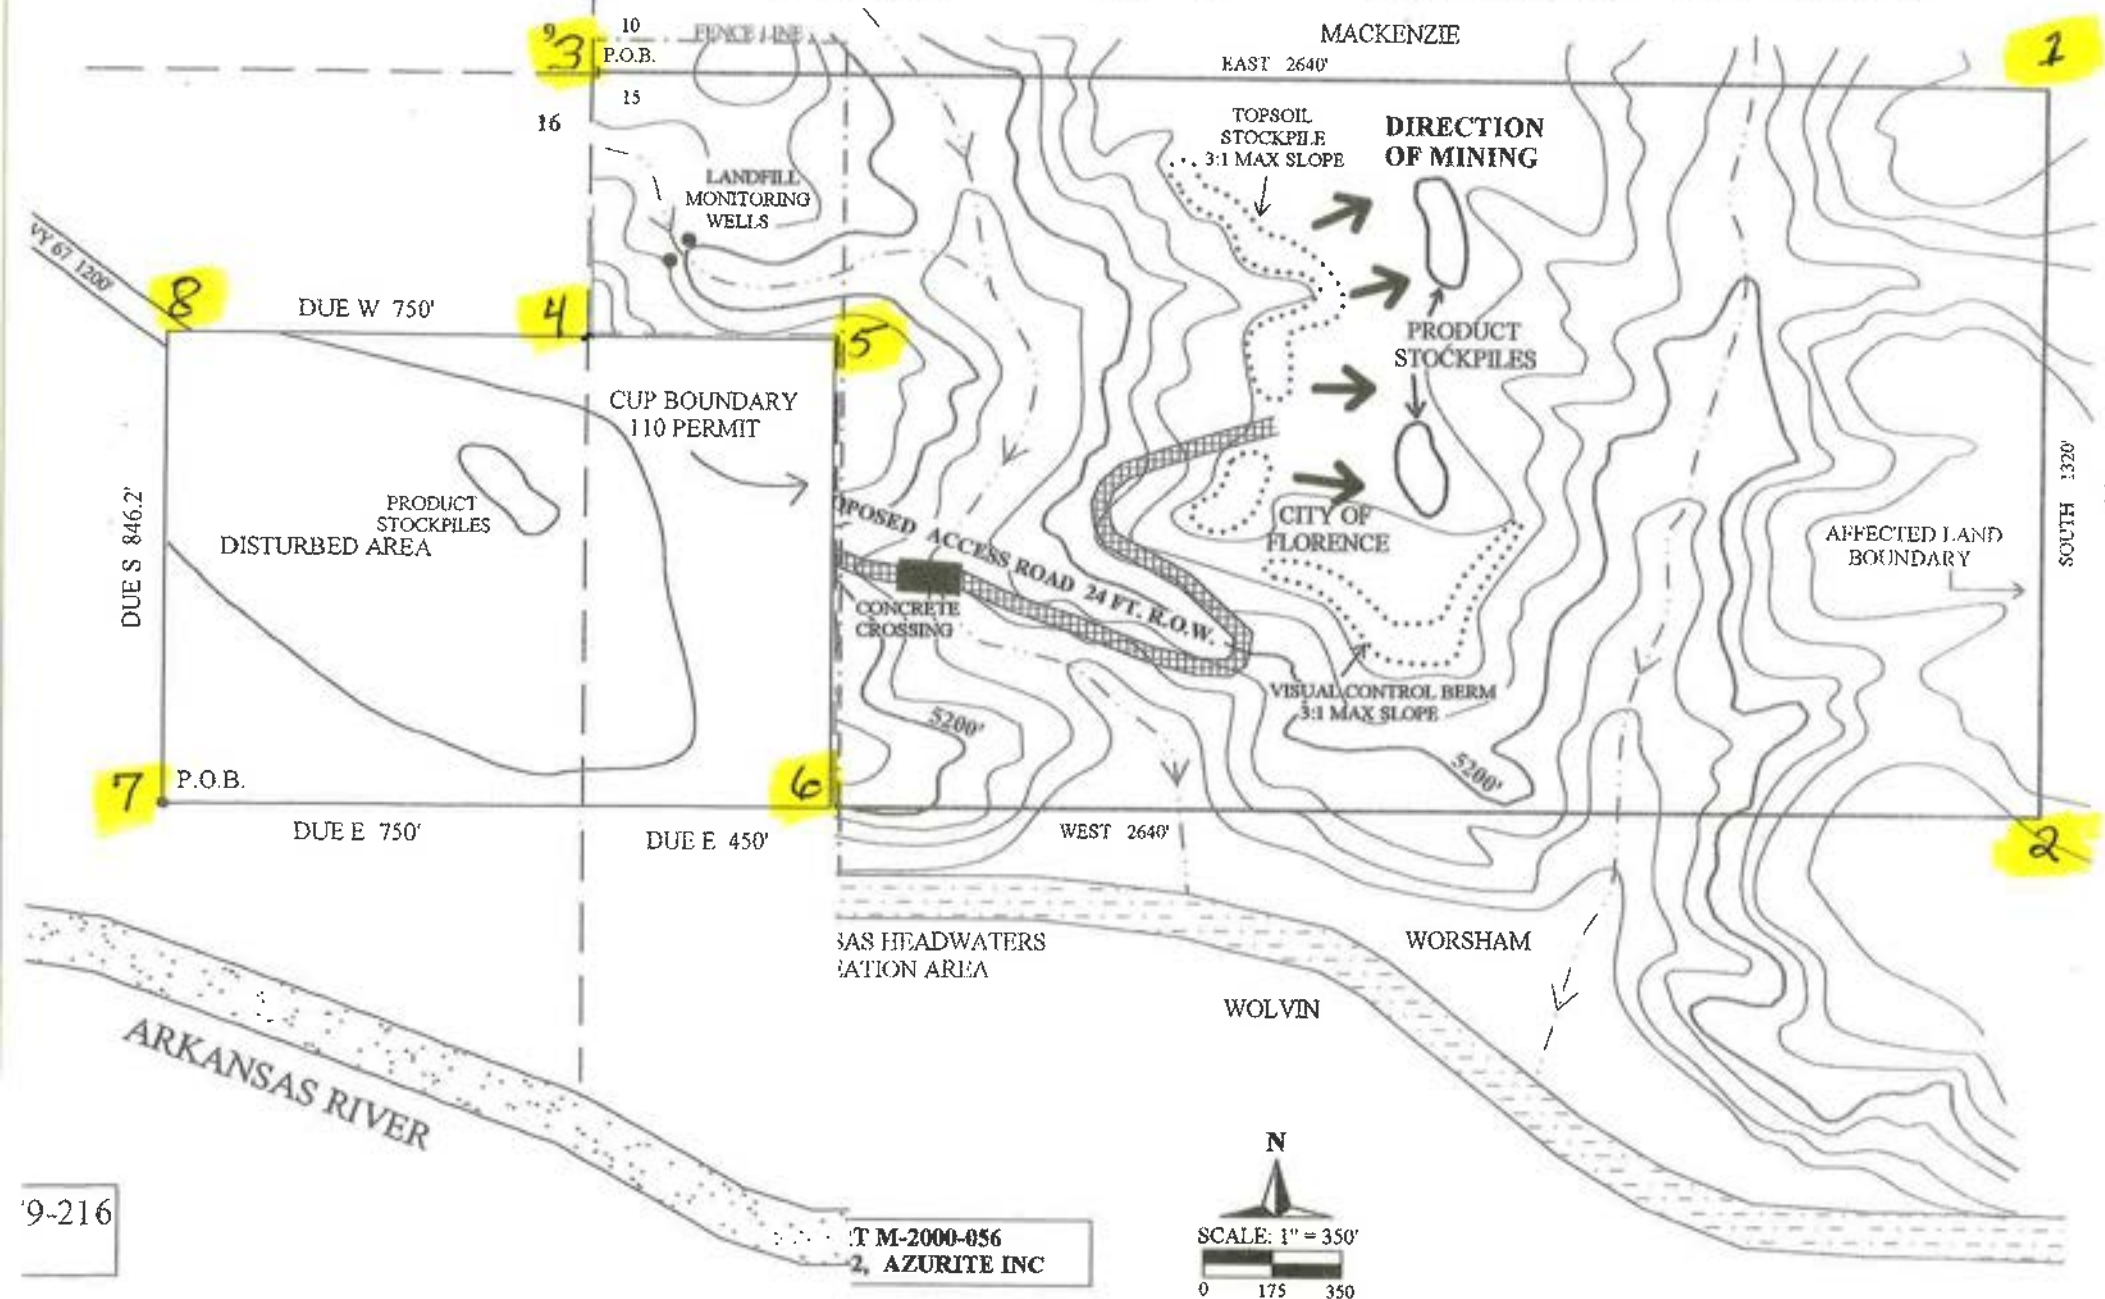
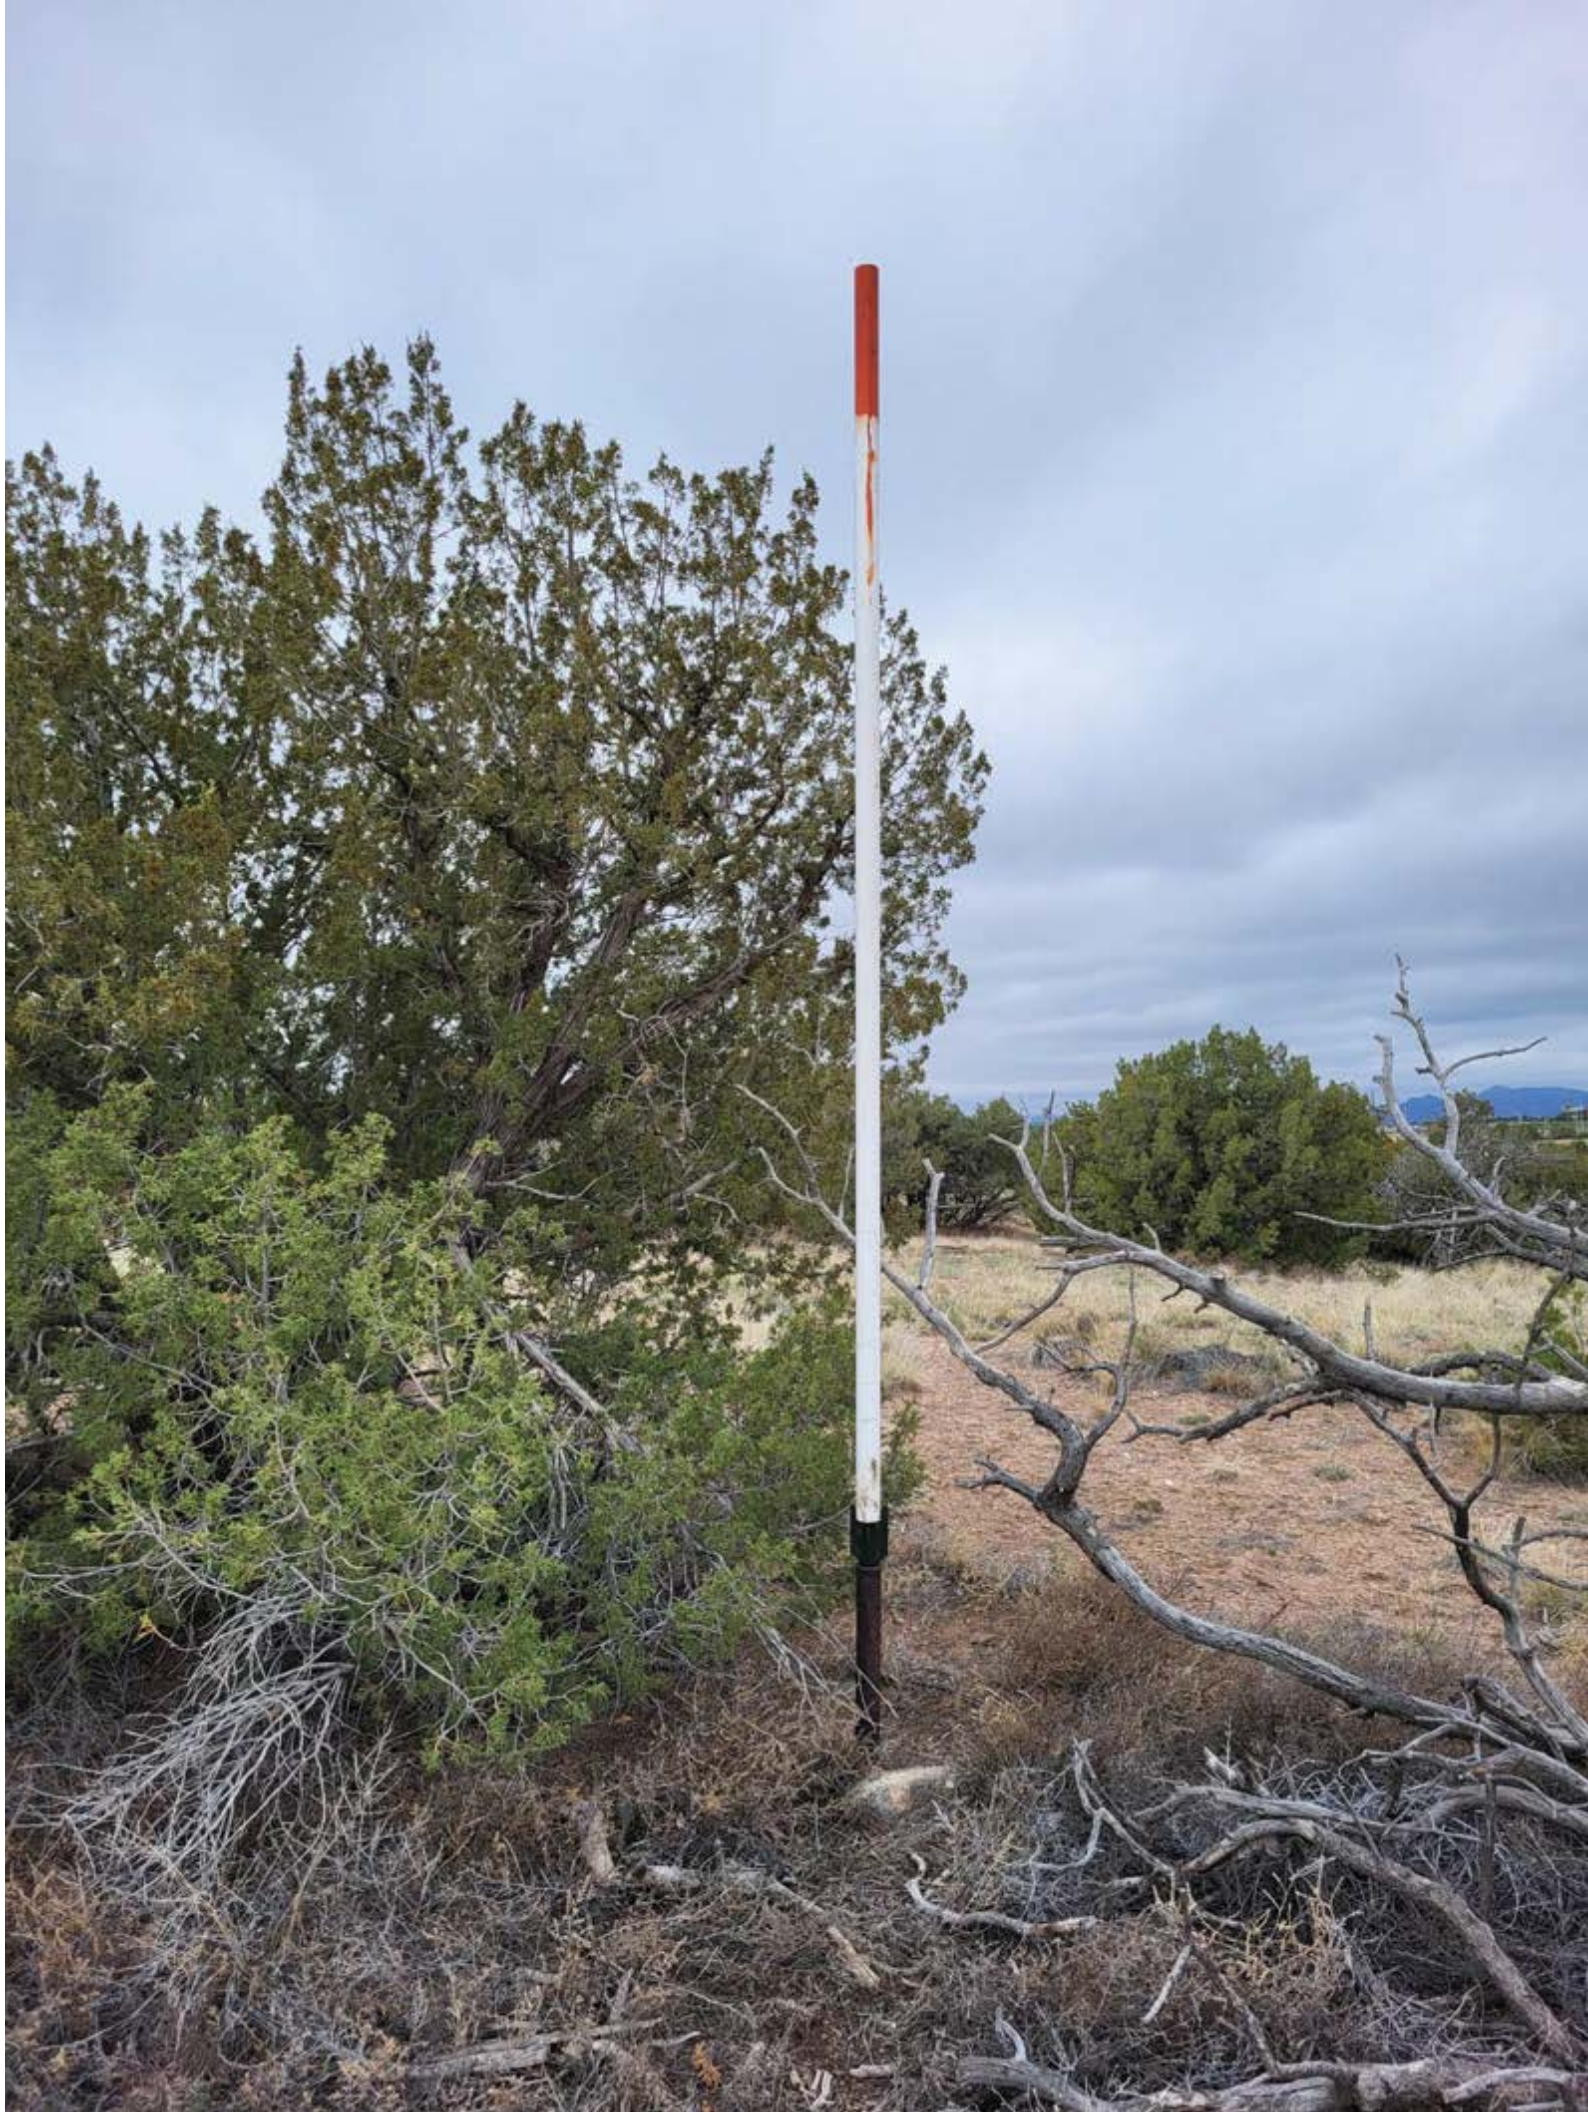
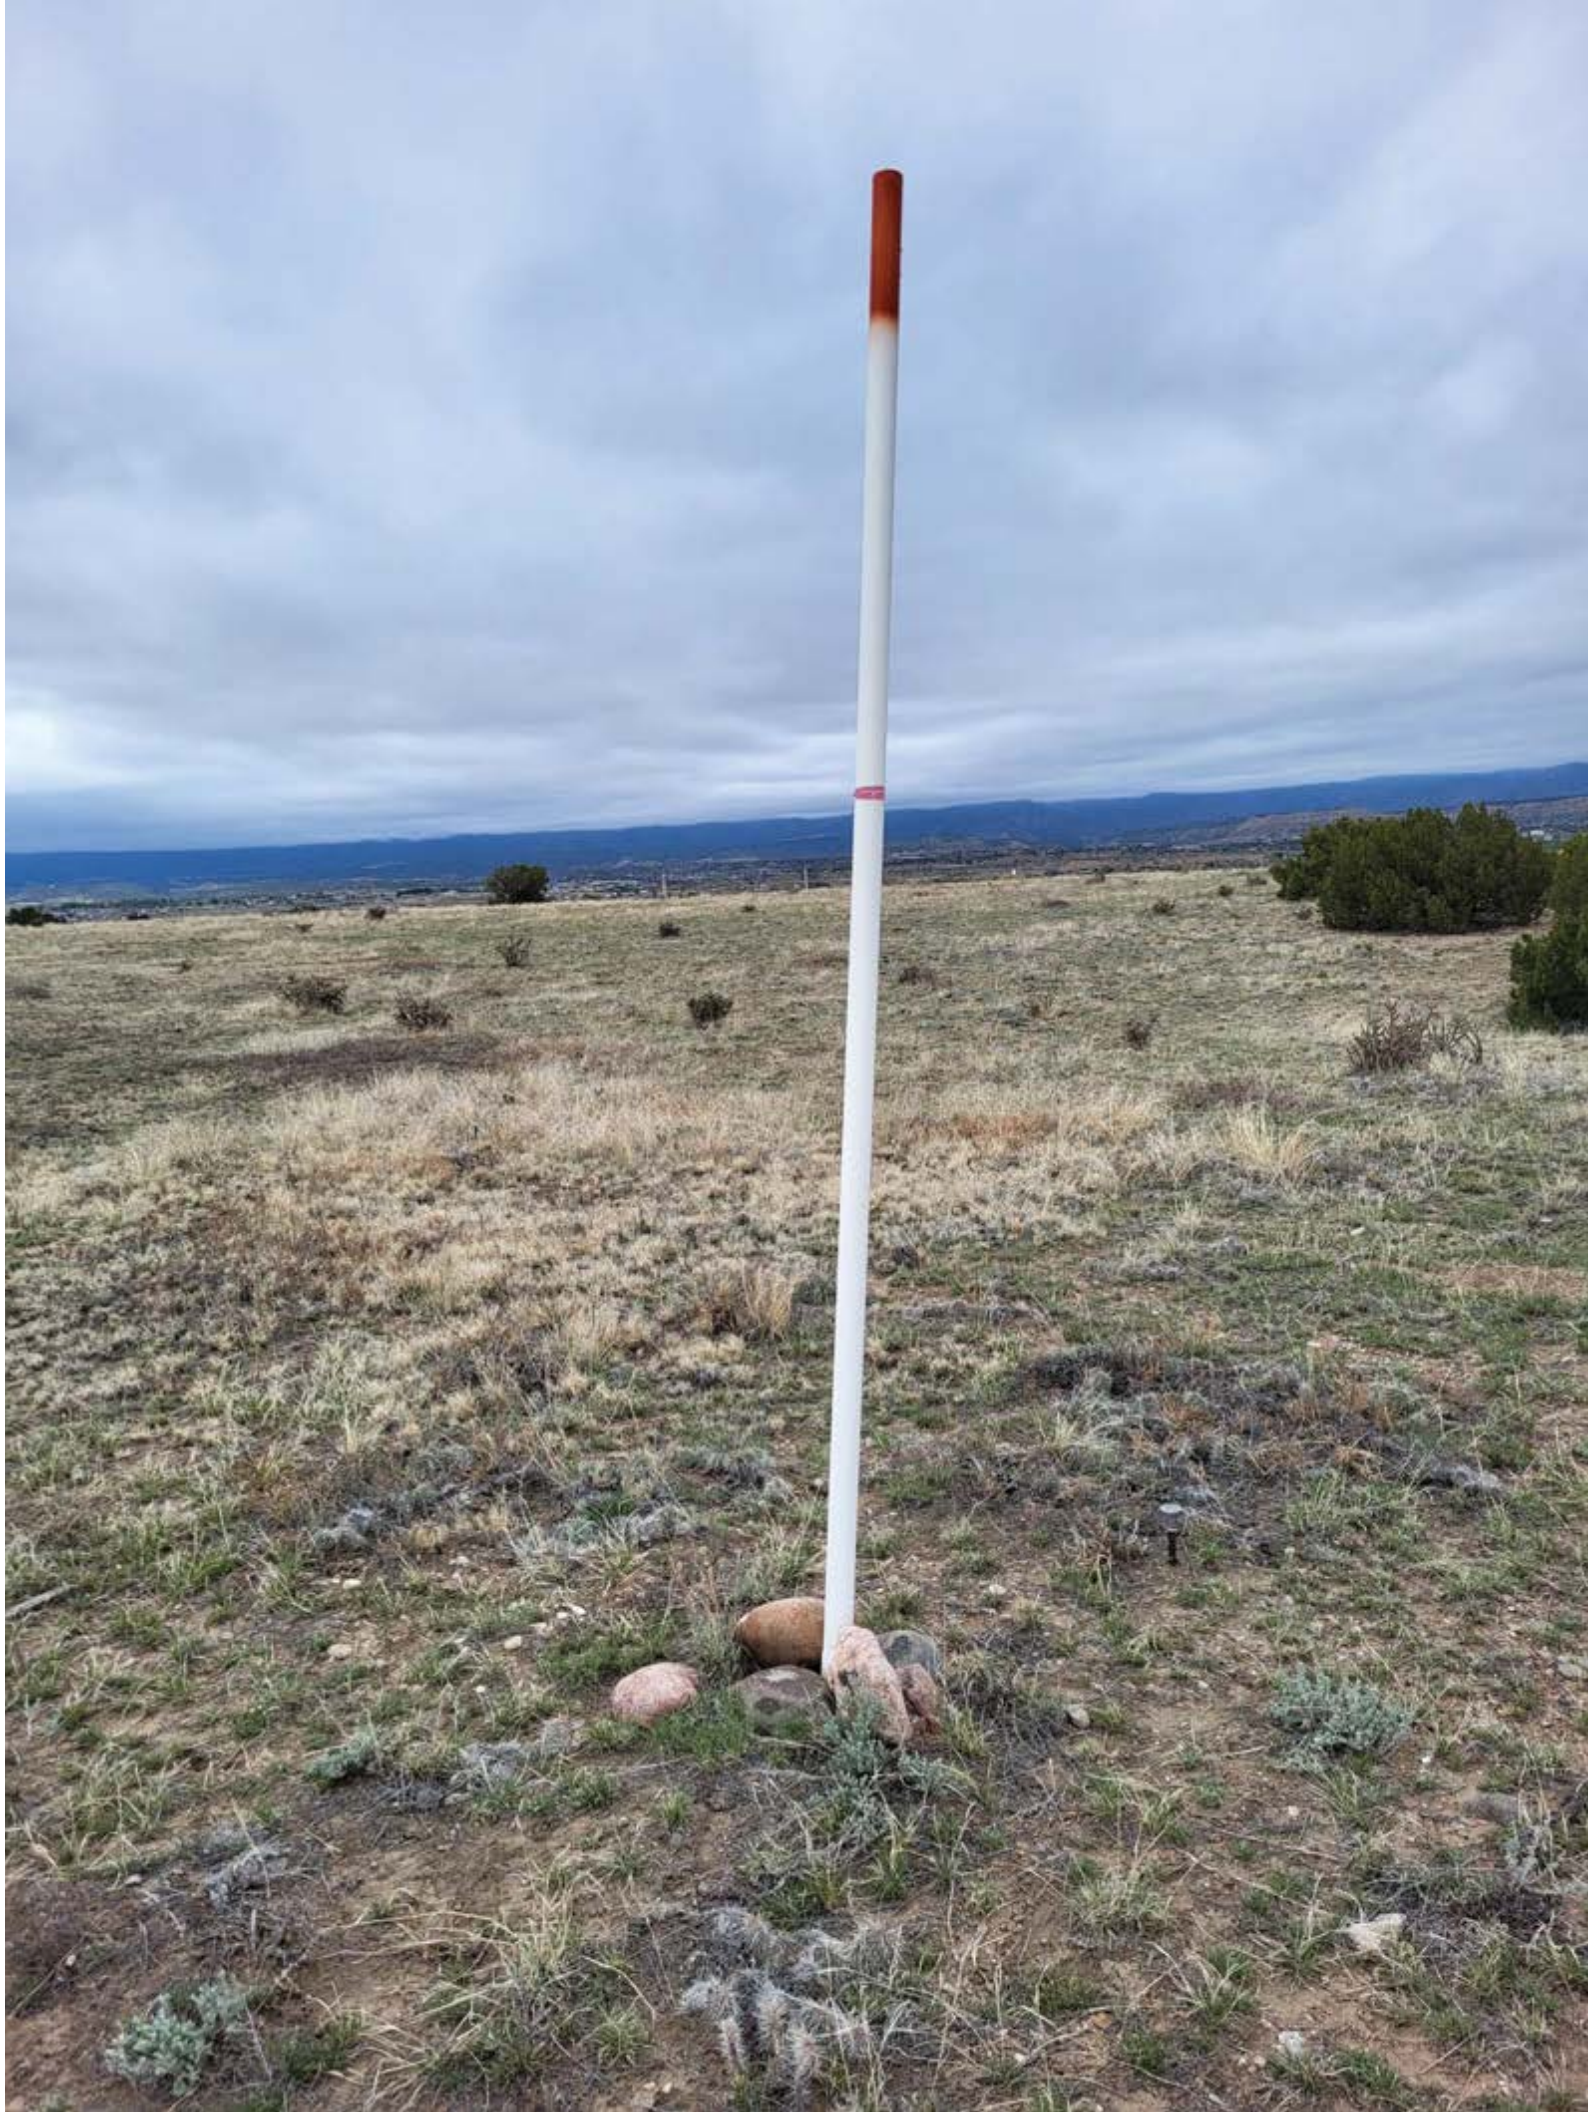
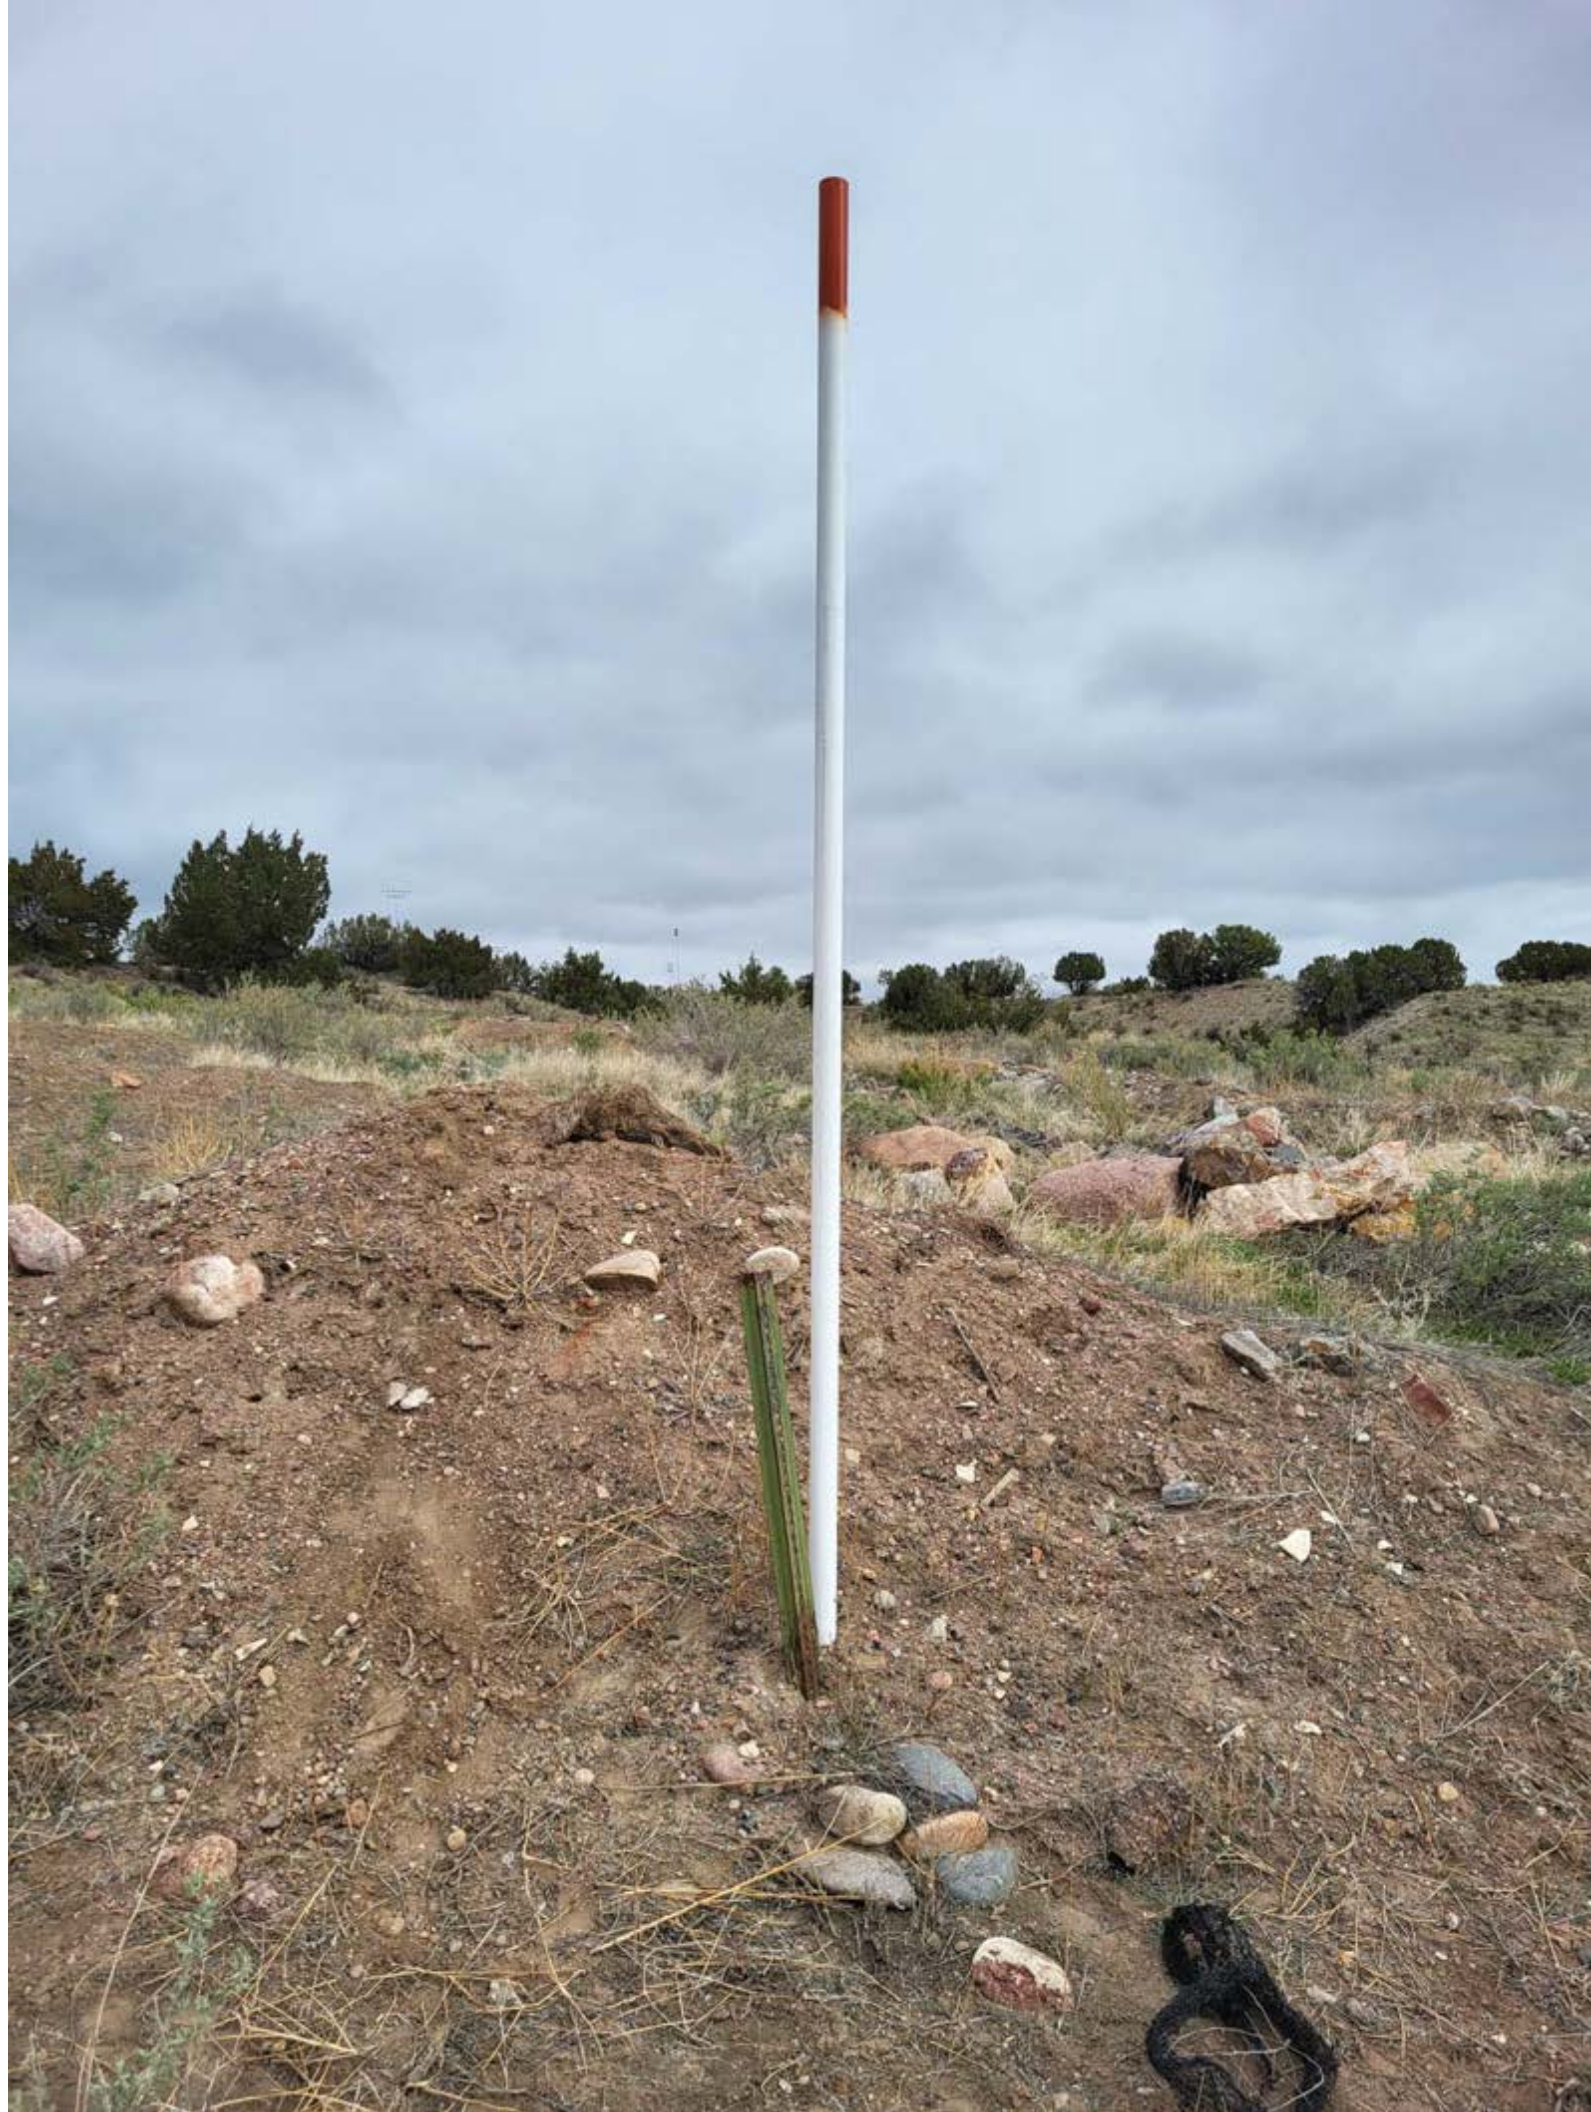
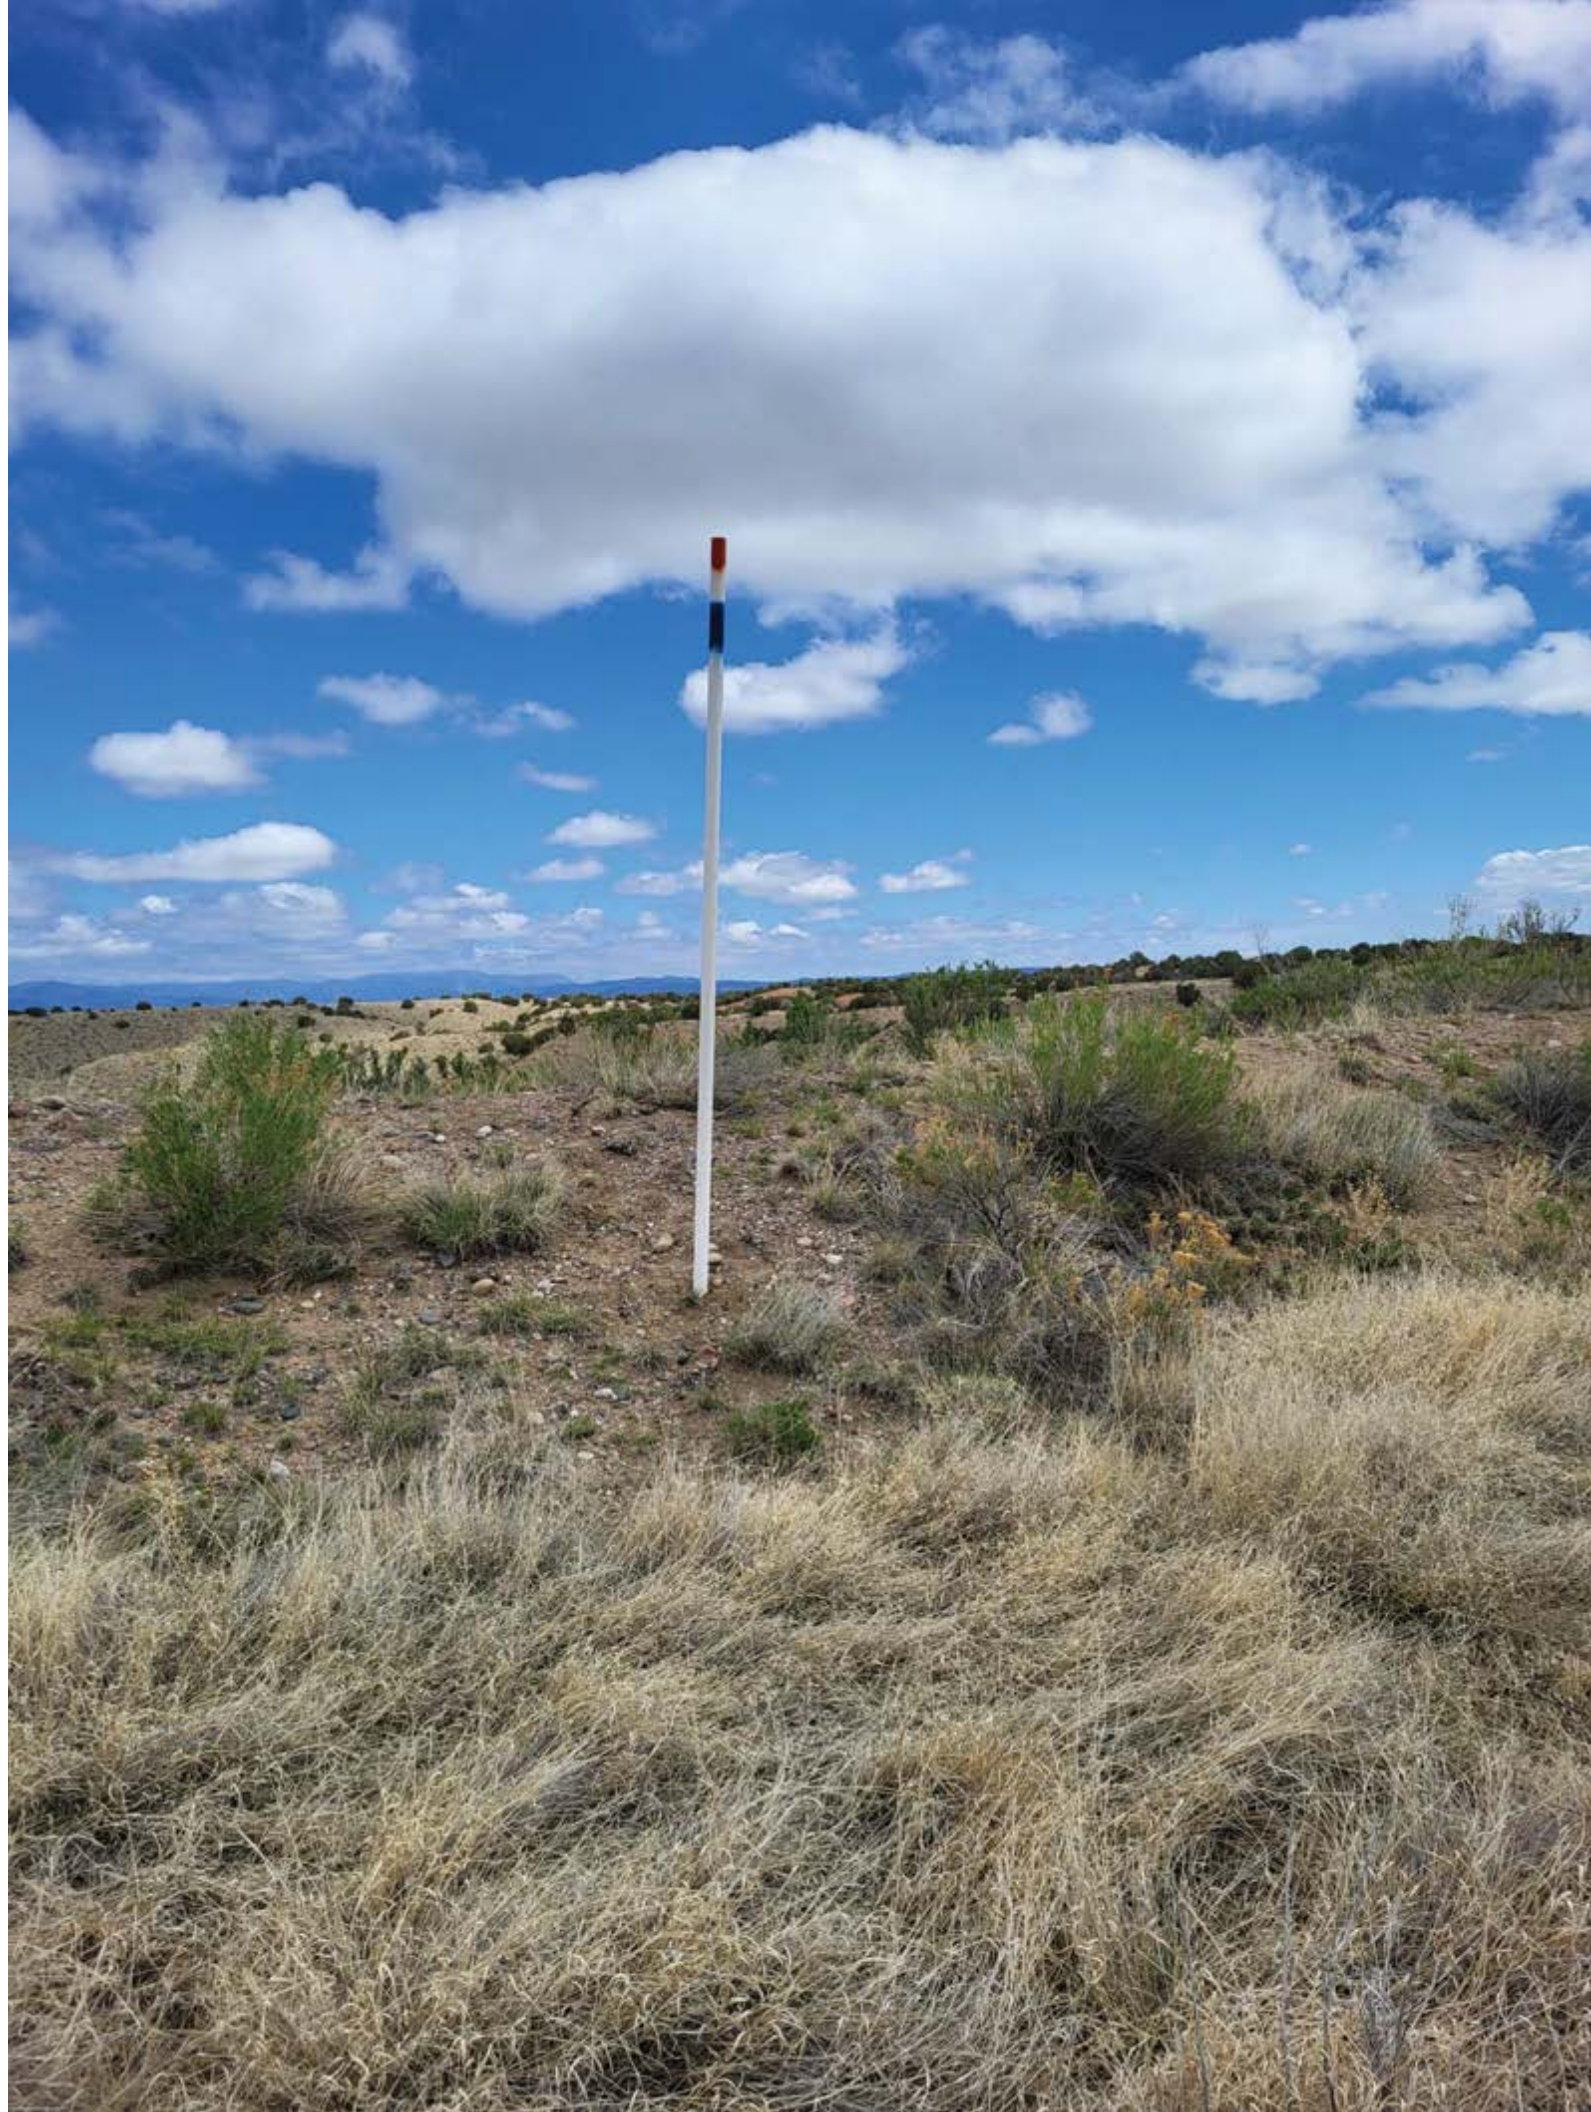
Enclosure Operator's Photos of Boundary Marker

On April 29, 2025, the operator provided a map and corresponding photos, attached to this report. The Union Gravel Pit is marked with PVC that are marked with orange, the Dis. No. 2 Pit is marked with blue, and those that mark the shared boundary line are marked with both blue and orange.
