Permit Number: C-1996-084 Mine Name: Lorencito Canyon Mine Operator: New Elk Coal Company, LLC Operator Address: 12250 Highway 12 Weston, CO 81091	County: Las Animas Operation Type: Surface Permit Status: Suspended Ownership: Private
	Operator Representative Present: None
Operator Representative Signature: (Field Issuance Only)

Inspection Start Date: April 24, 2025 Inspection Start Time: 09:18 Inspection End Date: April 24, 2025 Inspection End Time: 10:09	Inspection Type: Coal Partial Inspection Inspection Reason: Normal I&E Program Weather: Cloudy
Joint Inspection Agency: None	Joint Inspection Contacts:
Post Inspection Agency: None	Post Inspection Contacts:
Inspector(s): Amber M. Gibson	Inspector's Signature:

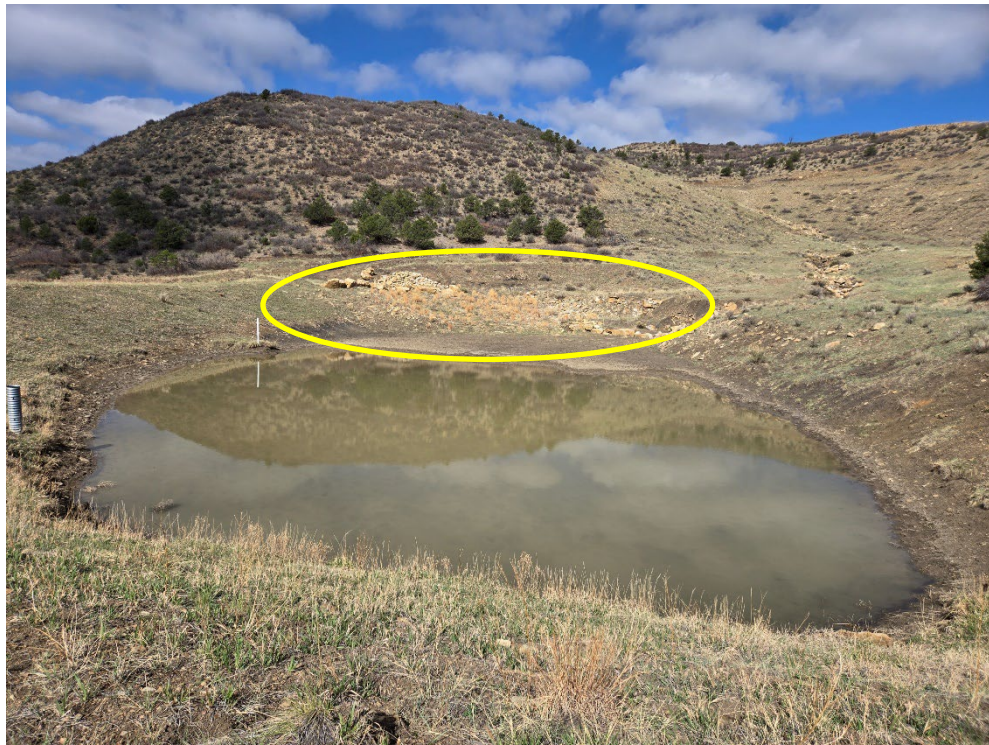
1. Erosion rills are forming on the north and west banks of Pond 006a. The erosion on the north bank appears to have been addressed at some point, because rebar is placed above the rills. However, it appears that the prior BMPs are no longer functioning adequately. **Pursuant to Rule 4.05.5(1)(c), the Operator shall address the erosion and repair the north bank.** The erosion on the west bank appears to have been caused by runoff from the road located east of Pond 006a. **Pursuant to Rule 4.05.5(1)(c), the Operator shall address the erosion and repair the west bank.**

Photo 1: Pond 006a looking west. The western erosion appears to have volunteer vegetation cover that is aiding in stabilization (yellow circle).

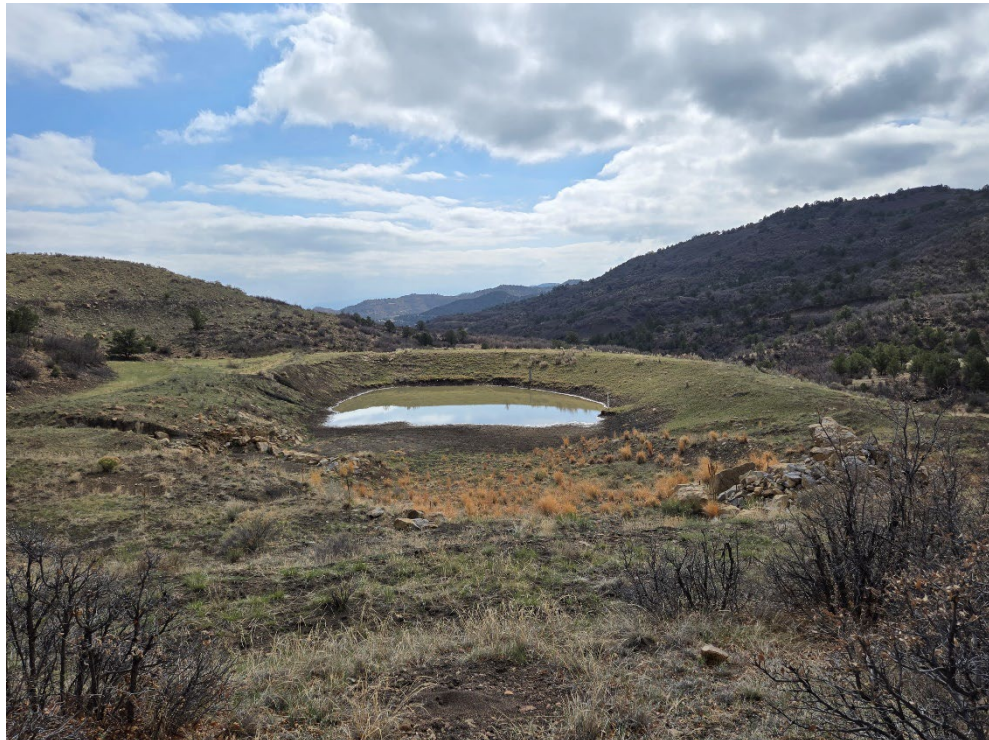
Photo 2: Pond 006a looking east. The erosion on the north slopes still needs to be repaired.

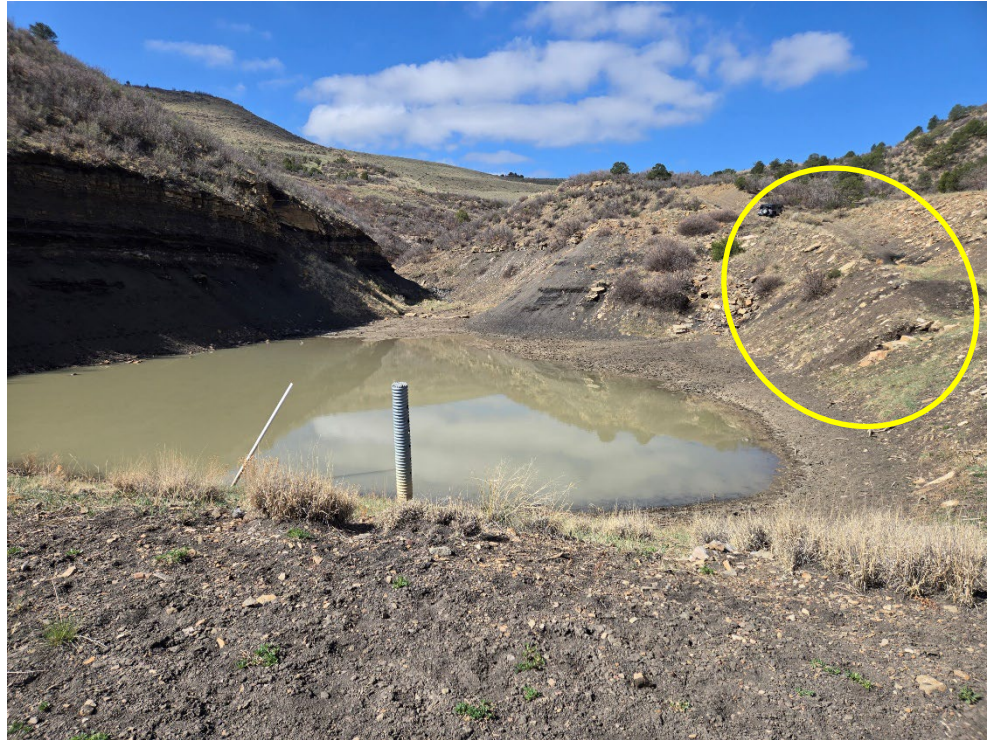
2. The majority of Pond 008's embankment was stable and vegetated; however, the west bank contains some erosion rills and gullies. The erosion appears to have been caused by run-off from the roads above and down to the pond. **Pursuant to Rule 4.05.5(1)(c), the Operator shall repair the erosion and stabilize the west bank of Pond 008.** The Operator stated that they will likely install additional rock berms along the western-most road to help prevent run-off from running down the slopes and into the pond. The Operator also stated that they plan to remove the sediment (deposited as a result of the bank erosion) along the west bank of Pond 008.

Photo 3: Looking south at Pond 08. Circled is the erosion on the west banks.

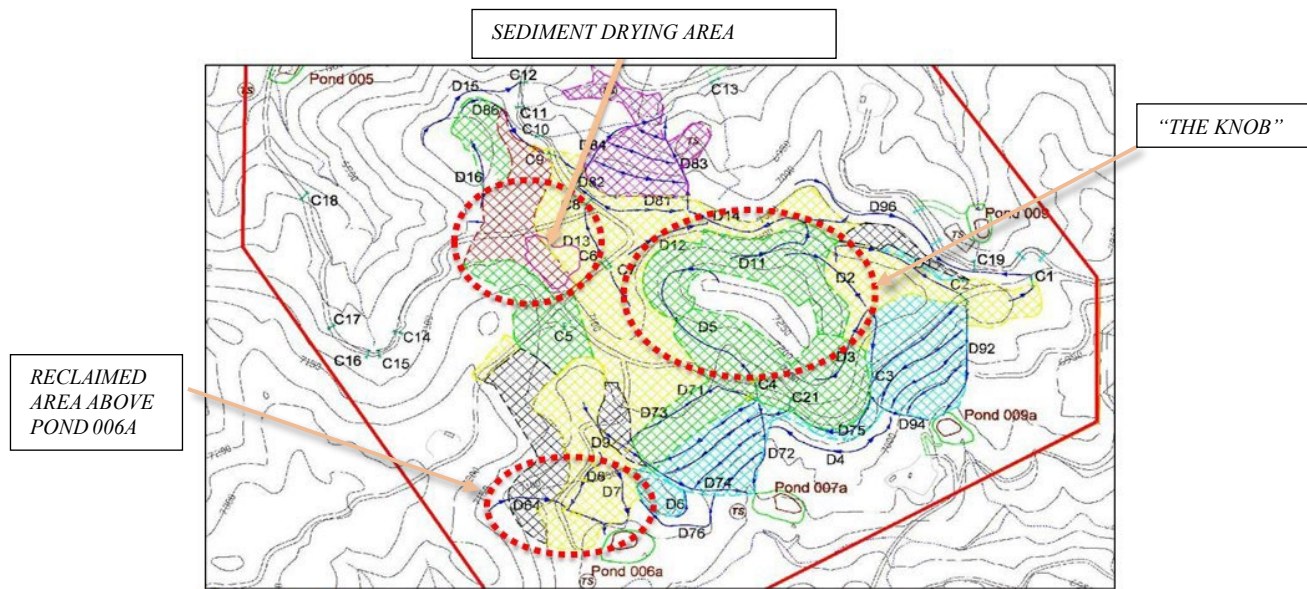
4. The following items pertain to ongoing erosional issues in the areas shown in Figure 1, that pursuant to Rule 4.14.6 need to be addressed. A Technical Revision will be required to expand on the current Rill and Gully plan in the PAP. **The Operator shall submit the technical revision, obtain approval, repair the erosion, and stabilize the slopes pursuant to the approved plan by December 31, 2024.**

FIGURE 1. AREAS WHERE RILLS, GULLIES AND SPARSE VEGETATION HAS BEEN FOUND TO BE A PERSISTENT PROBLEM AT THE SITE ARE WITHIN THE DOTTED CIRCLE AREAS. BACKGROUND IMAGE IS THE 2020 ANNUAL REPORT MAP.

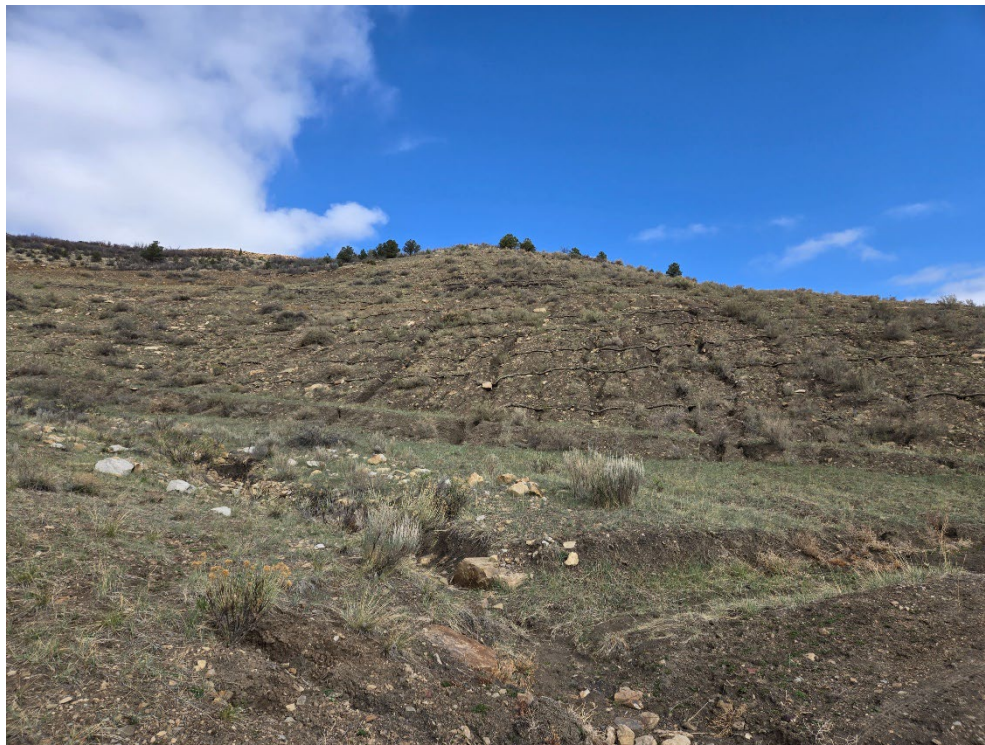
Photo 4: Looking northwest at the erosion on the 'Reclaimed Area above Pond 006a' shown in Figure 1.

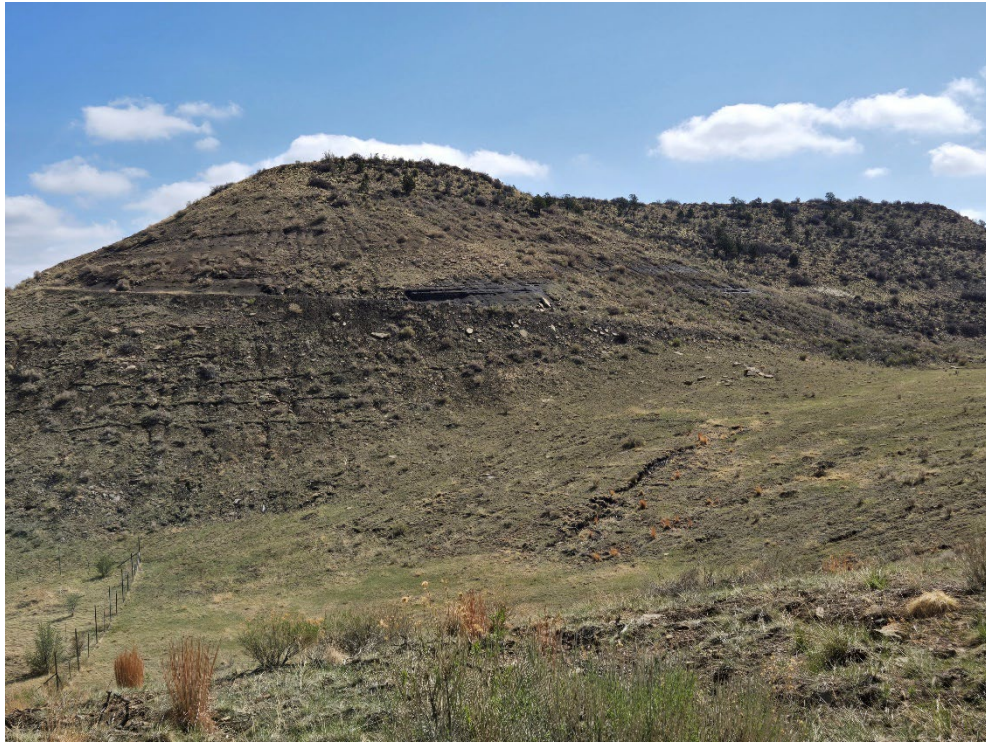
Photo 5: Looking northeast at the erosion on the west side of 'The Knob' shown in Figure 1.

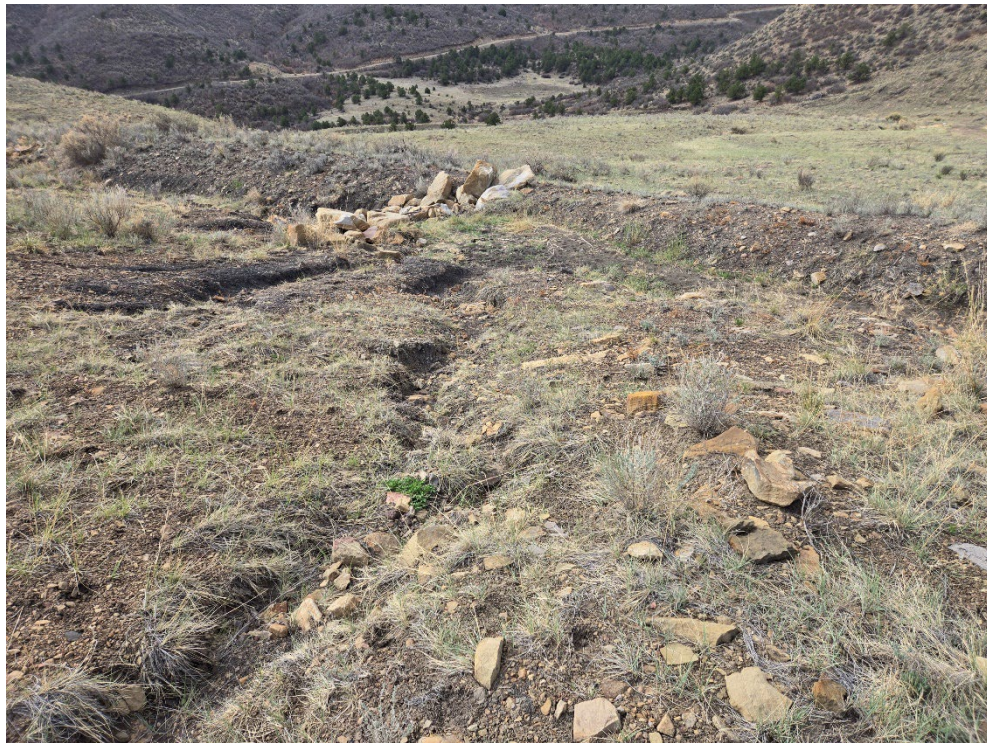
- d. in an area designated as a vegetation test plot. **The Operator shall treat and/or remove the Mullein within this area.**
7. (August 2024 report) The check dams within Ditch D9, leading down to Pond 006a, contain an excess amount of sediment. A gully was also observed cutting down from the road and adding sediment to the third check dam. **The Operator shall remove the excess sediment from the check dams within D9.**

Photo 6: Looking south at the check dams in D9.

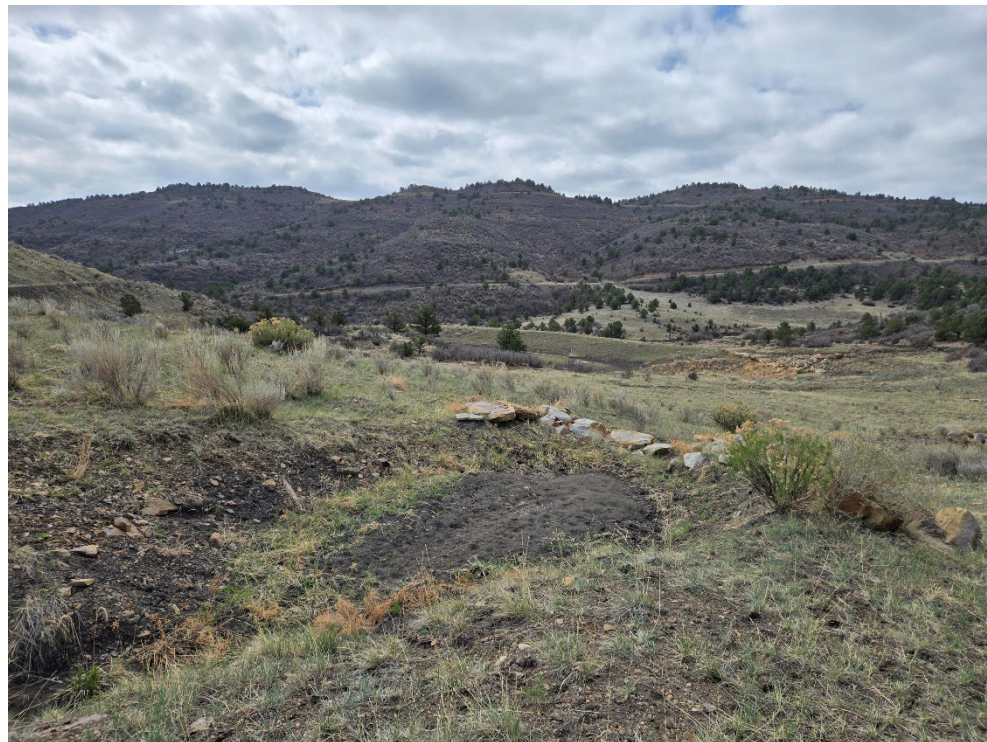
Photo 7: Check dam full of sediment above Pond 006a.

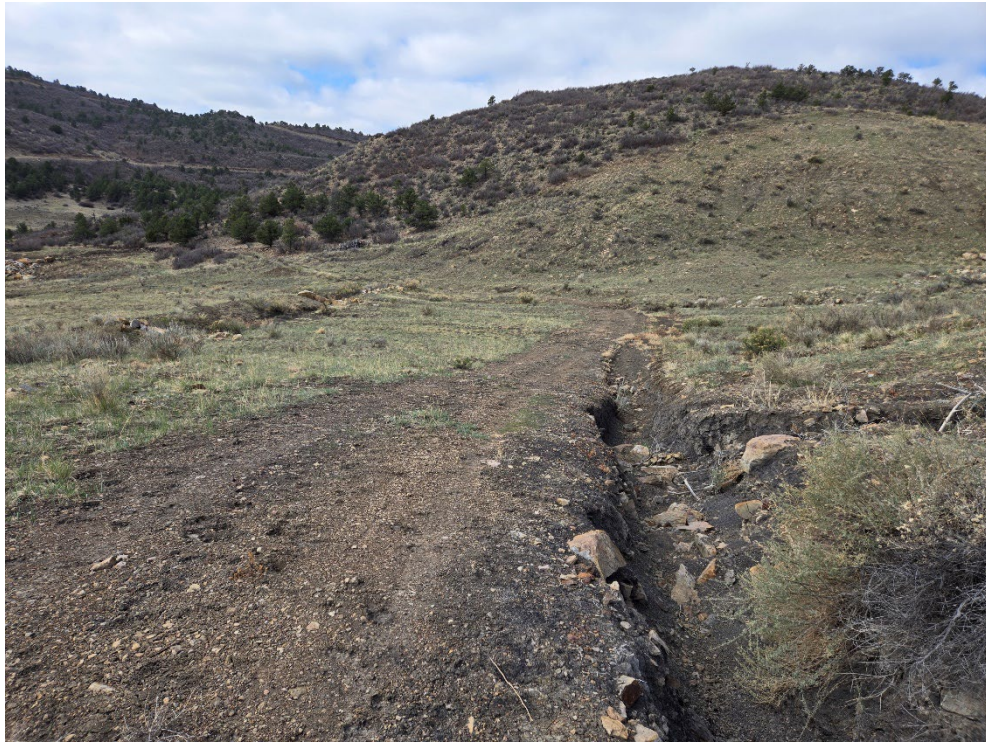
Photo 8: Erosion cutting into the north side of the road leading down to Pond 006a.

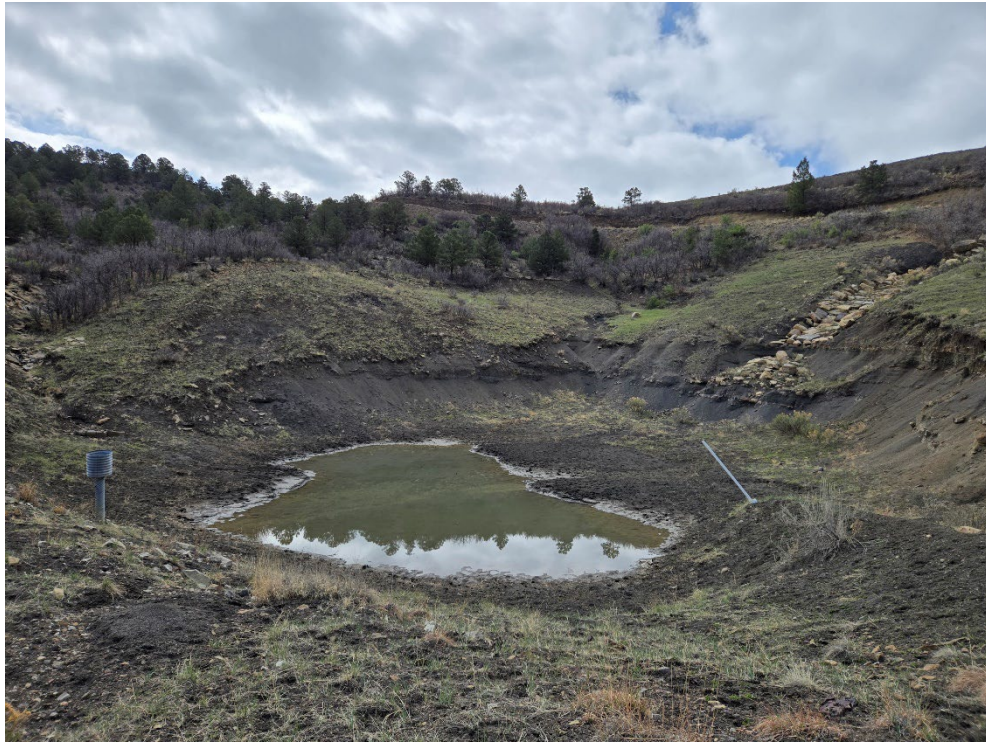
- a. (September 2024 report) The rills above the bank do not appear to have worsened, but the **Operator shall continue to monitor this area.**
- b. (November 2024 report) Some vegetation has grown over and into the flume. The **Operator shall clear the excess plant material in the flume.**

Photo 9: Looking south at the currently stable erosion above Pond 009.

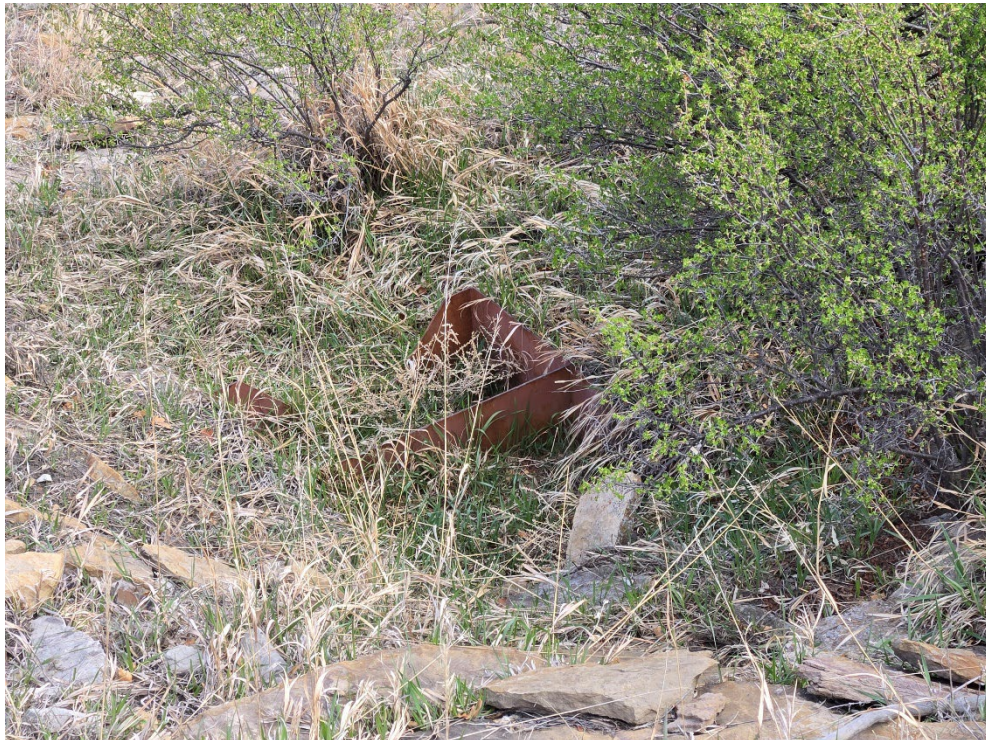
Photo 10: Looking at the flume for Pond 009 that needs to be cleaned.

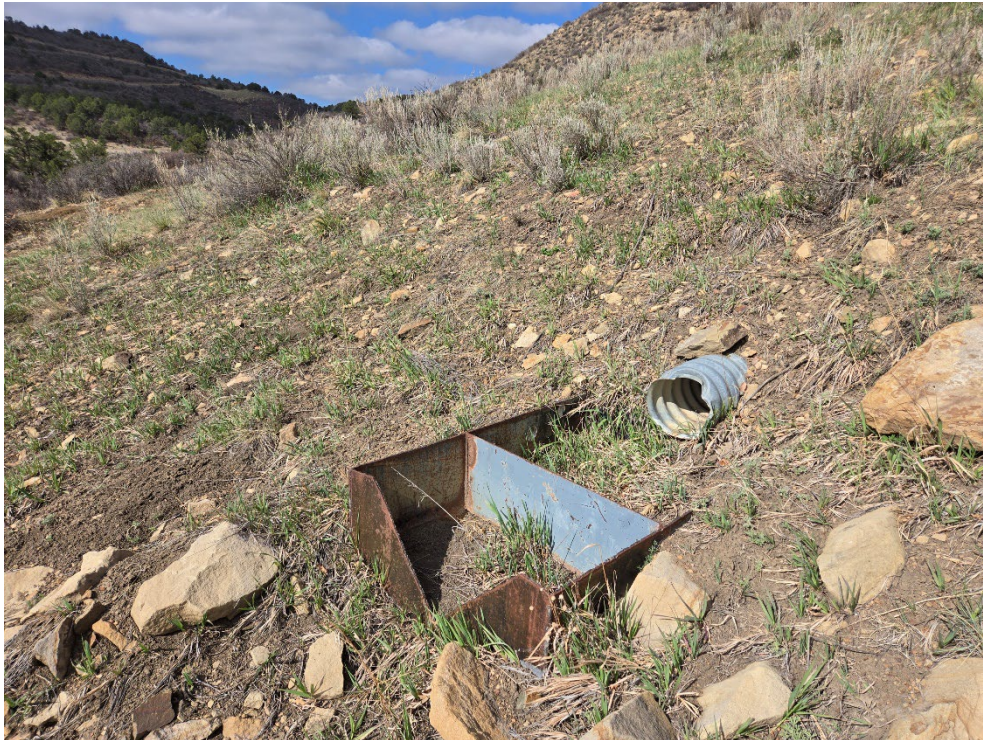
9. (October 2024 report) Pond 006a - Sediment has built up within the upper portion of the flume. **The Operator shall clean the flume of sediment and vegetation to ensure it functions properly.**

Photo 11: Looking west at the sediment accumulated in the flume for Pond 006a.

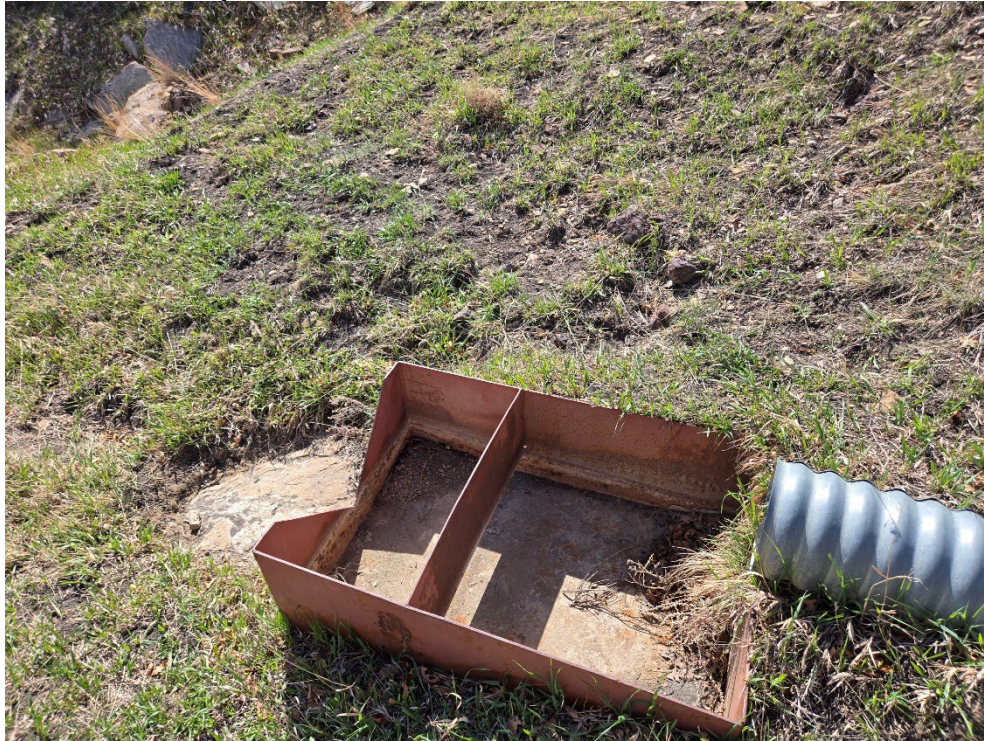
Photo 12: Flume for Pond 08.

- Pond 006:
 - a. Pond 006a contained water and was not discharging at the time of the inspection (Photo 1-2).
 - b. The primary and emergency spillways appeared to be clear and functional.
 - c. The ongoing maintenance issues listed in Item #3 at the beginning of this report are still a concern.
- Pond 008:
 - a. The pond was dry at the time of the inspection. (Photo 3).
 - b. The pond embankment appeared to be stable and vegetated.
 - c. The primary and emergency spillways appeared clear and functional.
 - d. The flume was dry.

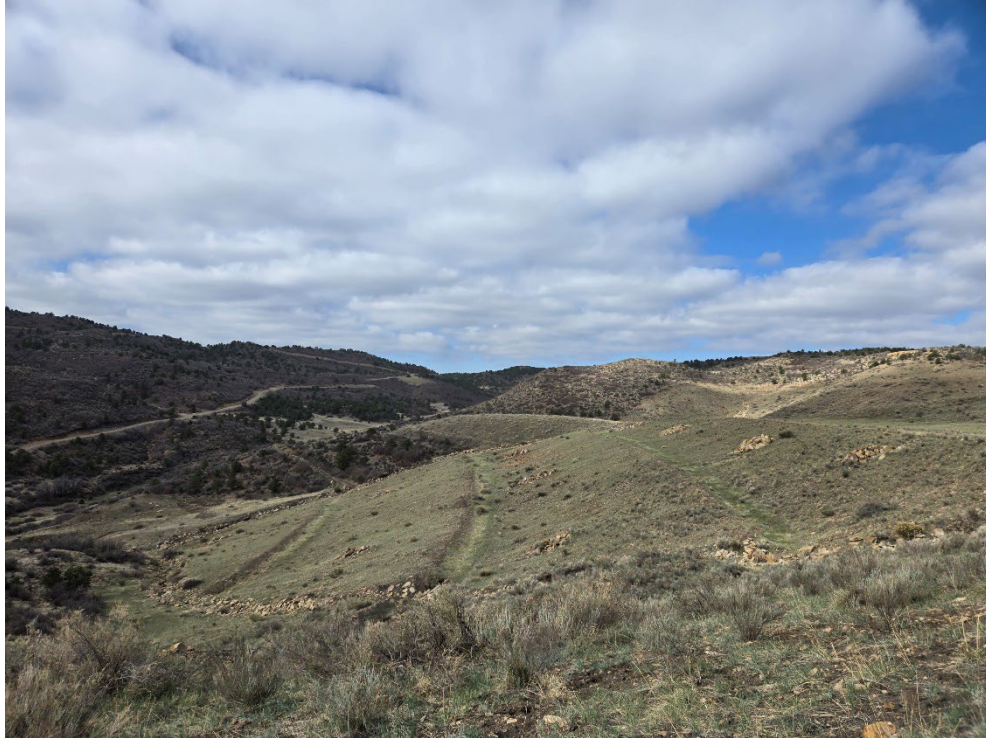
Photo 13: Fill 7

- Fill 7 was observed. Fill 7 was well vegetated and appeared stable.

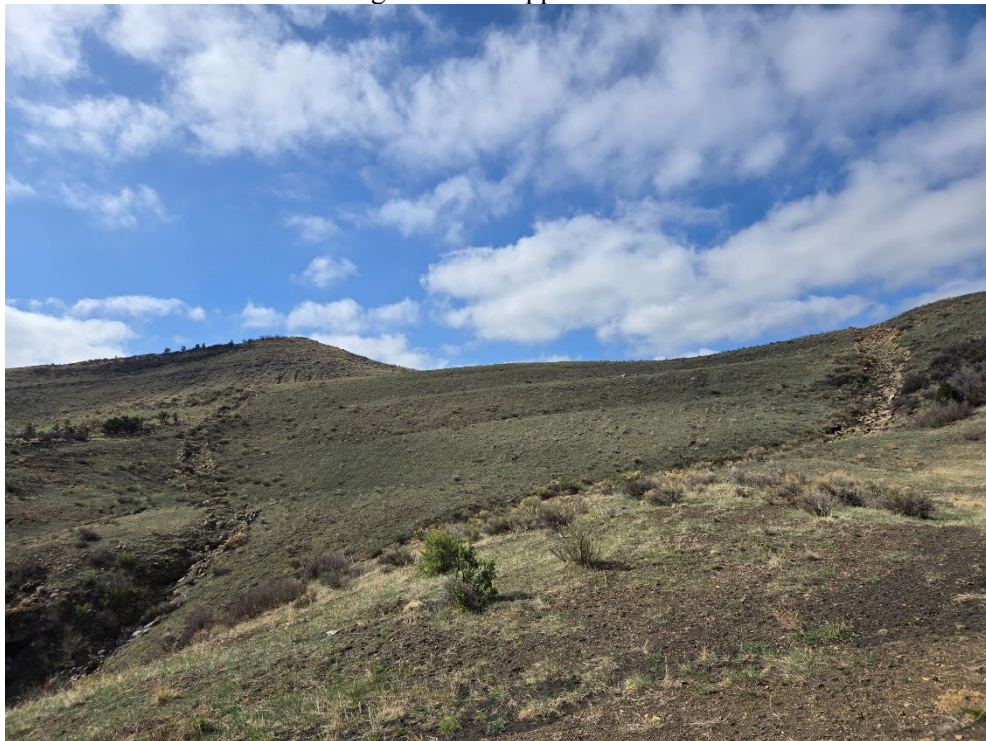
Photo 14: Fill 8

- Fill 8 was observed. Fill 8 was well vegetated and appeared stable.

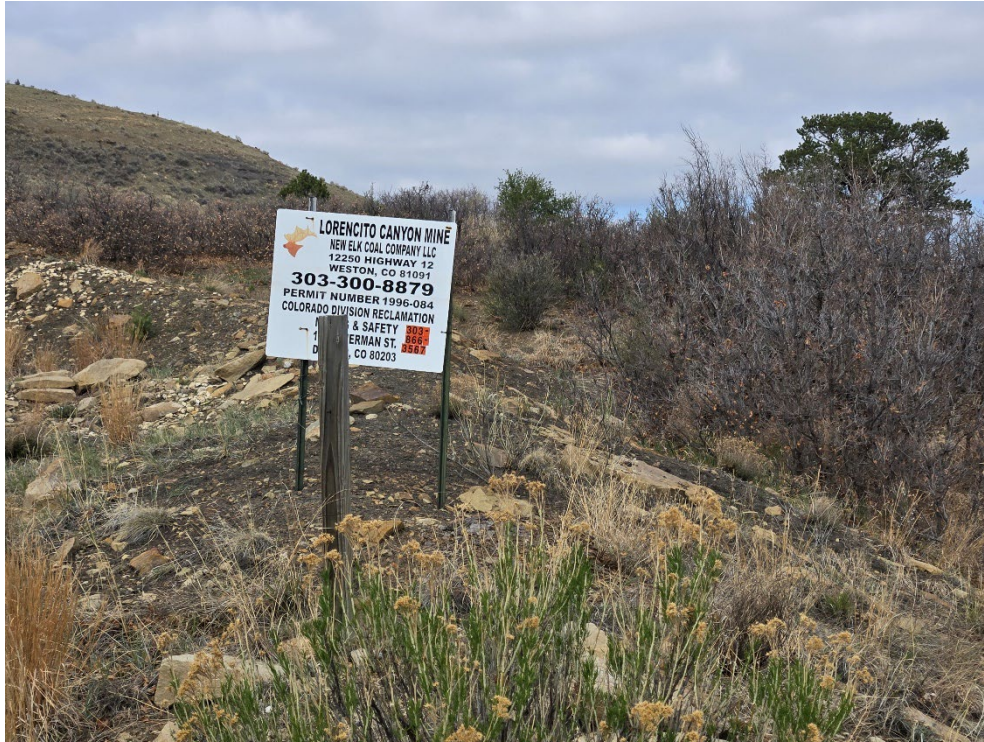
Photo 15: Mine sign

- Mine signs were posted at road entrances and at the entrance to the permit boundary in compliance with Rule 4.02.
