Division of Reclamation,
Mining and Safety

PERMIT INFORMATION

Permit Number: C-1981-012 Mine Name: New Elk Mine Operator: New Elk Coal Company, LLC Operator Address: 12250 Highway 12 Weston, CO 81091	County: Las Animas Operation Type: Underground Permit Status: Suspended Ownership: Private
	Operator Representative Present: None
Operator Representative Signature: (Field Issuance Only)

Inspection Start Date: April 24, 2025 Inspection Start Time: 12:20 Inspection End Date: April 24, 2025 Inspection End Time: 13:27	Inspection Type: Coal Partial Inspection Inspection Reason: Normal I&E Program Weather: Cloudy
Joint Inspection Agency: None	Joint Inspection Contacts:
Post Inspection Agency: None	Post Inspection Contacts:
Inspector(s): Amber M. Gibson	Inspector's Signature:

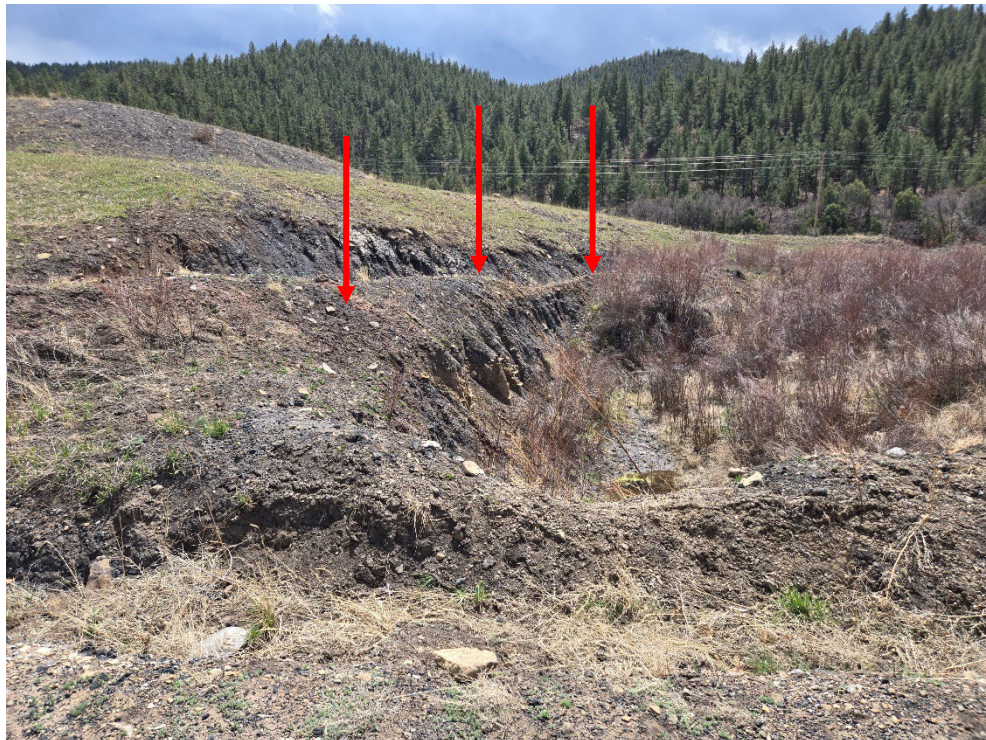
During the September 2023 inspection, it was noted that the embankment slope on the northwest side of the Soil Storage Area was eroding and sluffing into the ditch that discharges to ditch D6. NECC was instructed to repair and stabilize the area. The ditch embankment separating the affected land drainage from the adjacent clear water ditch (D7) is very thin in areas. Failure of this embankment may overwhelm the ditch and cause sediment to discharge into the clean water ditch D7 that discharges to the river. During the October 2023 inspection, the Operator stated that they had hydro-mulched the northwest side of the Soil Storage Area in an attempt to stabilize the slope. They also stated that they are unable to safely get equipment in the area to mechanically stabilize the slope and berm separating the treated water run-off from the clean water ditch. NECC had been monitoring this area. As of this December 2024 inspection, it appears that the hydro-mulching and seeding of the bench has failed, as no vegetation appears to have been established. **The Operator shall determine how to re-stabilize this bench and do so as soon as possible.**

Photo 1: The arrow points to the embankment separating D6 from D7 that needs to be stabilized

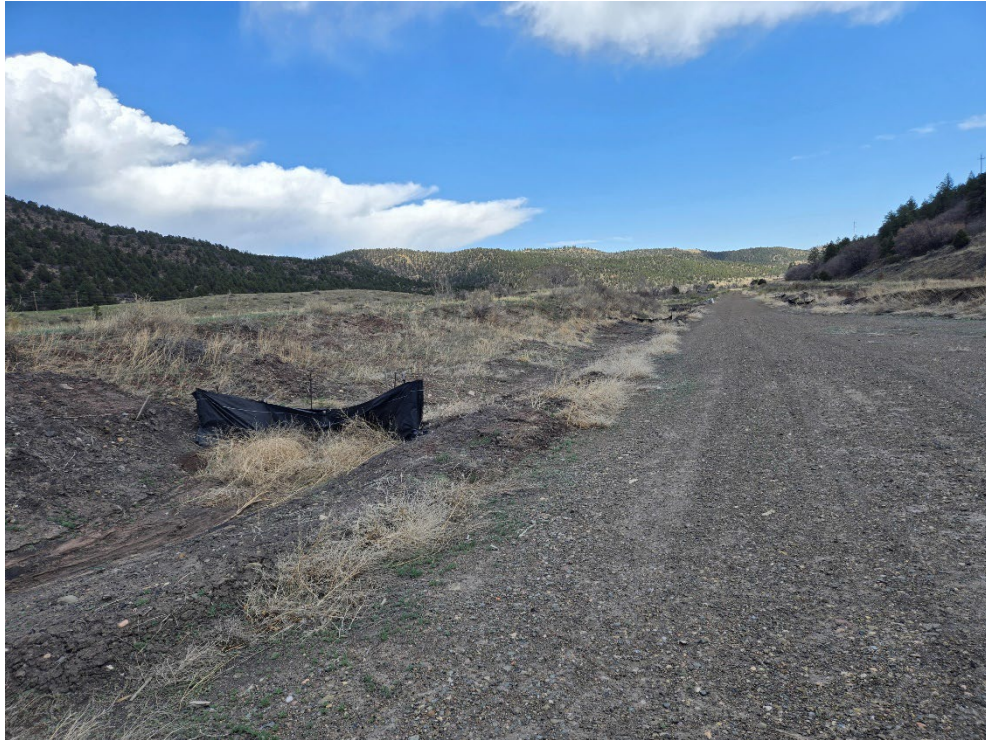
2. (January 2024 report) **The silt fences along the road in the SAE south of Pond 007 are damaged and need to be repaired.**

Photo 2: Silt fences within the S.A.E area south of Pond 007a.

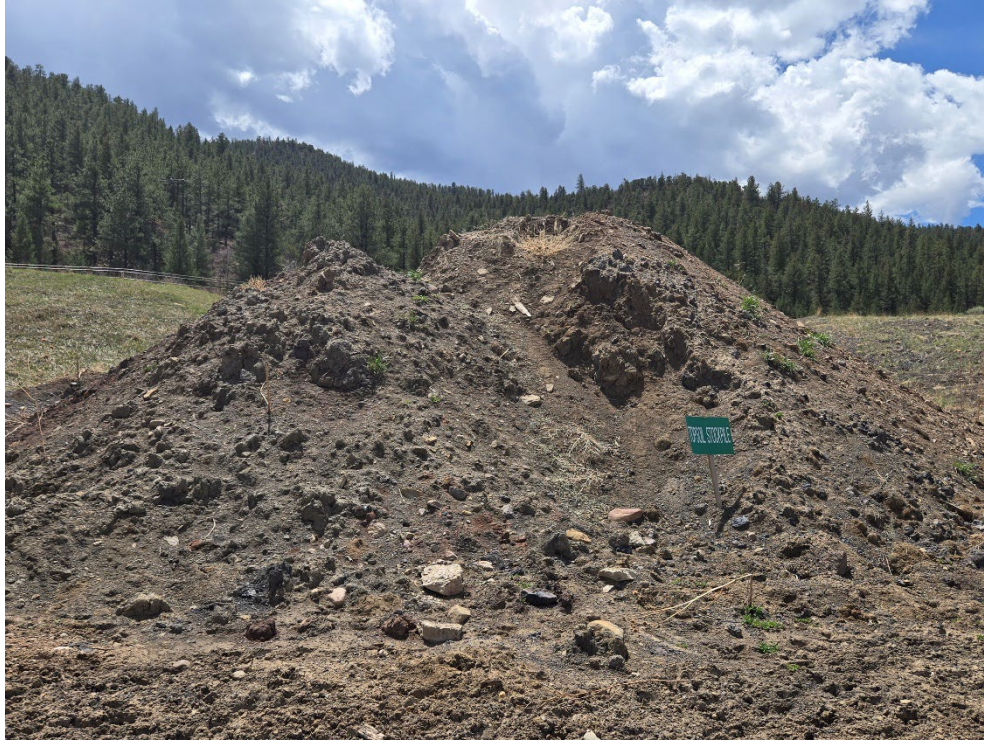
3. (February 2024) In the Stockpile Storage Area, there is a new pile of soil.
 - a. The Operator stated that the soil was salvaged during the debris clean-up work conducted during the past year in the Train Yard Area. The Operator believes that the pile contains topsoil quality soil. **If the Operator intends to salvage this material as topsoil, the topsoil pile must be stabilized with a vegetative cover (Rule 4.06.3(2)(a)(i)).**

Photo 3: New topsoil pile

- Topsoil piles were observed throughout the site. Each pile was out of the way of on-going mining operations, had a sign to identify the stockpiles as topsoil, and had been stabilized with vegetative cover (except for the newest one located in the Stockpile Storage Area north-west of Topsoil Stockpile #1- see outstanding maintenance problem #3 above).

- b. The Operator shall submit a Minor Revision (MR) to update *Map 11-Sheet 3: East Portal Facilities* and pages 37-41 of section 2.05 of the PAP to account for the location, source, and volume of the new topsoil pile.**

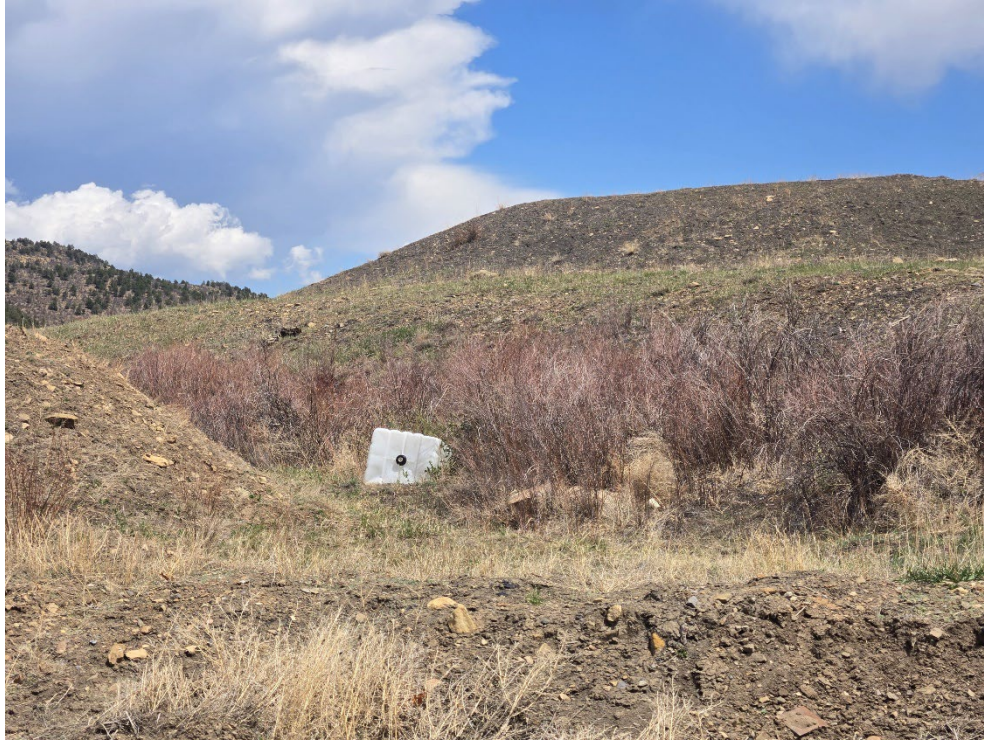
13. (December 2024 report) The Portable Explosives and Chemical Storage area was overall stable. However, the Division observed an empty tank in the ditch to the east of the storage area. **The Operator shall remove the tank from the ditch.**

Photo 4: Empty tank located in the ditch east of the Chemical Storage yard.

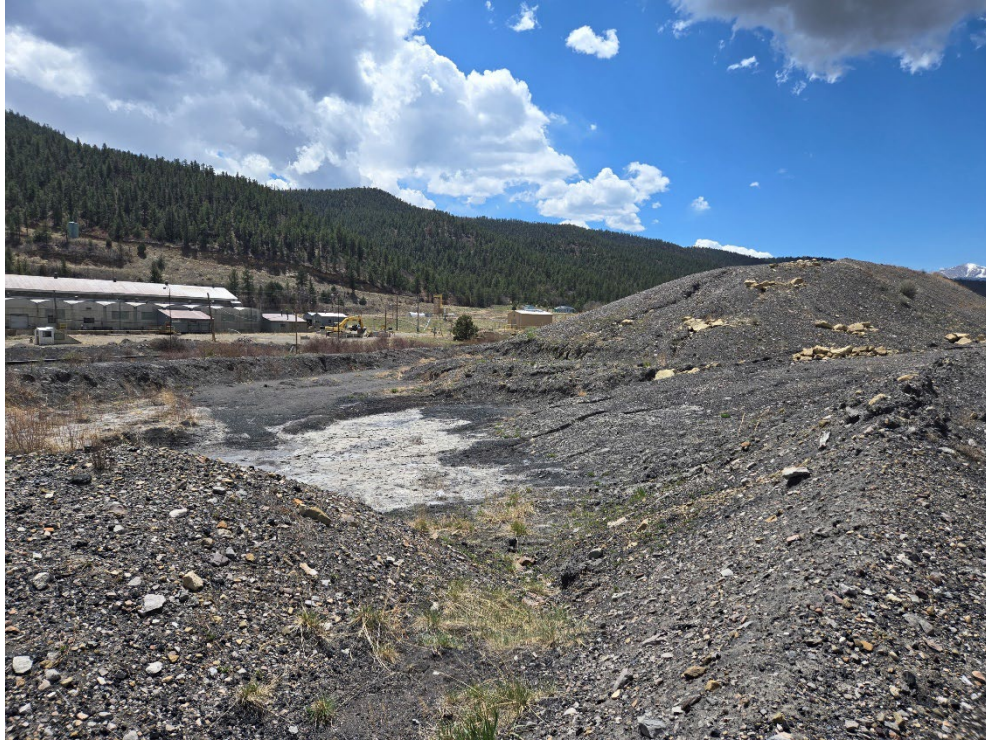
- The sediment basin at the east end of DWDA #2 was not holding water at the time of the inspection.

Photo 5: Sediment basin on east side of DWDA #2.

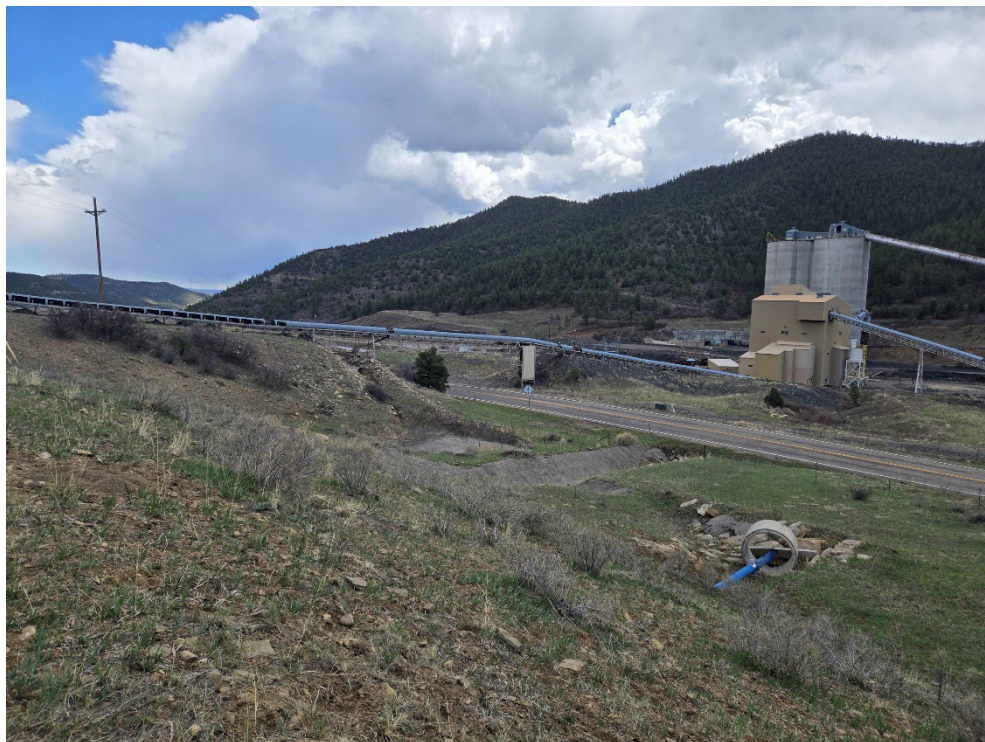
- Containment area #3 was dry.
- Containment area #4 was dry.
- Containment area #5 contained some water and was below capacity.

Photo 6: Looking south at Containment Area #5.

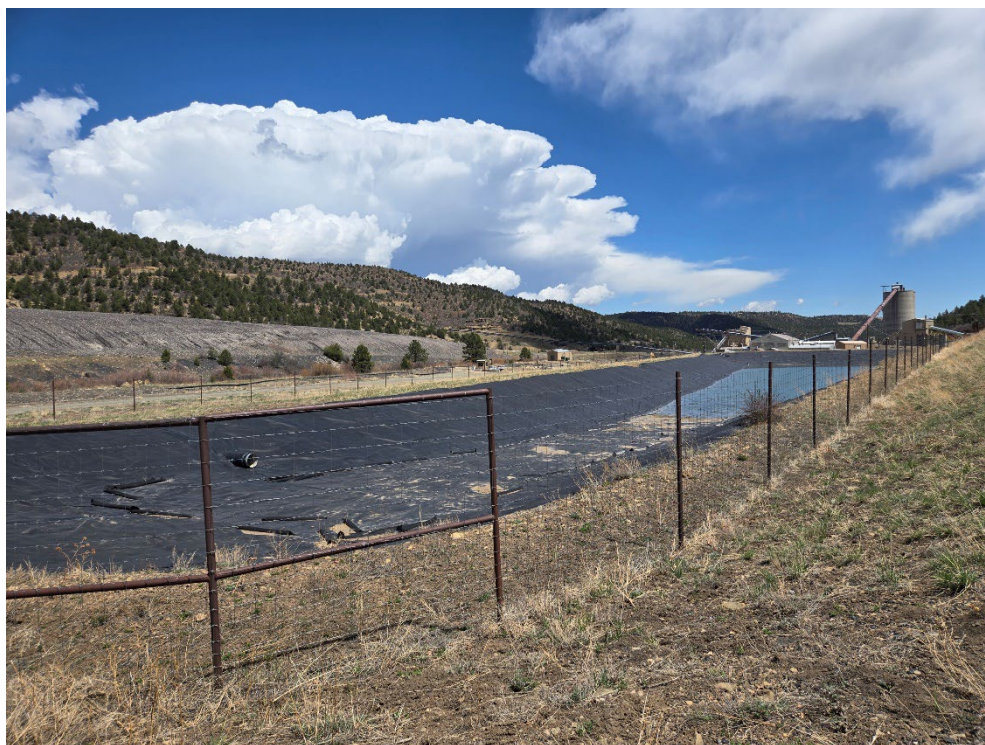
- Pond 001A held some water at the time of the inspection. No tears were observed in the lining.

Photo 7: Pond 001A

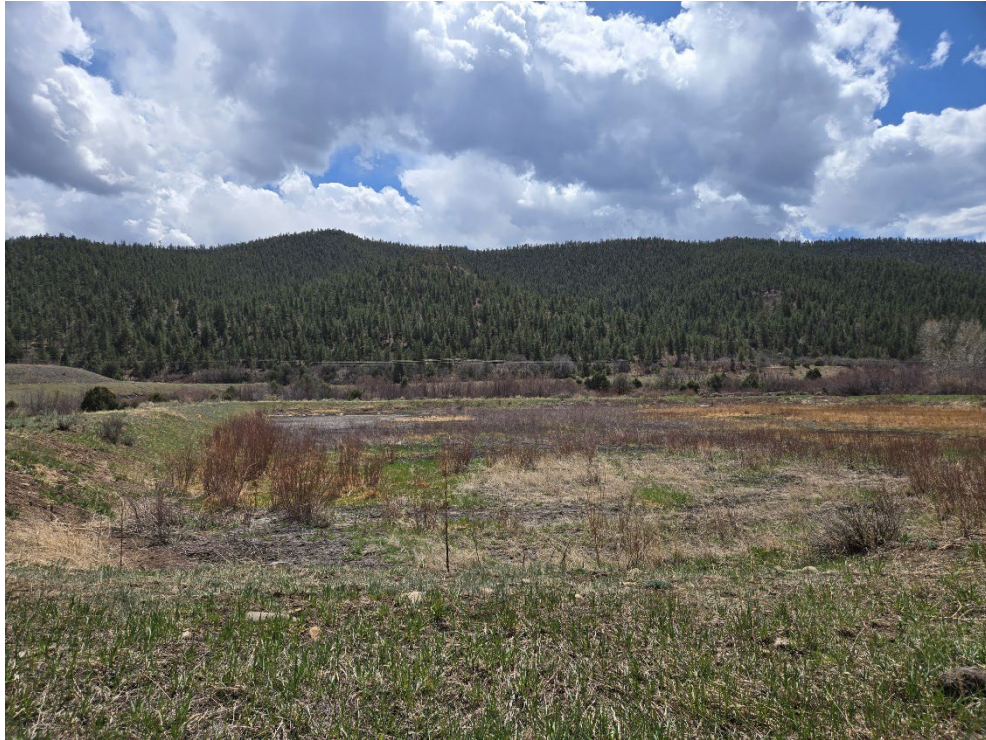
- Pond 004A contained a small amount of water located within the southeast corner.

Photo 8: Looking south at Pond 004A

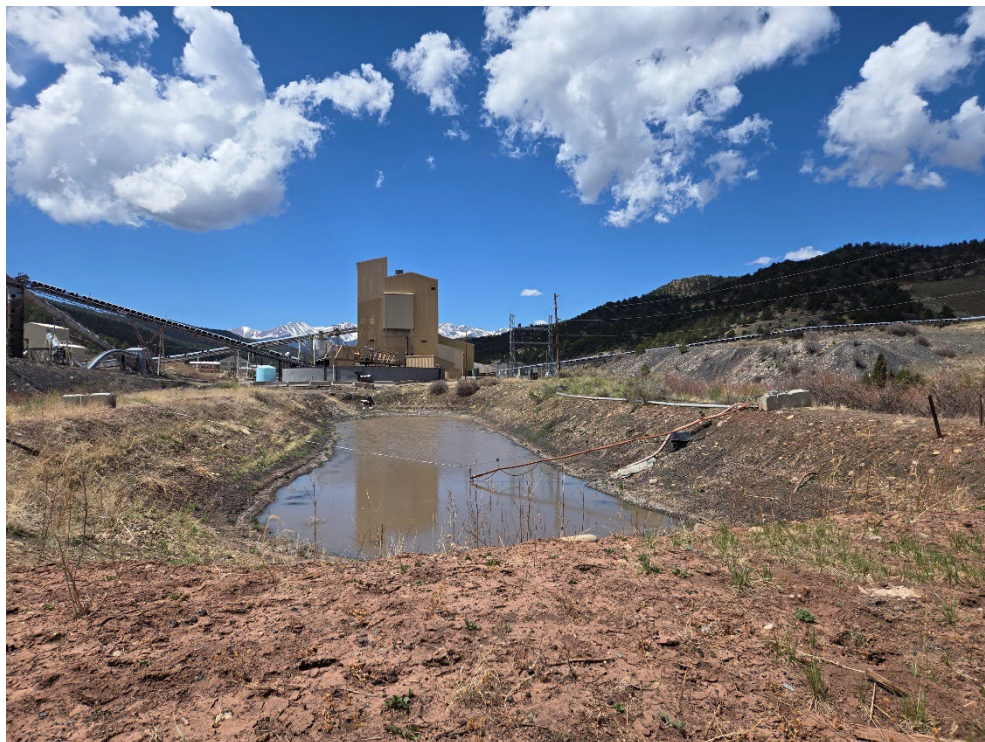
- Pond 006A contained some water at the time of the inspection. The banks of the pond appeared to be stable.

Photo 9: Pond 006A

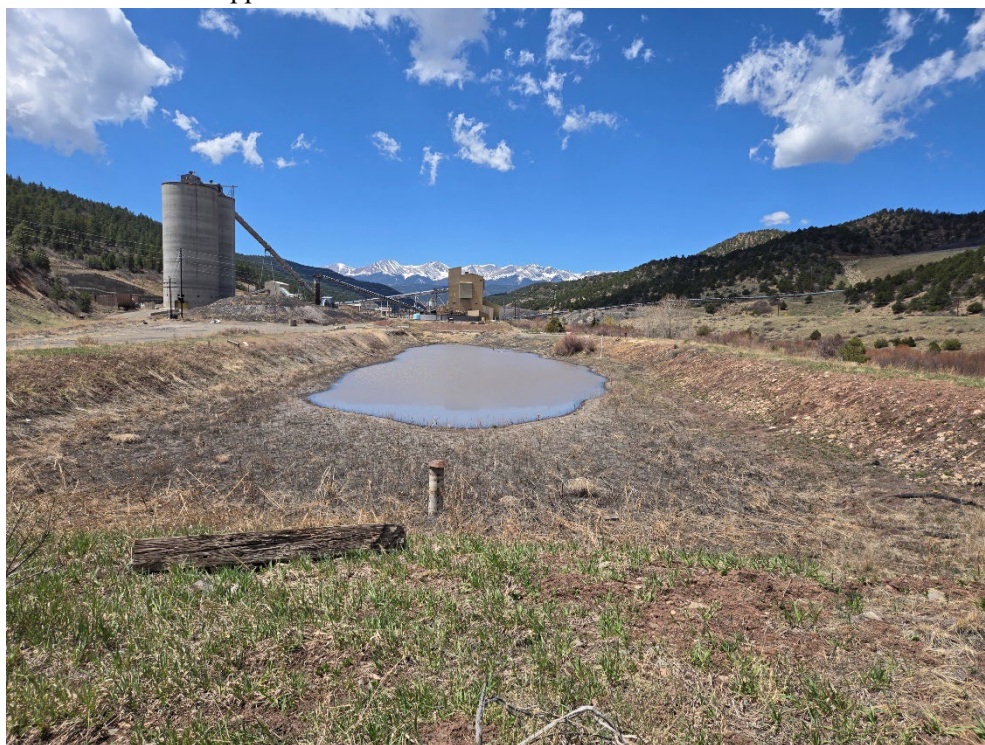
- Pond 007A contained some water at the time of the inspection. The primary and emergency spillways were clear and the banks appeared to be stable.

Photo 10: Pond 007A

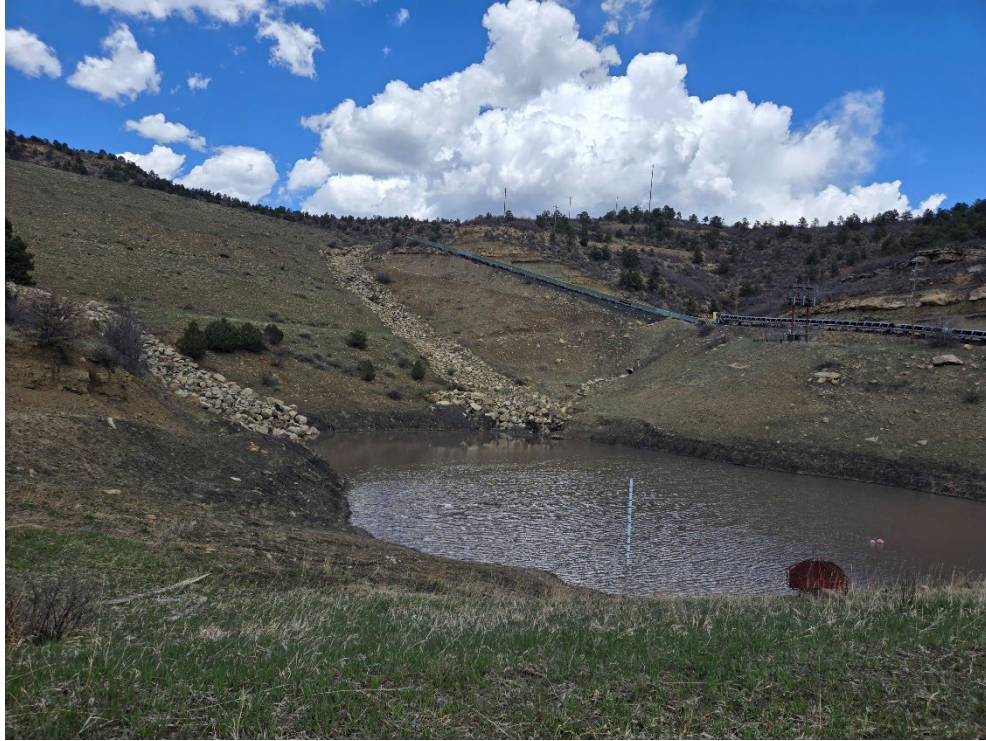
- Pond 08 contained some water at the time of the inspection and was below its capacity. The spillways appeared clear, and the banks were stable. Pond 08 was not discharging.

Photo 11: Pond 08

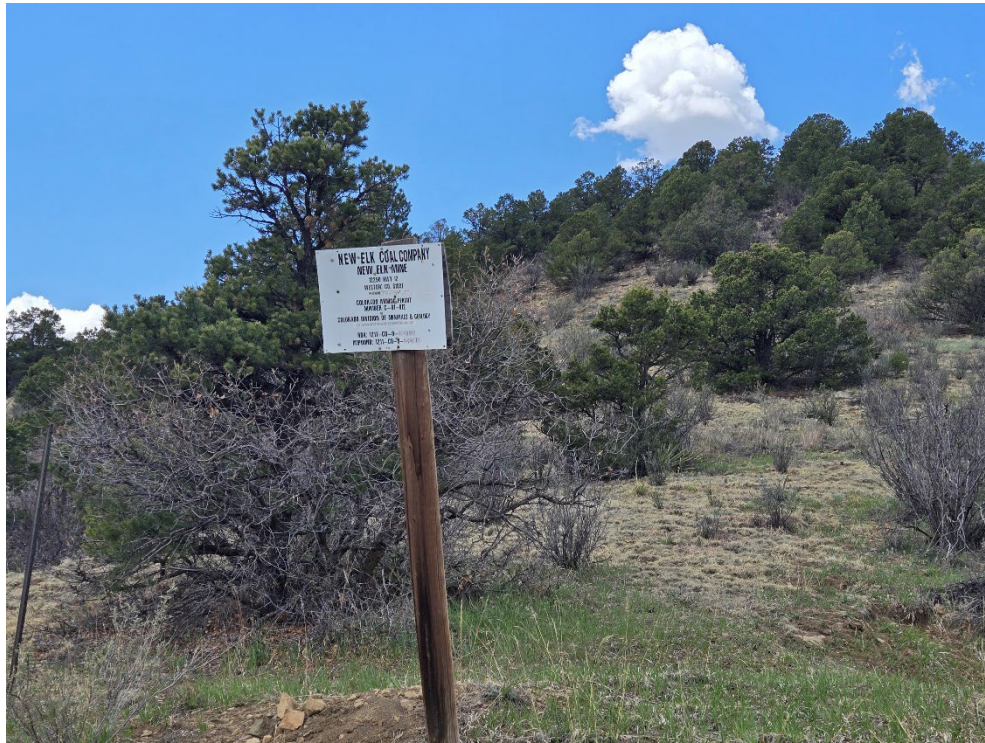
- Mine signs were observed at the main entrance to the New Elk mine site, around the permit boundary.

Photo 12: Mine sign posted near Pond 08
