MINERALS PROGRAM INSPECTION REPORT
PHONE: (303) 866-3567

MINE NAME: Langston Borrow Pit	MINE/PROSPECTING ID#: M-2020-023	MINERAL: Borrow material for construction	COUNTY: Fremont
INSPECTION TYPE: Monitoring	WEATHER: Clear	INSP. DATE: April 9, 2025	INSP. TIME: 12:30
OPERATOR: Langston Concrete, Inc.	OPERATOR REPRESENTATIVE: Zac Langston	TYPE OF OPERATION: 112c - Construction Regular Operation	
REASON FOR INSPECTION: Normal I&E Program	BOND CALCULATION TYPE: None	BOND AMOUNT: \$95,765.00	
DATE OF COMPLAINT: NA	POST INSP. CONTACTS: None	JOINT INSP. AGENCY: None	
INSPECTOR(S): Jocelyn Carter	INSPECTOR'S SIGNATURE:

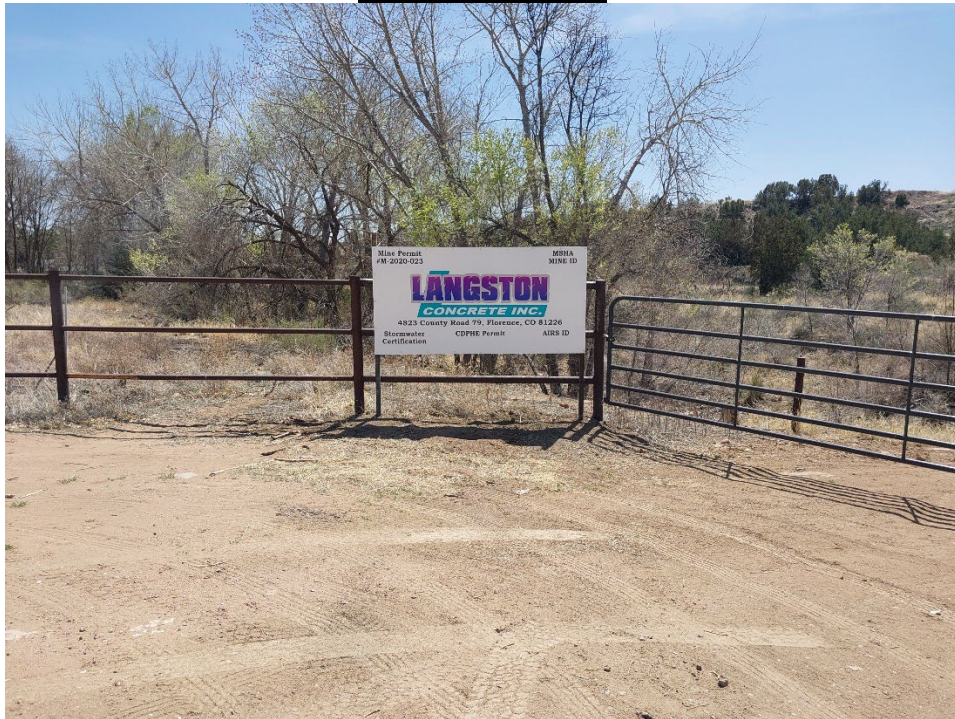
The mine sign is posted in accordance with Rule 3.1.12(1). Permit boundary markers are in place, see Photo #1. White PVC tubes over T-posts are used to mark the boundary, see Photo #4 and #6.

Photo #1: Mine sign posted at the entrance on the south side of County Road 79.

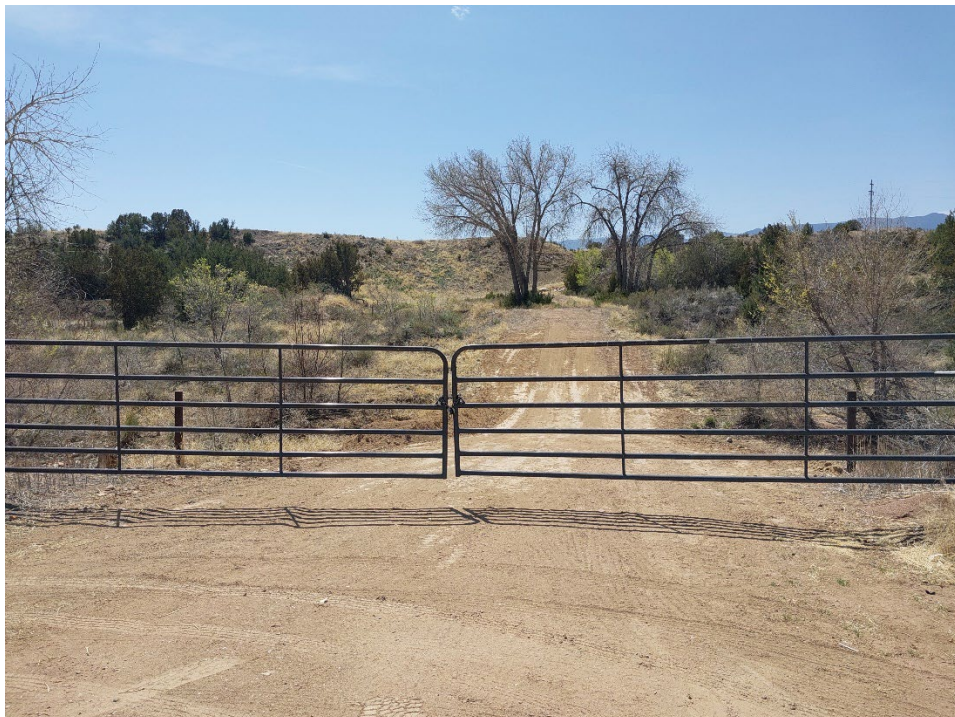
There are two easement roads that go through the permitted area, one traverses north-south from the entrance through the west side of the permit (Photo #2), and the other traverses east-west along the south permit boundary (Photo #3). The permit boundary intersects the north-south road north of the intersection of the two roads. Both roads are used by the Operator as well as the City of Florence and Fremont County to access utilities that go through the permitted area and facilities adjacent to the permitted area. The roads are maintained by all three parties, as needed.

Photo #2: Gate at the entrance of the permit site, looking to the southwest, the easement road can be seen beyond the gate.

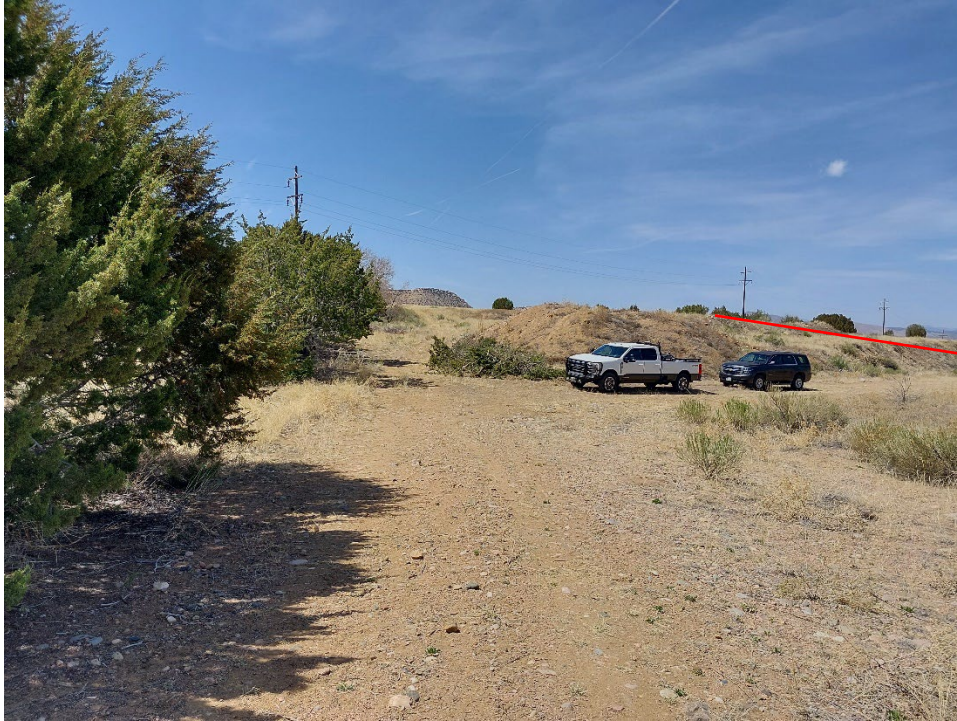
The portion of the road that is outside the permit area was the focus of this inspection to document the area before mining activities occurred. Satellite images are misleading, and the area appears to have been disturbed in recent imagery. During the site visit, it was clear that the area was not disturbed by mining operations, see Photos #3 - #6.

Photo #3: View of the portion of the easement road that is outside the permit boundary, looking to the northwest. The red line on the right side of the photo is the approximate location of the permit boundary.

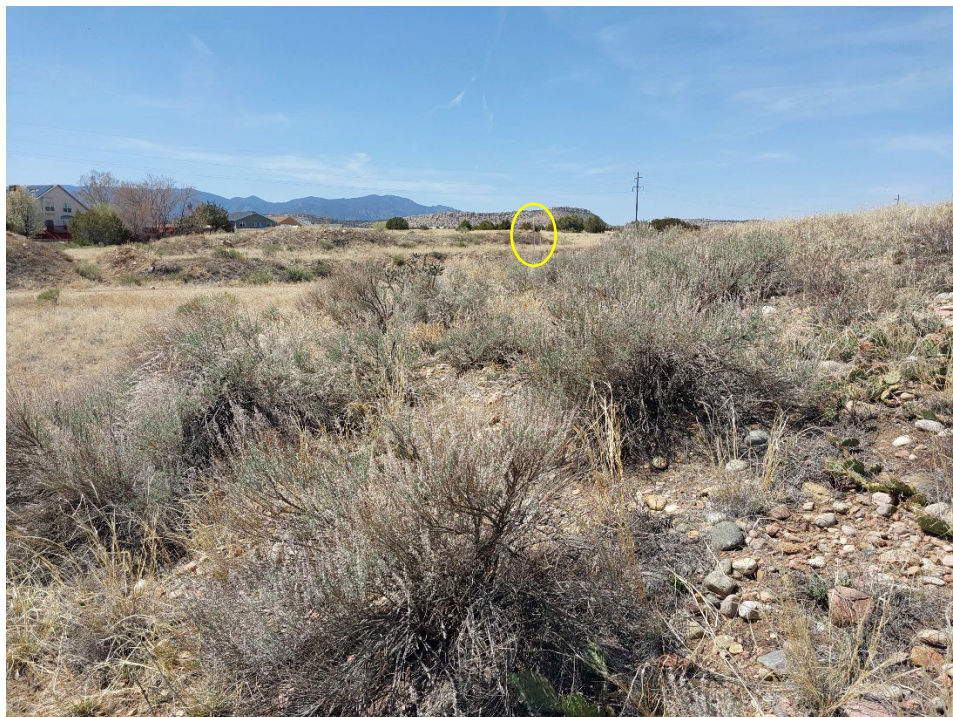
Photo #4: Looking west from the permit boundary marker in the southwest corner of the permit, the southwest corner boundary marker can be seen, circled in yellow.

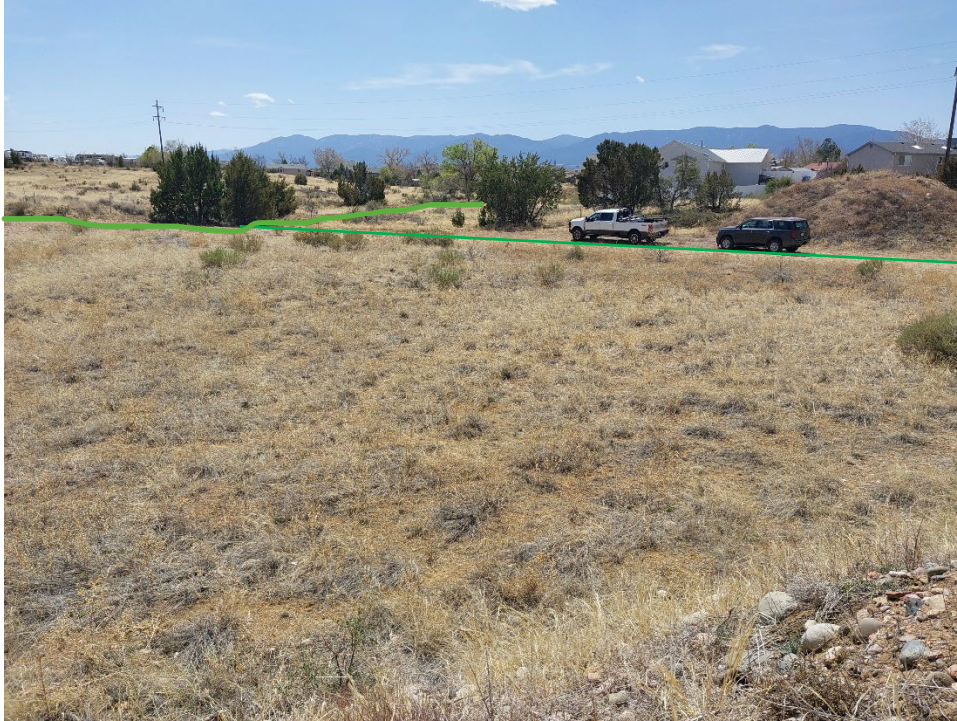
Photo #5: View of the area outside the permit boundary, looking to the southwest of the permit boundary corner. The green lines indicate where both easement roads are located.

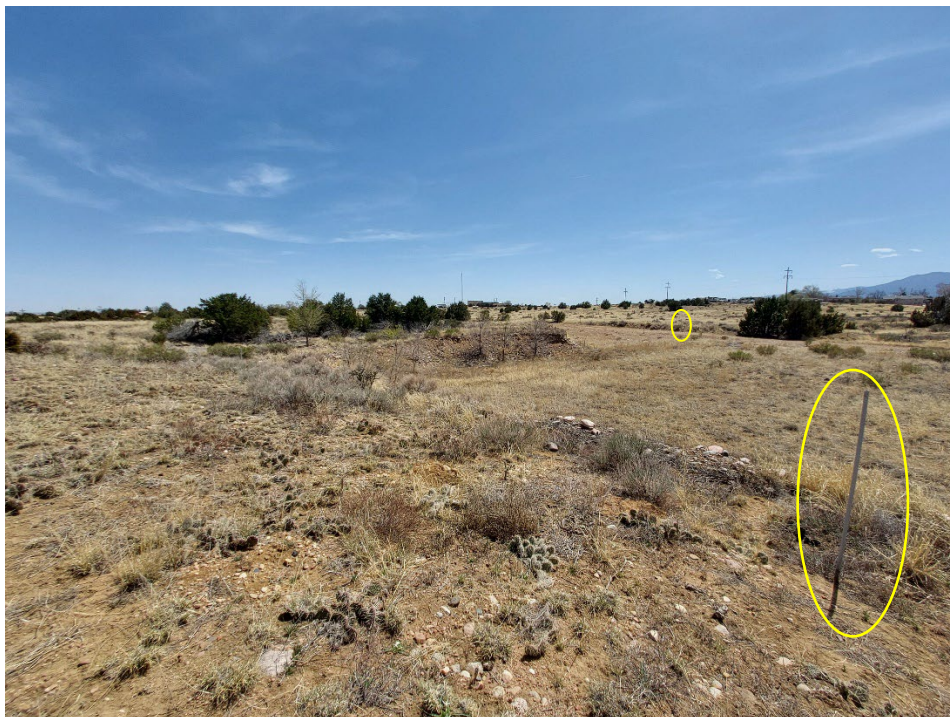
Photo #6: The post on the far right of the photo, in the foreground, is the corner boundary marker of the permit. The permit boundary marker, also circled in yellow, in the background is located on the south side of the east-west easement road. Looking to the south.
