MINERALS PROGRAM INSPECTION REPORT
PHONE: (303) 866-3567

| MINE NAME: Ferrero Pit | MINE/PROSPECTING ID#: M-2000-028 | MINERAL: Sand and gravel | COUNTY: Huerfano |
| INSPECTION TYPE: Surety Release Inspection | WEATHER: Cloudy | INSP. DATE: April 23, 2025 | INSP. TIME: 12:45 |

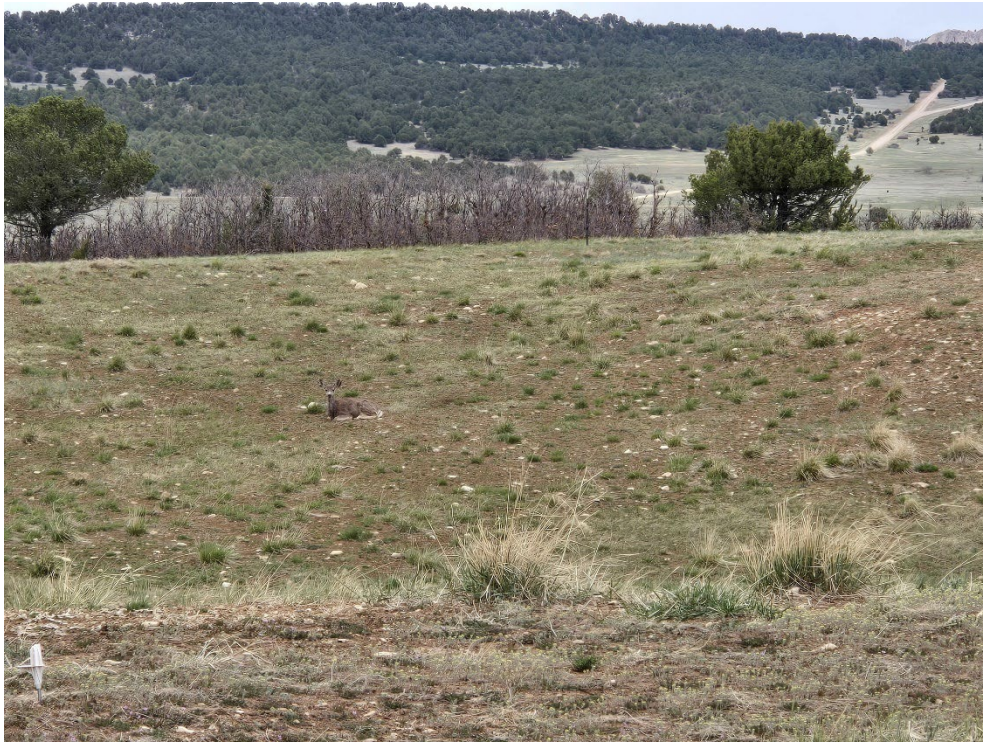
Photo 1: Looking northeast at the northern reclaimed pit slope. Pictured is a deer laying on the slope.

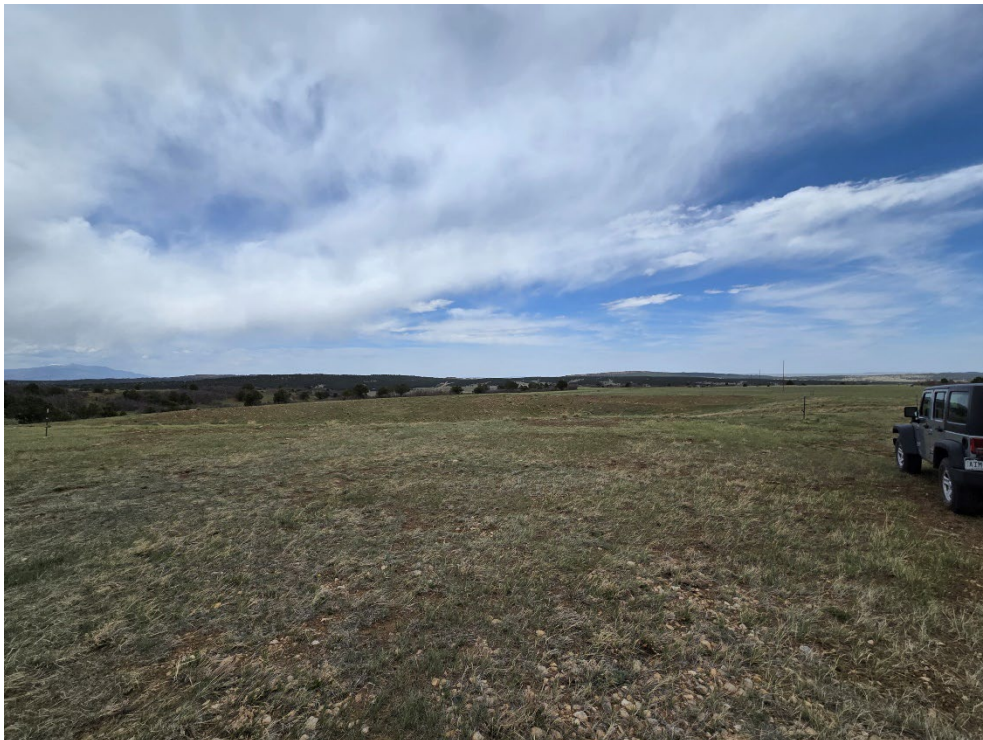
Photo 2: Wide-angle photo showing the entirety of the reclaimed excavated area.

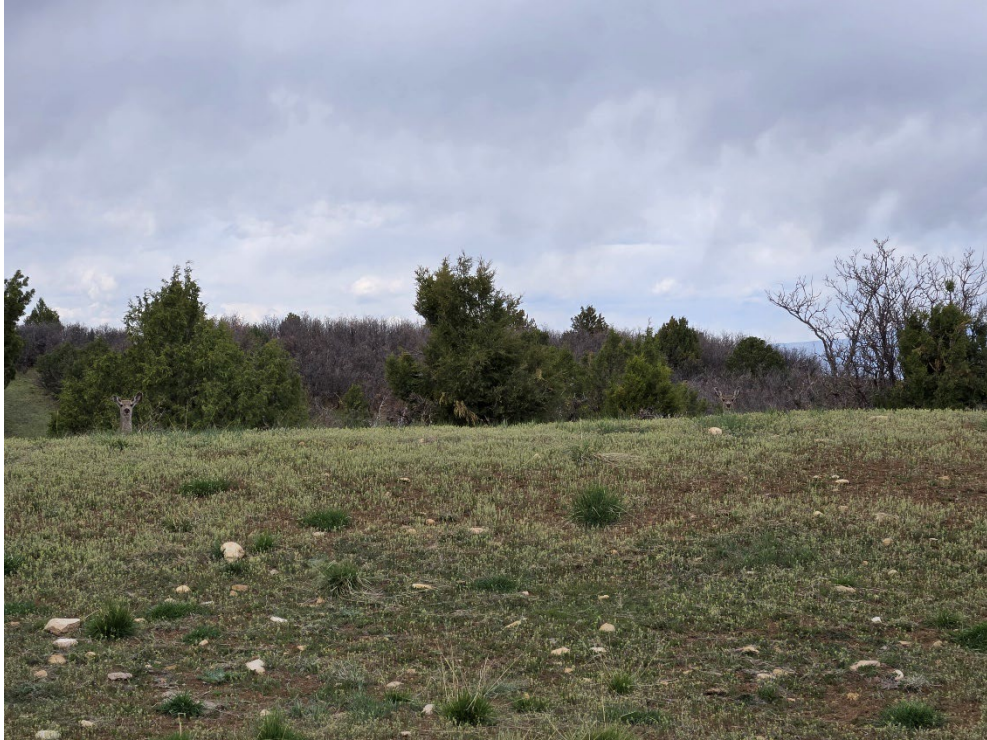
Photo 3: Looking at the vegetation on the pit slopes.

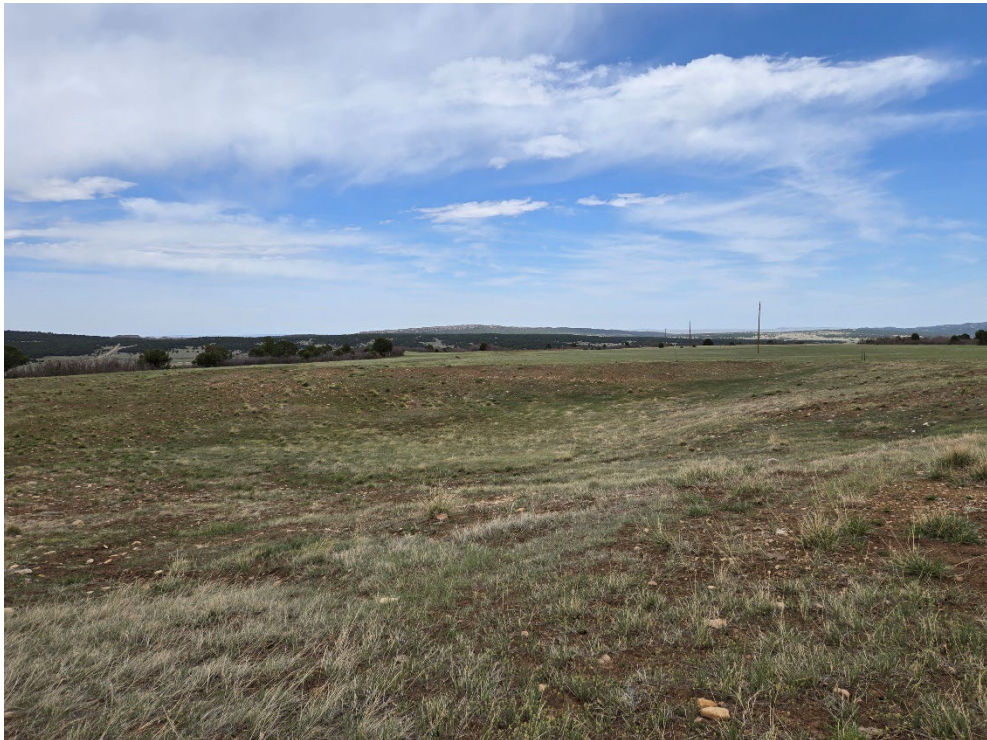
Photo 4: Looking south at the vegetation on the reclaimed pit slopes.

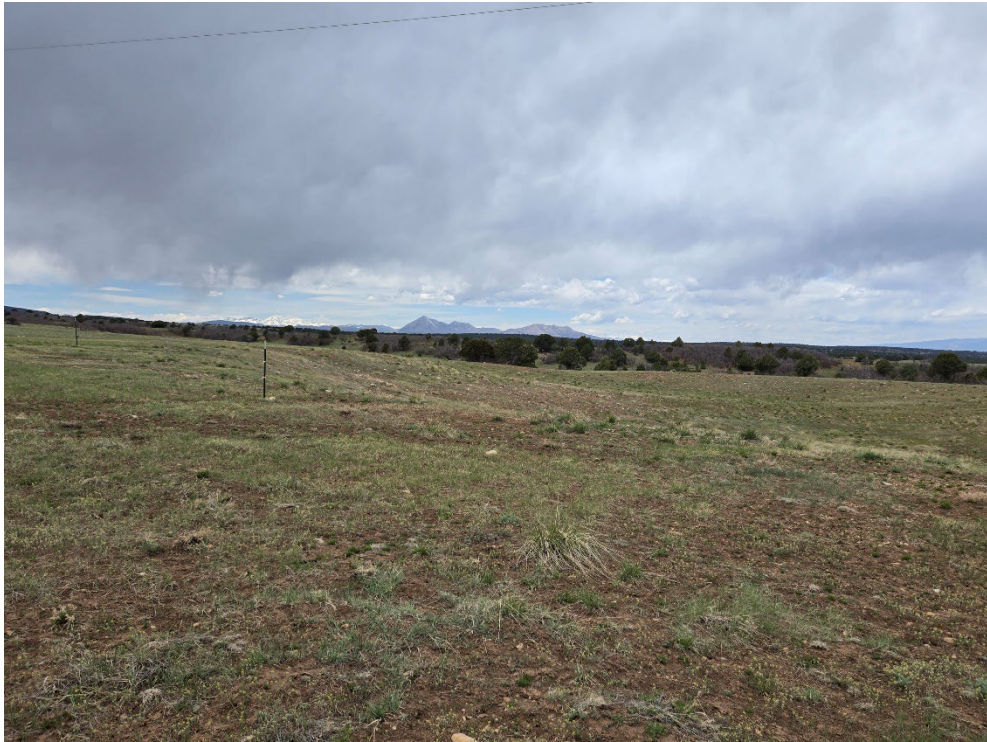
Photo 5: Looking west at the southern slopes in the reclaimed pit area.

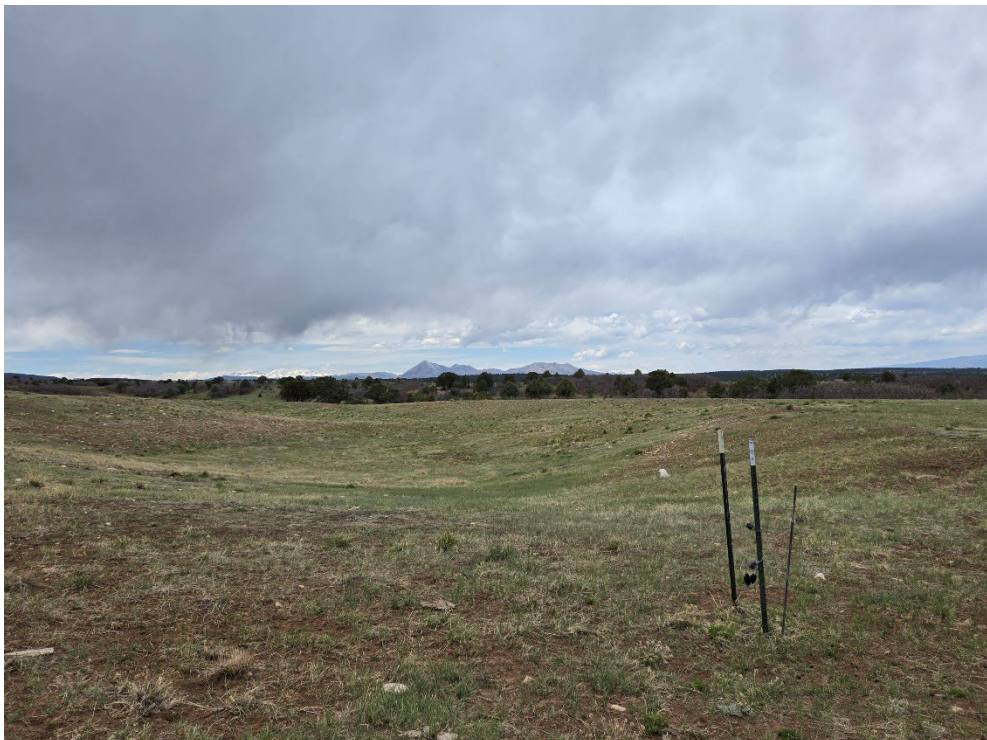
Photo 6: Looking west at the reclaimed slopes in the pit.
