MINERALS PROGRAM INSPECTION REPORT
PHONE: (303) 866-3567

MINE NAME: Tamarcaz Pit	MINE/PROSPECTING ID#: M-1985-072	MINERAL: Sand and gravel	COUNTY: Gunnison
INSPECTION TYPE: Monitoring	WEATHER: Clear	INSP. DATE: April 29, 2025	INSP. TIME: 12:45
OPERATOR: Gunnison County	OPERATOR REPRESENTATIVE:	TYPE OF OPERATION: 110c - Construction Limited Impact	
REASON FOR INSPECTION: Normal I&E Program	BOND CALCULATION TYPE: None	BOND AMOUNT: \$0.00	
DATE OF COMPLAINT: NA	POST INSP. CONTACTS: None	JOINT INSP. AGENCY: None	
INSPECTOR(S): Dustin Czapla	INSPECTOR'S SIGNATURE:

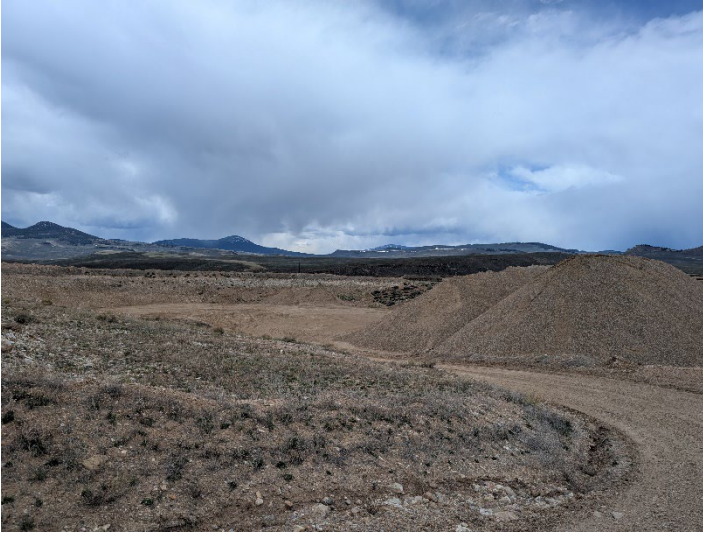
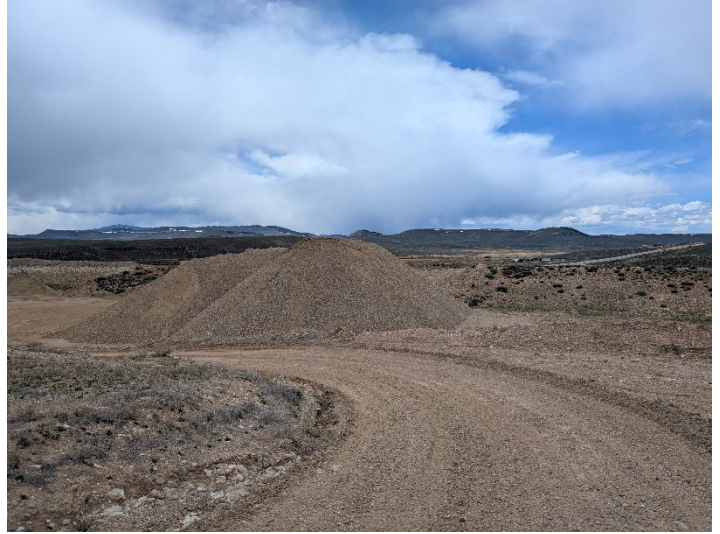
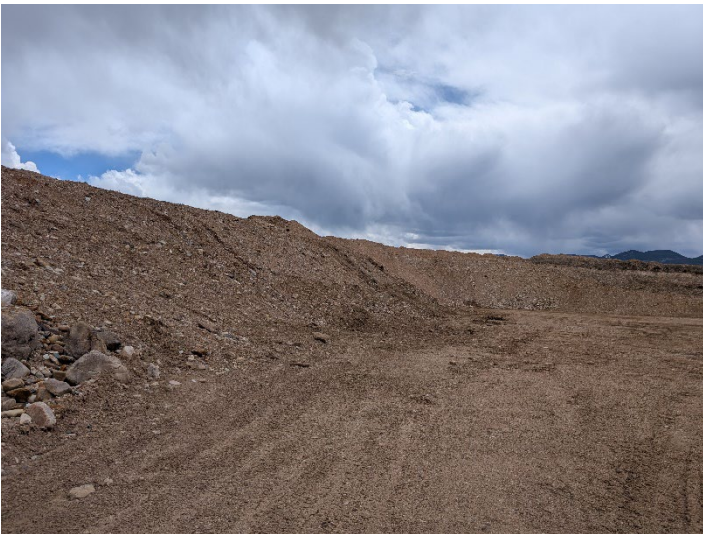
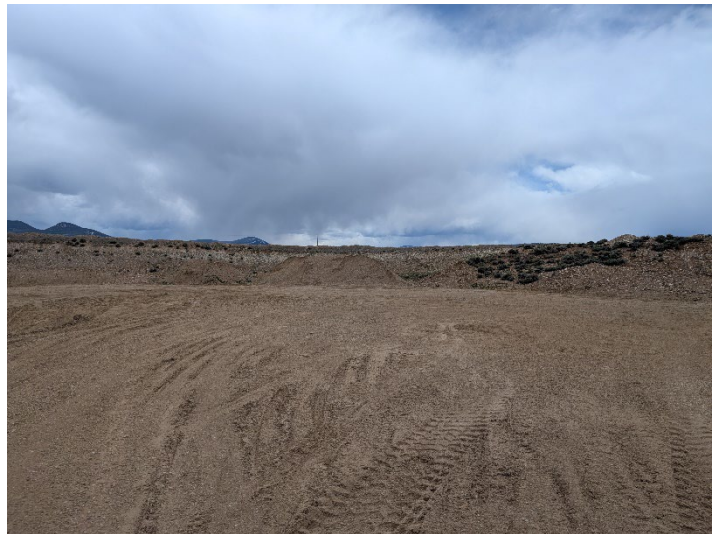
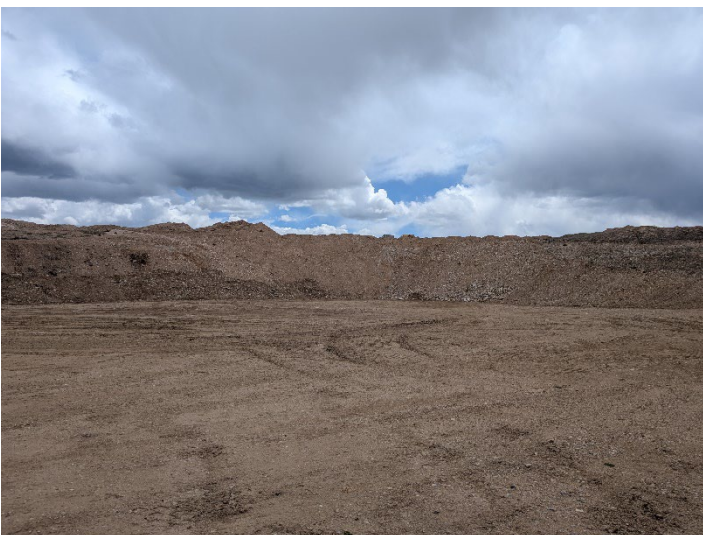
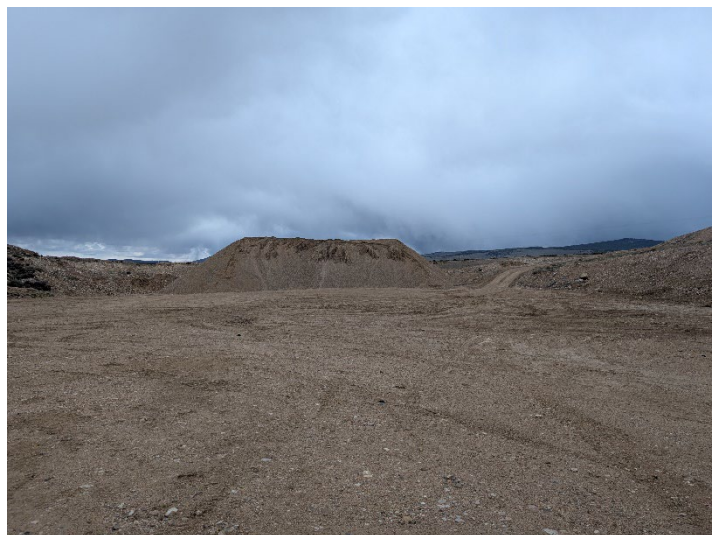
The county typically mines and crushes enough material to last for approximately three years, so mining/processing is infrequent at this site. The highwall slopes, ranging from approximately 15-20 feet high and spanning approximately 1,400 linear feet around the pit, have been graded to 2H:1V or less and appear stable. Crushed gravel is stockpiled within the pit.
