MINERALS PROGRAM INSPECTION REPORT
PHONE: (303) 866-3567

MINE NAME: Whinnery Pit	MINE/PROSPECTING ID#: M-1998-055	MINERAL: Sand and gravel	COUNTY: Gunnison
INSPECTION TYPE: Monitoring	WEATHER: Clear	INSP. DATE: April 28, 2025	INSP. TIME: 13:00
OPERATOR: Helen Whinnery	OPERATOR REPRESENTATIVE:	TYPE OF OPERATION: 110c - Construction Limited Impact	
REASON FOR INSPECTION: Normal I&E Program	BOND CALCULATION TYPE: Complete Bond	BOND AMOUNT: \$29,000.00	
DATE OF COMPLAINT: NA	POST INSP. CONTACTS: None	JOINT INSP. AGENCY: None	
INSPECTOR(S): Dustin Czapla	INSPECTOR'S SIGNATURE:

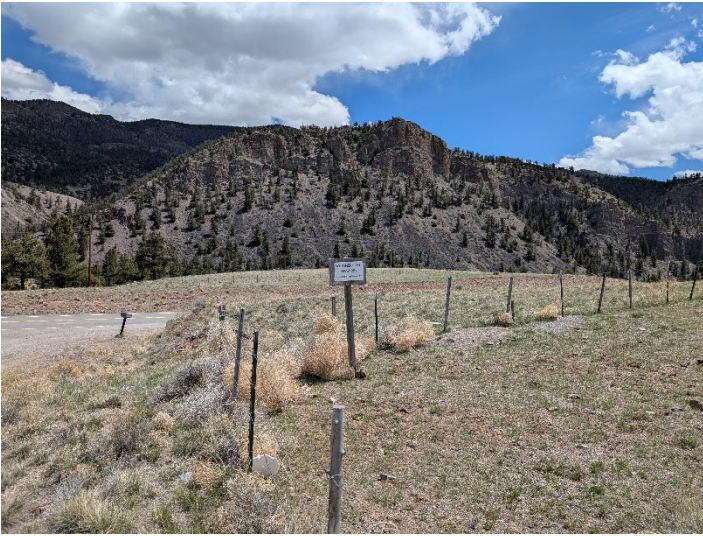
Adequate mine identification signage was noted at the entrance to the site.

Mine sign at site entrance

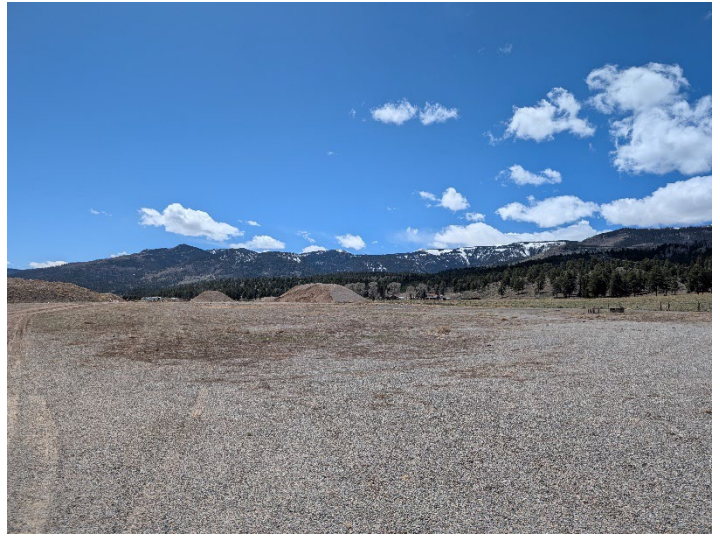
Stockpiled material on west side of pit

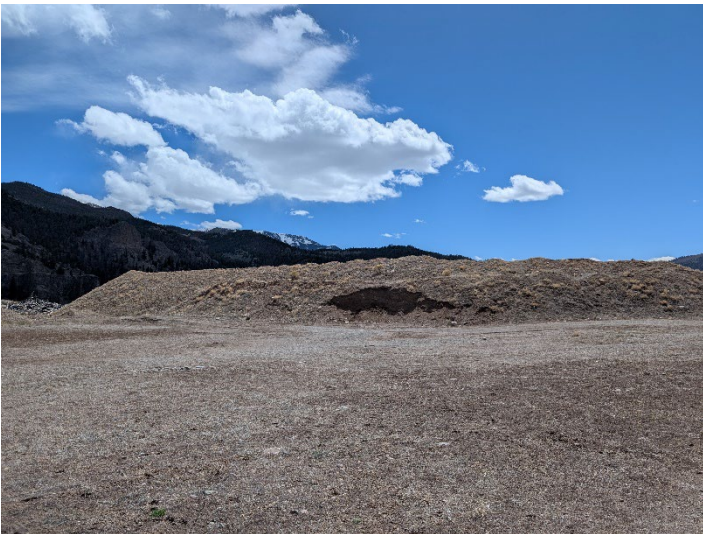
Topsoil stockpile on south end of pit

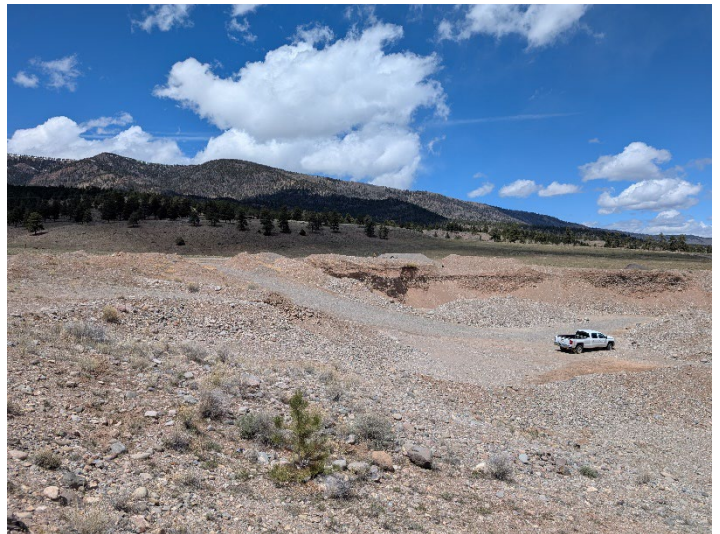
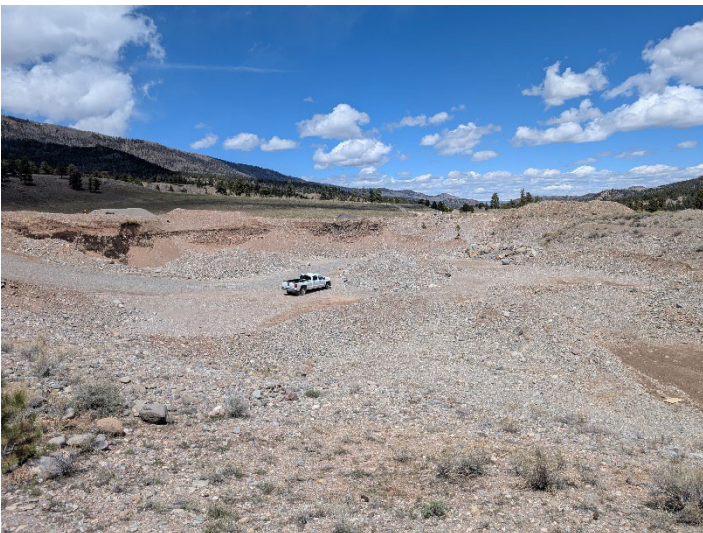
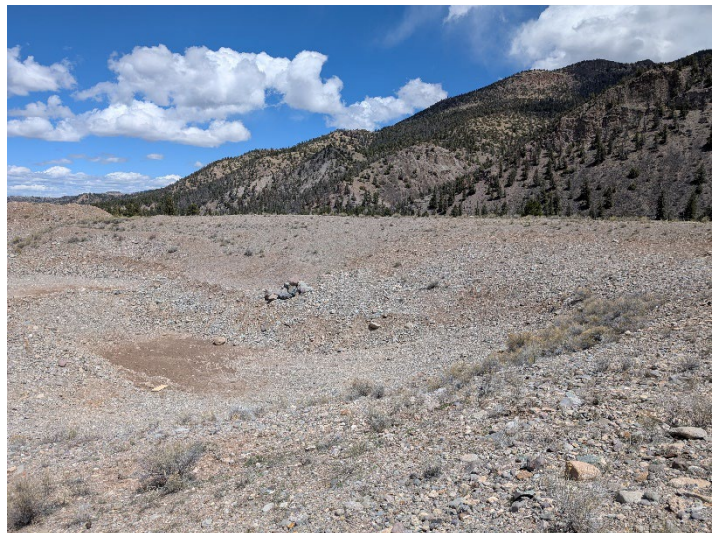
Mining was not occurring during this inspection. Processed gravel stockpiles are located on the west side of the pit. The pit currently covers approximately four acres and is approximately twenty feet deep. Slopes around most of the pit range from approximately 2-3H:1V and appear stable. Approximately 250 linear feet of highwall in the northwest corner of the pit has been left at roughly 1H:1V. Topsoil is stockpiled at the south end of the pit.

View of pit from south end
