Bowie #2 (C1996-083) inspection report

PERMIT INFORMATION

Permit Number: C-1996-083 Mine Name: Bowie No. 2 Mine Operator: Bowie Resources, LLC Operator Address: Mr. Art Etter	County: Delta Operation Type: Underground Permit Status: Active Ownership: Private			
P.O. Box 1488	Operator Representative Present:			
Paonia, CO 81428	P			
1 aoma, CO 01420	None in field			
Operator Representative Signature: (Field Issuance Only)

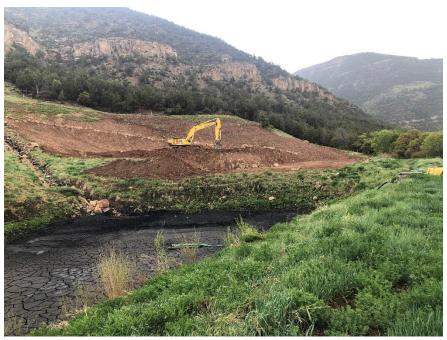
Six sediment ponds were inspected: B, C, D, F, J, and K. None of the ponds were close to discharging. All of them were dry or nearly dry. No significant problems were identified with embankments, spillways, inlet channels, or other features of the ponds.

Pond F and adjacent soil pile

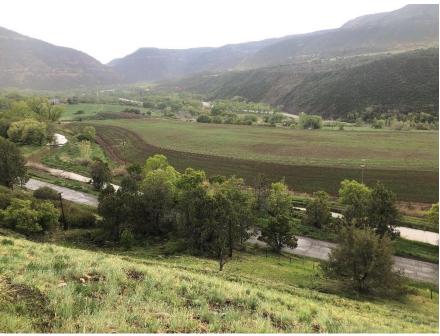
Gob Piles 1, 2, 3, and 4 appeared stable, and no significant erosion was observed. The overburden pile that is southeast of Gob Pile #2 has been reduced to a small amount of material, as most of it has been spread on this pile.

Gob Pile #3

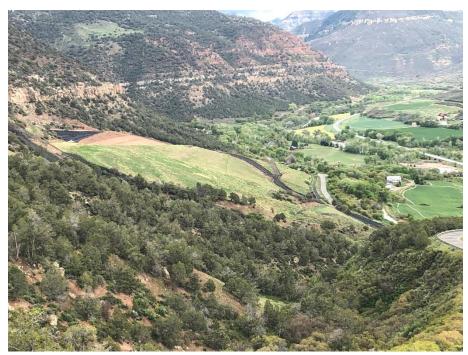
The vegetation on Gob Piles 1 and 4 was very green. No weed problems were identified.

Looking east toward Gob Piles 1,2, and 4

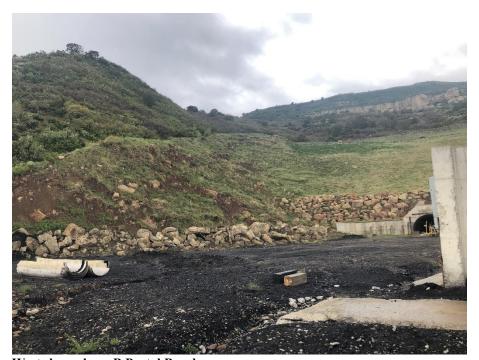
No problems were seen on the slopes above and below the benches. The slides above the B Portal Bench and Curve 11 (noted in the past) look stable. The slide above Curve Number 10 also looked stable, compared to photographs taken in recent months.

West slope above B Portal Bench

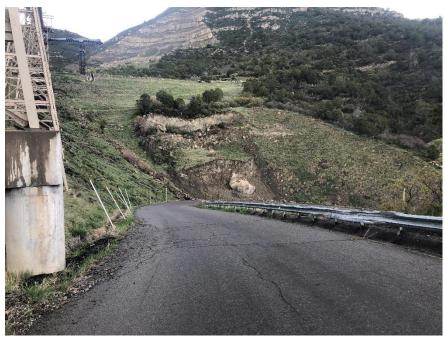
The road to the portals was in adequate condition. The slopes adjacent to this road are generally stable, except for the slide at Curve 10 (see Slides and Other Damage section).

Slide at Curve 10

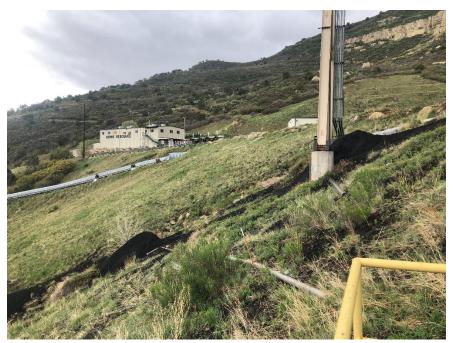
Slope below D Portal Bench

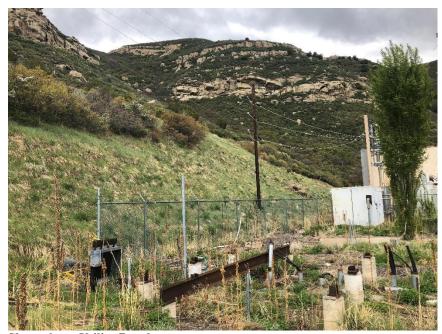
Slope above Utility Bench

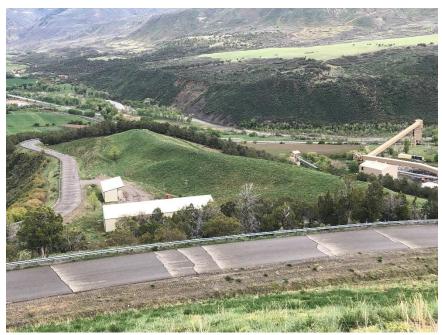
Topsoil stockpiles appeared to be stable.

Topsoil Stockpile A

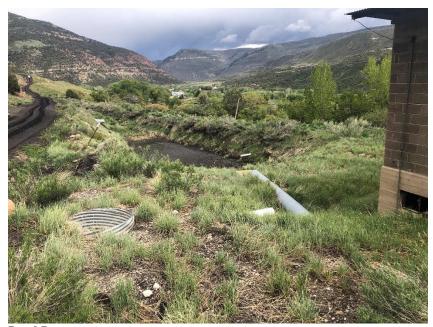
Pond D

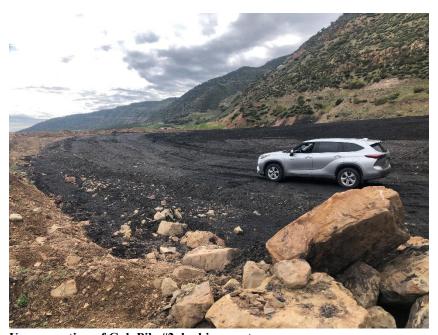
Upper portion of Gob Pile #2, looking west

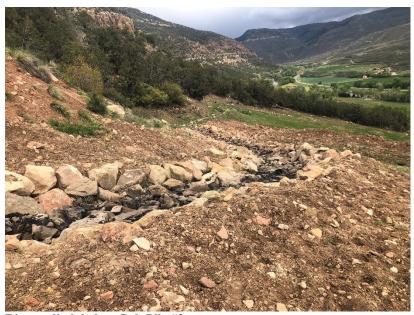
Riprap ditch below Gob Pile #2

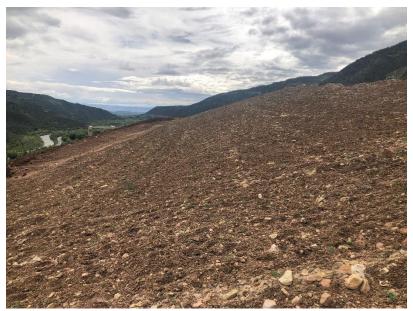
Recently reclaimed portion of Gob Pile #2, looking west
