Inspection report for C1981-038

Permit Number: C-1981-038 Mine Name: Bowie No. 1 Mine Operator: Bowie Resources, LLC Operator Address: Mr. Art Etter P.O. Box 1488 Paonia, CO 81428	County: Delta Operation Type: Underground Permit Status: Active Ownership: Private
	Operator Representative Present: Art Etter in office
Operator Representative Signature: (Field Issuance Only)

Inspection Start Date: May 6, 2025 Inspection Start Time: 10:30 Inspection End Date: May 6, 2025 Inspection End Time: 14:00		Inspection Type: Coal Complete Inspection Inspection Reason: Normal I&E Program Weather: Cloudy	
Joint Inspection Agency: None		Joint Inspection Contacts: 	
Post Inspection Agency: None		Post Inspection Contacts: 	
Inspector(s): Robert Zuber, P.E.	Inspector's Signature:

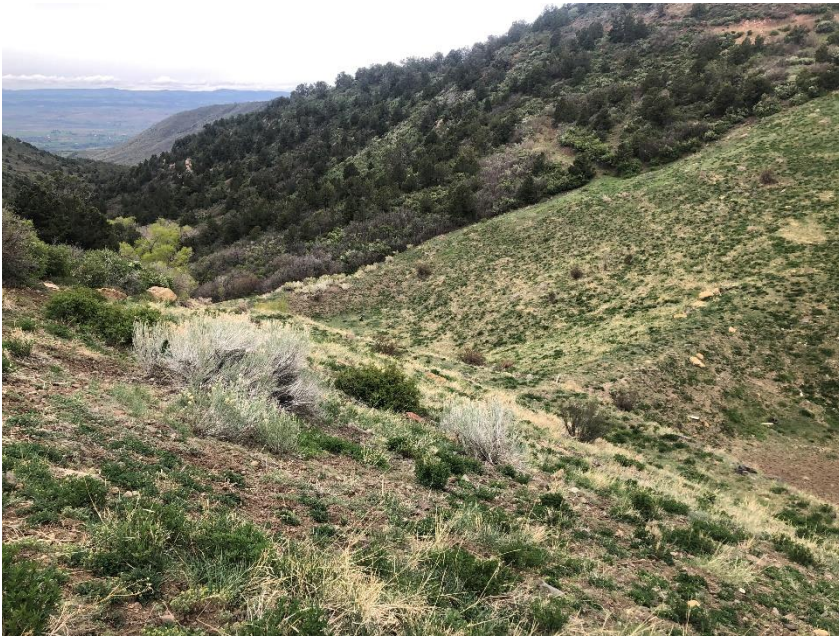
The ponds contained no water. This includes the ponds at the loadout and the Coal Storage Area (near Highway 133) and the ponds at the West Mine. No discharge was observed. No problems were identified with embankments, spillways, or other aspects of these ponds.

Pond W-1 at West Mine

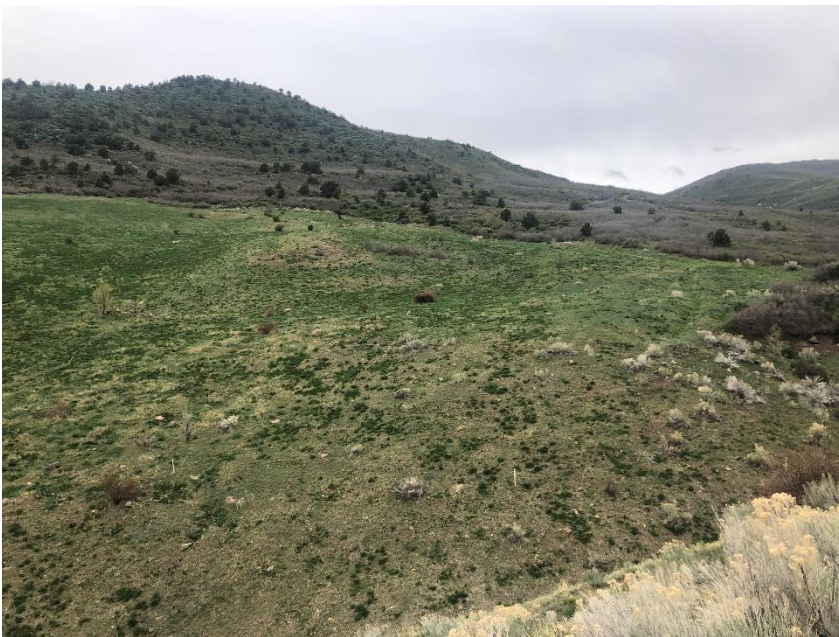
No erosion was seen at the reclaimed areas of the West Mine, including the reclaimed road.

Northern portion of West Mine

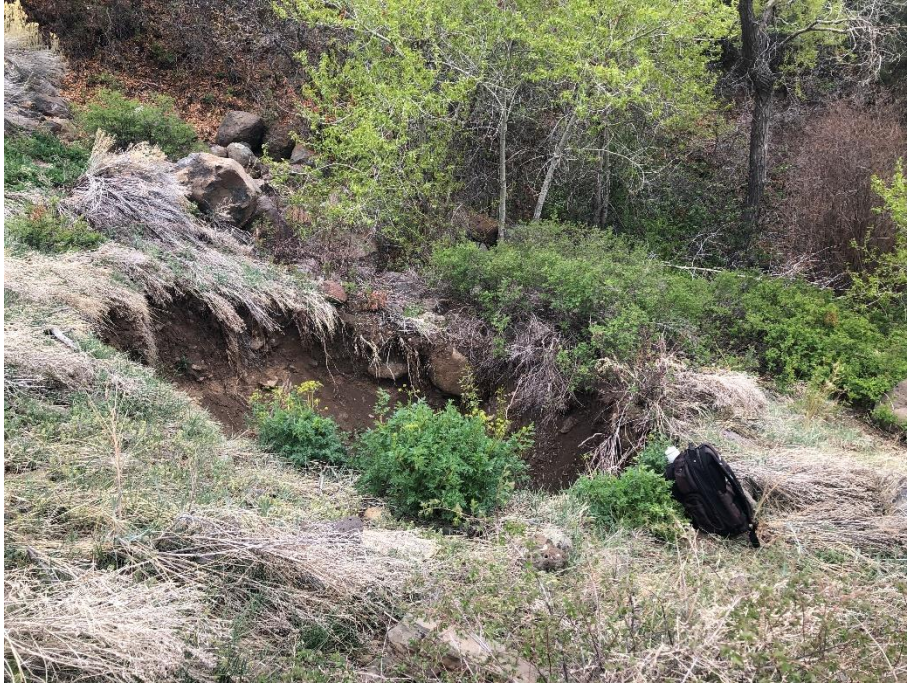
The large culvert under the West Mine was functioning, and the water was approximately 18 inches deep at the lower end. However, a sinkhole was seen above the lower portion of this culvert. This hole is close to the toe of the embankment of the W-1 pond (the lower pond at the West Mine) and approximately 100 feet below the crest of the embankment. The sinkhole was approximately 15 to 20 feet in diameter and approximately 10 to 20 feet deep. BRL should try to address this issue in 2025, preferably by completing the West Mine reclamation. If permitting or other issues delay the project, the issue should be addressed in 2026. In the short term, BRL should consider some mitigation to prevent the hole from getting worse and to protect wildlife from this hazard.

Sinkhole near lower end of large culvert at West Mine

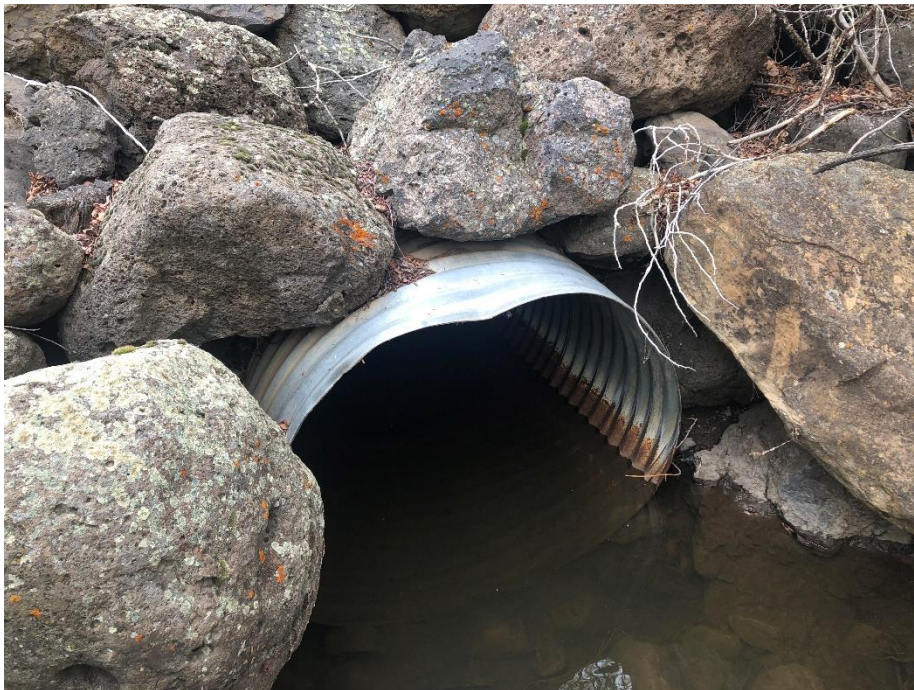
Lower end of large culvert at West Mine (East Roatcap Creek)

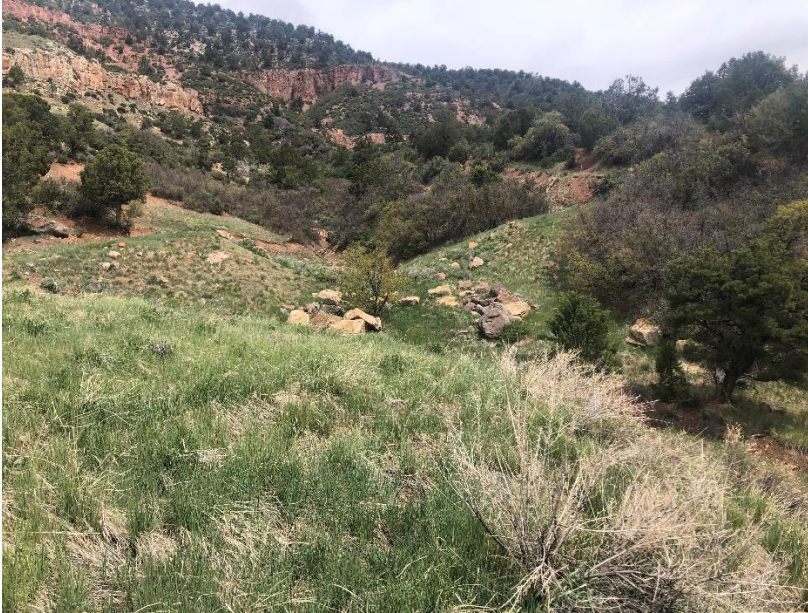
No problems were identified with the reclamation in the area of Ponds 1, 2, 3, and 4 (East Mine).

Reclaimed Pond 1 at East Mine, looking upstream

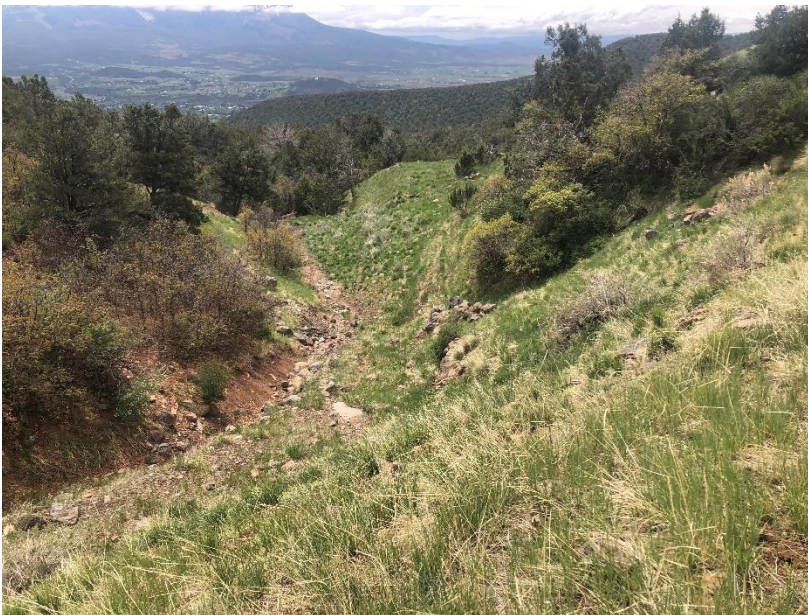
Reclaimed Pond 2 at East Mine, looking downstream

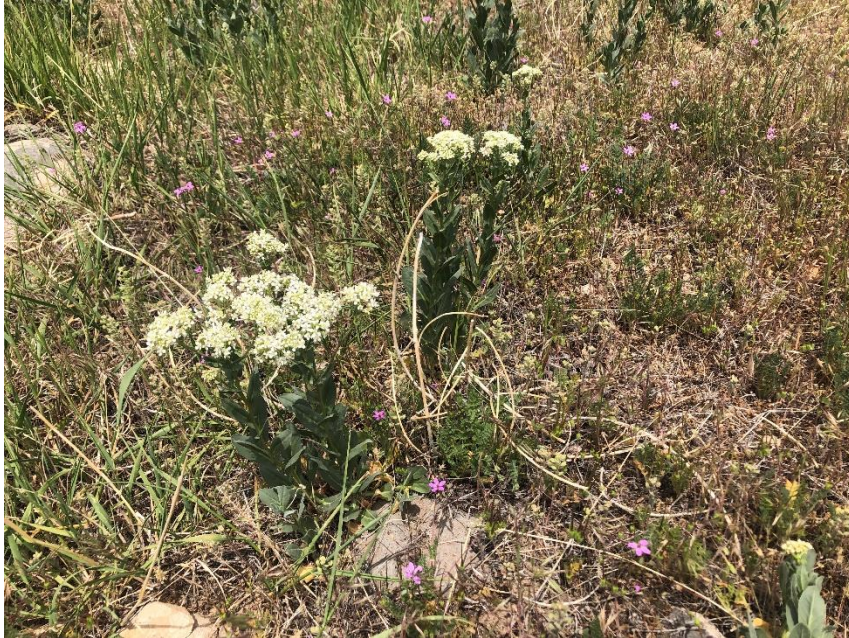
Whitetop, aka hoary cress, was seen at the Coal Storage Area beside Highway 133 and the loadout pond. This invasive plant is a “B List” species, per the Colorado Weed Management Association. Also, there was considerable cheat grass at the Coal Storage Area by the highway. No other weed problems were observed at any of the locations that were inspected. These areas include the West Mine (the area that has not been released), the reclaimed ponds at the East Mine, the Coal Storage Area by the highway, and the loadout.

Whitetop at Coal Storage by Highway

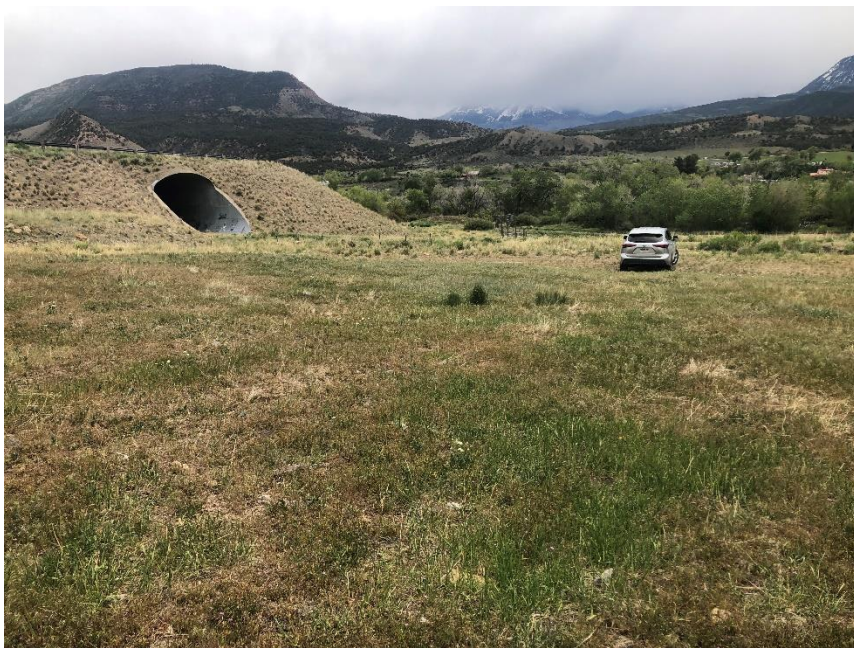
No erosion or other problems were seen with the Coal Storage Area beside Highway 133.

Coal Storage by Highway

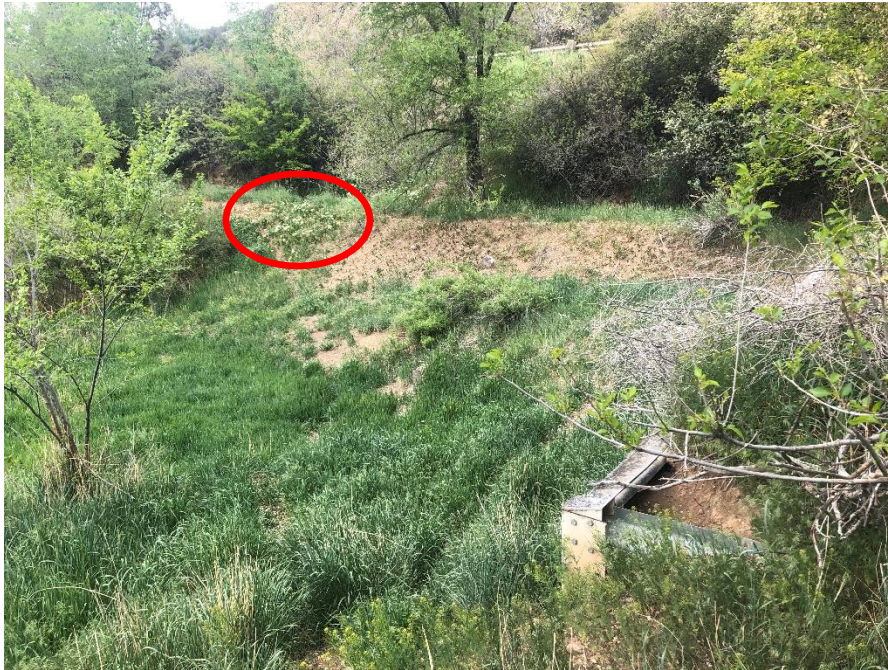
Pond at loadout – note whitetop in circle

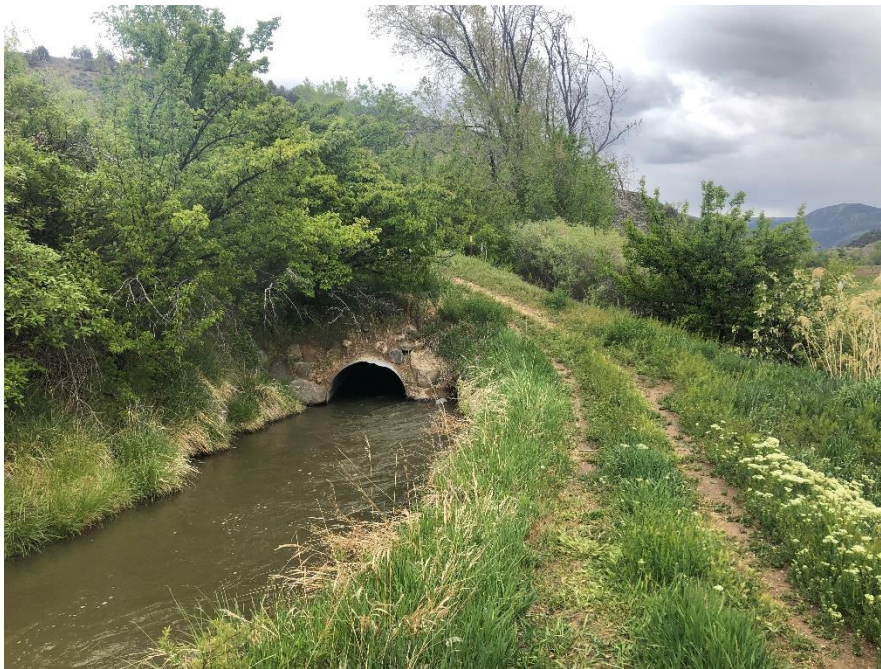
No problems were identified with the large culvert (that carries the Farmers Ditch) or the other ditches and culverts at the loadout. The Farmers Ditch was flowing about half full in the culvert.

Lower end of large culvert at loadout (Farmers Ditch)
