**MINERALS PROGRAM INSPECTION REPORT**  
**PHONE: (303) 866-3567**

<b>MINE NAME:</b> Rollins-Clapper Pit.	<b>MINE/PROSPECTING ID#:</b> M-2025-018	<b>MINERAL:</b> Aggregate	<b>COUNTY:</b> Kit Carson
<b>INSPECTION TYPE:</b> Preoperation Inspection	<b>WEATHER:</b> Raining	<b>INSP. DATE:</b> May 6, 2025	<b>INSP. TIME:</b> 11:00
<b>OPERATOR:</b> Rollins Construction and Trucking LLC	<b>OPERATOR REPRESENTATIVE:</b>	<b>TYPE OF OPERATION:</b> 110c - Construction Limited Impact	
<b>REASON FOR INSPECTION:</b> Preoperation Inspection	<b>BOND CALCULATION TYPE:</b>	<b>BOND AMOUNT:</b>	
<b>DATE OF COMPLAINT:</b> NA	<b>POST INSP. CONTACTS:</b> None	<b>JOINT INSP. AGENCY:</b> None	
<b>INSPECTOR(S):</b> Ben Hammar	<b>INSPECTOR'S SIGNATURE:</b>

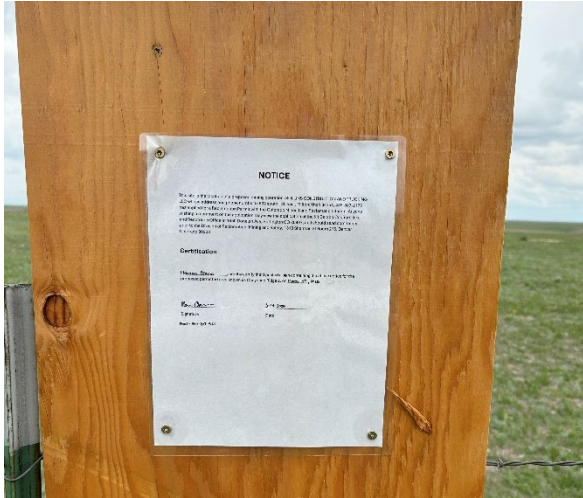
Regarding the posted notice sign, the sign was observed during this inspection and was found to be in compliance with all Division requirements.

Photo 1: Posted notice sign.

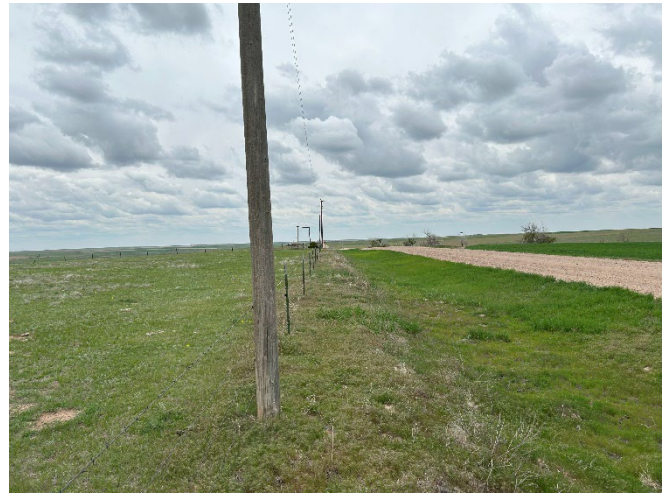
Regarding structures found within 200 feet, two significant structures were found within 200 feet of the permit boundary during this inspection. A fence was found, which the DRMS notice was posted on. In addition, a transmission line runs parallel to the fence. Please provide structure agreement or similar documentation as mentioned in the associated adequacy letter.

Photo 2: Nearby transmission lines and fenceposts.

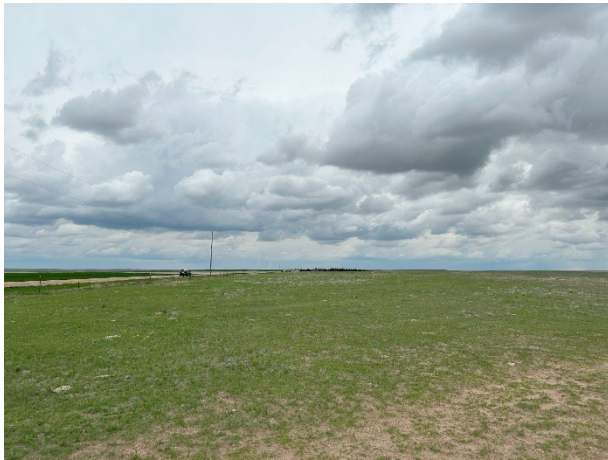
No significant hydrological features were observed near the permit boundary, and no other issues were found with the site during this inspection. No bond has been calculated at this time, and a reclamation bond will be calculated by the Division following a response to the first adequacy letter for this site.

Photo 3: Pre-mining site conditions.
