Re: M-1977-573 - West Pueblo Pit – TR07 Request Letter

The Arkansas Groundwater and Reservoir Association (“AGRA”), permit holder of active permit M-1977-573 (the Permit), would like to submit this letter to you requesting from the Division of Reclamation, Mining, and Safety (DRMS) a Technical Revision (TR) to the existing mine reclamation plan currently approved for the Permit and the West Pueblo Pit (Pit).

UPDATED RECLAMATION PLAN MAP FOR M1977-573 - TR07

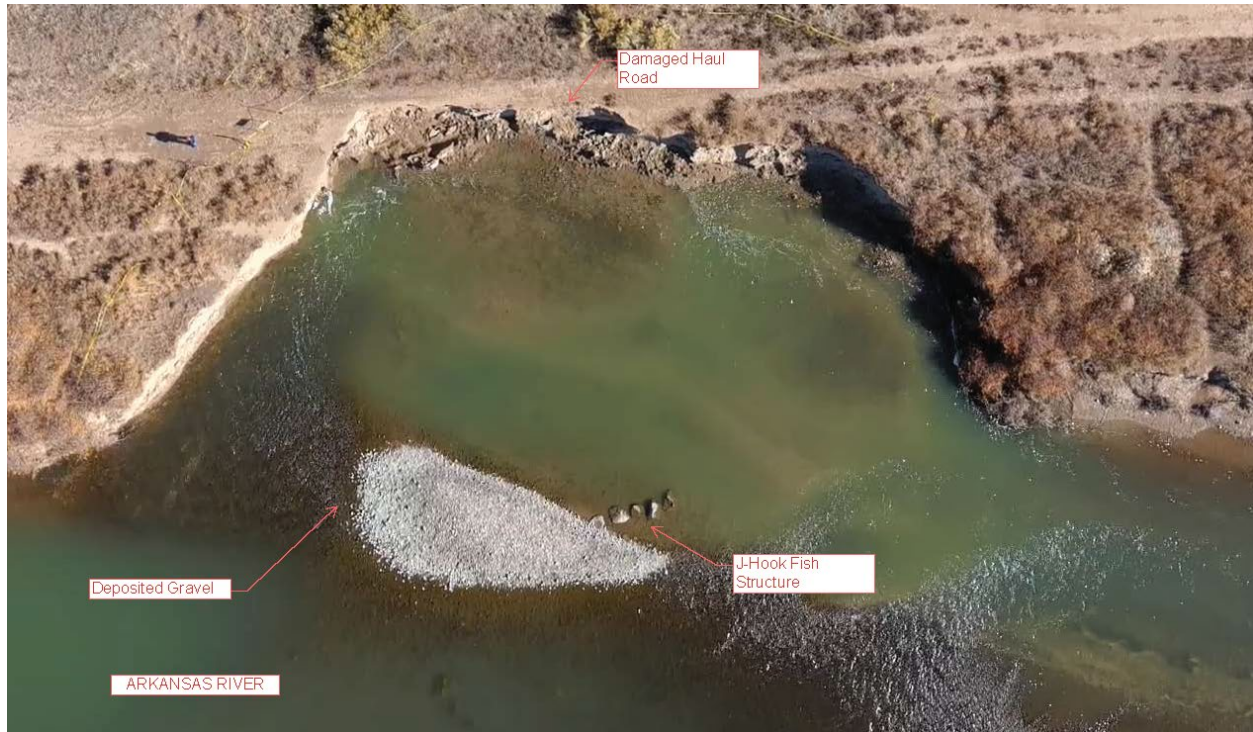
The second issue addressed by this TR is a section of localized scour along the Arkansas River at the western property boundary. The river has created a large scour hole as the result of a malfunctioning rock fish structure placed in the river near the river’s edge. AGRA and Colorado Parks and Wildlife (CPW), the two property owners affected by this erosion, have been collaborating on a solution to this problem. This solution consists of slope grading and riprap placement to protect against further erosion.

Figure 2 below shows an overview of the scour hole and shows the cause of the erosion and the damage that has been sustained on AGRA's property as a result.

Figure 2. Overview of The Scour Hole at West Pueblo Pit, Showing Cause of Erosion and Damaged Areas.

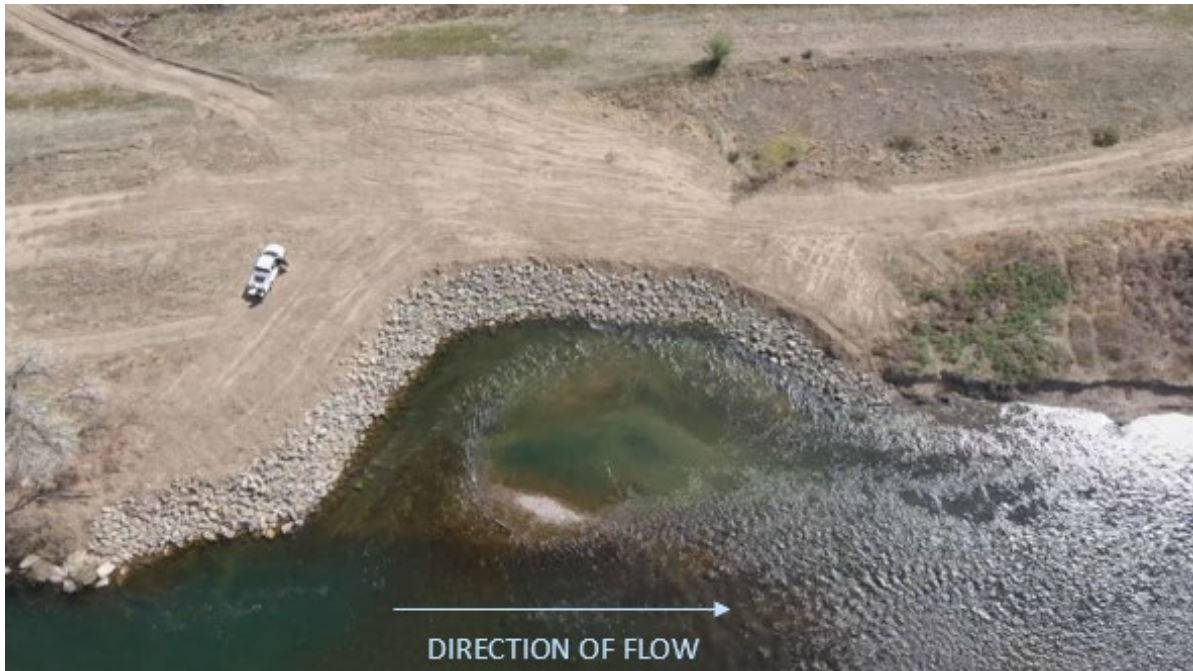
Figure 5. An Overview of Completed Bank Repairs at the West Pueblo Pit, April 25th, 2025.
