**MINERALS PROGRAM INSPECTION REPORT**  
**PHONE: (303) 866-3567**

| <b>MINE NAME:</b><br>Henderson Mine | <b>MINE/PROSPECTING ID#:</b><br>M-1977-342 | <b>MINERAL:</b><br>Molybdenum | <b>COUNTY:</b><br>Clear Creek |
| <b>INSPECTION TYPE:</b><br>Monitoring | <b>WEATHER:</b><br>Cloudy | <b>INSP. DATE:</b><br>April 28, 2025 | <b>INSP. TIME:</b><br>09:37 |

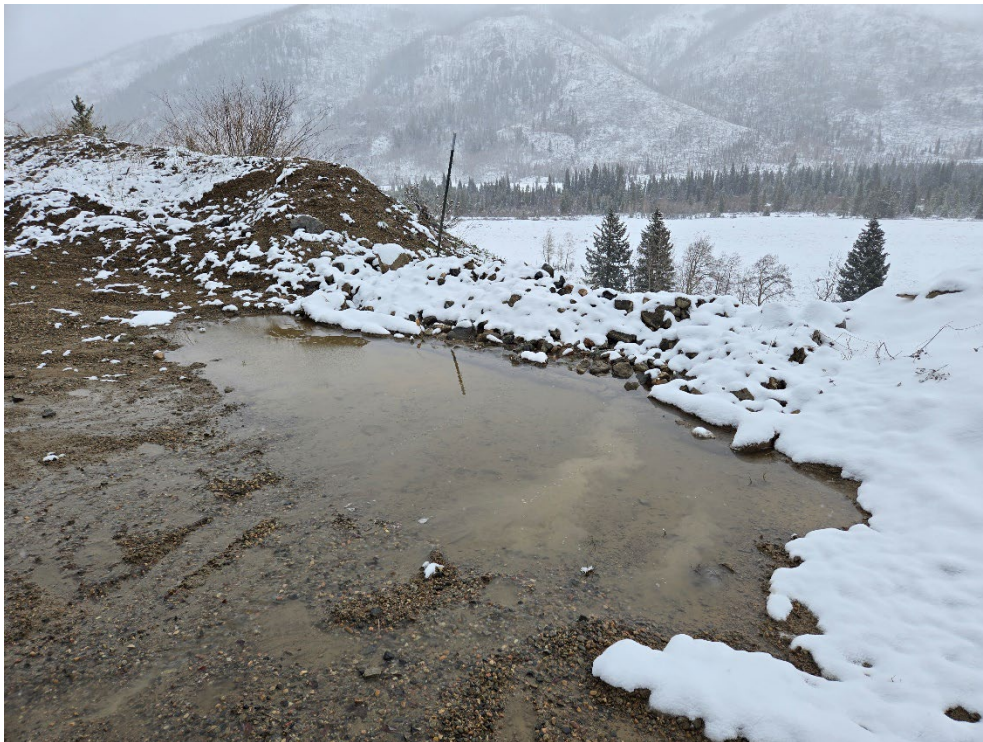
**OF-M11** (Photo 1) - The outfall for OF-M11 was under snow and the sign was missing. The BMP is located uphill and to the west of the outfall location and consists of wattles in front of a rock check dam leading to a rip-rap outfall. The BMP's location on the SWMP map is north of where it is actually located. The Division observed water moving through this structure during the inspection. This outfall location appeared to be in good condition.

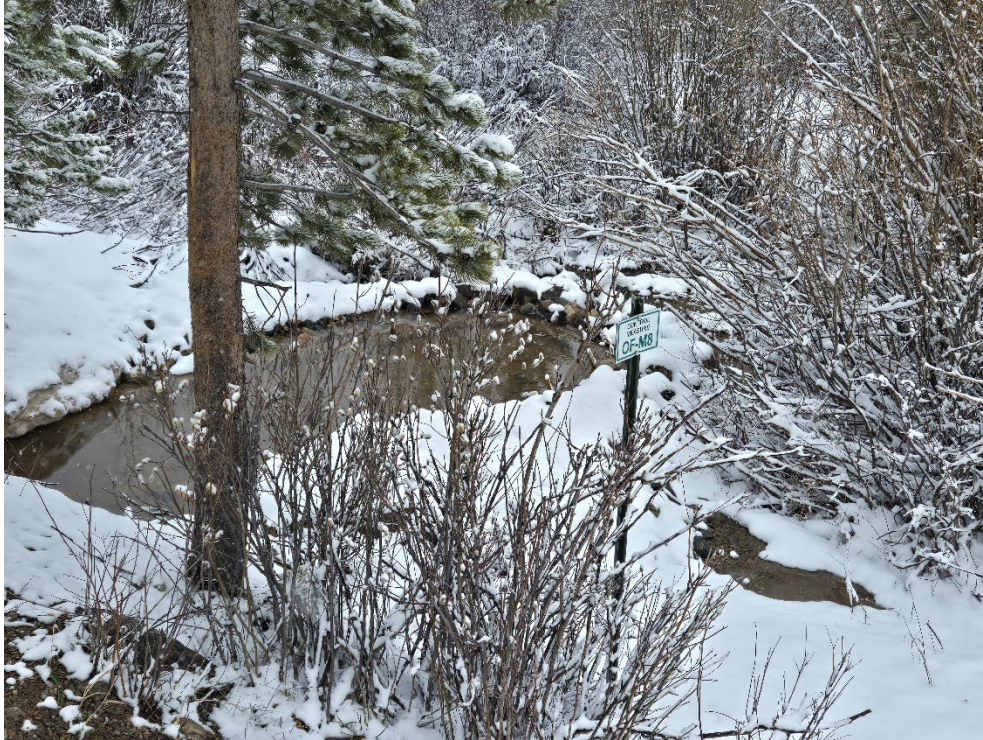
**OF-M08 (Photo 2)** - The BMP for this outfall location consists of rip-rap that directs stormwater into a drainage pipe that discharges stormwater north of this location. The settling basin held water at the time of the inspection. The rip-rap was partially covered with snow but appeared to be in good condition.

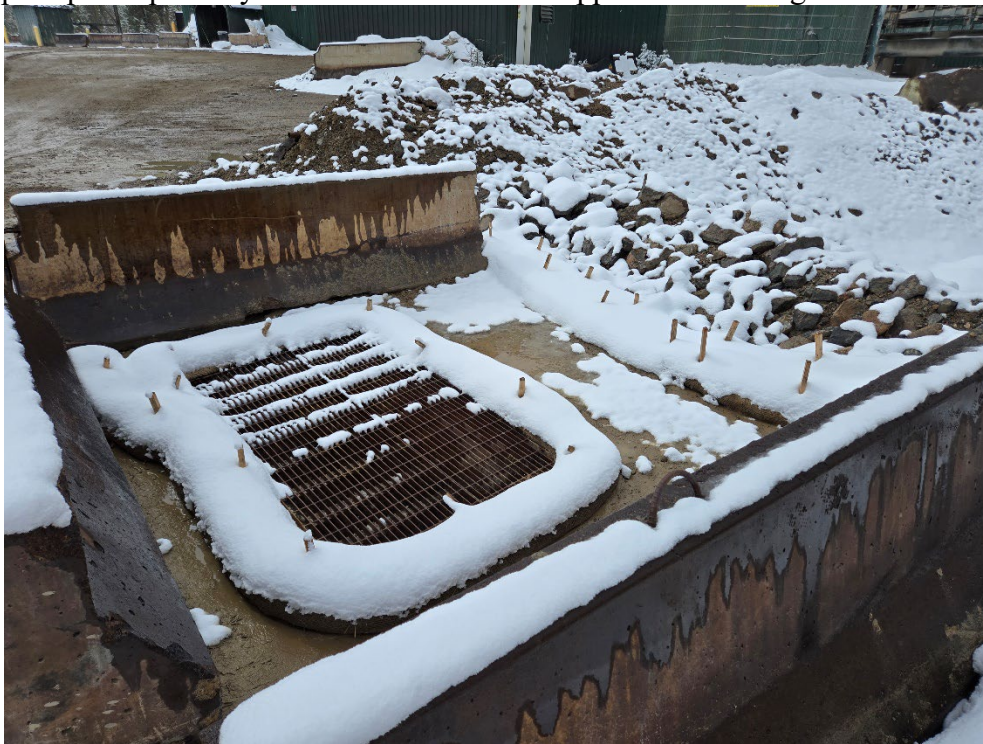
**Collection basin for OF-M08 (Photo 3)** – Uphill from the OF-M08 outfall, there is a collection basin near the turn-around for the conveyor belt that drains to the outfall. The collection basin, straw wattles, and surrounding rip-rap appeared to be in good condition.

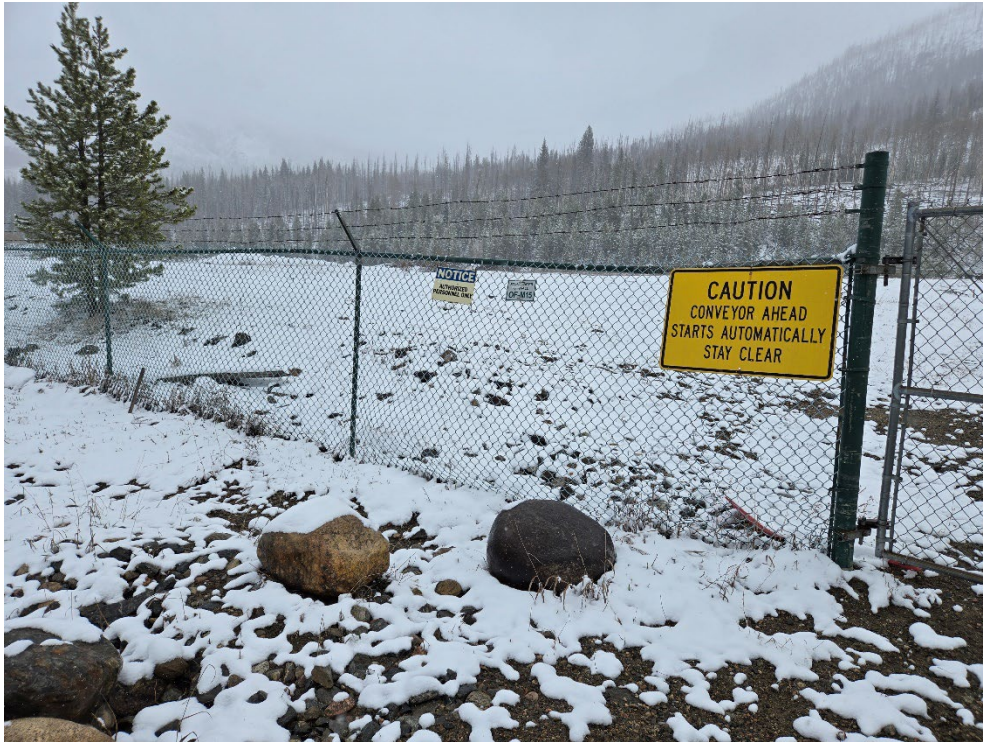
**OF-M15** (Photo 4) – There is no channelized flow leading to OF-M15. Instead, this area generally experiences sheet flow when run-off does occur. The BMPs of this outfall location consist of riprap. This outfall was mostly covered in snow but appeared to be in good condition.

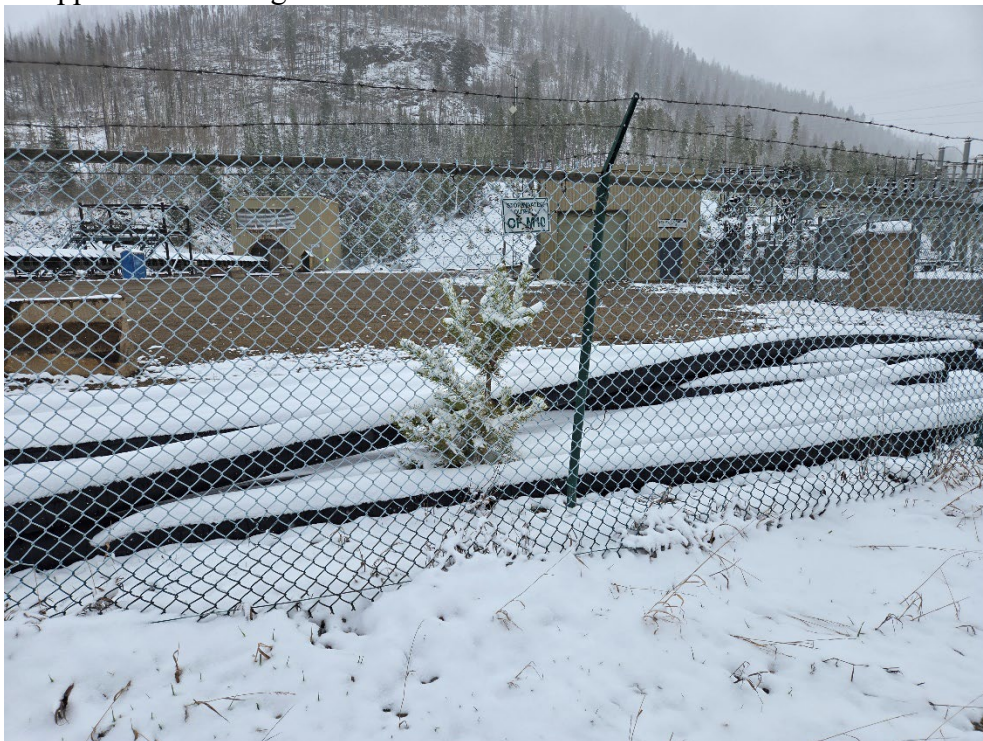
**OF-M10** (Photo 5) – This is a low spot near the lay down yard where water may accumulate. However, this outfall does not experience a lot of flow. The BMPs of this outfall location consist of riprap, which was covered with snow at the time of inspection.

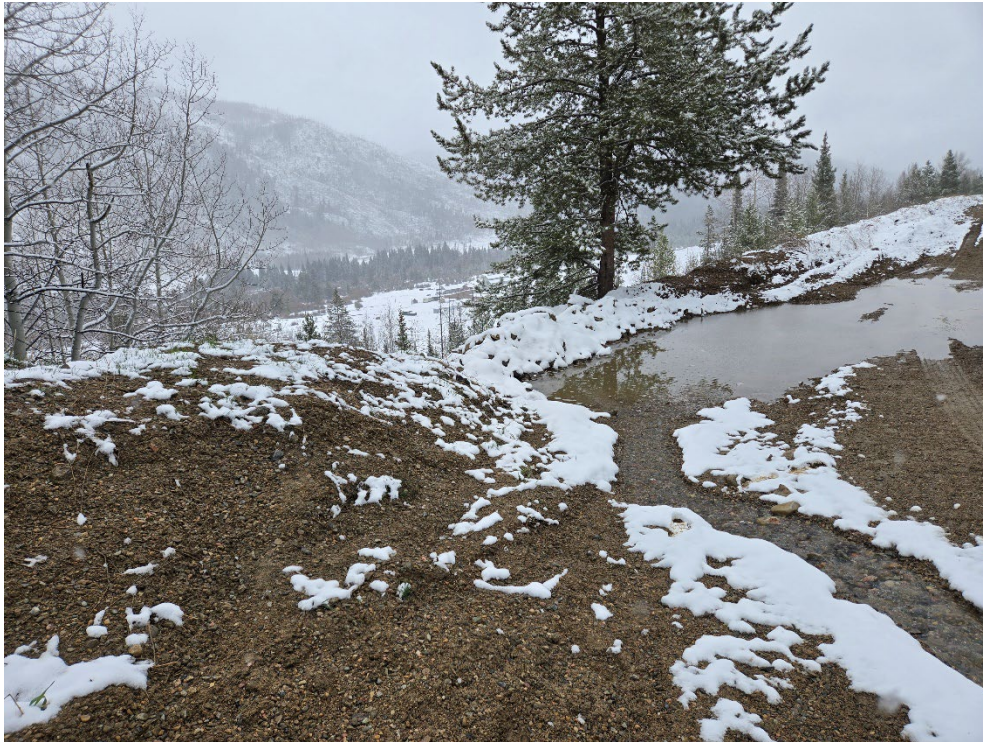
**OF-M07** (Photo 6) - The BMPs of this outfall location consist of wattles in front of a rock check dam leading to a rip-rap outfall. The Division observed water moving through this structure during the inspection. The wattles were covered in snow and it was difficult to assess their condition, but this outfall location appeared to be working well.

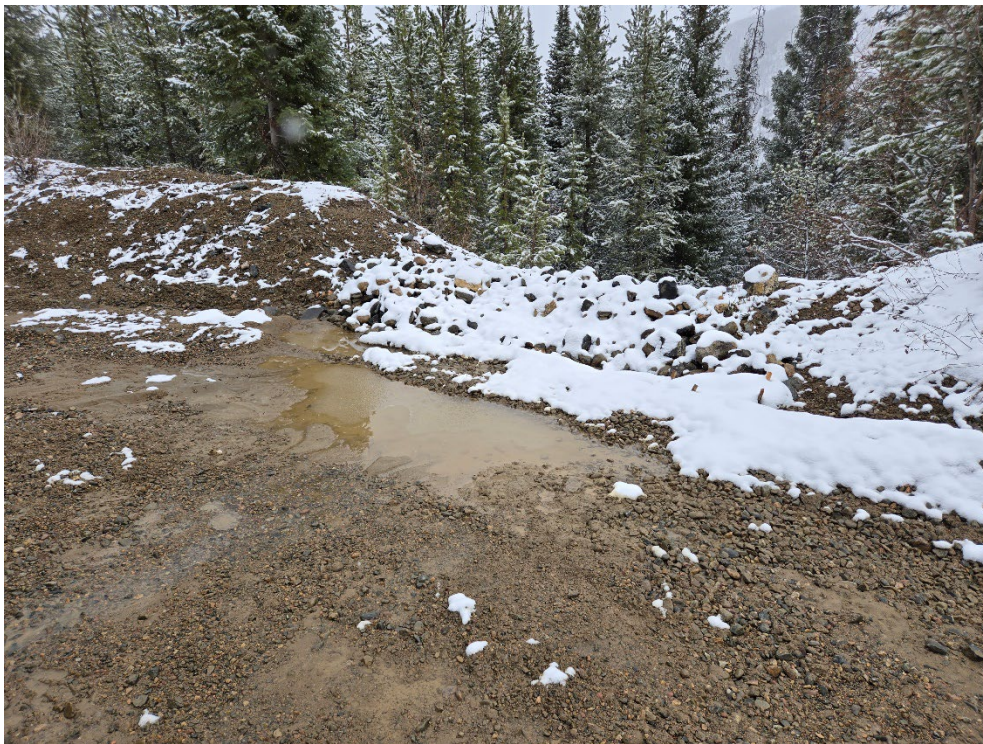
**OF-M12** (Photo 7) - The BMPs of this outfall location consist of wattles in front of a rock check dam leading to a rip-rap outfall. The Division observed water moving through this structure during the inspection. This outfall location appears to be in good condition.

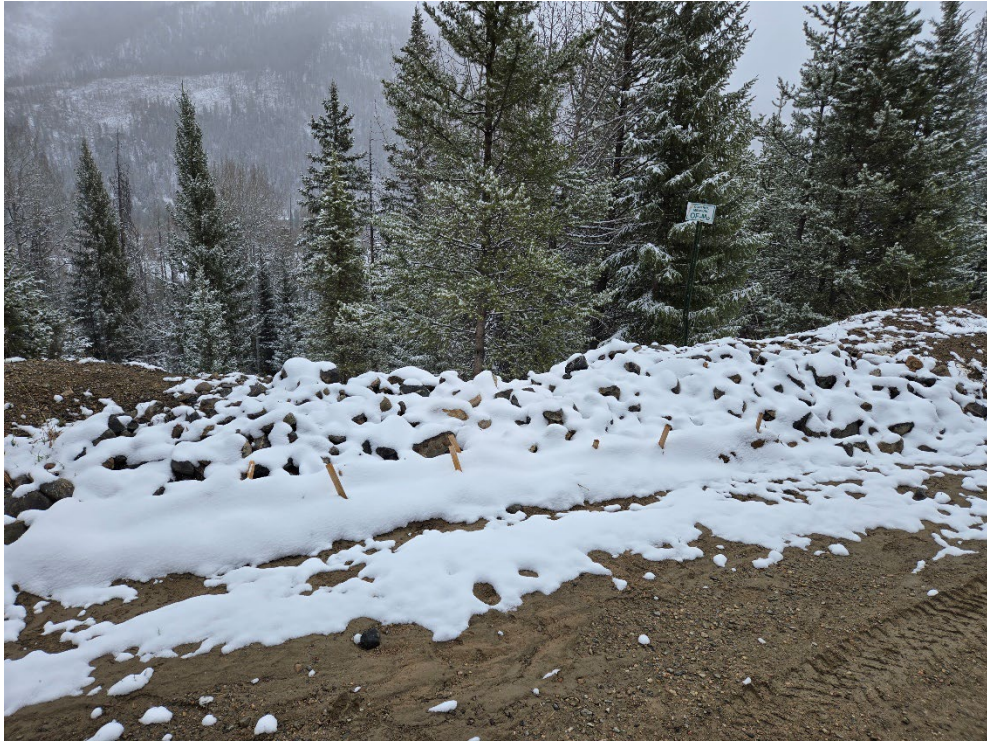
**OF-M06 (Photo 8)** - The BMPs of this outfall location consist of wattles in front of a rock check dam leading to a rip-rap outfall. No water was observed moving through this structure during the inspection. This outfall location appears to be in good condition. The sign was damaged, but the Operator has already ordered new signs.

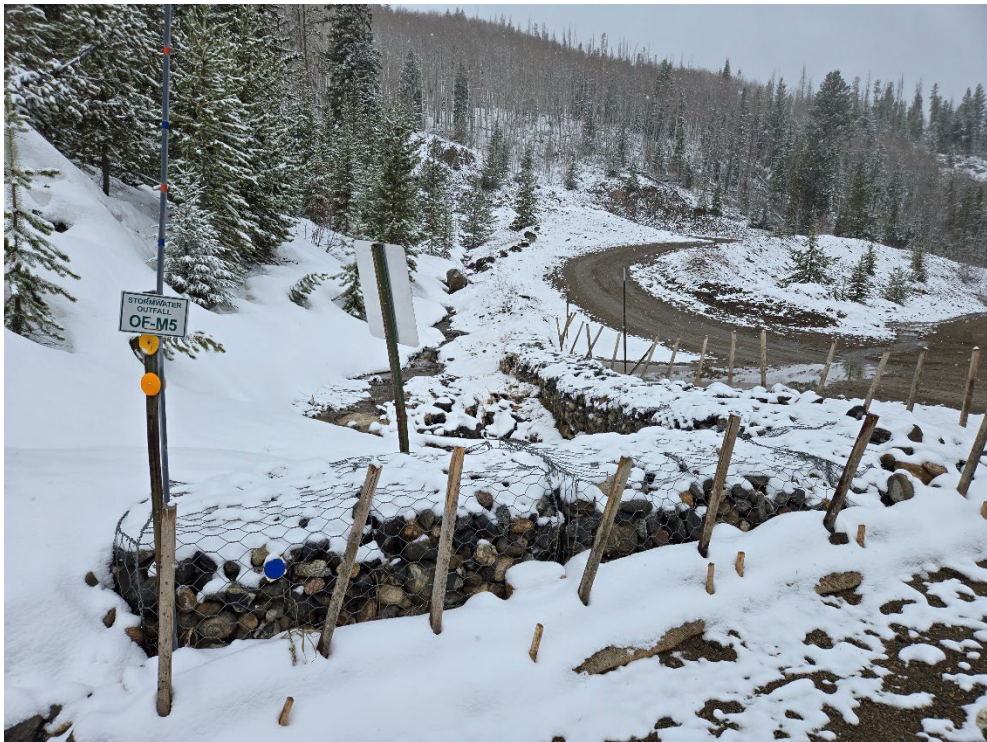
**OF-M05 (Photo 9)** - The BMPs of this outfall location consist of wattles in front of a rock check dam. Stormwater that goes through this structure converges with clean water coming from the south. Water then

enters a grate and is discharged up north. The grate was covered with snow at the time of inspection. The settling area where water accumulates on the north side of the structure held water at the time of the inspection.

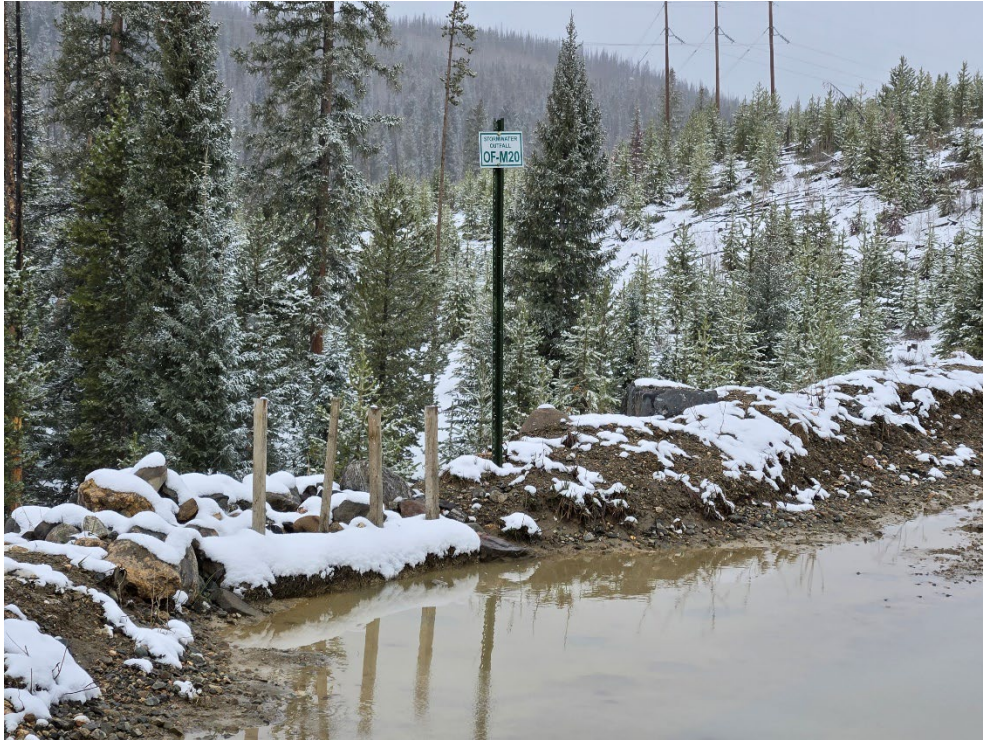
**OF-M20** (Photo 10) - The BMPs of this outfall location consist of wattles in front of a rock check dam leading to a rip-rap outfall. The Division observed water moving through this structure during the inspection. This outfall location appears to be in good condition.

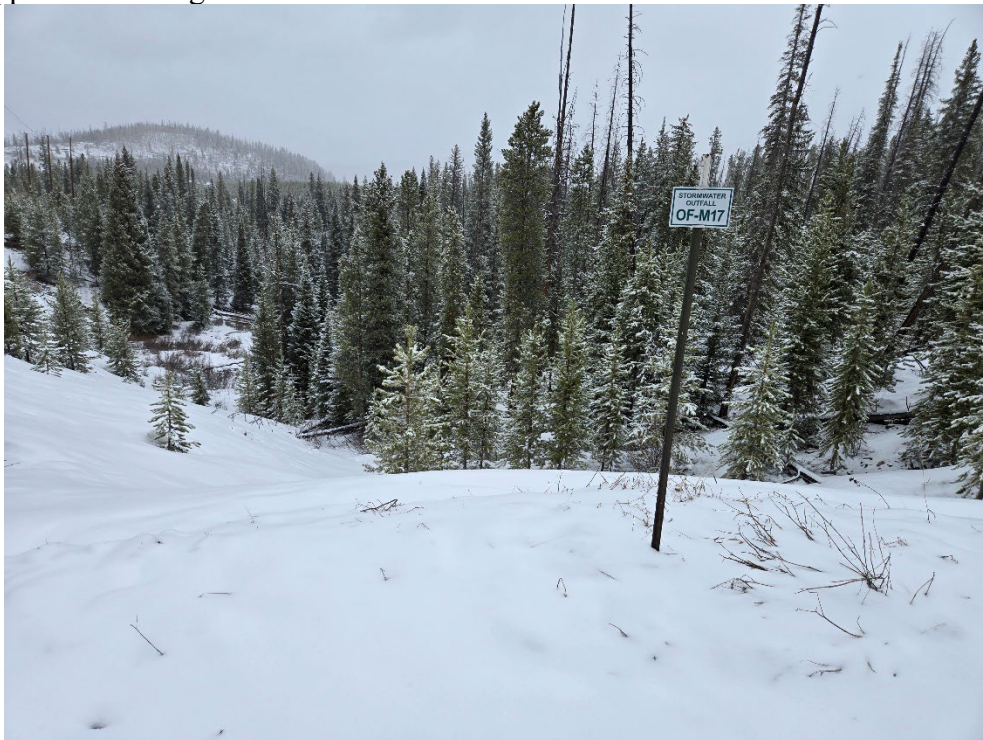
**OF-M17** (Photo 11) - The BMP at this outfall location consisted of riprap, which was covered with snow at the time of inspection. The Operator stated that this outfall does not experience much flow.

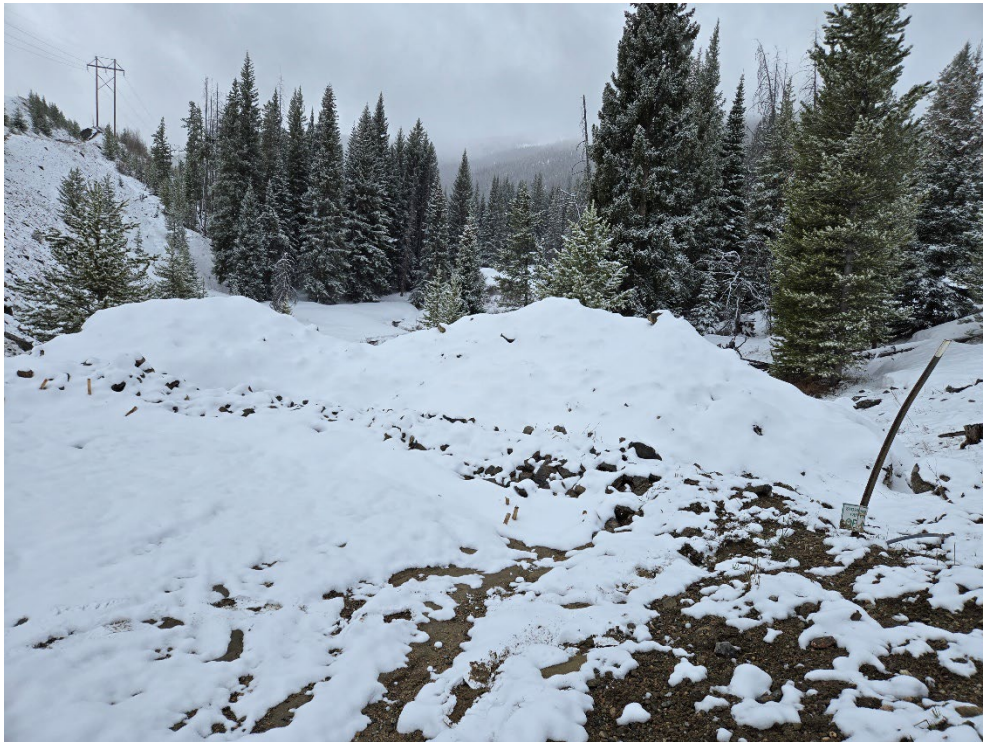
**OF-M04** (Photo 12) The BMPs of this outfall location consist of wattles in front of a rock check dam leading to a rip-rap outfall. These structures were covered in snow at the time of inspection. The sign had fallen off the post.

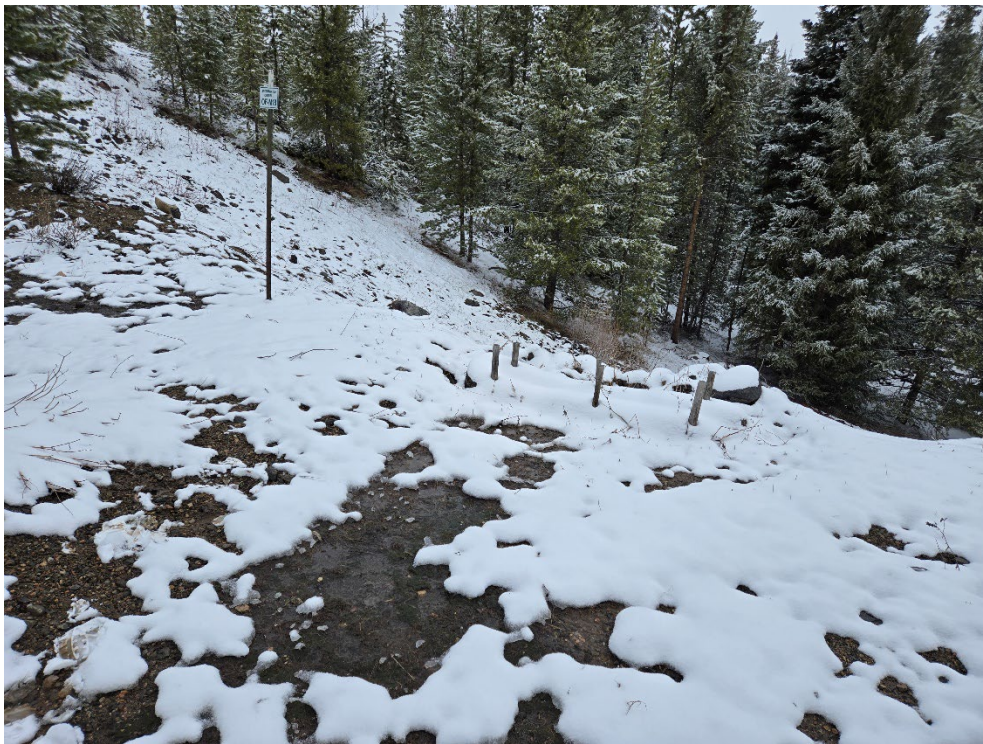
**OF-M18** (Photo 13) - The BMP at this outfall location consisted of riprap, which was covered with snow at the time of inspection. The Operator stated that this outfall does not experience much flow.

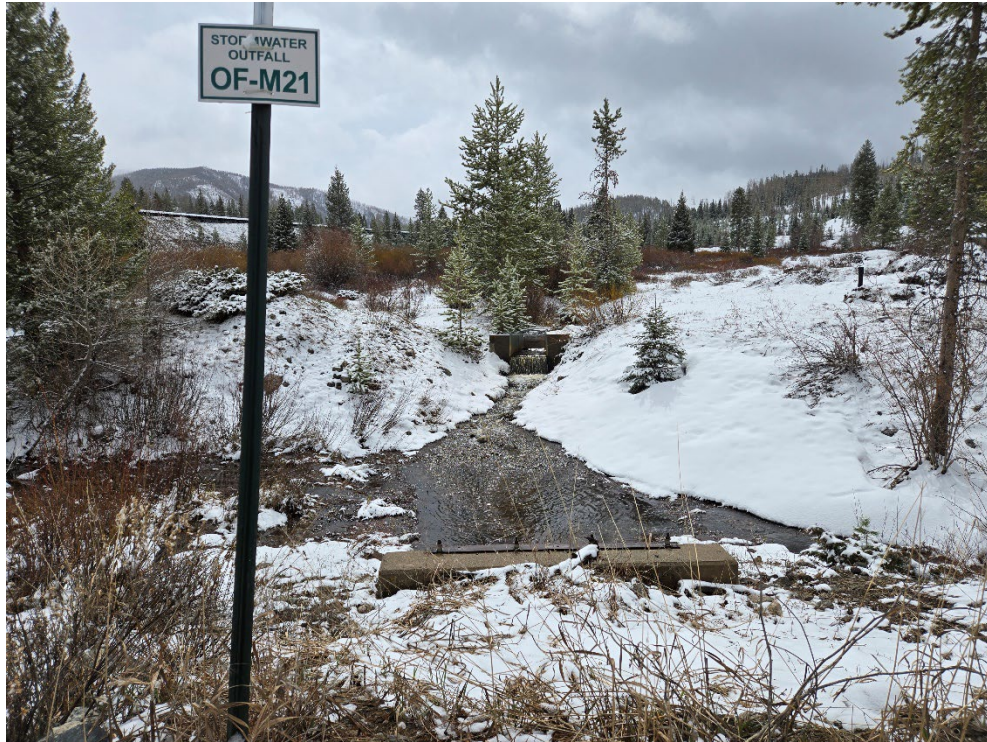
**OF-M21** (Photo 14) - The BMPs of this outfall location consist of wattles in front of a rock check dam leading to a rip-rap outfall. This outfall location appears to be in good condition. This outfall is located west of what is depicted on the SWMP maps.

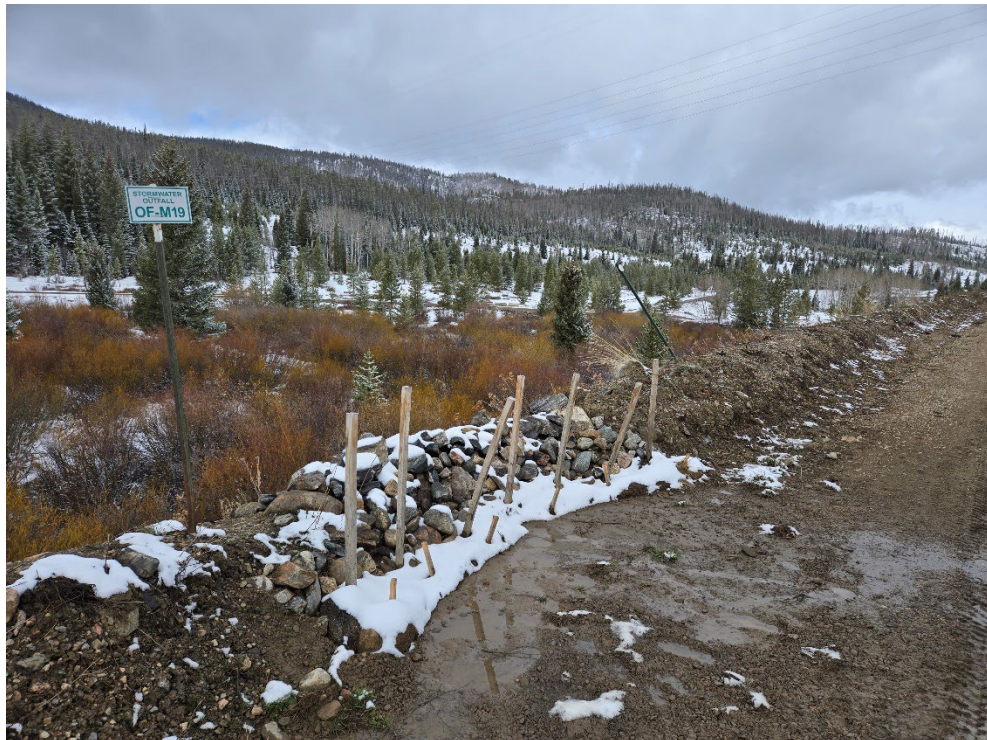
**OF-M19** (Photo 15) - The BMPs of this outfall location consist of wattles in front of a rock check dam leading to a rip-rap outfall. This outfall location appears to be in good condition.

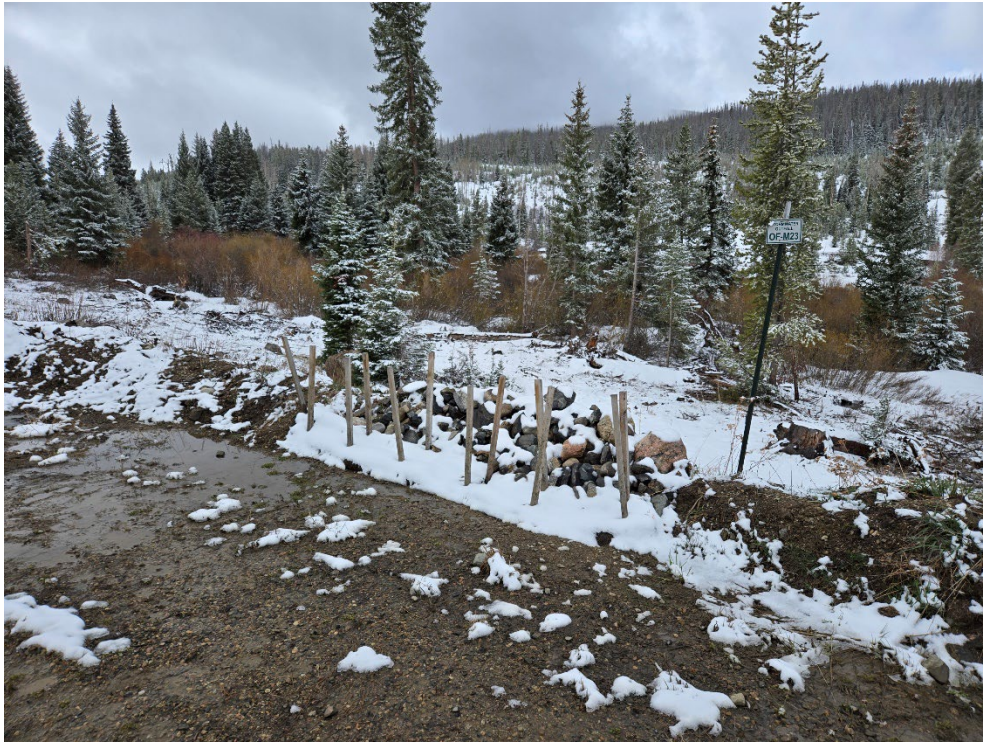
**OF-M23** (Photo 16) - The BMPs of this outfall location consist of wattles in front of a rock check dam leading to a rip-rap outfall. This outfall has a small drainage collection area and was not holding a lot of water or excess sediment at the time of the inspection. Some water appeared to be pooling on the sides of the wattles and rock check dam, but the structure appears to be working well.

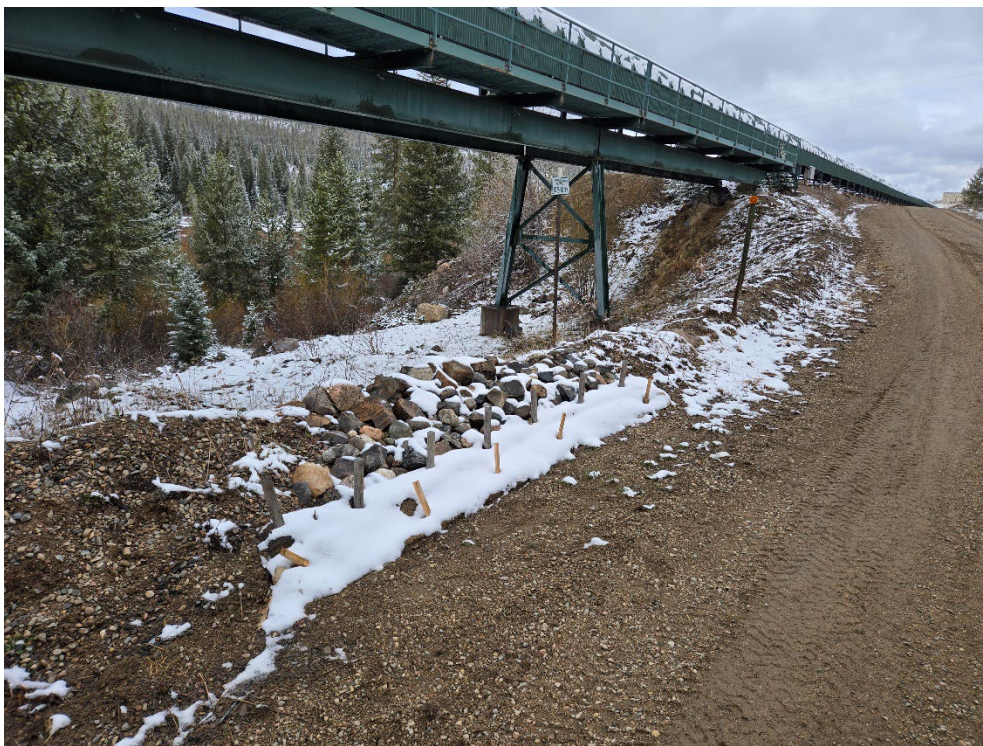
**OF-M31** (Photo 17) - The BMPs of this outfall location consist of wattles in front of a rock check dam leading to a rip-rap outfall. No water was moving through this structure during the inspection. The Operator stated that this outfall does not experience a lot of flow. This outfall location appears to be in good condition.

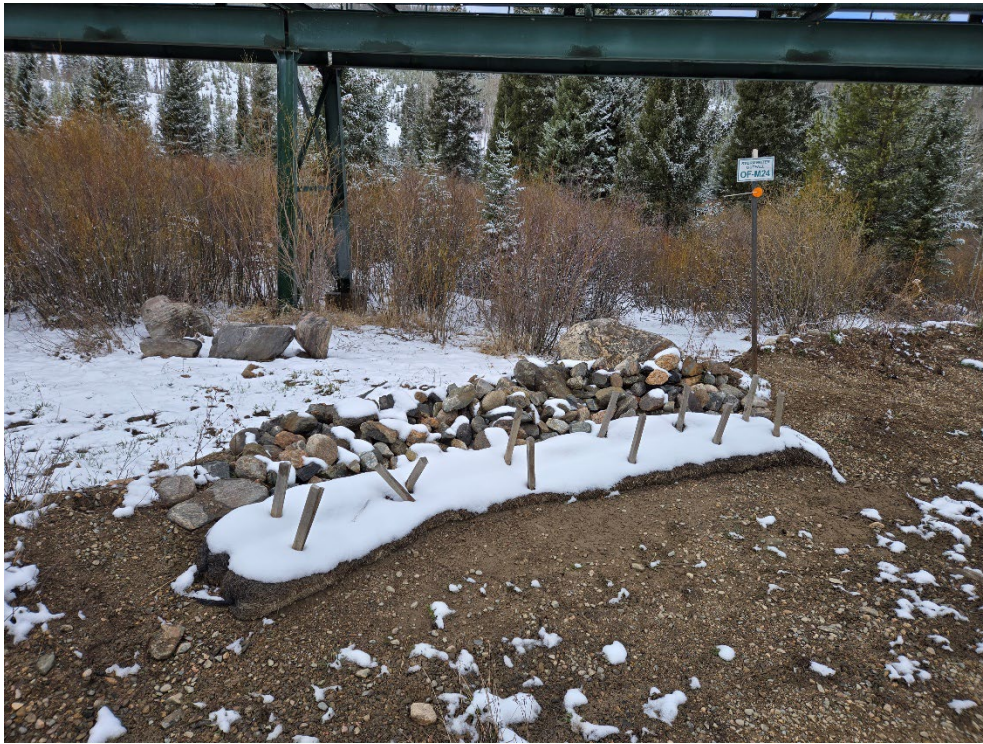
**OF-M24** (Photo 18) - The BMPs of this outfall location consist of wattles in front of a rock check dam leading to a rip-rap outfall. This outfall collects drainage from the north side of the road, but it does not appear that it had experienced much runoff recently. This outfall location appears to be in good condition.

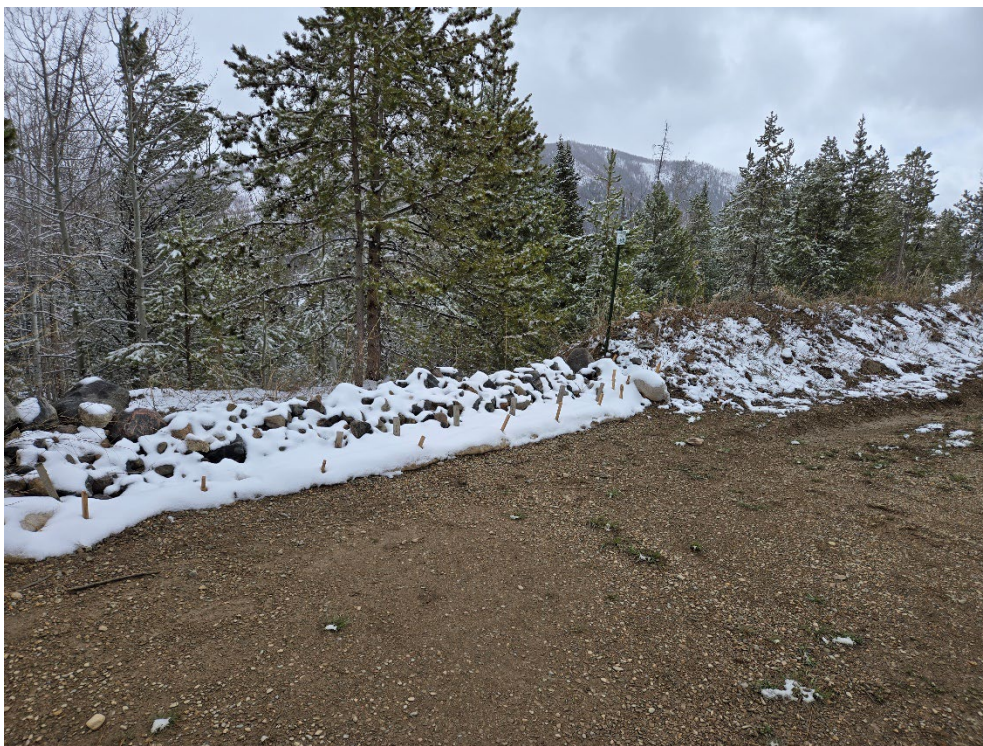
**OF-M30** (Photo 19) - The BMPs of this outfall location consist of wattles in front of a rock check dam leading to a rip-rap outfall. This outfall collects drainage from the northwest lay down area areas and the southeast side of the road. However, the area did not hold water or excess sediment at the time of the inspection. This outfall

location appears to be in good condition.

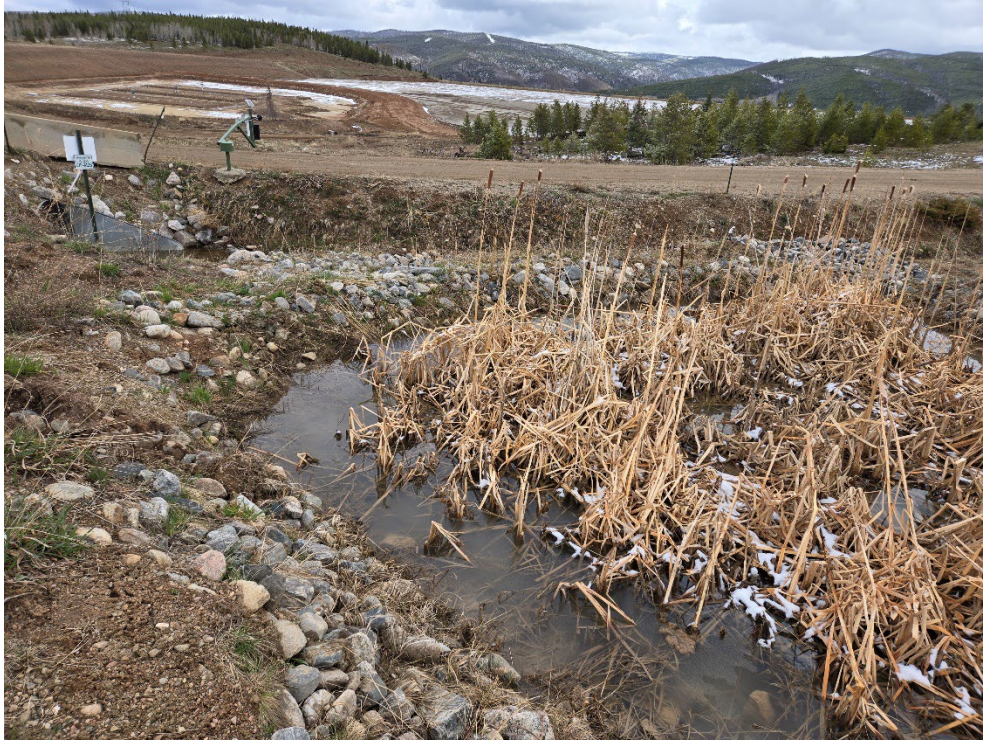
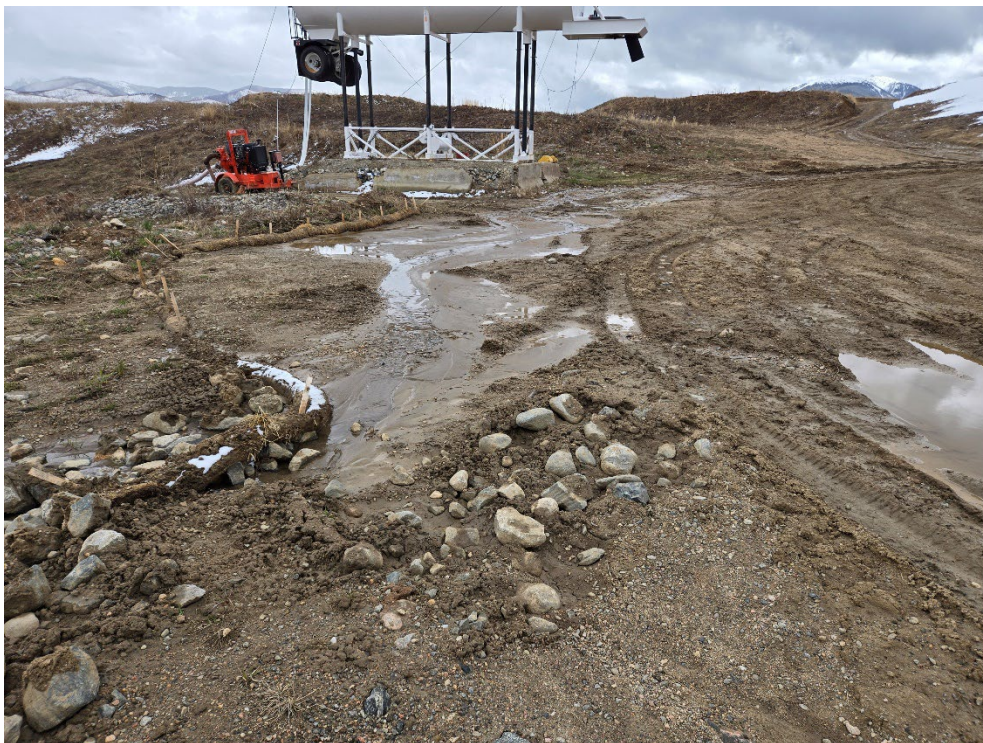
**OF-M26** (Photo 20) (Top)- The BMPs of this outfall location consist of riprap, and a settling basin. The basin held water at the time of the inspection but was not discharging. (Bottom) Straw wattles line the side of the road, collecting drainage from the topsoil piles, and directing it to OF-M26. The straw wattles will need to be replaced during the Operator's Spring stormwater inspections.

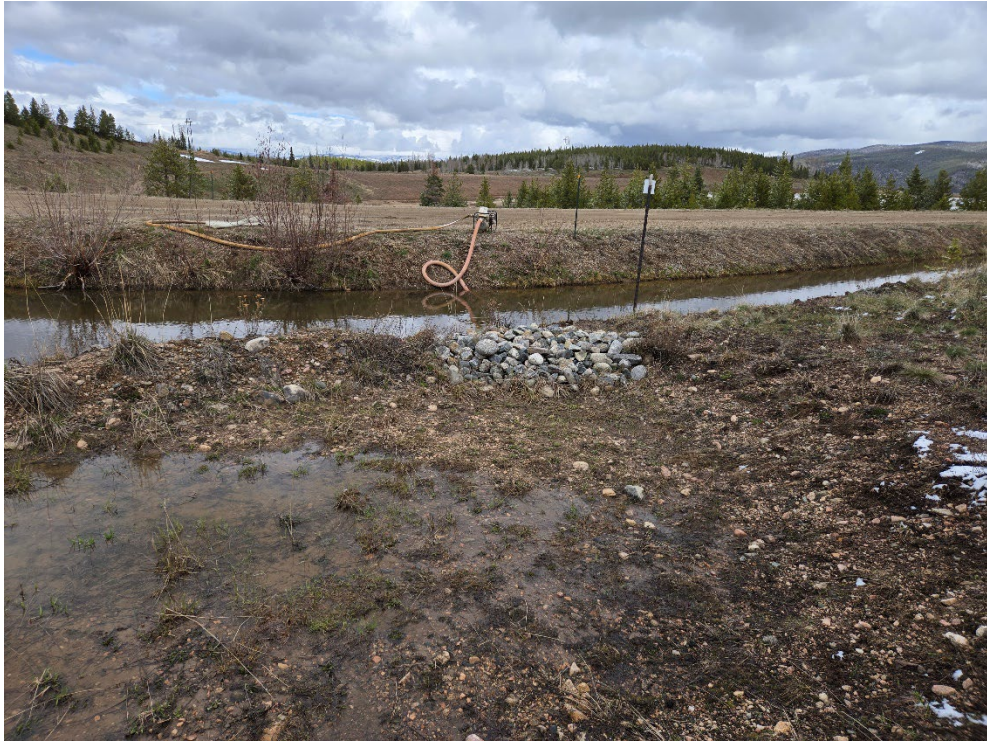
**OF-M32** (Photo 21) - The BMPs of this outfall location consist of riprap, and a shallow basin. The basin held a little bit of water at the time of the inspection, and no water was discharging at the outfall.

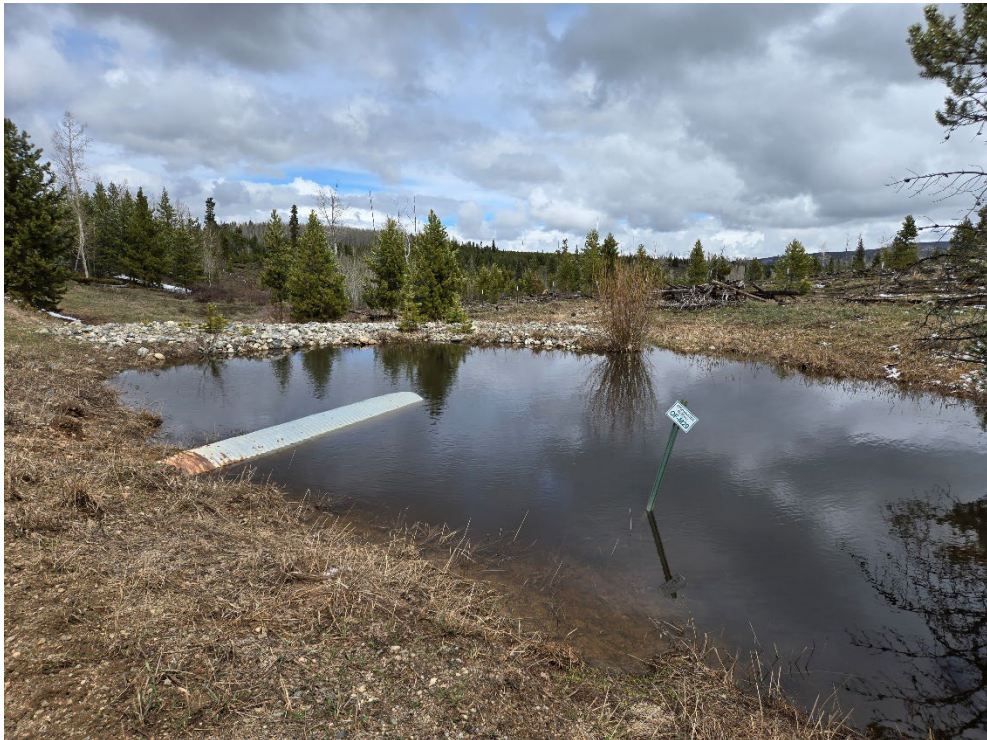
**OF-M29** (Photo 22) – The BMPs at this location consisted of a settling pond and a rip-rapped bank. The pond held water at the time of the inspection. This outfall appeared to be in good condition.

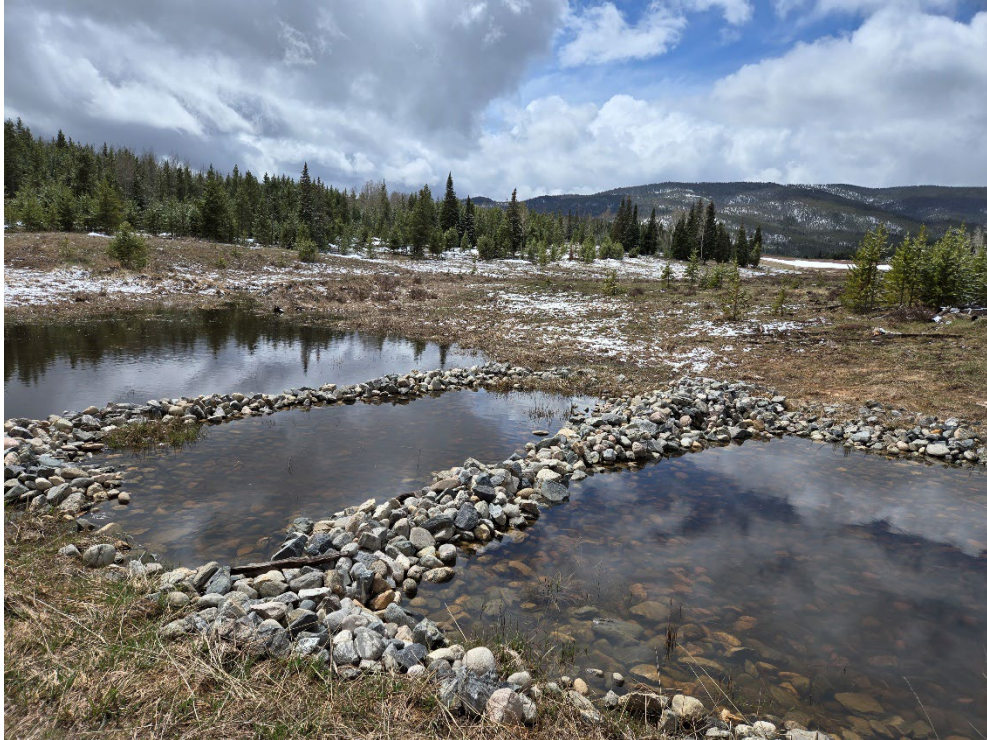
(Photo 23) - A series of check dams lead to **OF-M29** and discharge into the pond seen in Photo 22 through a culvert that goes under the road.

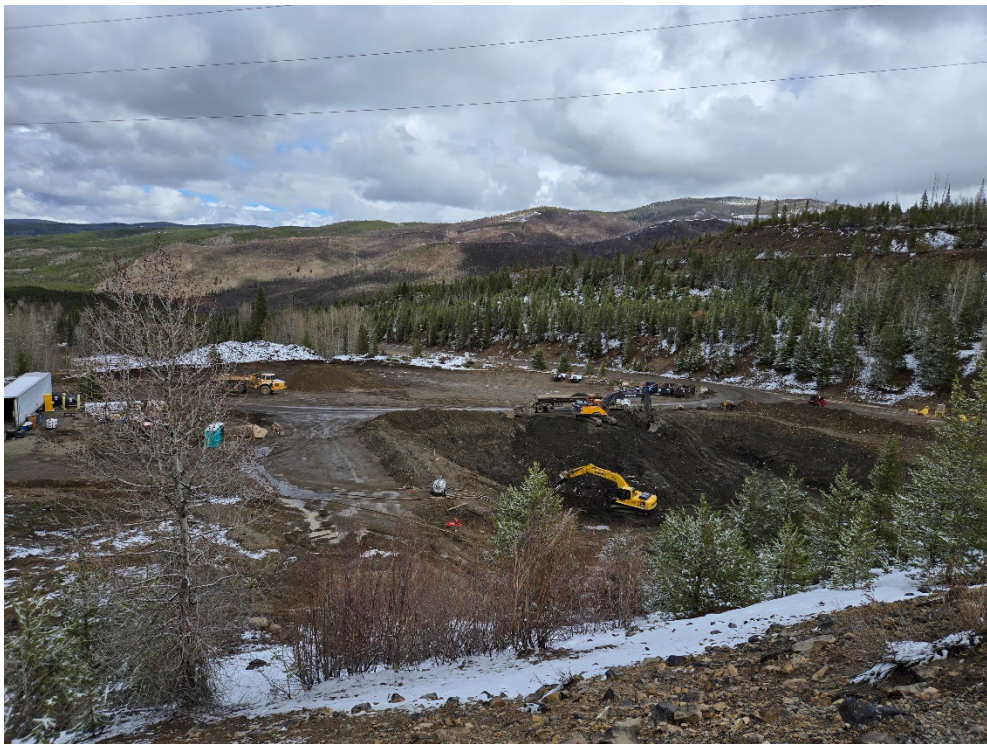
Photo 24: Current progress made on the construction of the new water treatment plant approved through TR35. During the inspection, equipment was being used to conduct some pre-building clean up and excavating debris. The Operator stated that soil testing had recently been conducted to determine whether there were any materials previously buried in this area.
