## Riveras Excavation Gravel M2004053- April 2025 Inspection Report and Cost Estimate

**MINERALS PROGRAM INSPECTION REPORT**  
**PHONE: (303) 866-3567**

<b>MINE NAME:</b> Riveras Excavation Gravel Pit	<b>MINE/PROSPECTING ID#:</b> M-2004-053	<b>MINERAL:</b> Gravel	<b>COUNTY:</b> Costilla
<b>INSPECTION TYPE:</b> Monitoring	<b>WEATHER:</b> Clear	<b>INSP. DATE:</b> April 22, 2025	<b>INSP. TIME:</b> 13:00
<b>OPERATOR:</b> Rivera's Excavation	<b>OPERATOR REPRESENTATIVE:</b> Eleuto Rivera	<b>TYPE OF OPERATION:</b> 110c - Construction Limited Impact	
<b>REASON FOR INSPECTION:</b> Normal I&E Program	<b>BOND CALCULATION TYPE:</b> Complete Bond	<b>BOND AMOUNT:</b> \$11,849	
<b>DATE OF COMPLAINT:</b> NA	<b>POST INSP. CONTACTS:</b> None	<b>JOINT INSP. AGENCY:</b> None	
<b>INSPECTOR(S):</b> Chris Girardi	<b>INSPECTOR'S SIGNATURE:</b>

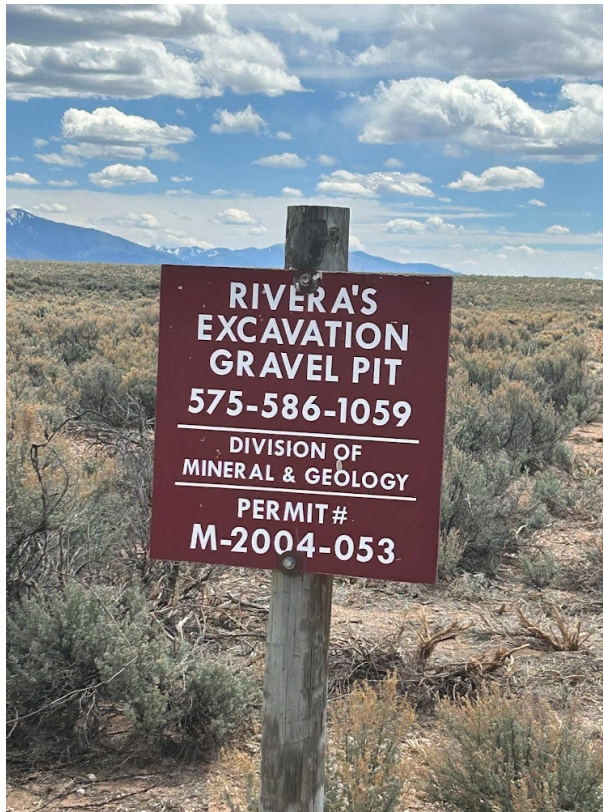
A mine entrance sign was observed in accordance with Rule 3.1.12 (see Photo 1). The affected area was delineated with t-post boundary markers.

Photo 1: Mine entrance sign.

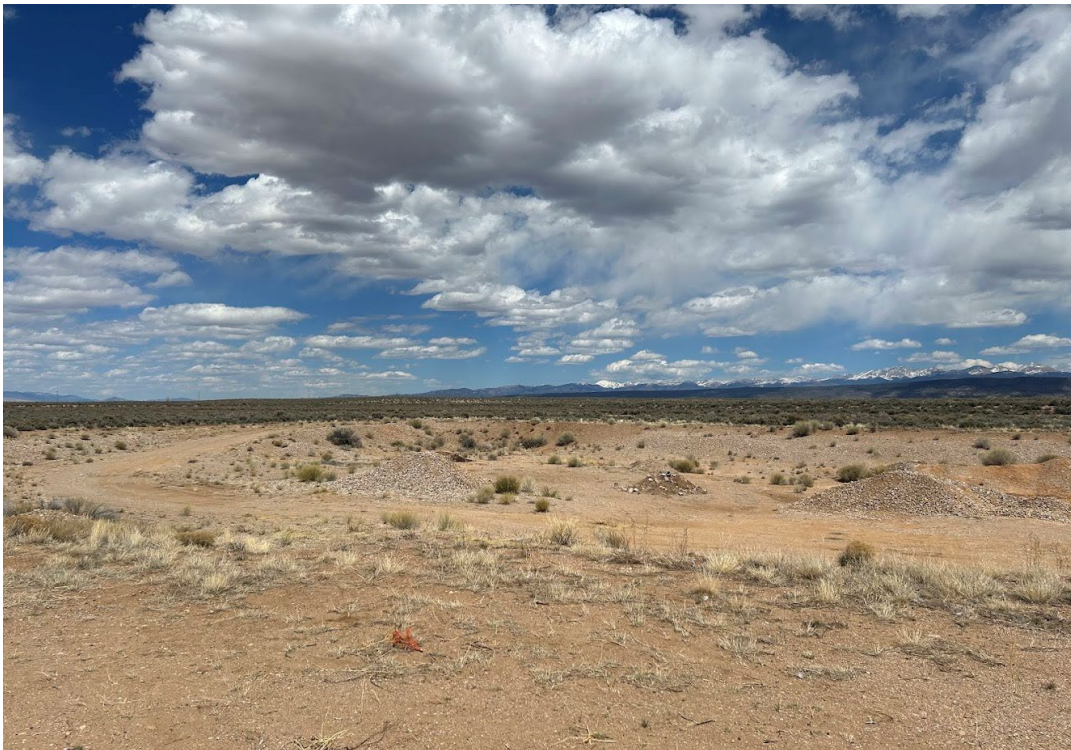
Photo 2: View of gravel pit containing stockpiles of material, facing east.

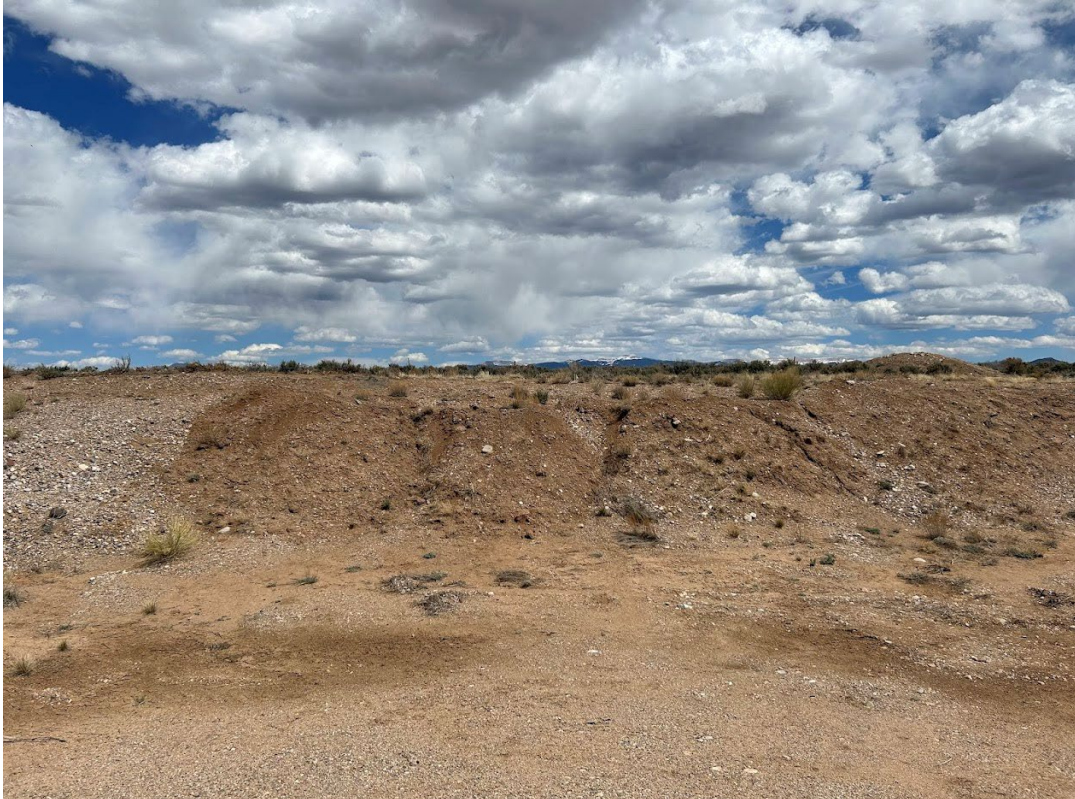
Photo 3: View of gravel pit wall with minor amount of erosional rilling, facing east.

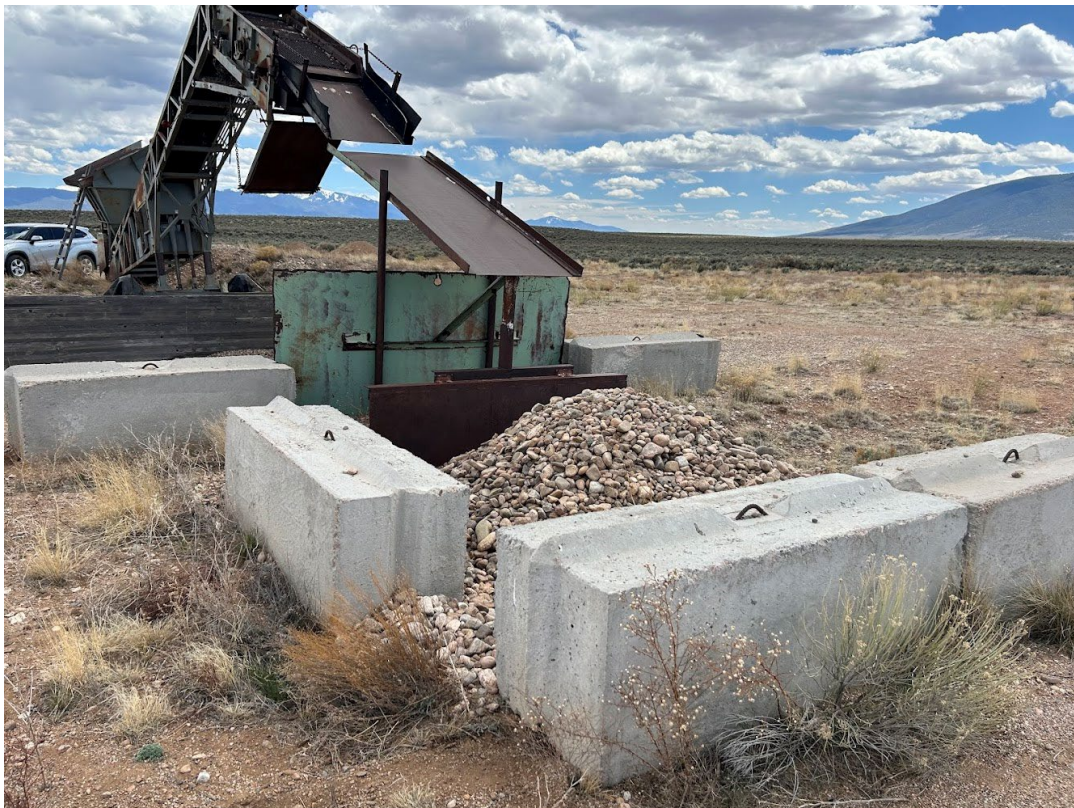
Photo 4: View of processing area and gravel stockpile

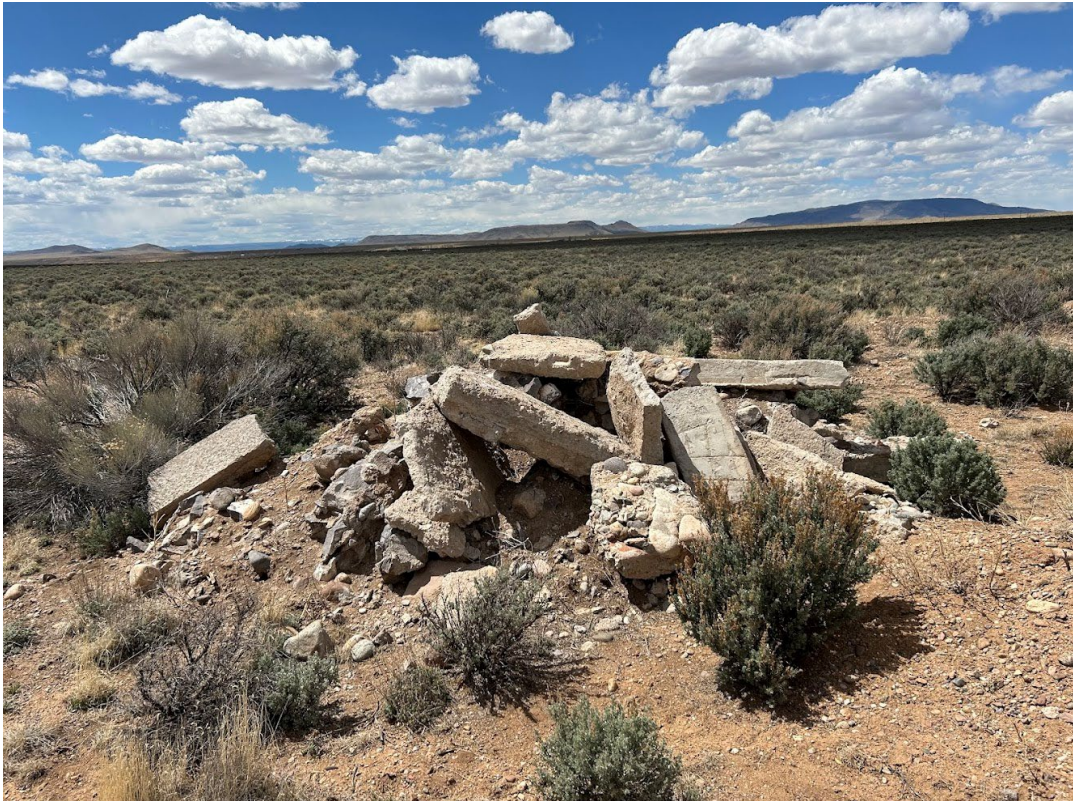
The site is located to the west of the Sangre De Cristo Mountains and within the San Luis Valley. The surrounding area is mostly flat with moderate amounts of vegetation, including Blue grama, Rubber rabbitbrush and Big sagebrush (see Photo 7). No noxious weeds were observed. The site was not active during the inspection. The current disturbed area is approximately 2.3 acres, consisting of a small 1-acre pit, and a processing area adjacent to the west of the pit. The pit was approximately six (6) feet in depth, contained stockpiles of gravel, and had minimal amount of erosional rilling (see Photos 2-3). The pit exhibited gentle slopes below 3:1 configuration (horizontal to vertical ratio), and volunteer vegetation has been minimally established along the pit floor. Topsoil stockpiles were observed adjacent to the outside of the pit and were in stable condition. The processing area contained a screener, a conveyer, with a small, processed stockpile surrounded by concrete blocks (see Photos 4). The processing area also contained a stockpile of recycled asphalt, and what appeared to be concrete stockpile (see Photos 5-6).

Photo 5: View of concrete road base outside the gravel pit, facing west.

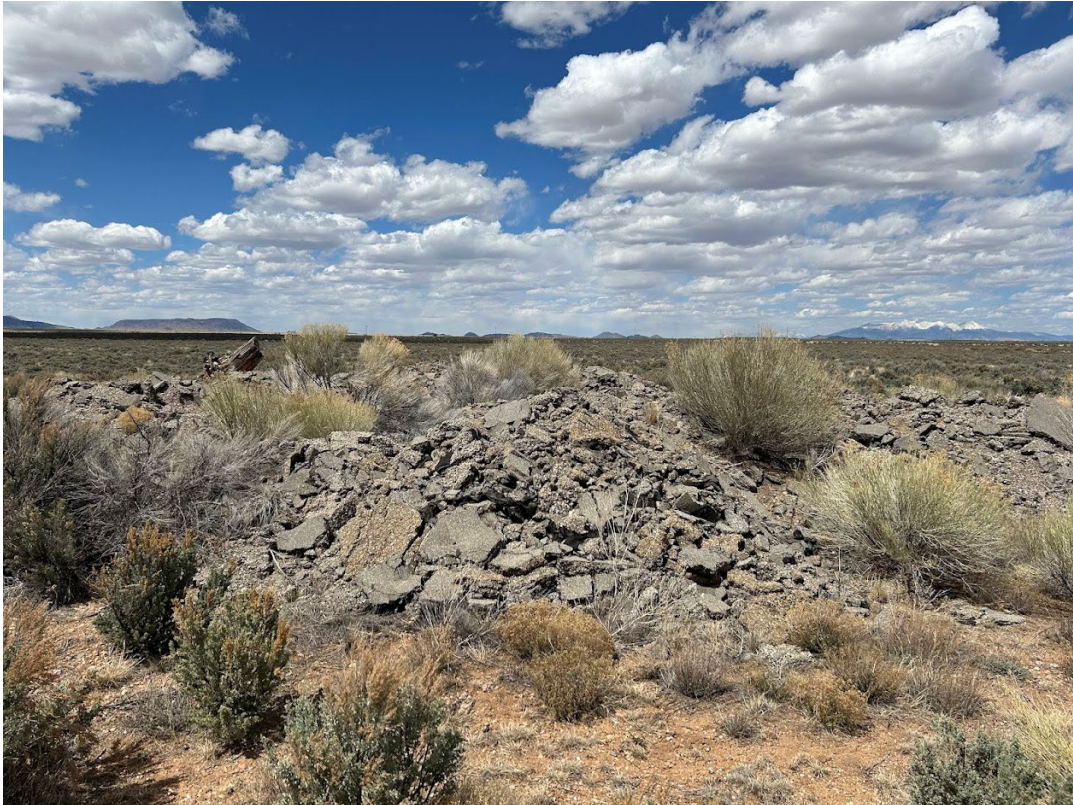
During the inspection conducted by the Division on October 6, 2016, the Division observed a stockpile of recycled asphalt outside the pit. According to the Inspection Report (dated October 27, 2016), the Operator had indicated that the asphalt stockpile would only be stored temporarily until it could be properly recycled. It is unclear if the recycled asphalt stockpile observed on April 22, 2025 is the same stockpile observed in 2016. The Division notes that the asphalt and concrete materials are unable to be used as backfill material for the gravel pit and will need to be removed during reclamation

Photo 6: View of recycled asphalt stockpile outside the gravel pit, facing west.

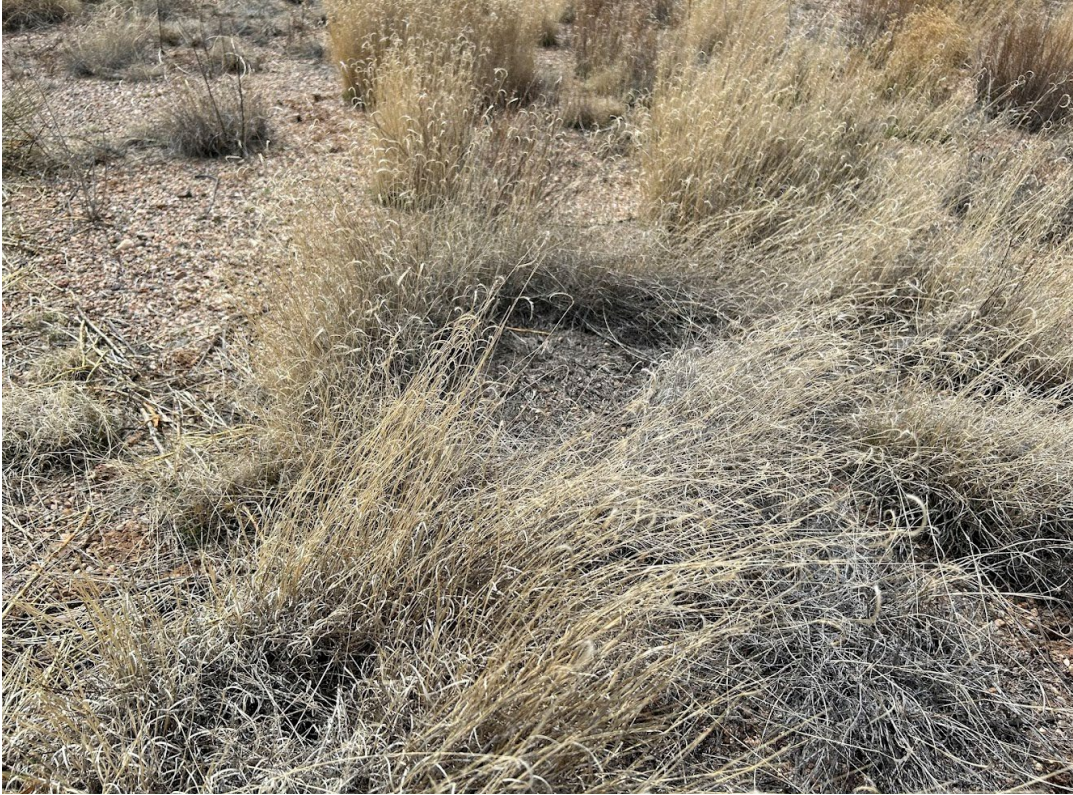
Photo 7: View of native vegetation, including Blue grama, within the undisturbed portion of the permit area.
