MINERALS PROGRAM INSPECTION REPORT
PHONE: (303) 866-3567

MINE NAME: Ready Mix Pit	MINE/PROSPECTING ID#: M-1977-023	MINERAL: Sand and gravel	COUNTY: Gunnison
INSPECTION TYPE: Monitoring	WEATHER: Clear	INSP. DATE: April 29, 2025	INSP. TIME: 08:00
OPERATOR: Oldcastle SW Group, Inc. dba United Companies of Mesa County	OPERATOR REPRESENTATIVE: Jesse Farmer	TYPE OF OPERATION: 112c - Construction Regular Operation	
REASON FOR INSPECTION: Normal I&E Program	BOND CALCULATION TYPE: Complete Bond	BOND AMOUNT: \$292,670.00	
DATE OF COMPLAINT: NA	POST INSP. CONTACTS: None	JOINT INSP. AGENCY: None	
INSPECTOR(S): Dustin Czapla	INSPECTOR'S SIGNATURE:

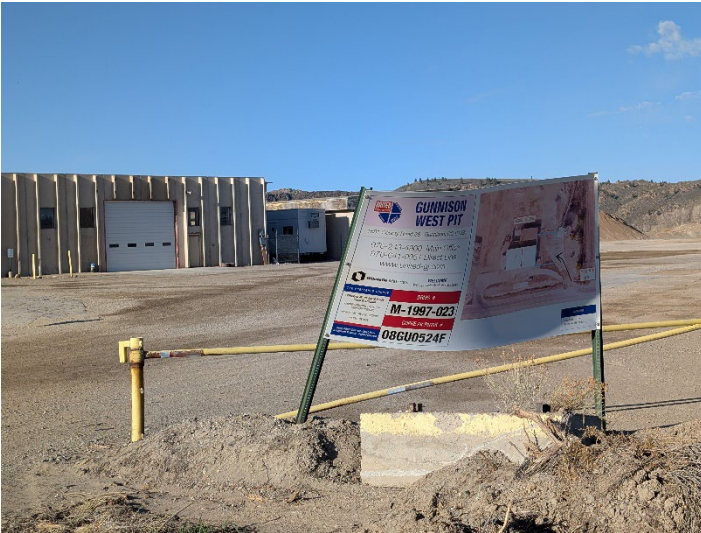
Adequate mine identification signage was noted at the entrance to the site.

Sign at mine entrance

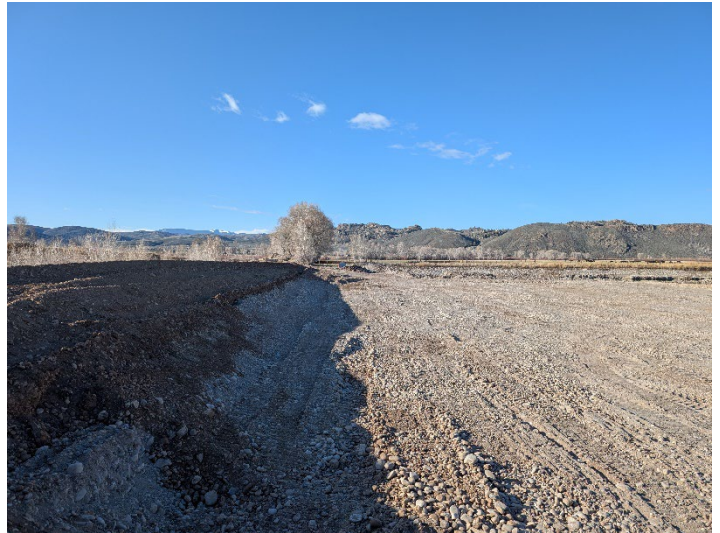
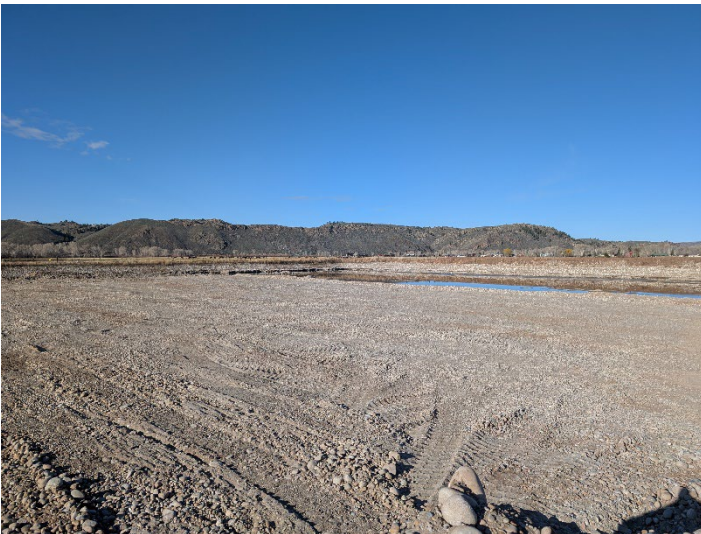
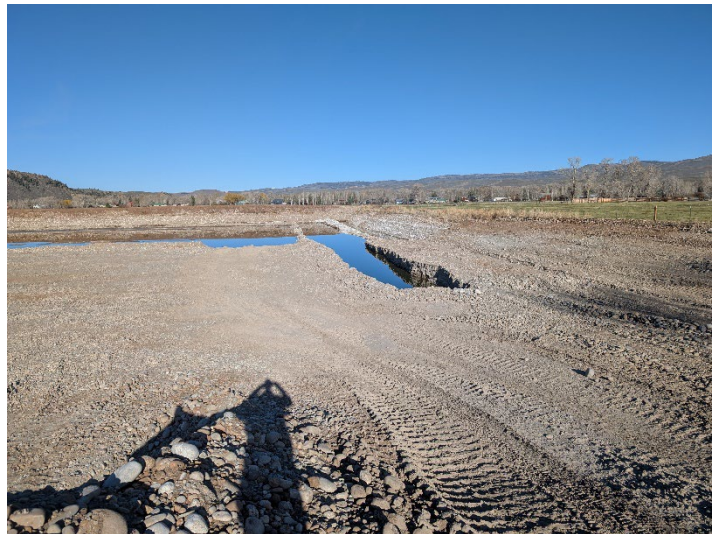
AM1 area

Mining has progressed into the AM-1 area. Topsoil has been removed, pushed into a berm above the west highwall. The pit has been excavated to a depth of approximately five feet. Slopes around the pit are approximately 1H:1V. A dewatering trench has been excavated around the mining area.

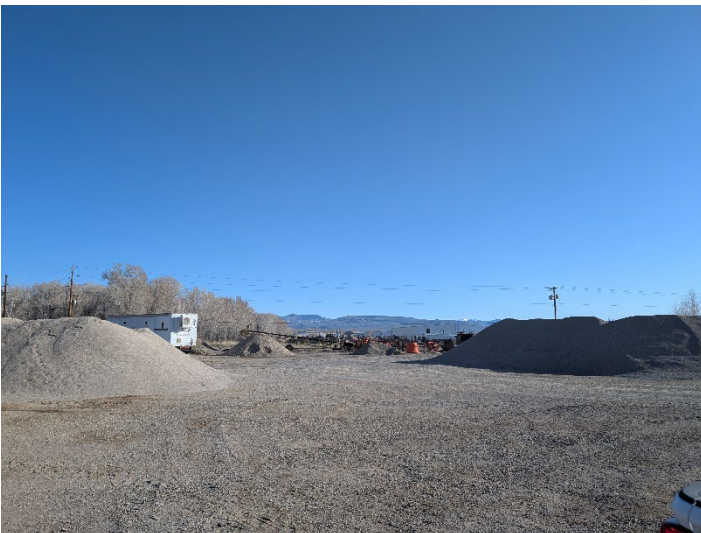
The processing/stockpile area is located in the north end of the permit area. Crushing was occurring during this inspection. Fuels stored on site were in adequate secondary containment structures. Mining equipment on site was stored in an orderly fashion.

Stockpile/storage area northwest part of permit area

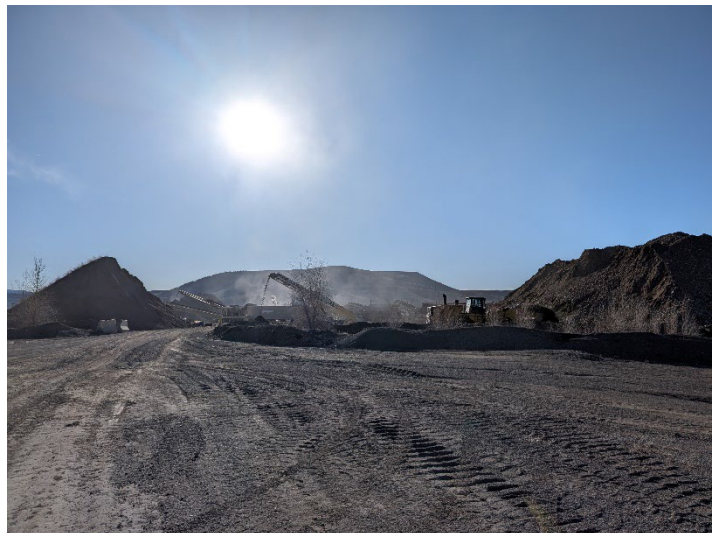
Processing area north part of permit area

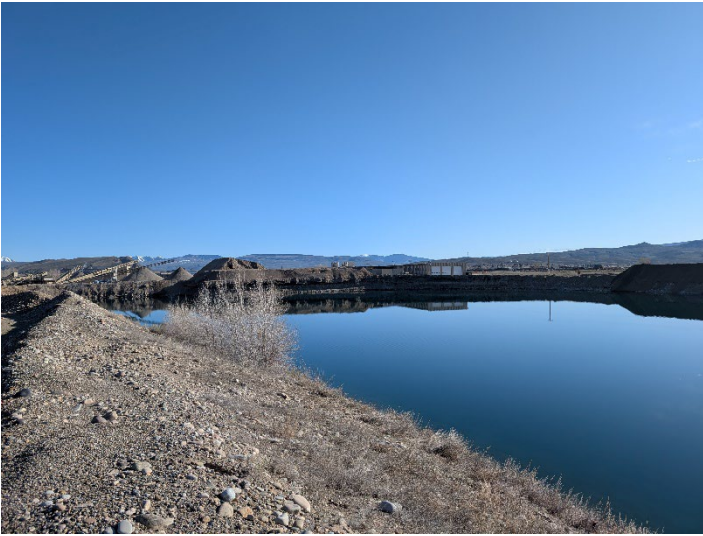
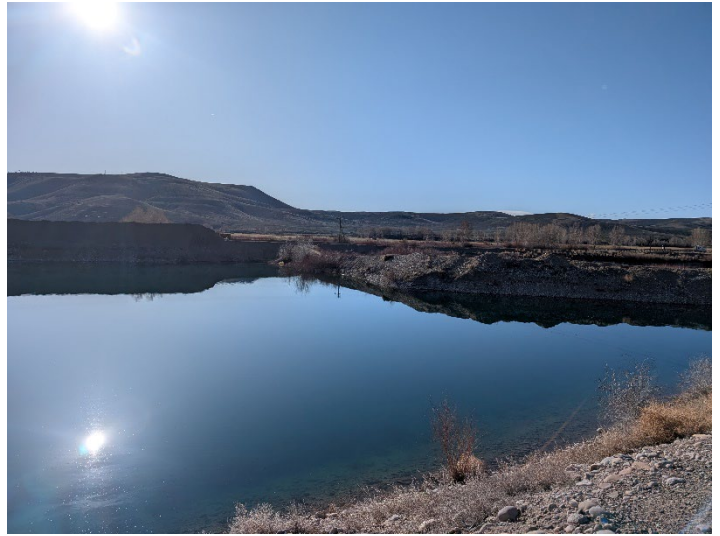
Northwest pond

There are four ponds within the original permit area. The two southern ponds are mostly reclaimed. The banks have been regraded and vegetation is becoming well established. The two reclaimed ponds cover approximately 22 acres. Mining still occurs in the two northern ponds. Slope reduction has not occurred in these ponds yet. The two northern ponds were not dewatered during this inspection. These two ponds cover approximately 20 acres.
