MINERALS PROGRAM INSPECTION REPORT
PHONE: (303) 866-3567

MINE NAME: Vader Pit	MINE/PROSPECTING ID#: M-1978-287	MINERAL: Sand and gravel	COUNTY: Gunnison
INSPECTION TYPE: Monitoring	WEATHER: Clear	INSP. DATE: April 29, 2025	INSP. TIME: 08:20
OPERATOR: Oldcastle SW Group, Inc. dba United Companies of Mesa County	OPERATOR REPRESENTATIVE: Jesse Farmer	TYPE OF OPERATION: 112c - Construction Regular Operation	
REASON FOR INSPECTION: Normal I&E Program	BOND CALCULATION TYPE: Complete Bond	BOND AMOUNT: \$100,712.00	
DATE OF COMPLAINT: NA	POST INSP. CONTACTS: None	JOINT INSP. AGENCY: None	
INSPECTOR(S): Dustin Czapla	INSPECTOR'S SIGNATURE:

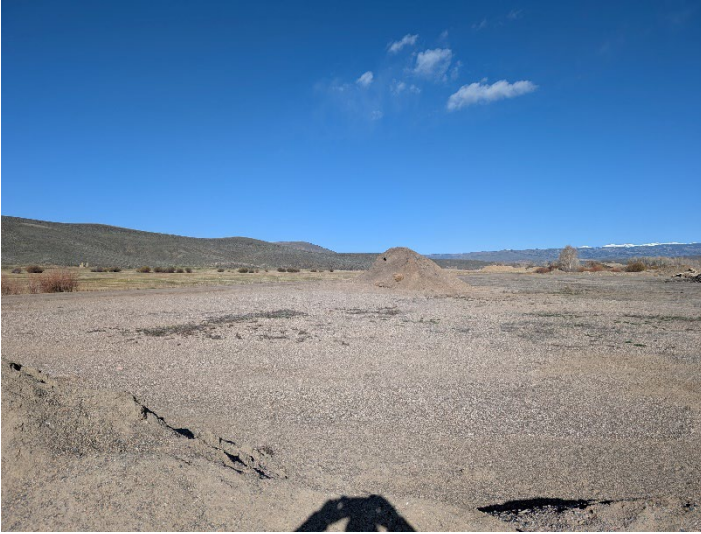
The area south of Tomichi Creek is primarily used for stockpiling materials. Various materials stockpiles are located throughout this area. Topsoil and overburden have been stripped from this area, but a pit has not been excavated yet. There was no mining equipment located in this area at the time of this inspection. Groundwater has not been exposed on this side of the creek.

Stockpile area on south side of Tomichi Creek

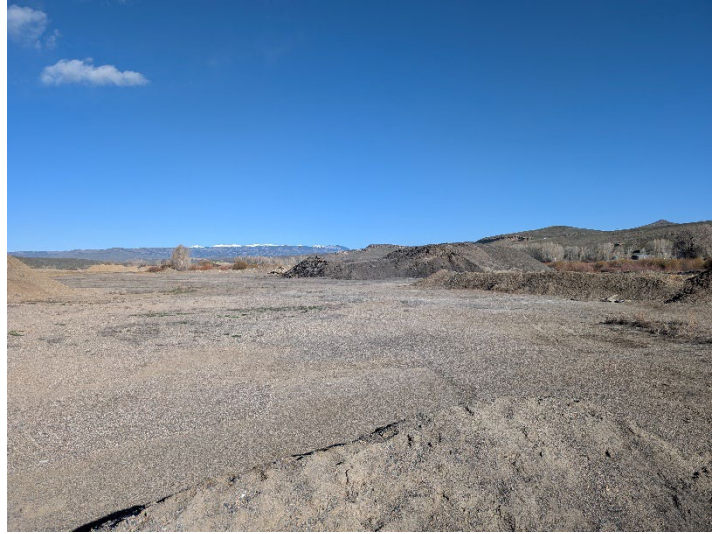
Stockpile area on south side of Tomichi Creek

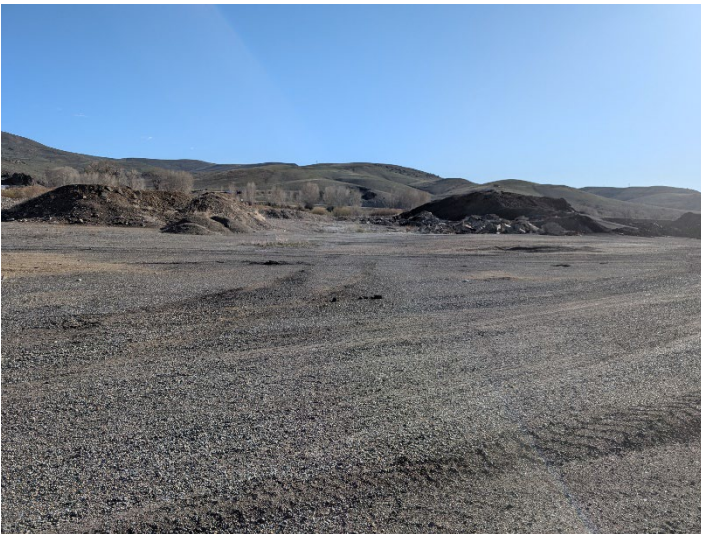
Stockpile area on south side of Tomichi Creek

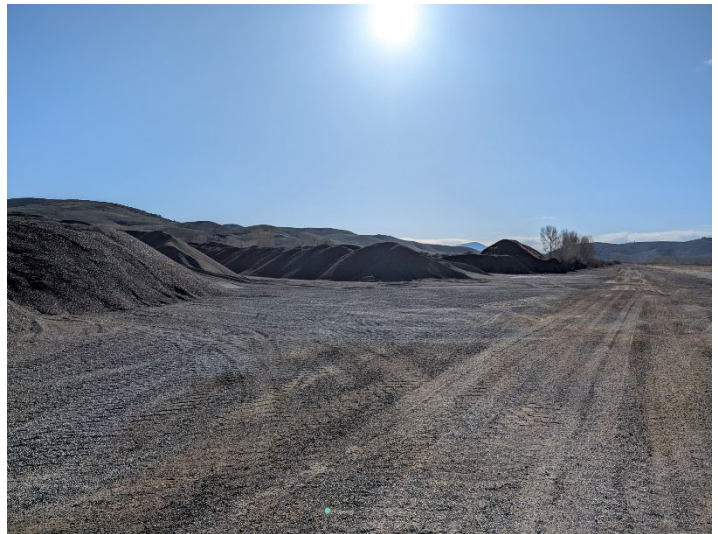
Stockpile area on south side of Tomichi Creek
