MINERALS PROGRAM INSPECTION REPORT
PHONE: (303) 866-3567

MINE NAME: Rozman Pit	MINE/PROSPECTING ID#: M-1981-014	MINERAL: Sand and gravel	COUNTY: Gunnison
INSPECTION TYPE: Monitoring	WEATHER: Clear	INSP. DATE: April 28, 2025	INSP. TIME: 16:00
OPERATOR: Oldcastle SW Group, Inc. dba United Companies of Mesa County	OPERATOR REPRESENTATIVE: Jesse Farmer	TYPE OF OPERATION: 112c - Construction Regular Operation	
REASON FOR INSPECTION: Normal I&E Program	BOND CALCULATION TYPE: None	BOND AMOUNT: \$128,069.00	
DATE OF COMPLAINT: NA	POST INSP. CONTACTS: None	JOINT INSP. AGENCY: None	
INSPECTOR(S): Dustin Czapla	INSPECTOR'S SIGNATURE:

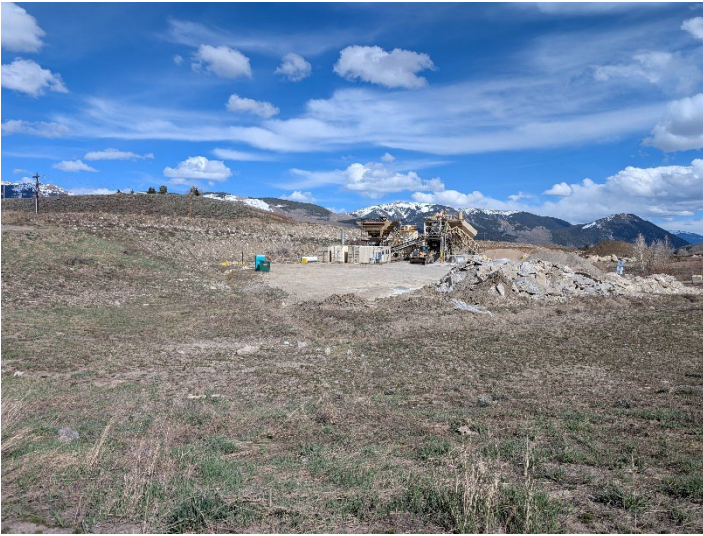
The Reclamation Plan was modified in 2018 through AM02 to change the post-mining land use for the area on the east side of Slate River to industrial/commercial. A batch plant is located in this area. The area around the batch plant appeared orderly and well kept. No problems were noted in this area.

Batch plant on east side of Slate River

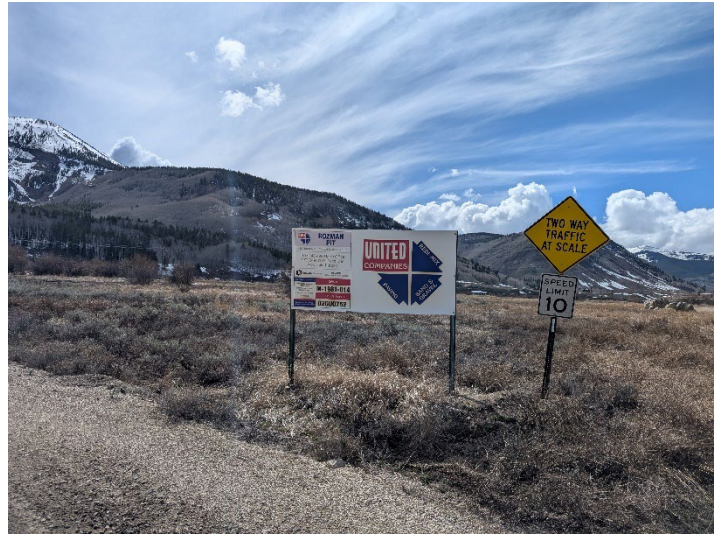
Adequate mine identification signage was noted at the entrance to the site.

Mine sign at entrance

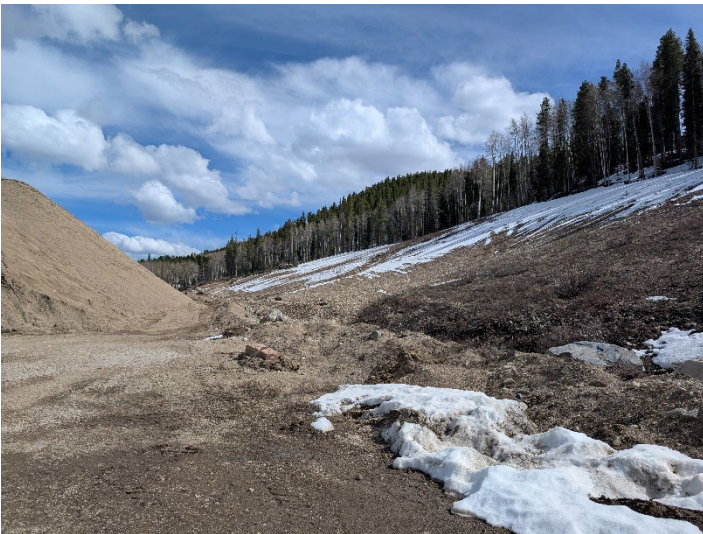
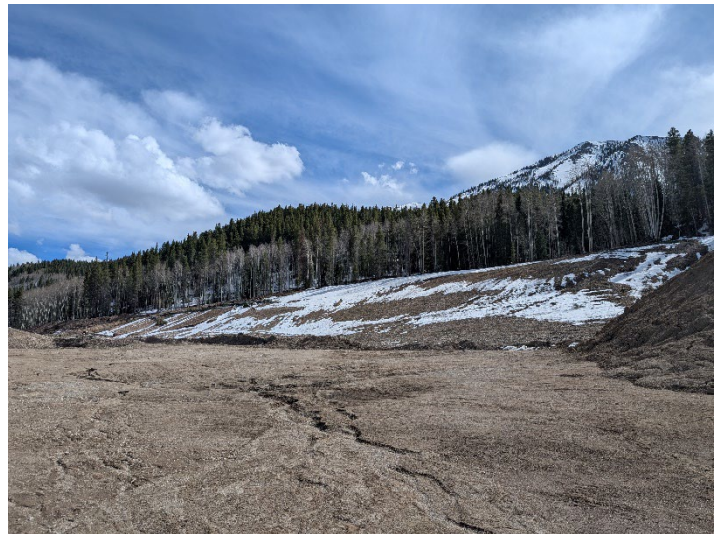
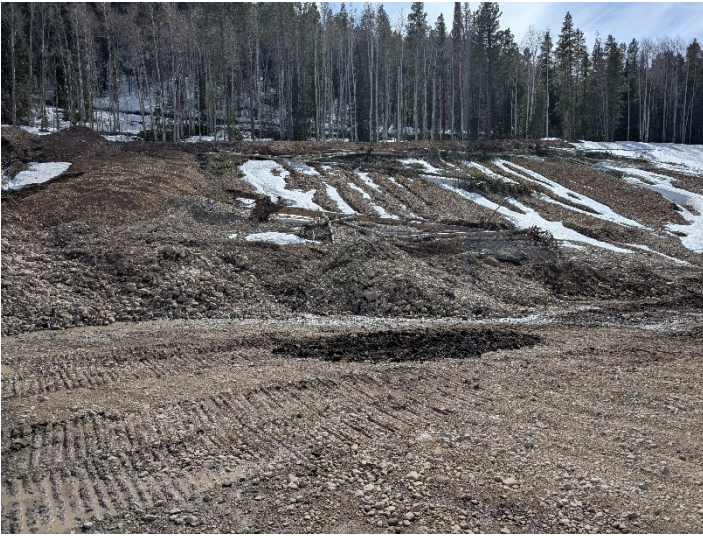
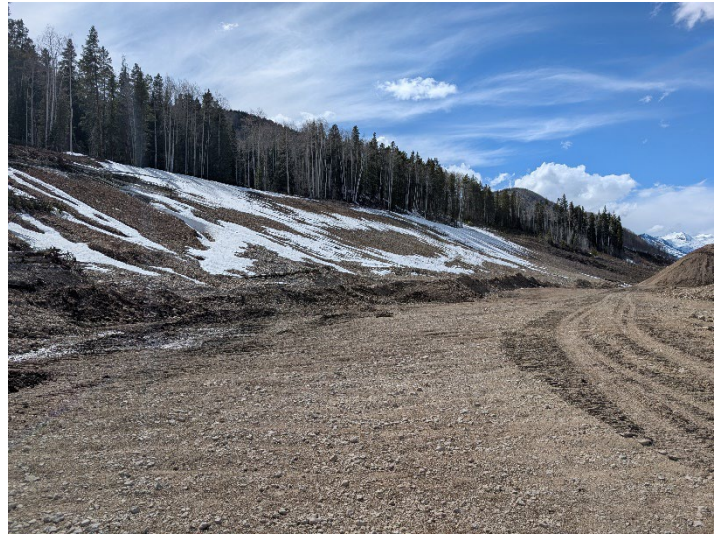
The active mining area is located on the west side of Slate River. This area will be reclaimed as rangeland. There are approximately 35 acres currently disturbed in this area. Mining is currently progressing to the south, in the southwest end of the pit. Most of the highwall, approximately 1,200 linear feet, along the east and south sides of the pit has been backfilled to 2-3H:1V.

Highwall slope on east side of pit

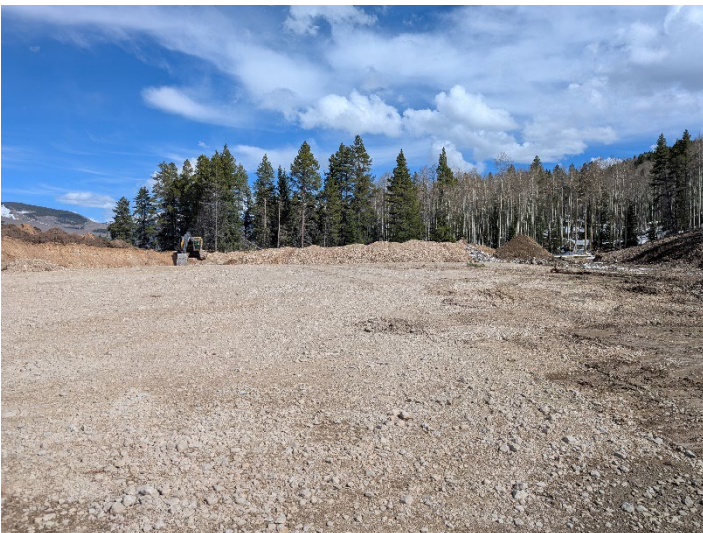
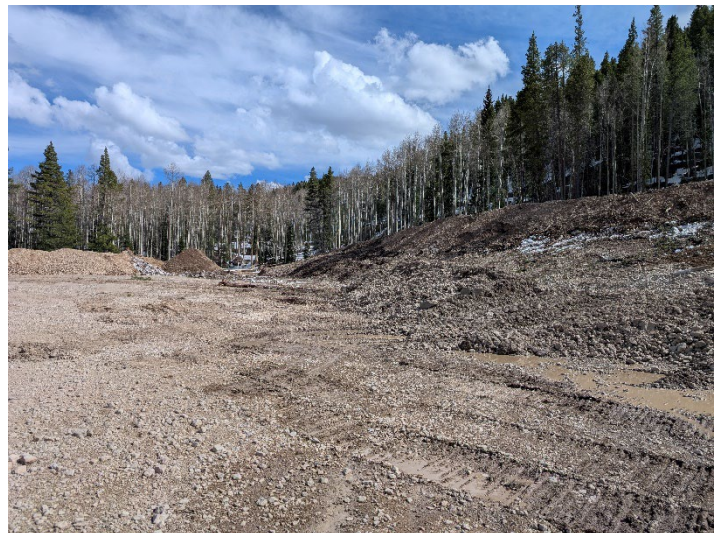
Mining occurring at south end of pit

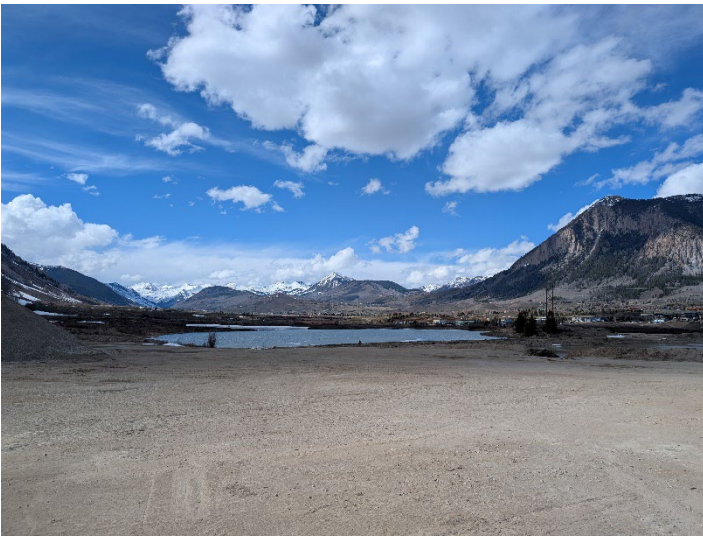
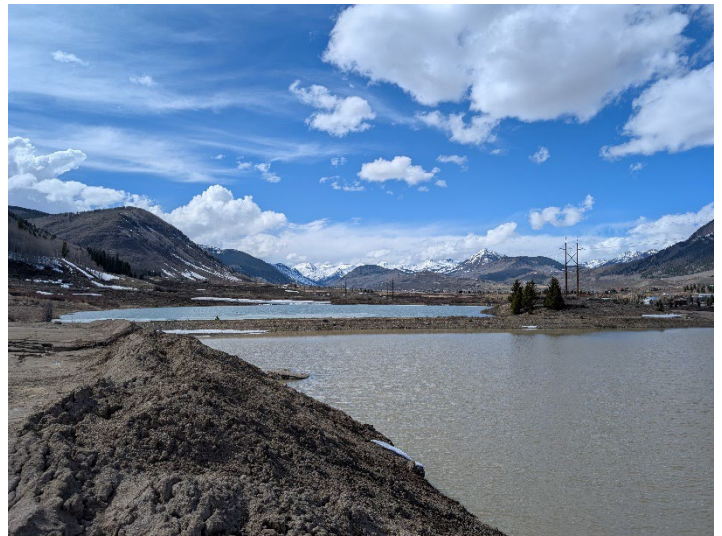
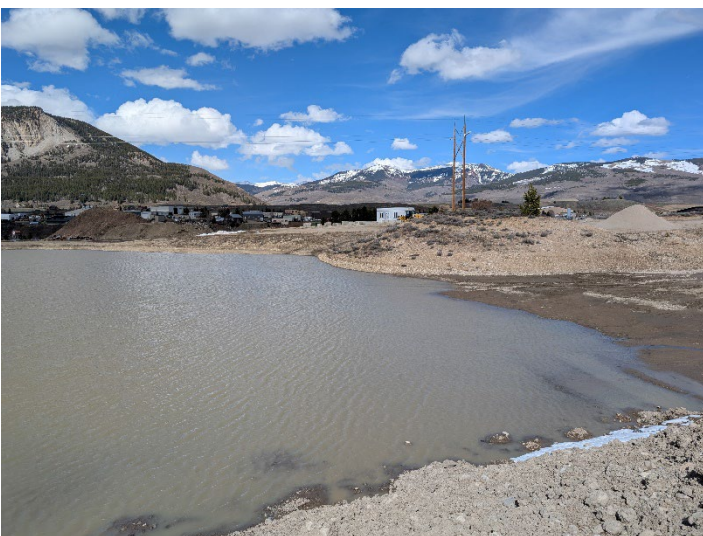
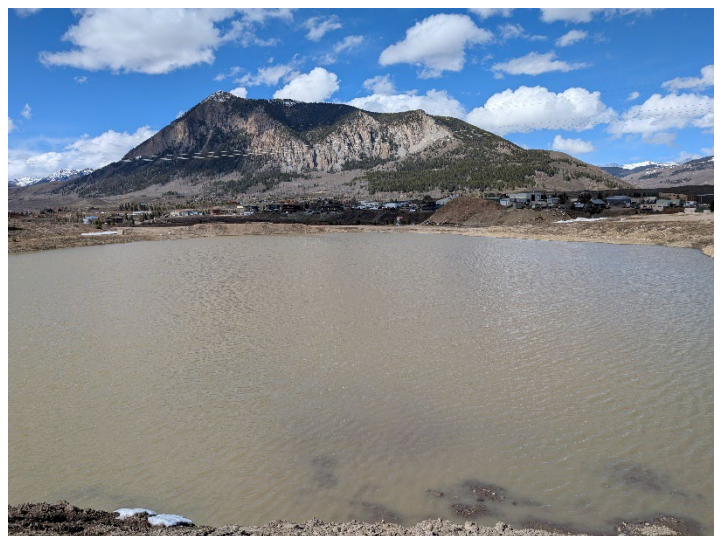
There are two ponds located on the north side of the pit, covering an area of approximately 10 acres. The pond banks appear stable.

Ponds on north side of pit
