MINERALS PROGRAM INSPECTION REPORT
PHONE: (303) 866-3567

MINE NAME: Schmalz Const Pit	MINE/PROSPECTING ID#: M-1984-069	MINERAL: Sand and gravel	COUNTY: Gunnison
INSPECTION TYPE: Monitoring	WEATHER: Clear	INSP. DATE: April 28, 2025	INSP. TIME: 14:20
OPERATOR: Schmalz Construction Ltd	OPERATOR REPRESENTATIVE: None	TYPE OF OPERATION: 110c - Construction Limited Impact	
REASON FOR INSPECTION: Normal I&E Program	BOND CALCULATION TYPE: Complete Bond	BOND AMOUNT: \$21,654.00	
DATE OF COMPLAINT: NA	POST INSP. CONTACTS: None	JOINT INSP. AGENCY: None	
INSPECTOR(S): Dustin Czapla	INSPECTOR'S SIGNATURE:

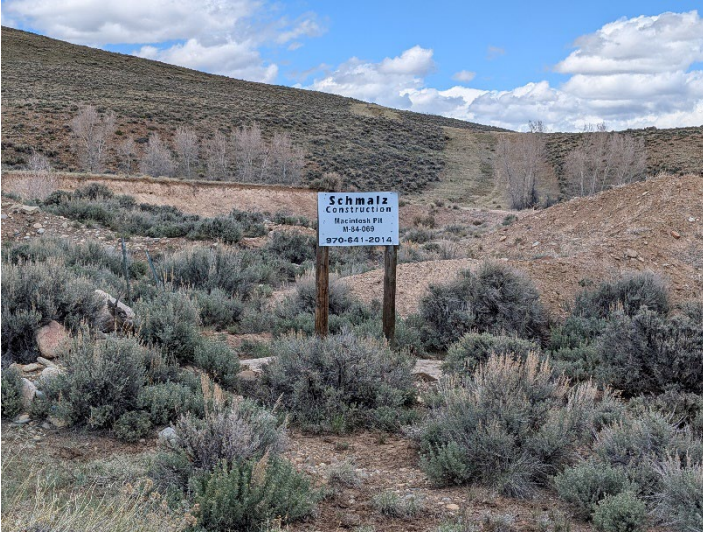
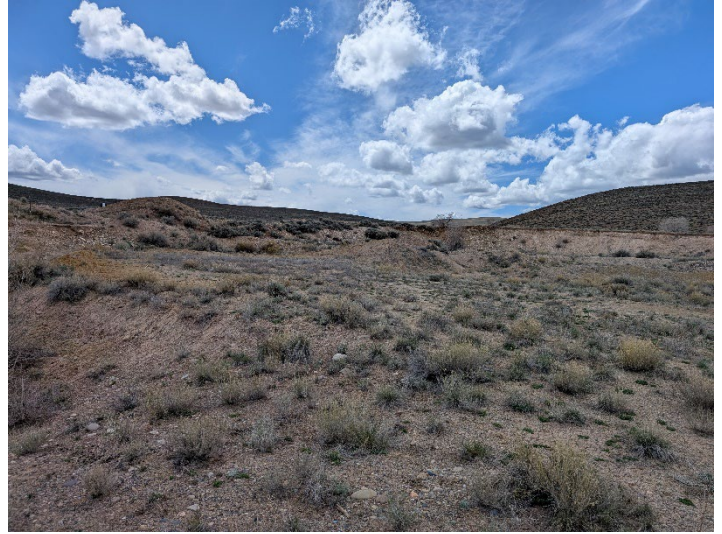
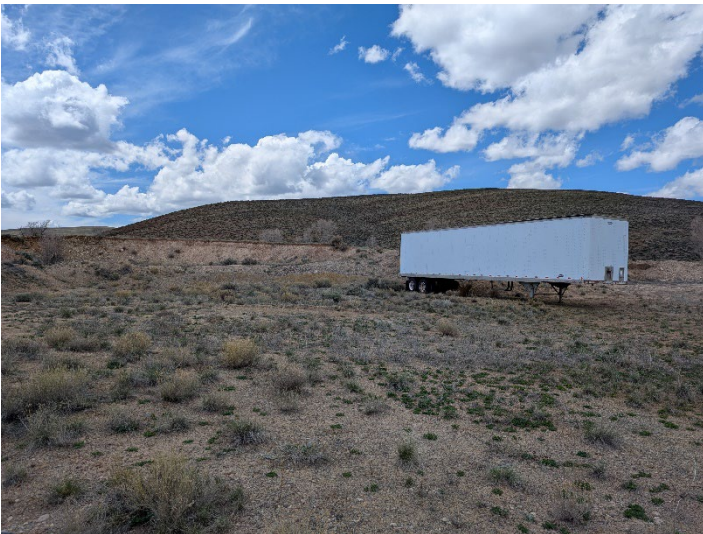
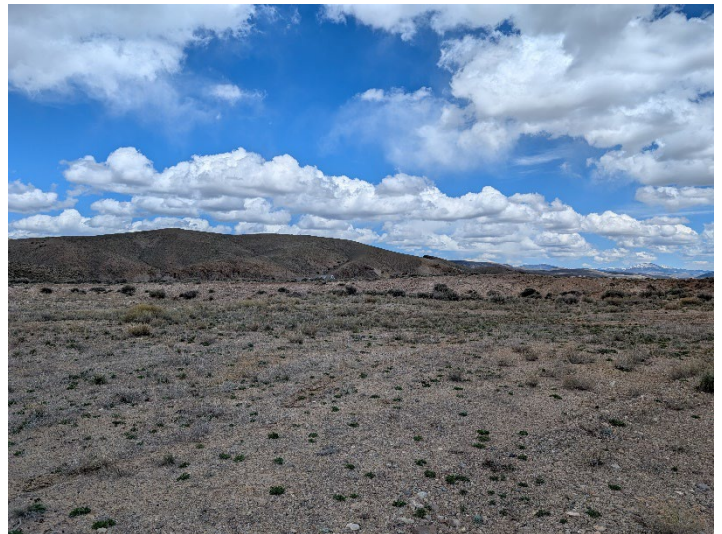
There has been little change at the site since the Division's last inspection. There are approximately four acres currently disturbed by the operation. The highwall along the west end of the pit is approximately 10'-12' high. Material has sloughed from the highwall resulting in an approximately 0.5H:1V slope. Several topsoil stockpiles were noted around the perimeter of the pit, and various product piles within the pit. The topsoil piles appear stable and protected from erosion due to a significant amount of vegetation from native volunteer species.
