MINERALS PROGRAM INSPECTION REPORT
PHONE: (303) 866-3567

MINE NAME: Sea Horse Ranch West Gravel Pit	MINE/PROSPECTING ID#: M-2001-113	MINERAL: Sand and aggregate	COUNTY: Gunnison
INSPECTION TYPE: Monitoring	WEATHER: Clear	INSP. DATE: April 29, 2025	INSP. TIME: 08:30
OPERATOR: Oldcastle SW Group, Inc. dba United Companies of Mesa County	OPERATOR REPRESENTATIVE: Jesse Farmer	TYPE OF OPERATION: 112c - Construction Regular Operation	
REASON FOR INSPECTION: Normal I&E Program	BOND CALCULATION TYPE: Complete Bond	BOND AMOUNT: \$167,363.00	
DATE OF COMPLAINT: NA	POST INSP. CONTACTS: None	JOINT INSP. AGENCY: None	
INSPECTOR(S): Dustin Czapla	INSPECTOR'S SIGNATURE:

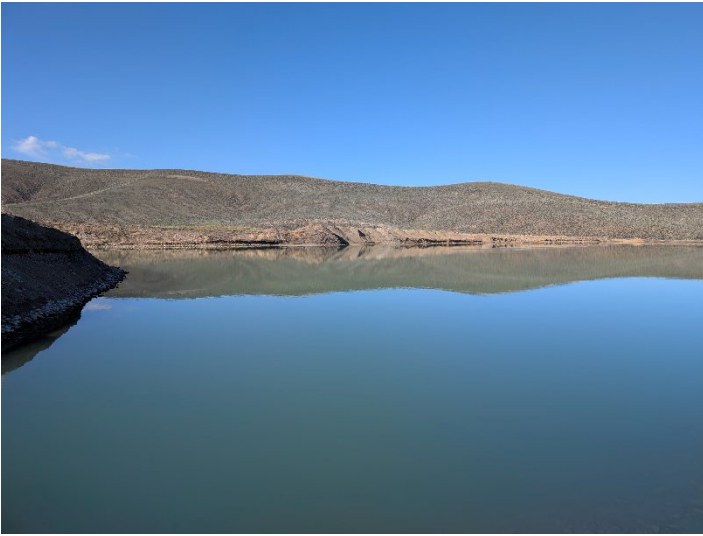
Pit lake viewed from east end

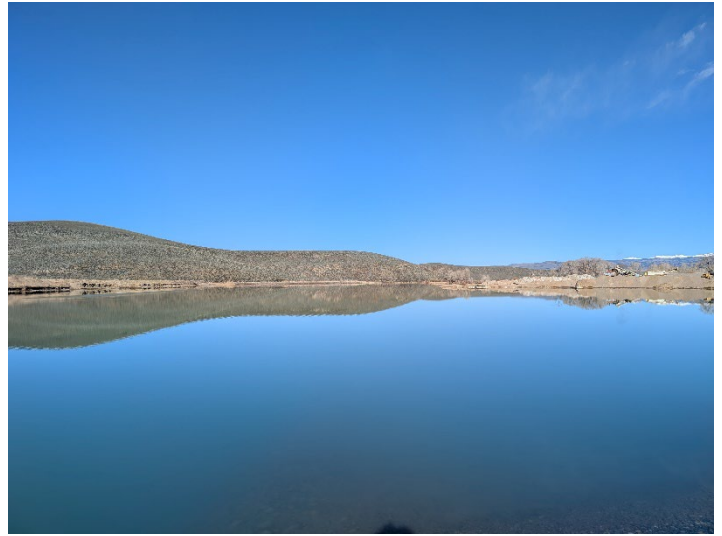
Pit lake viewed from east end

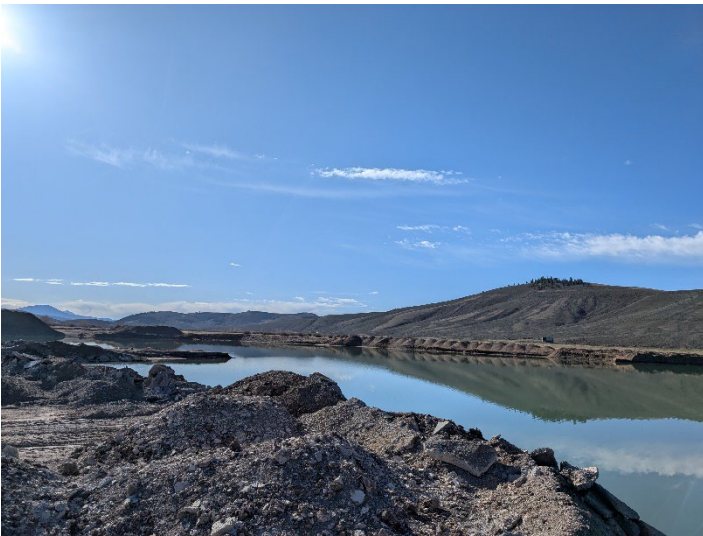
Pit lake viewed from north side

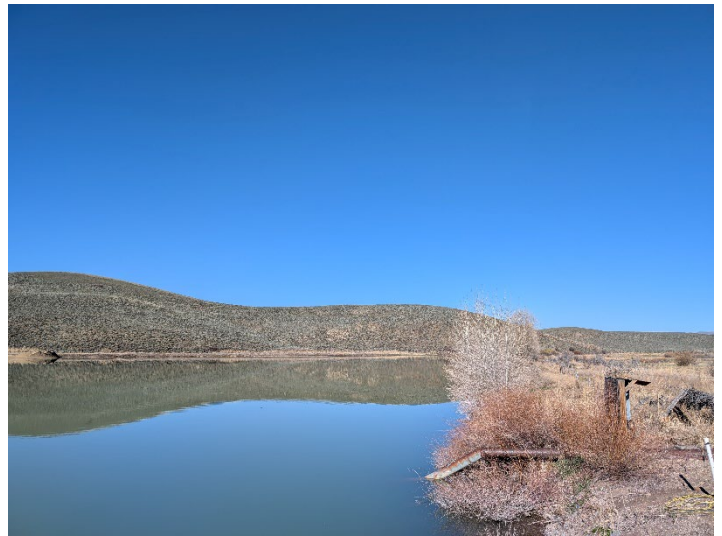
Pit lake viewed from north side

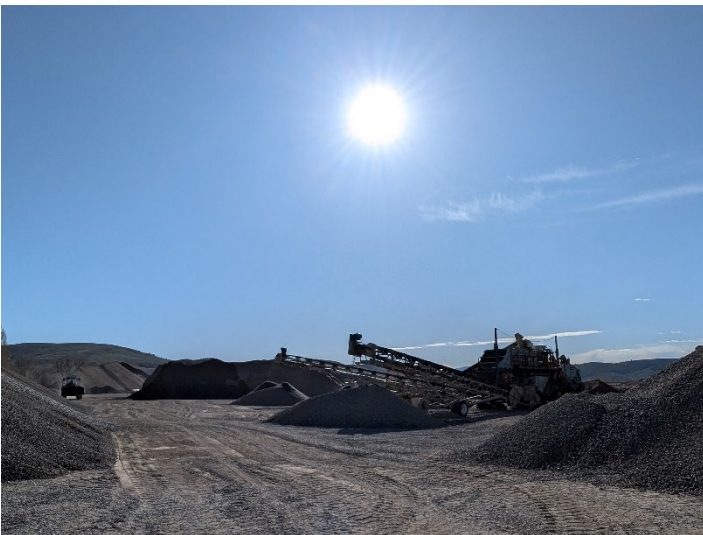
Crushing/stockpile area north of pit

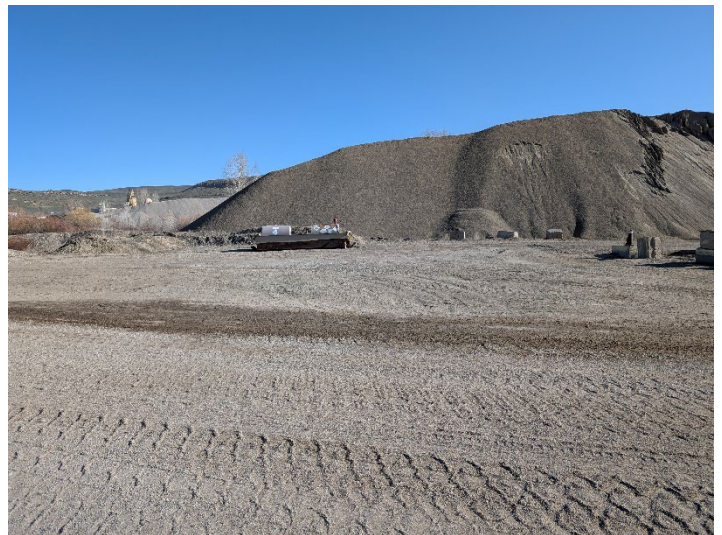
Crushing/stockpile area north of pit
