MINERALS PROGRAM INSPECTION REPORT
PHONE: (303) 866-3567

MINE NAME: 8-Mile Clay Mine	MINE/PROSPECTING ID#: M-1977-320	MINERAL: Clay (general)	COUNTY: Fremont
INSPECTION TYPE: Monitoring	WEATHER: Clear	INSP. DATE: April 16, 2025	INSP. TIME: 07:40
OPERATOR: Summit Brick & Tile Co.	OPERATOR REPRESENTATIVE: Ms. Julie Welte	TYPE OF OPERATION: 112c - Construction Regular Operation	
REASON FOR INSPECTION: Normal I&E Program	BOND CALCULATION TYPE: Complete Bond	BOND AMOUNT: \$49,166.00	
DATE OF COMPLAINT: NA	POST INSP. CONTACTS: None	JOINT INSP. AGENCY: None	
INSPECTOR(S): Jocelyn Carter	INSPECTOR'S SIGNATURE:

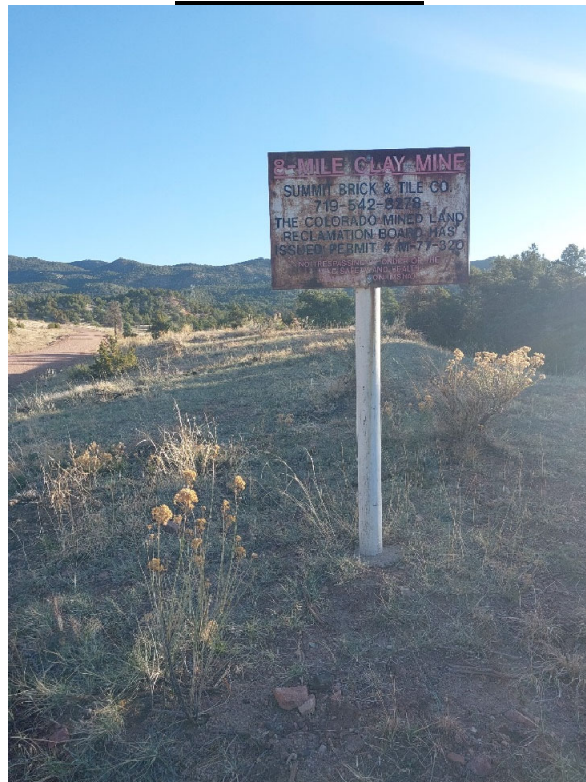
The mine sign is posted in accordance with Rule 3.1.12(1), see Photo #1. The permit boundary is marked with

Photo #1: Mine sign near the entrance of the permit area, located on the east side of County Road 62.

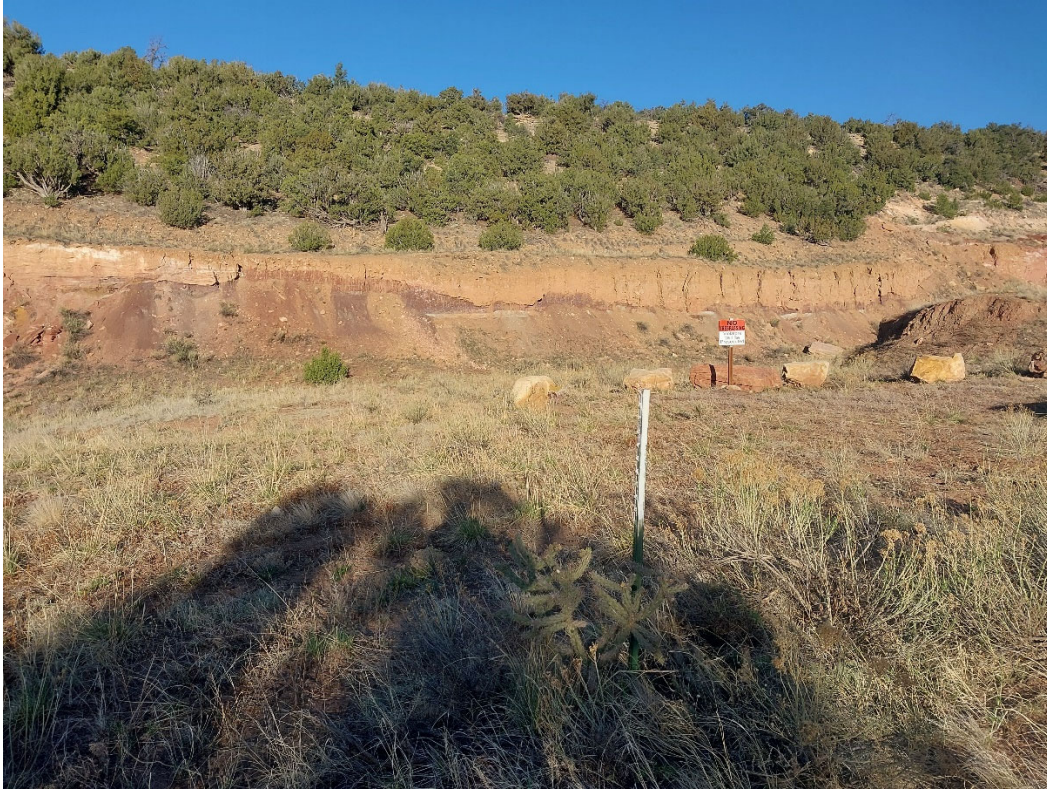
white-topped T-posts, see Photo #2.

There is a pre-law disturbance within the permitted area that has been reclaimed, see Photos #2 and #7. The area appears to be well vegetated with a variety of plants including rabbitbrush and established pine trees. There did not appear to be erosion issues or disturbances to the hydrologic balance in this area.

Photo #2: Example of a permit boundary marker, located across the road from the mine sign, on the west side of County Road 62. The area behind the marker is the southern end of the reclaimed area.

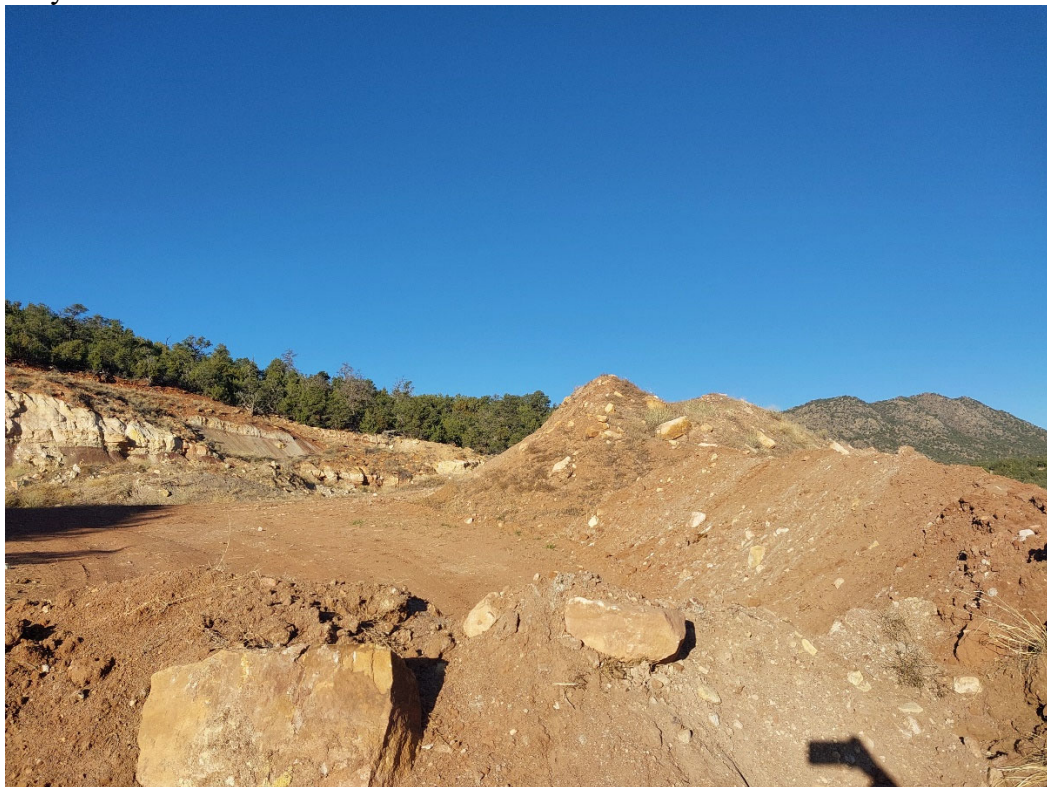
8-Mile Clay mine is in Fremont County, northeast of the intersection of U.S. Hwy 50 and State Hwy 9 off County Road 62. The nearest municipality is Canon City, approximately 11 miles to the southeast of the operation. There are two access drives to the site off the west side of County Road 62, both were blocked with berms of overburden material from the operation. The berms are constructed during times in inactivity to prevent trespassing and vandalism from occurring, see Photo #3 below.

Photo #3: View of the mine entrance with the berm to prevent trespassing on the right side of the photo.

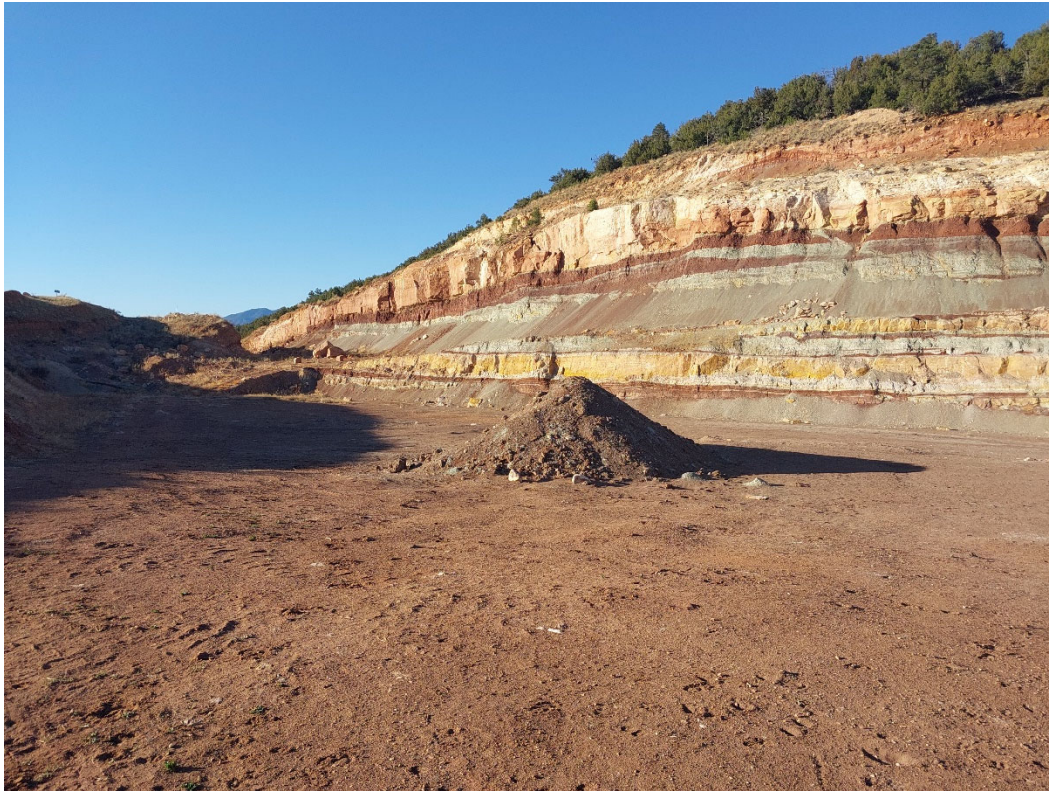
Photo #4: View of the highwall along the southern end of the active area, looking to the southwest. A small stockpile of material can be seen in the center of the photo.

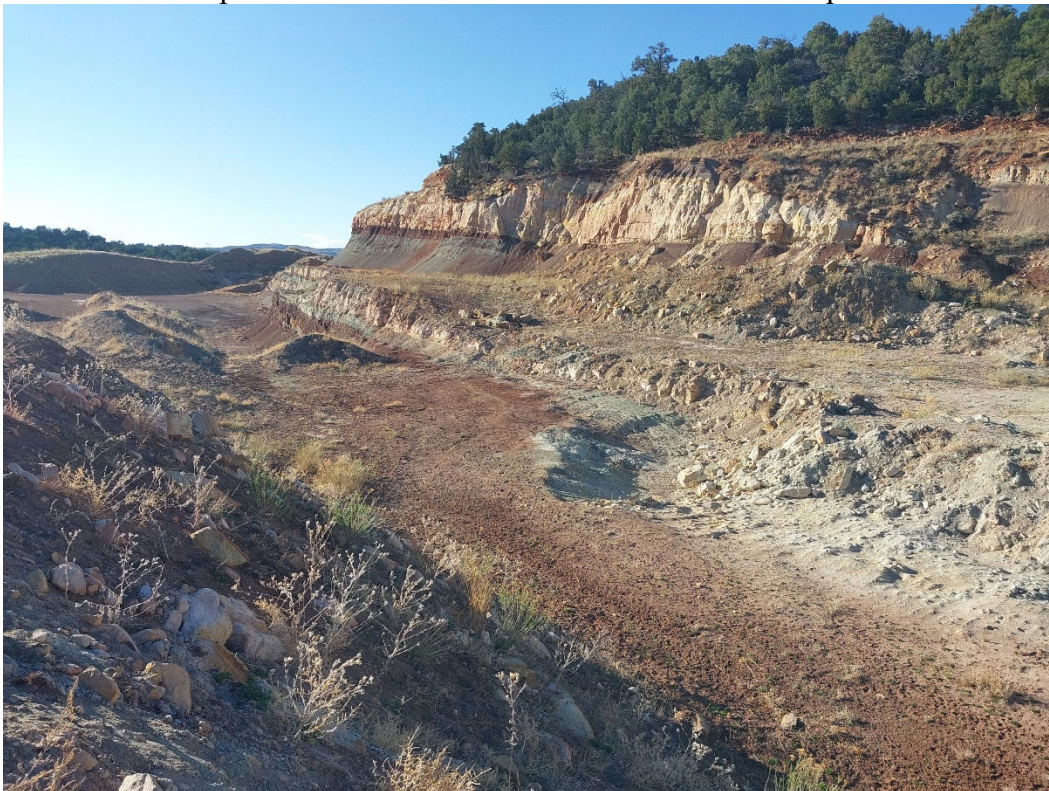
The operation extracts red and green clays out of the side of an uplift. The most recent satellite imagery was taken in October of 2024 and according to the annual report the last date of activity on the site was June 12, 2024. Using the satellite image, details about the operation were obtained. There is a high wall along the western boundary of the affected area, the height of the high wall does not appear to exceed the approved 40 feet, see Photo #4. There are two benches, a higher bench to the northwest that is approximately 240 feet in length and a lower bench to the southeast approximately 175 feet in length. The high wall and the benches follow the contour of the uplift, see Photo #5. The affected area measures to be about 3.2 acres.

Photo #5: View of the upper and lower benches, looking to the southeast from the northern portion of the active area.

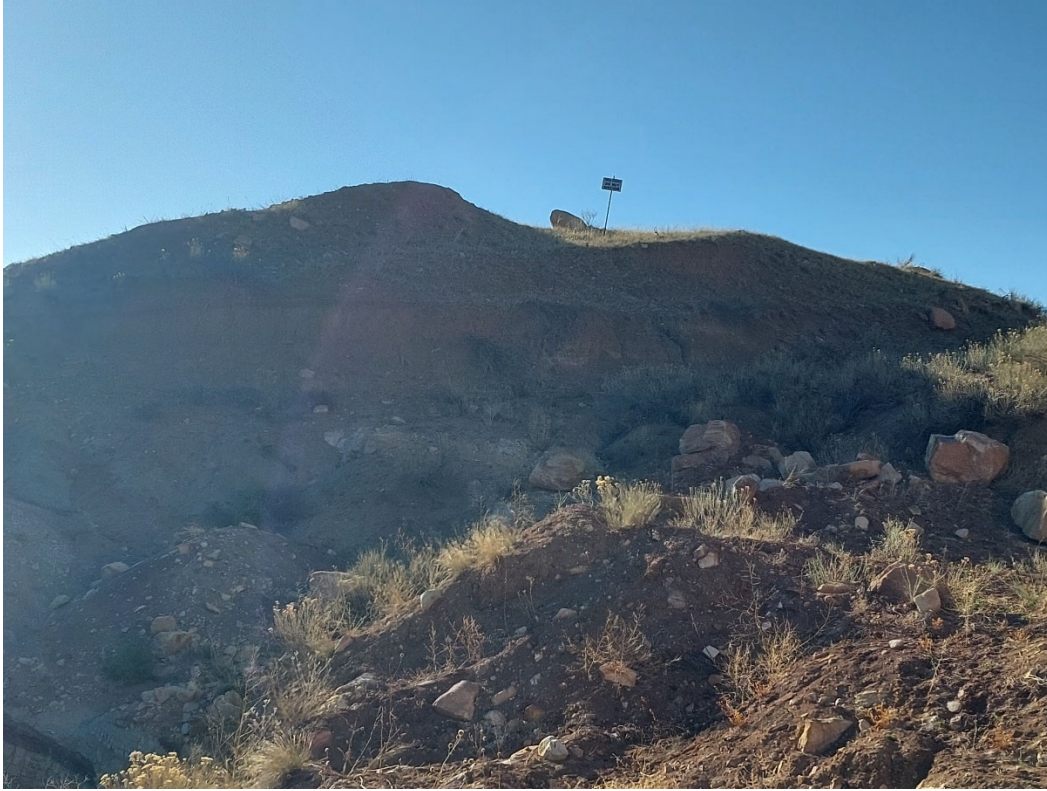
The topsoil stockpiles are marked and segregated from the main operation, the slopes are stable and there is adequate volume and vegetation to preserve the growth material, see Photo #6.

Photo #6: Example of a topsoil stockpile on the eastern side of the permitted area with a “Do Not Disturb” sign posted.

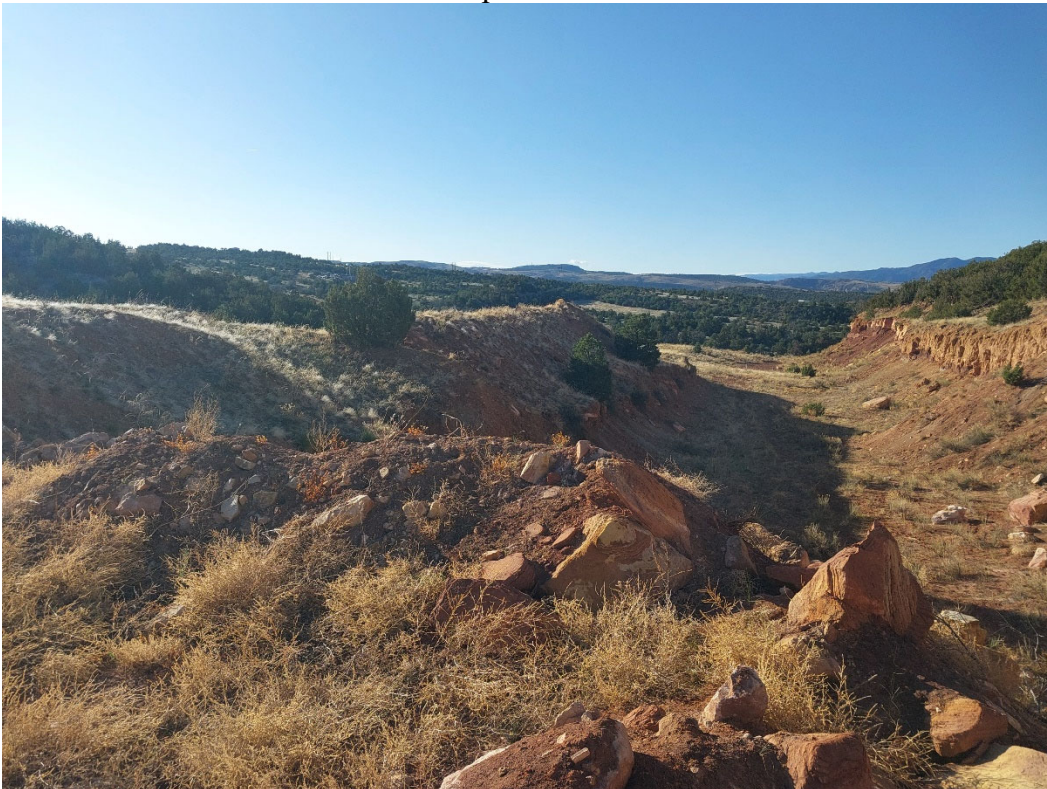
Photo #7: View of the area to the south of the active area that was originally affected by pre-law disturbance, the area has since been reclaimed.

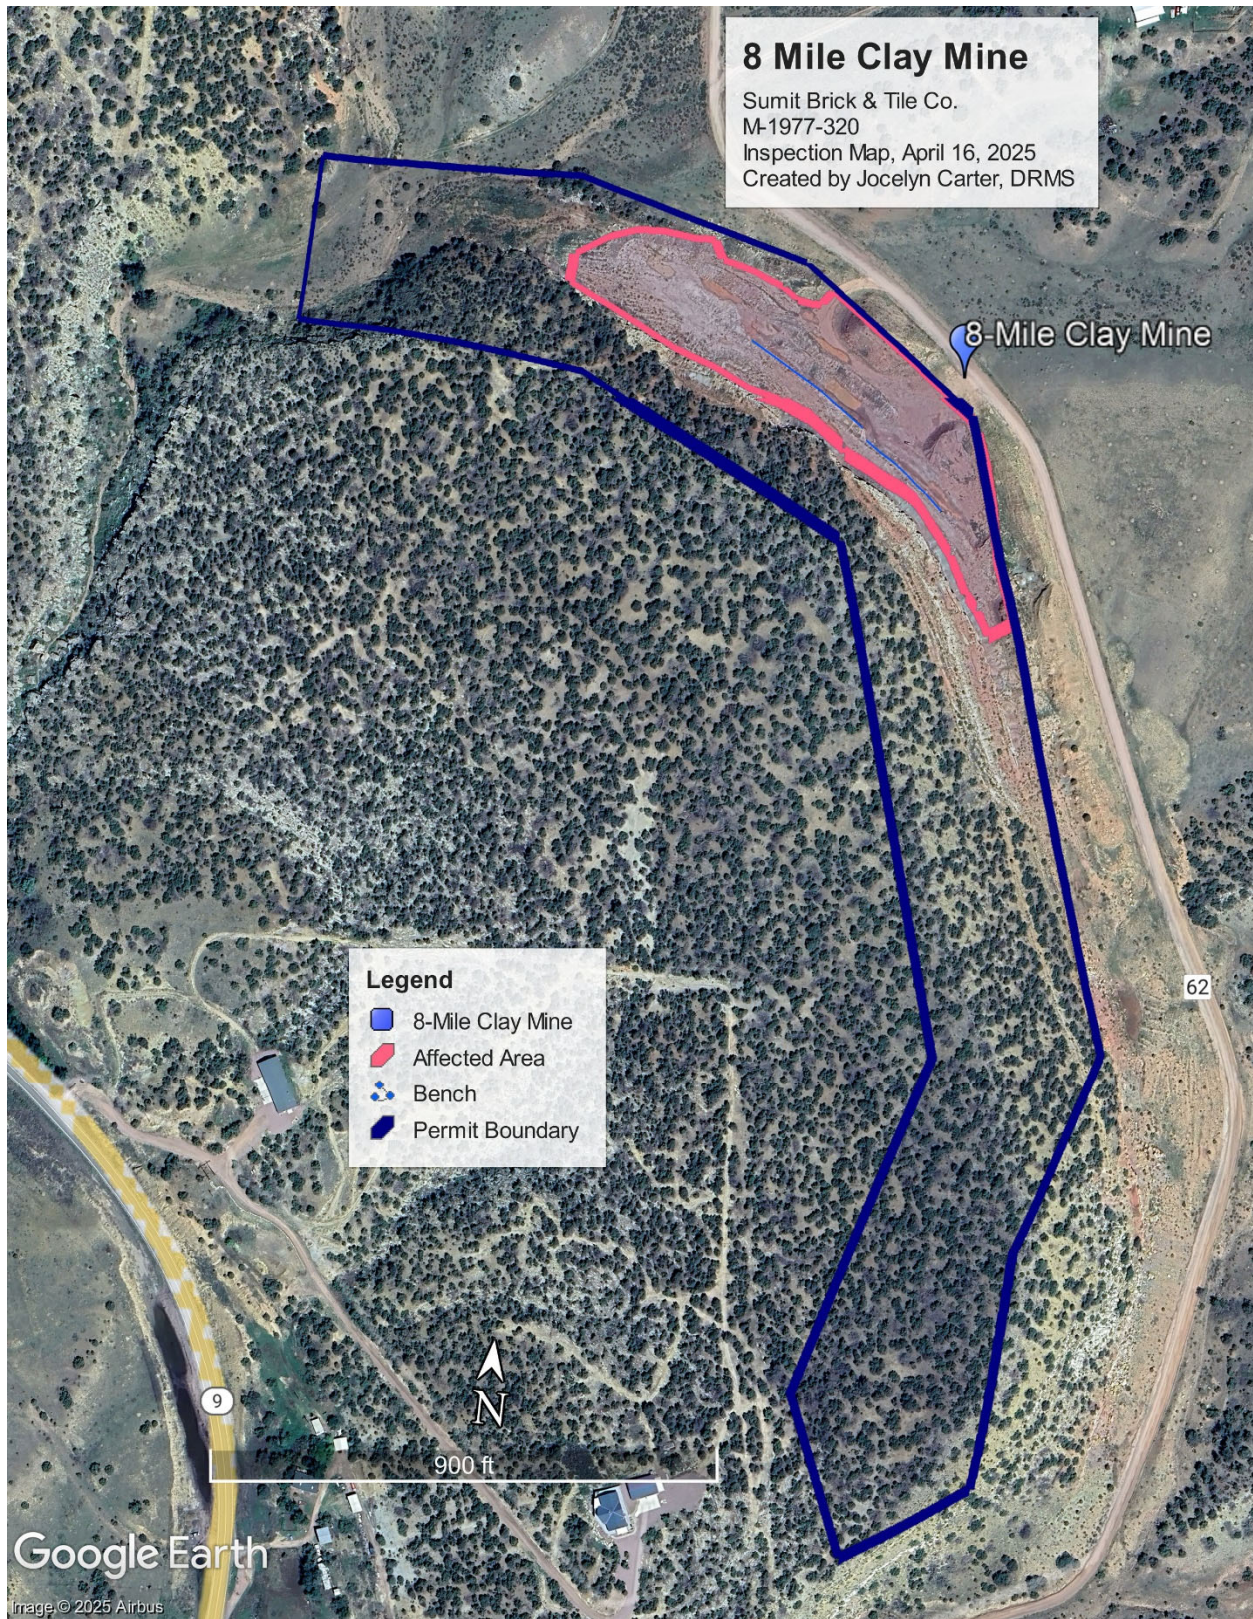
Figure 1: Satellite view of permit area with the permit boundary, affected/active area and benches shown.
