MINERALS PROGRAM INSPECTION REPORT

MINE NAME: Leadville Mill	MINE/PROSPECTING ID#: M-1990-057	MINERAL: Gold	COUNTY: Lake
INSPECTION TYPE: Monitoring	WEATHER: Clear	INSP. DATE: May 8, 2025	INSP. TIME: 09:58
OPERATOR: Union Milling Company, LLC	OPERATOR REPRESENTATIVE: Nick Michael, Gary Knippa	TYPE OF OPERATION: 110d - Designated Limited Impact

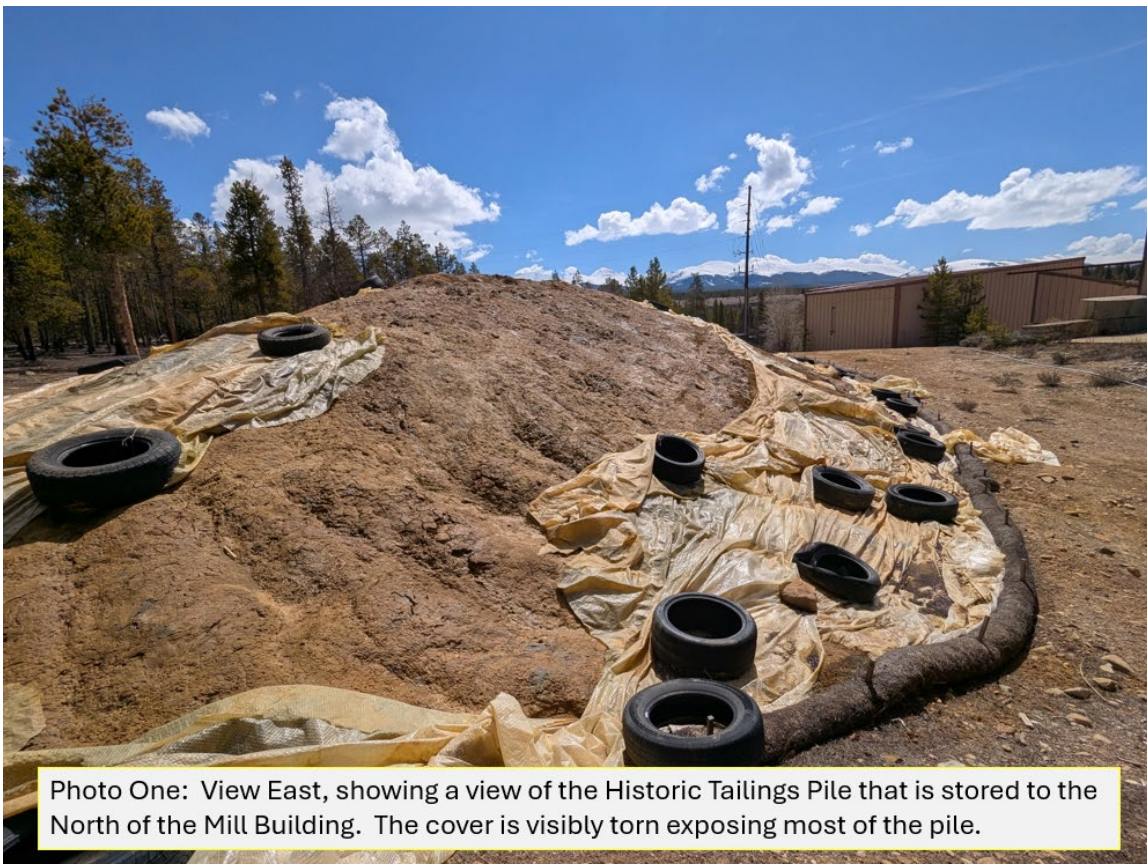
The complaint received, with photographs, showed that the covering that protects a historic tailings pile being stored on the North side of the mill had fallen into disrepair exposing the tailings and leaving the pile prone to erosion and transport. The historic tailings pile was relocated to this area, to be stored on a polypro liner with a visqueen cover under Technical Revision 5 (TR-5) submitted in October of 2020. The Operator was contacted on Wednesday April 30, 2025 via email, and the inspection was scheduled. In the time between scheduling and the day of the inspection the Operator contacted the Division to convey they were aware of the issue and were in process of conducting the corrective actions on all four piles located on site. The day of the inspection the historic tailings pile was observed and the covering was found to be torn, leaving the pile exposed as seen in Photos One and Two. Observations indicate that winter conditions including prevailing winds had deteriorated the covering. The pile itself showed no signs of significant erosion or sediment transport. The straw wattles surrounding the pile are still in good condition and appeared to be functioning as designed. On-site discussions with the Operator indicated the materials required to complete the repairs are on site, however had not yet been installed.

Based on the observations made during this inspection, Division staff has determined that the coverings over the piles, specifically LG 1 and the Historic Tailings Pile are considered a problem in need of corrective actions. The Operator shall, within 30 days of the date of this report, remove and properly dispose of the deteriorated pile coverings and replace the coverings on all four piles. Upon completion of the corrective actions, the Operator shall submit photo documentation to the Division showing the trash and remains of the old covers have been removed and that the new covers have been installed. Photo documentation must be received by the Division no later than Friday June 13, 2025.

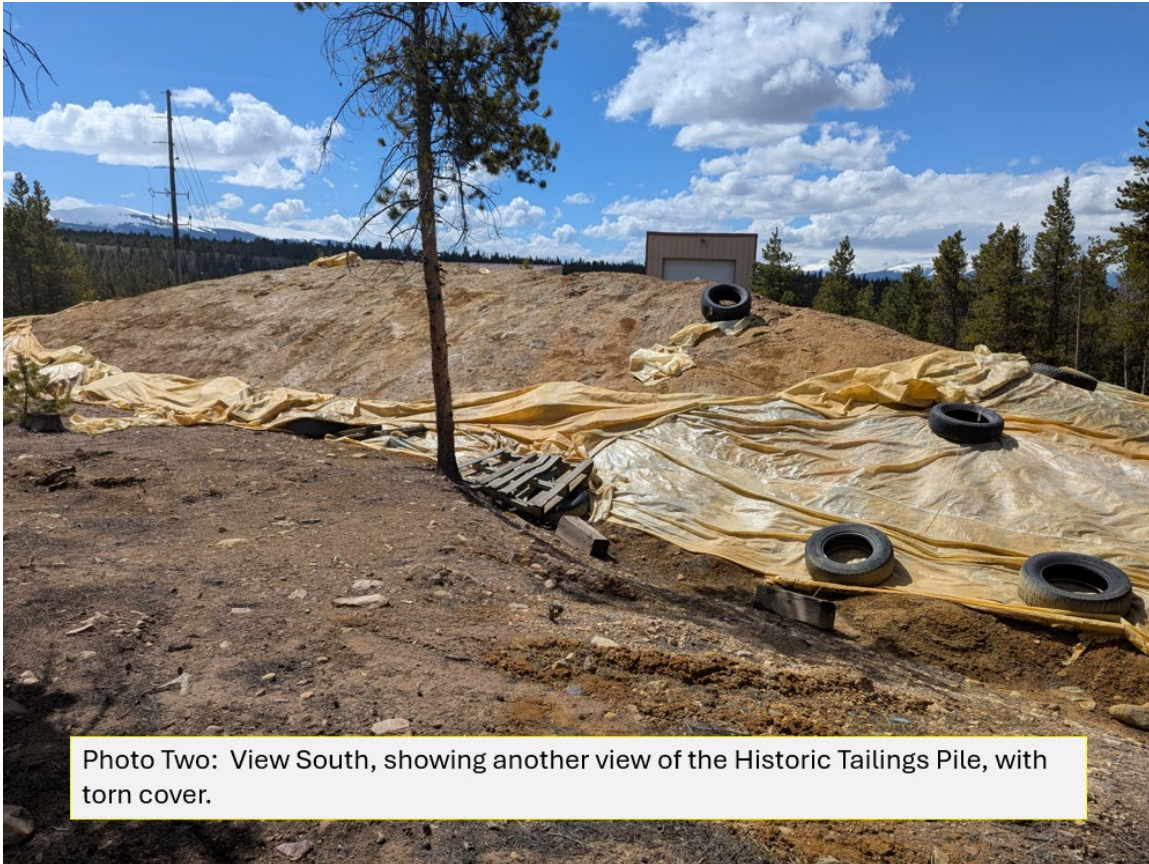
Photo Two: View South, showing another view of the Historic Tailings Pile, with torn cover.

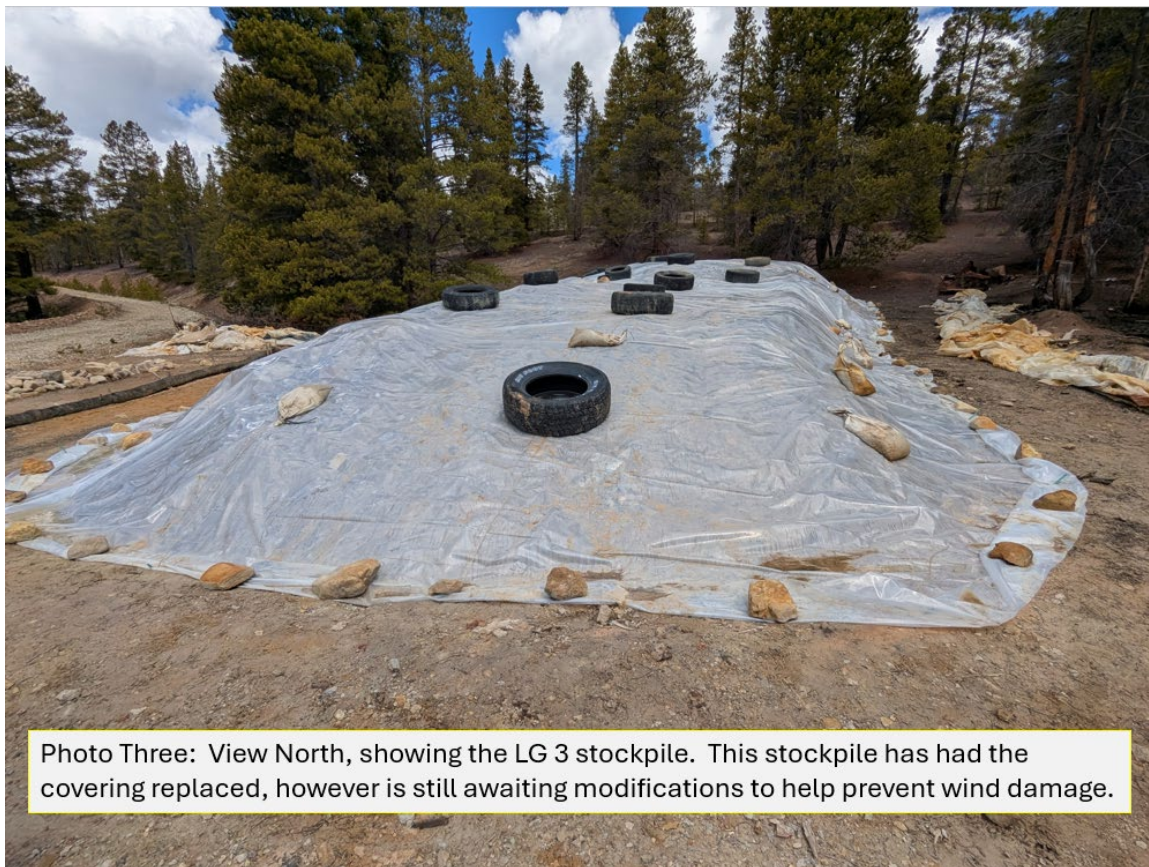
Photo Three: View North, showing the LG 3 stockpile. This stockpile has had the covering replaced, however is still awaiting modifications to help prevent wind damage.

In addition to the historic tailings pile stored on site, there are three piles of ore stored to be processed through the mill. Similar to the historic tailings these piles are required to be covered by the visqueen liner to prevent erosion and leachate from forming. The piles are referred to as LG1, 2 and 3 respectively. Though not called out in the complaint, the Operator surveyed the three piles and conducted repairs where necessary. The covering over LG 3 was also found to be in disrepair and the entirety of its cover has been replaced as seen in Photo Three. The covering over LG 2 was also found to be in disrepair and the cover has been replaced as seen in Photo Four. Pile LG 1's cover was also in need of replacement and the day of the inspection the cover had been mostly removed in preparation to install the new liner. Pile LG 1 can be seen in Photo Five. All of these piles are protected around their perimeter with straw wattles which were in good condition and functioning as designed. No evidence of erosion or sediment transport was noted. Minor modifications to the repaired coverings will be made, specifically the cover will be laced with rope and more ballast items will be placed to mitigate wind damage.

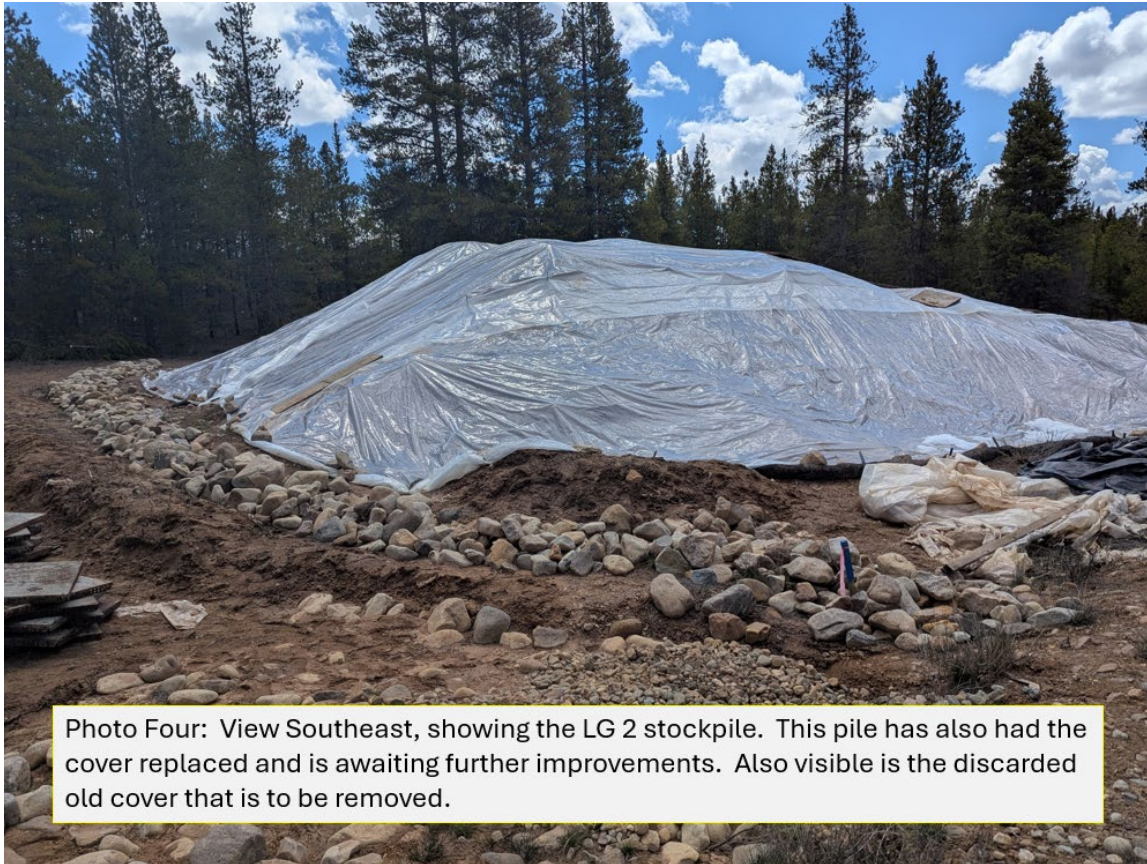
Photo Four: View Southeast, showing the LG 2 stockpile. This pile has also had the cover replaced and is awaiting further improvements. Also visible is the discarded old cover that is to be removed.

CORRECTIVE ACTIONS: The Operator shall, within 30 days of the date of this report, remove and properly dispose of the deteriorated pile coverings and replace the coverings on all four piles. Upon completion of the corrective actions, the Operator shall submit photo documentation to the Division showing the trash and remains of the old covers have been removed and that the new covers have been installed. Photo documentation must be received by the Division no later than Friday June 13, 2025.

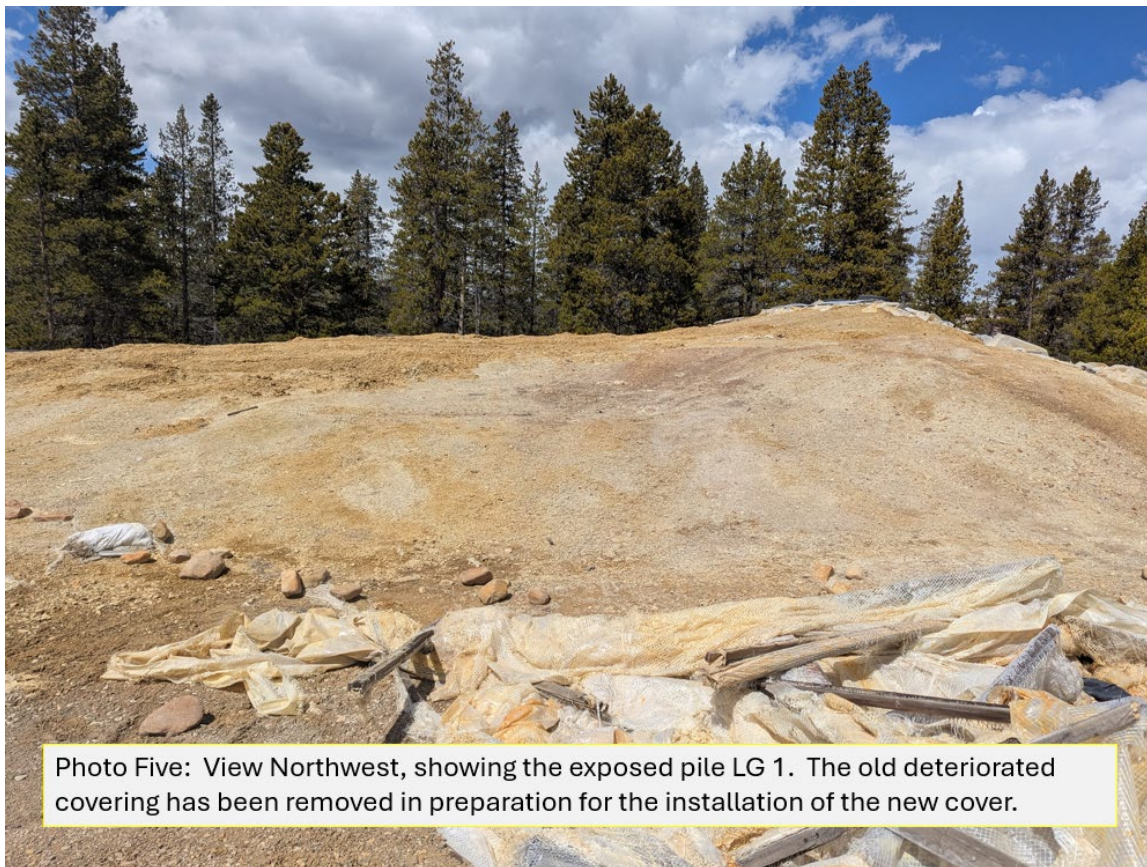
Photo Five: View Northwest, showing the exposed pile LG 1. The old deteriorated covering has been removed in preparation for the installation of the new cover.

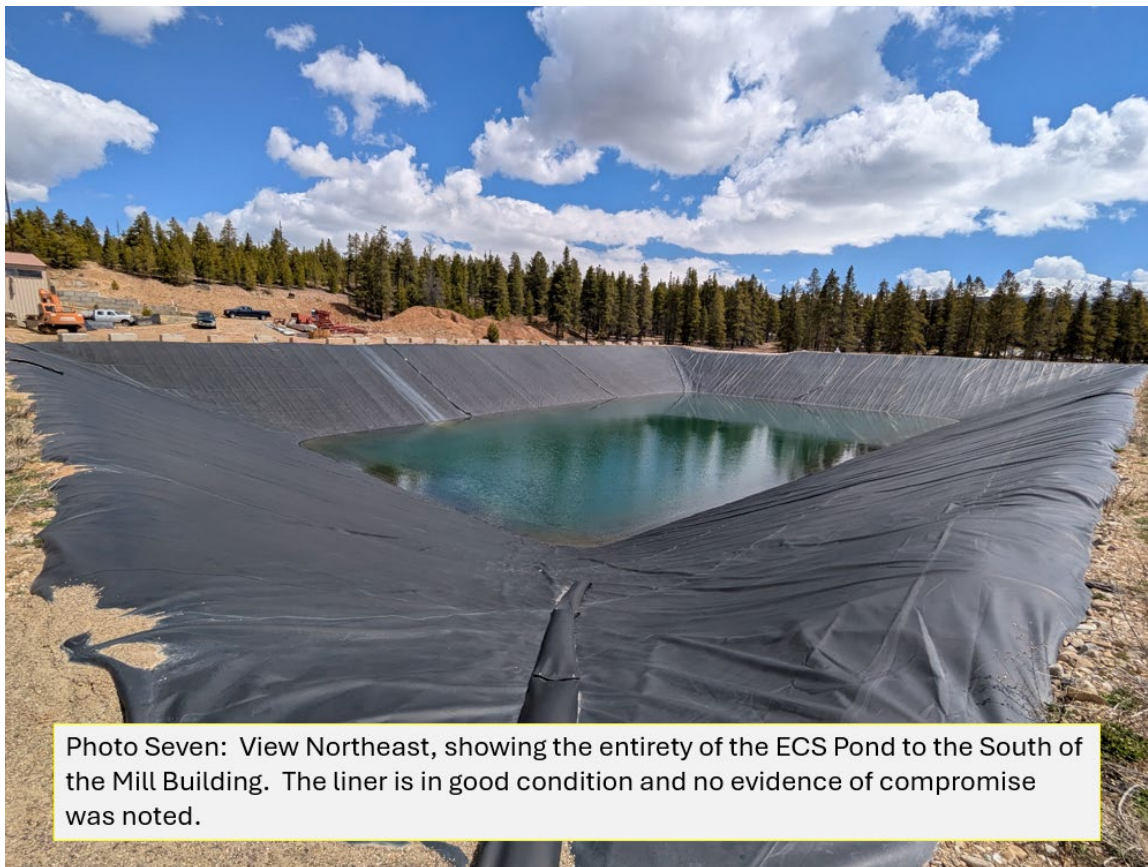
The remainder of the site was inspected and found to be in good condition. The proper Mine Identification signage and boundary markers were observed. The stormwater control structures including conveyance ditches, berms and upland diversion ditches were found to be in good condition and appeared to be functioning as designed. An example of the stormwater control structures can be seen in Photos Six. The ECS pond to the south mill building was found to be in good condition. The liner showed no signs of compromise,

and the pond contained a small amount of water as a result of snowmelt and other precipitation events. The ECS can be seen in Photo Seven.
