MINERALS PROGRAM INSPECTION REPORT
PHONE: (303) 866-3567

MINE NAME: MSF/Feister Pit #1	MINE/PROSPECTING ID#: M-2006-010	MINERAL: Sand, gravel and borrow material for construction	COUNTY: Las Animas
INSPECTION TYPE: Monitoring	WEATHER: Foggy	INSP. DATE: April 25, 2025	INSP. TIME: 08:30
OPERATOR: Las Animas County	OPERATOR REPRESENTATIVE: Keith Woodring	TYPE OF OPERATION: 112c - Construction Regular Operation	
REASON FOR INSPECTION: Normal I&E Program	BOND CALCULATION TYPE: None	BOND AMOUNT: \$0.00	
DATE OF COMPLAINT: NA	POST INSP. CONTACTS: None	JOINT INSP. AGENCY: None	
INSPECTOR(S): Amber M. Gibson	INSPECTOR'S SIGNATURE:

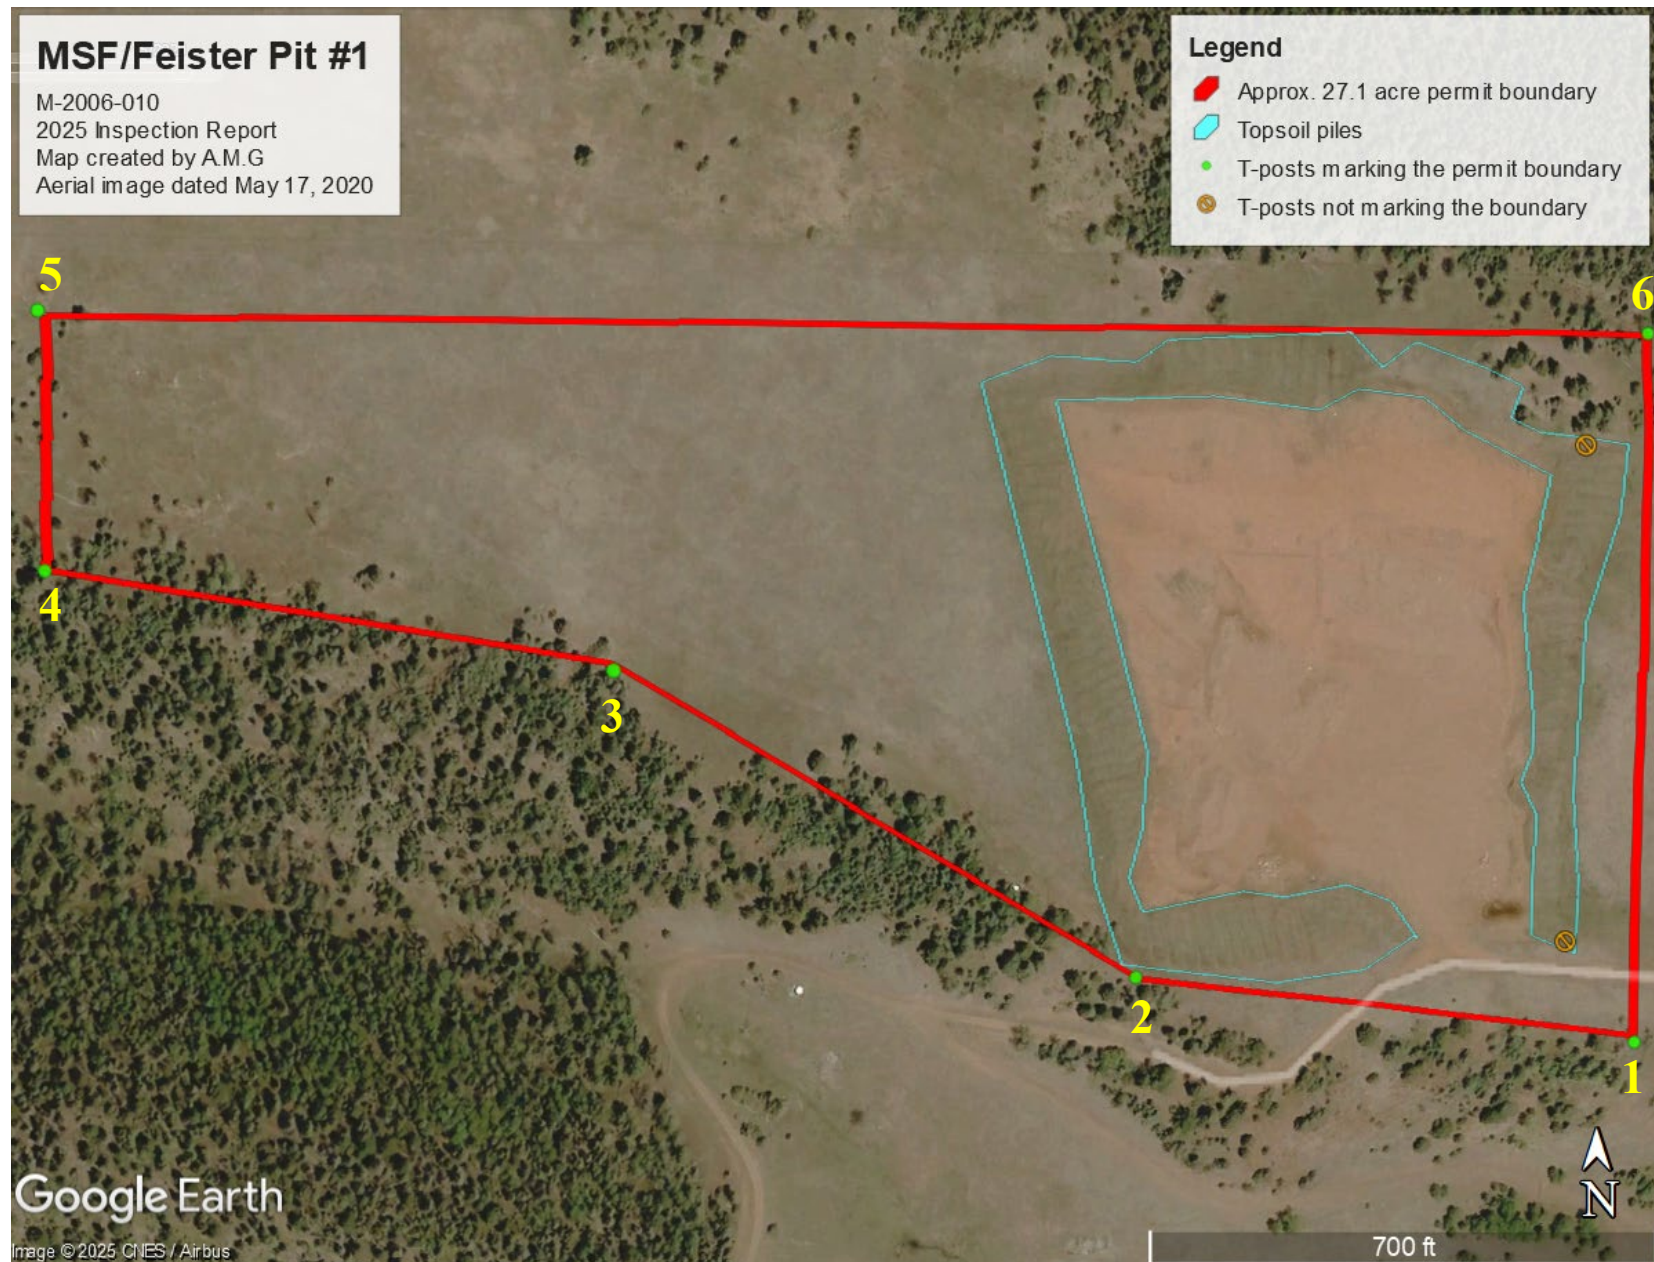
A mine sign was posted in compliance with Rule 3.1.12(1) and was located on the locked entrance gate leading to the site (Photo 21). The permit area is marked in compliance with Rule 3.1.12(2) and is identified by t-posts (Photo 22 and Map 1). The Inspector walked with the Operator around the permit boundary and collected the t-post's coordinates in the Esri Field Maps application. The permit boundary posts are indicated by the green circle icons on Map 1. There were also two additional t-posts with orange tops located near the pit on the northeast and southeast sides (see the orange slashed circles on Map 1).

Map 1: Inspection map for the inspection conducted on April 25, 2025. The aerial imagery is the clearest-most recent available in Google Earth Pro. The yellow numbers correspond with the t-post locations shown in Photo 22.

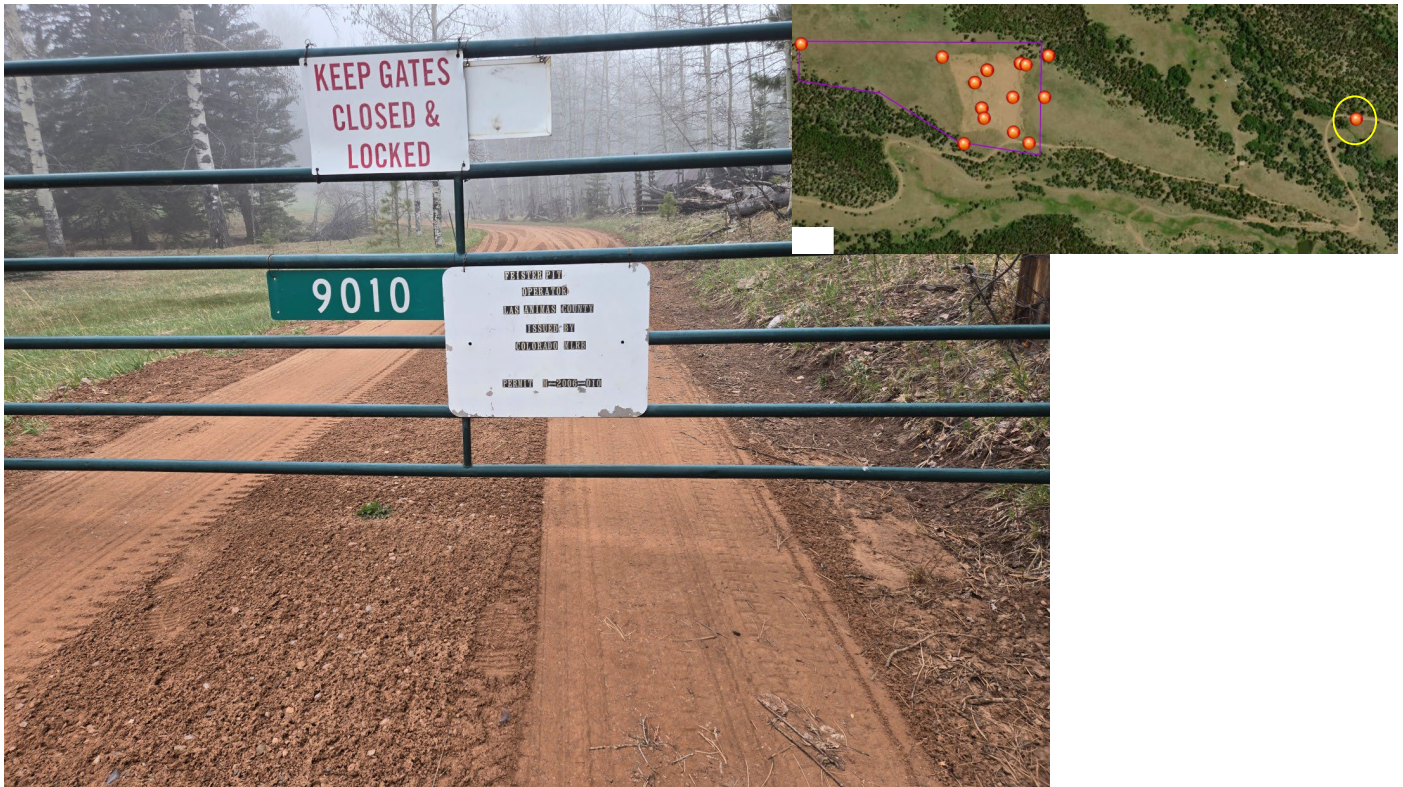
Photo 1: Mine sign posted on the entrance gate.

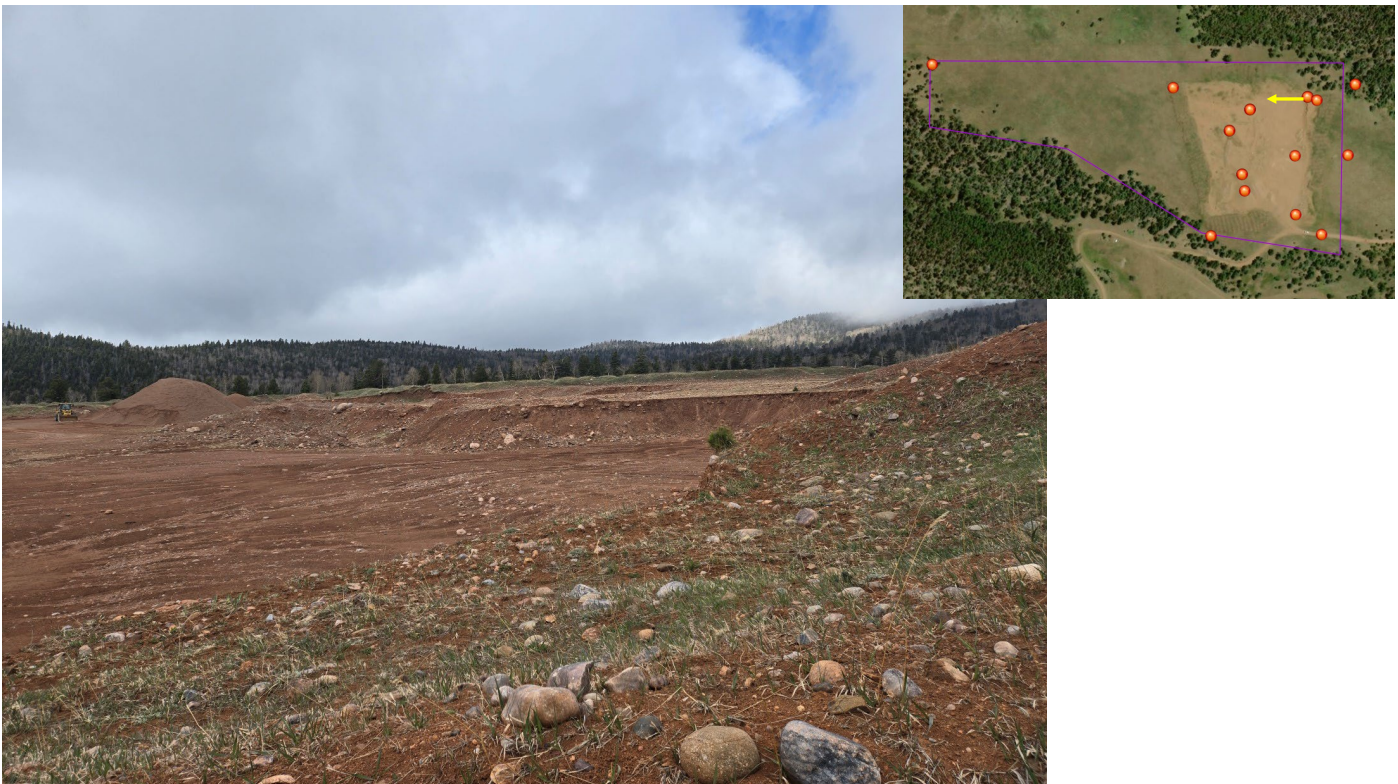
Photo 2: Looking west at where the excavated pit meets the elevated topsoil salvaged area.

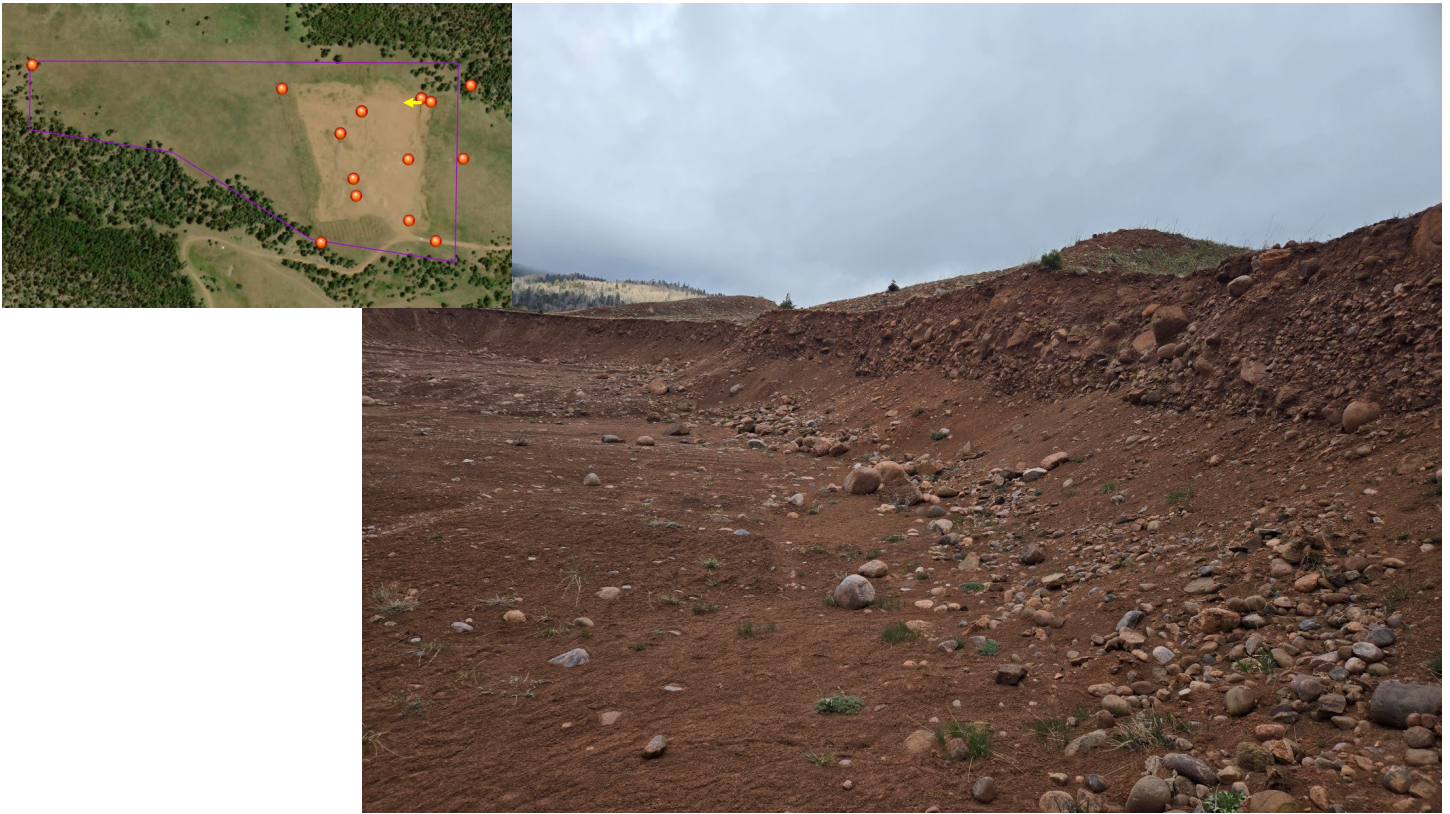
Photo 3: Steepest portion of the highwall within the pit.

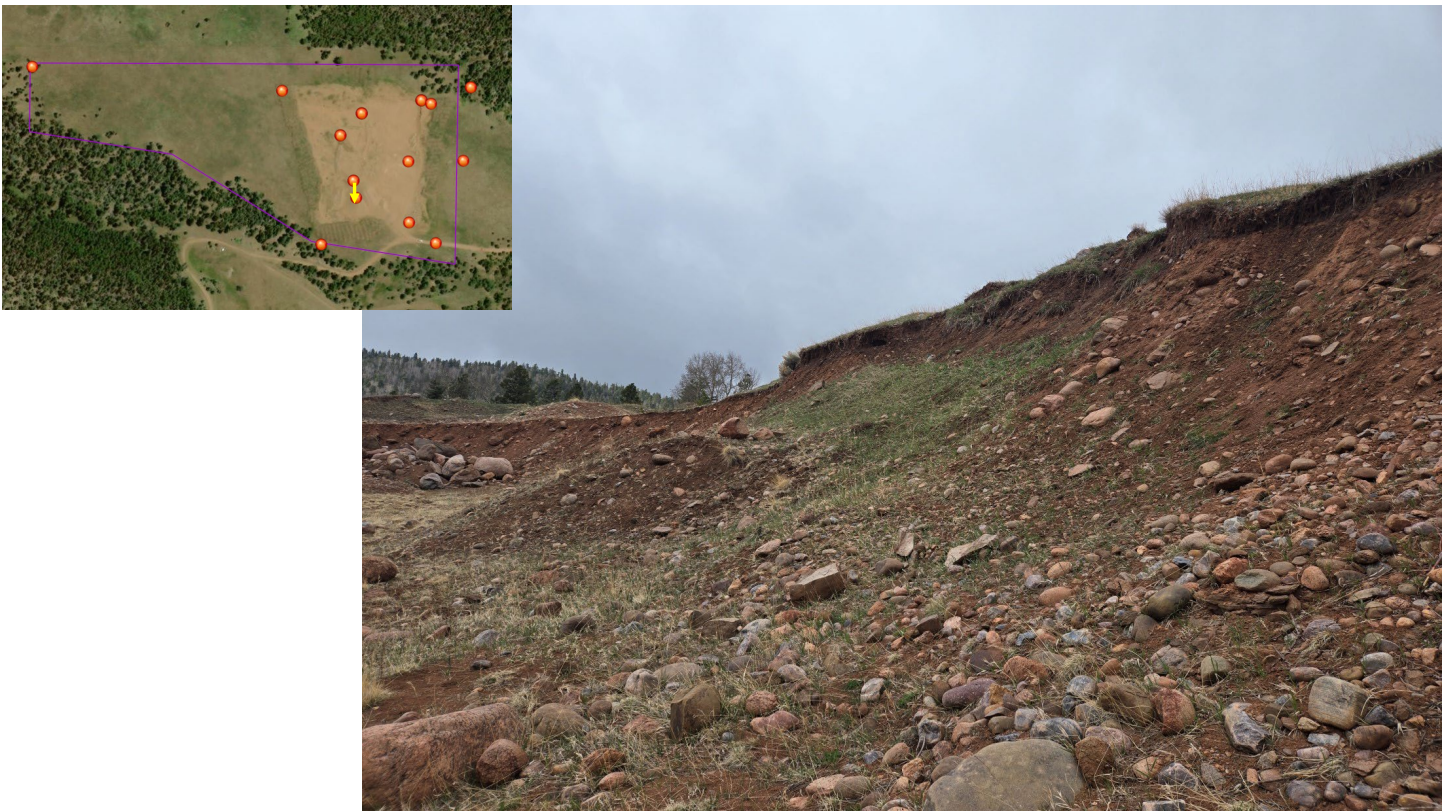
Photo 4: Gentler highwall slopes within the pit area.

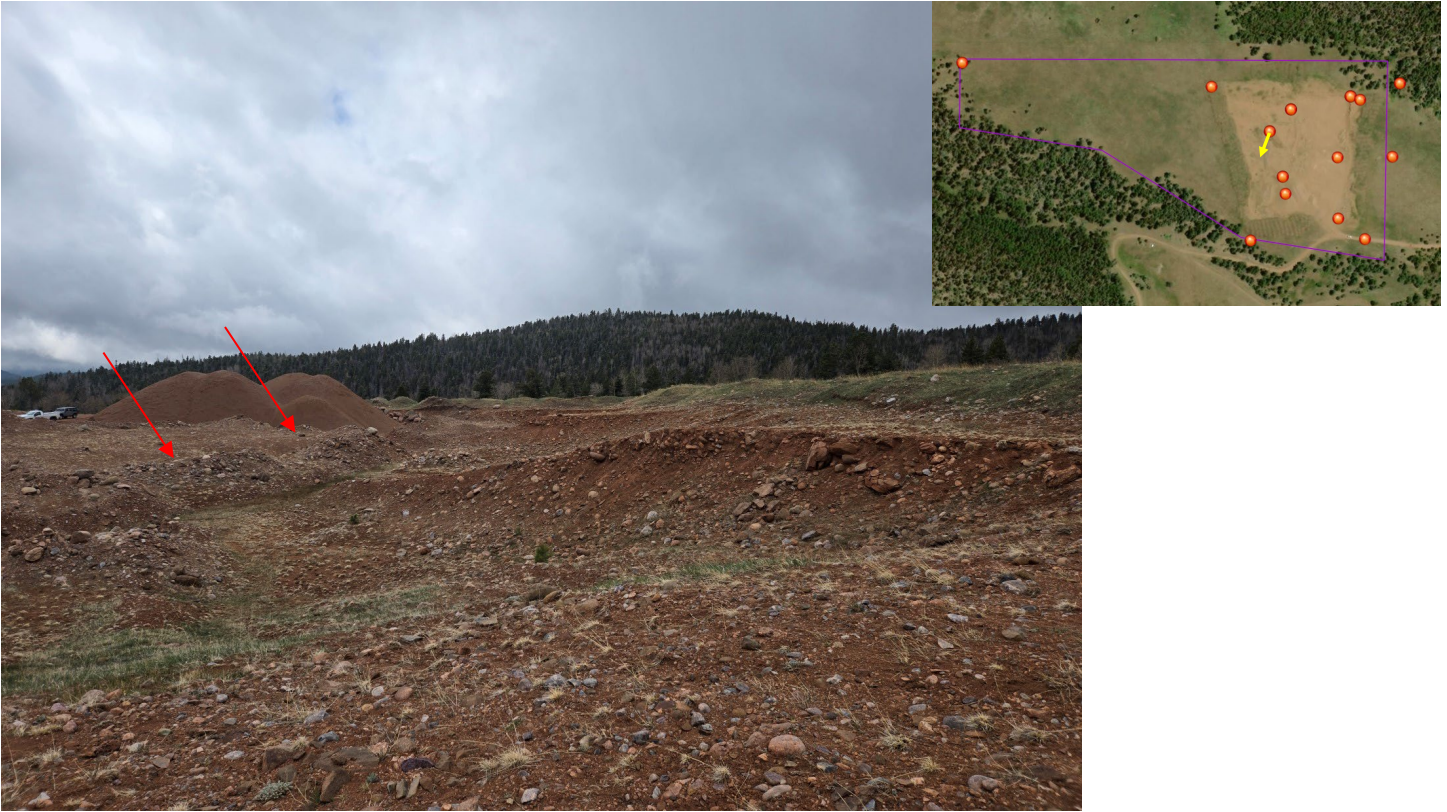
Photo 5: Red arrows point to some overburden stockpiles within the pit. The product stockpile is seen in the left side of the photo. Topsoil piles lining the pit can be seen from the center to the right side of the photo.

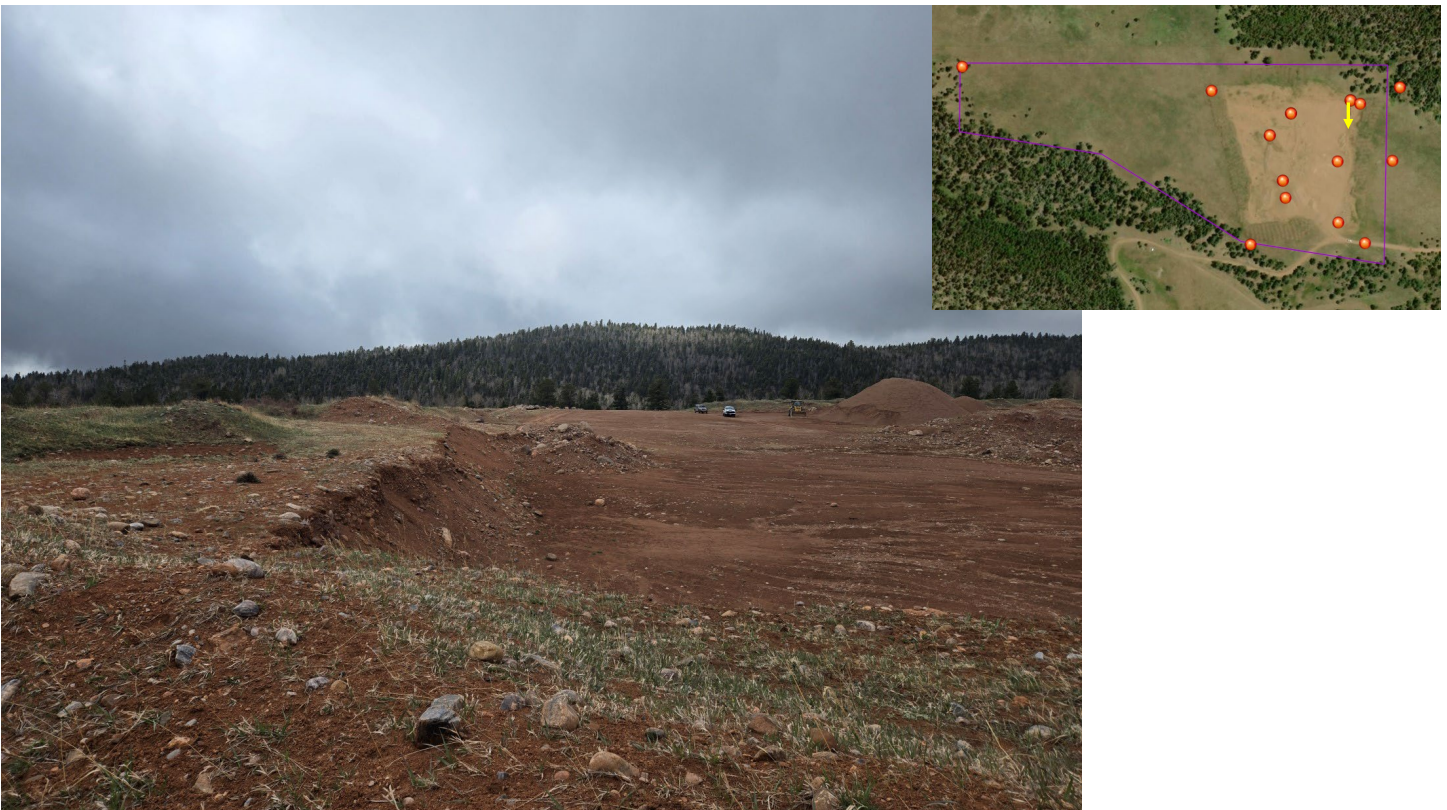
Photo 6: Looking south along the east side of the pit towards the entrance to the site.

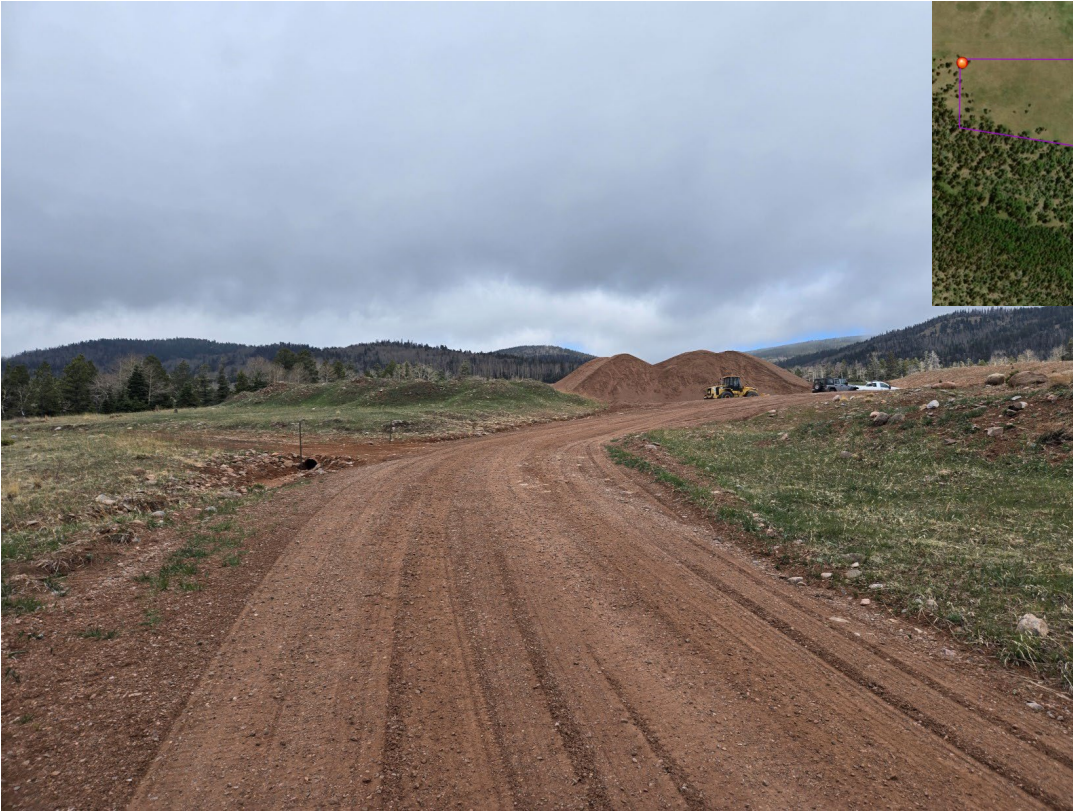
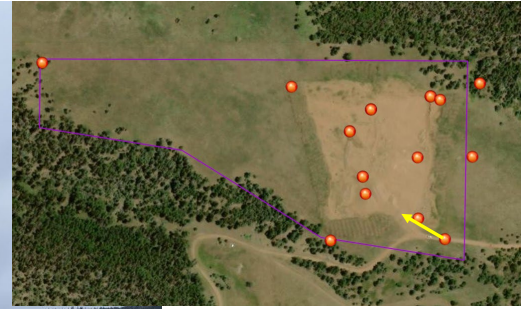
Photo 7: Looking into the site from the entrance road.

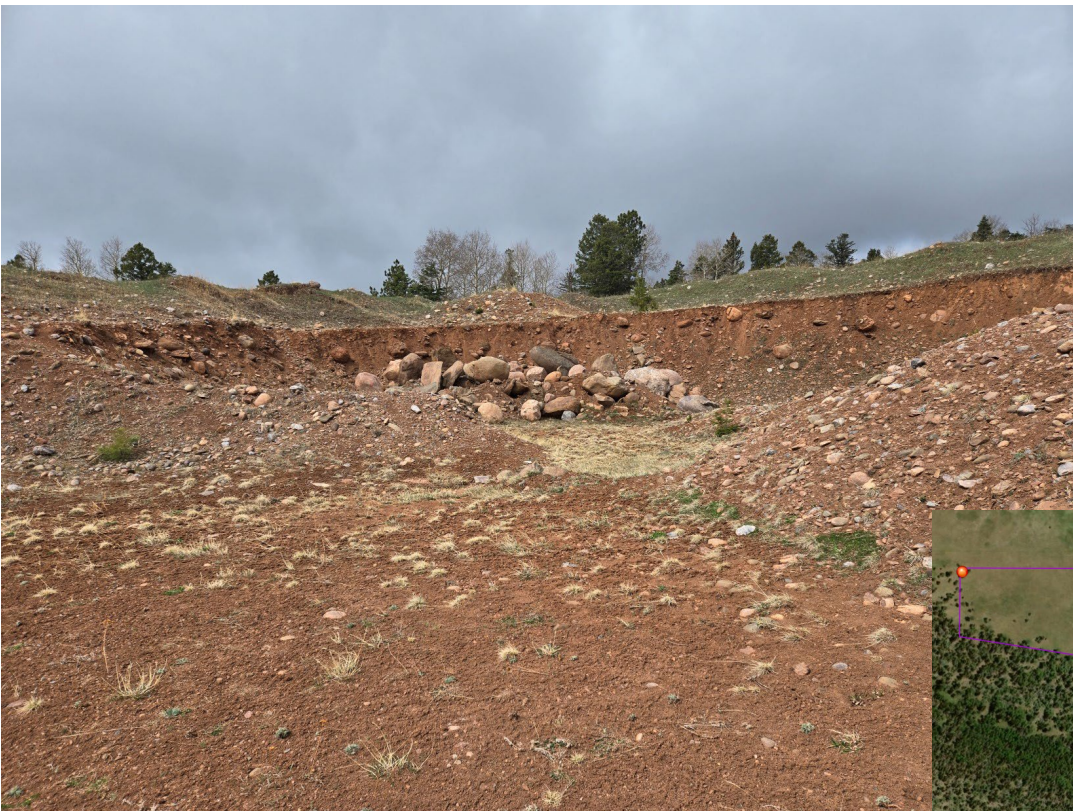
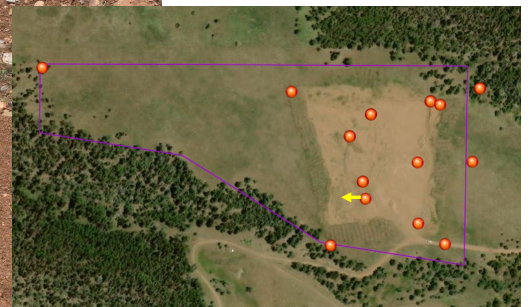
Photo 8: Large unsorted/uncrushed product material stockpile.

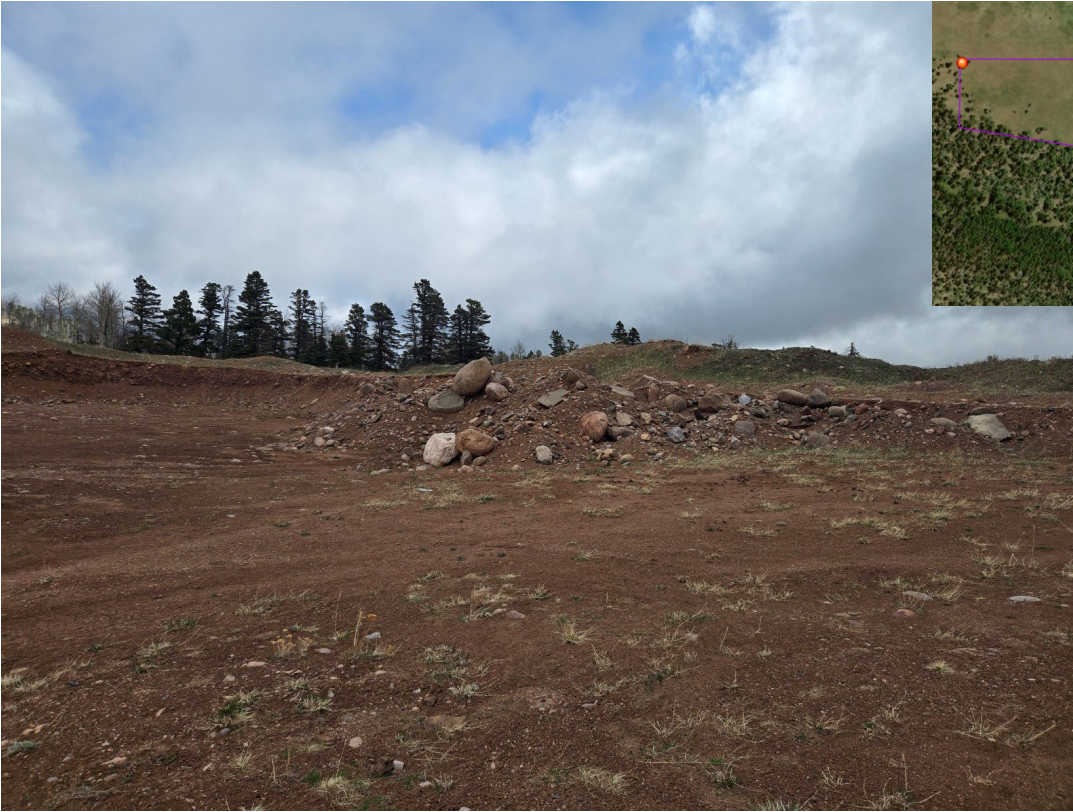
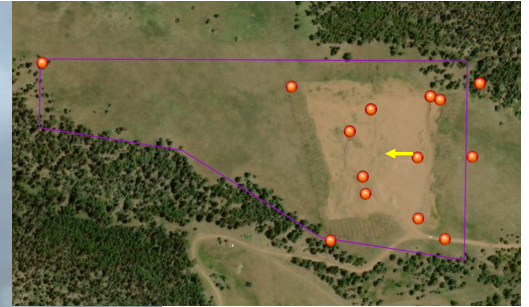
Photo 9: Uncrushed/unsorted material stockpile.

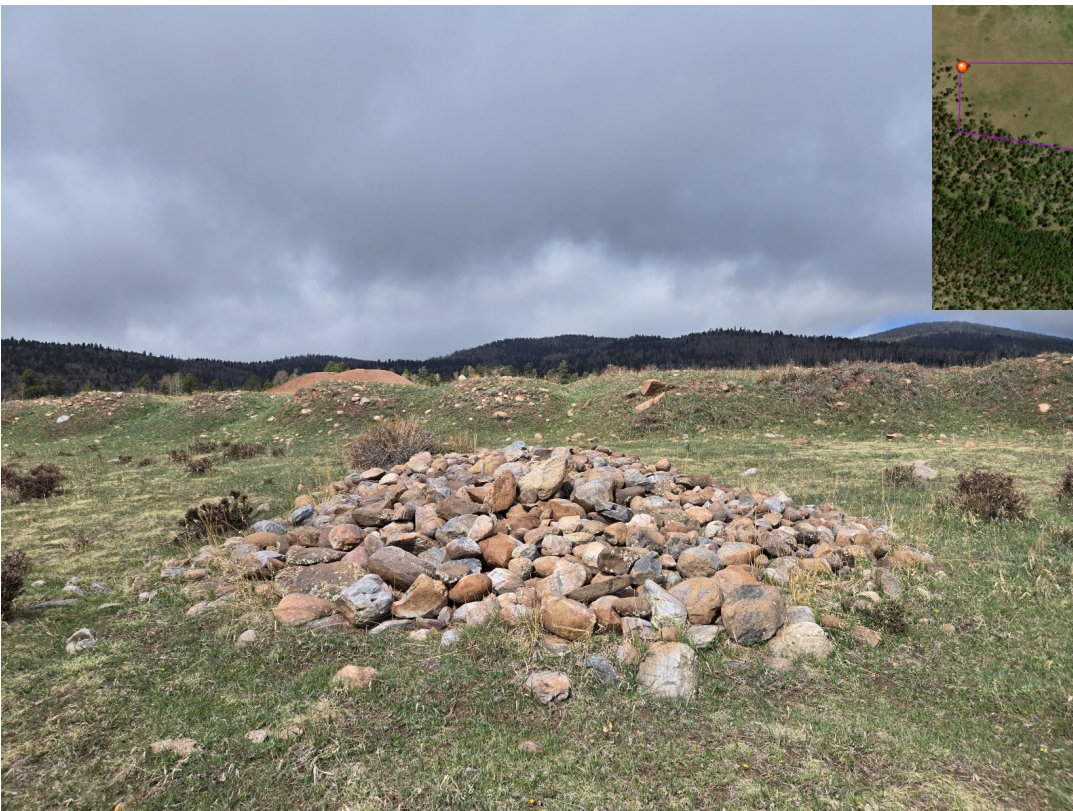
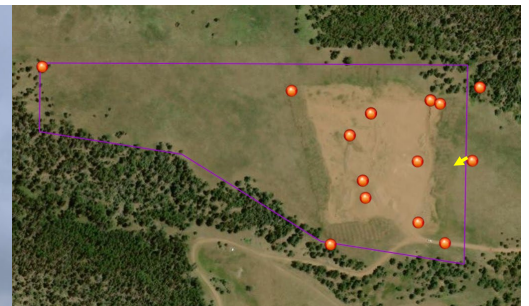
Photo 10: Small stockpile located east of the pit and east of the eastern topsoil berm, but within the permit boundary.

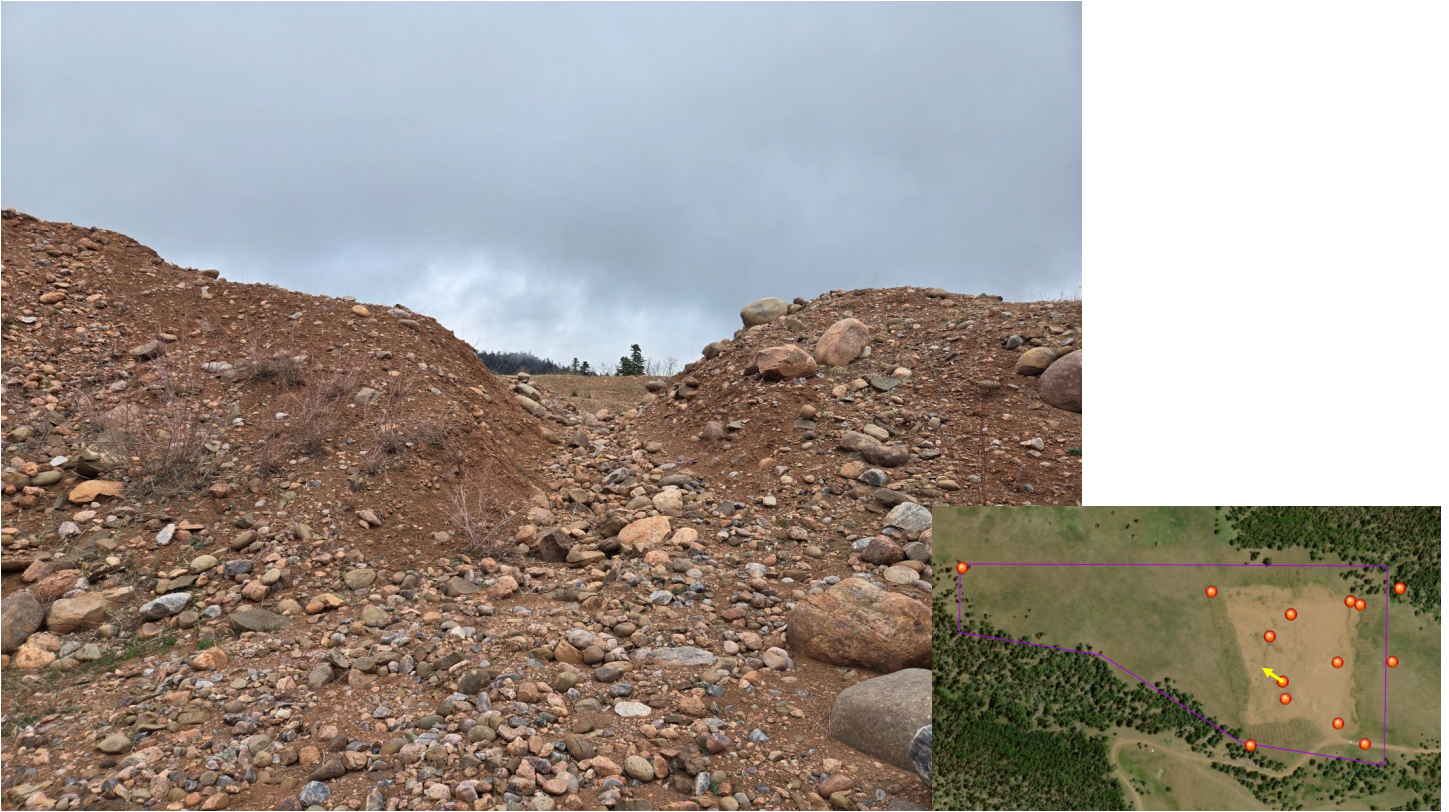
Photo 11: Path from within the pit up to the elevated western area.

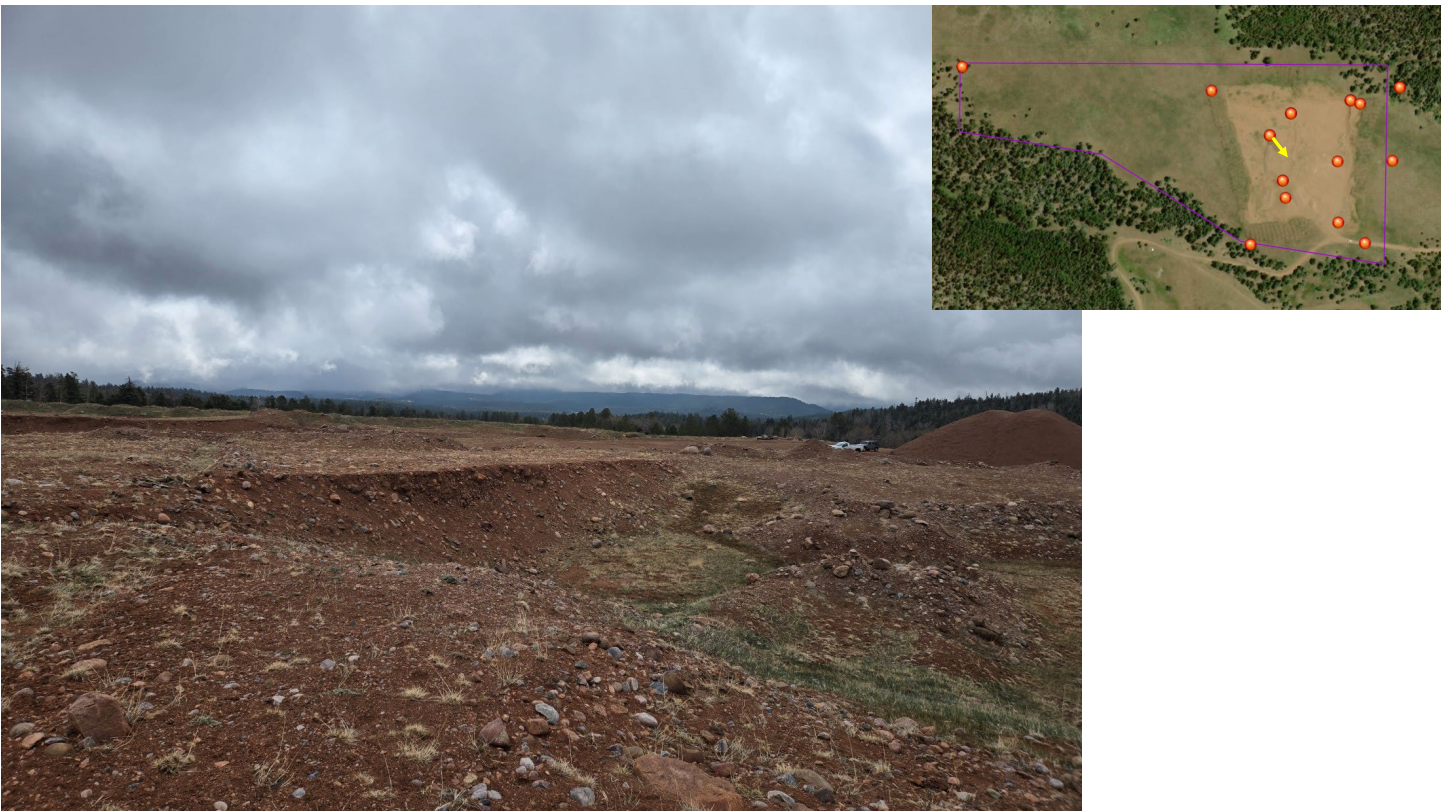
Photo 12: Looking across the pit from the elevated area.

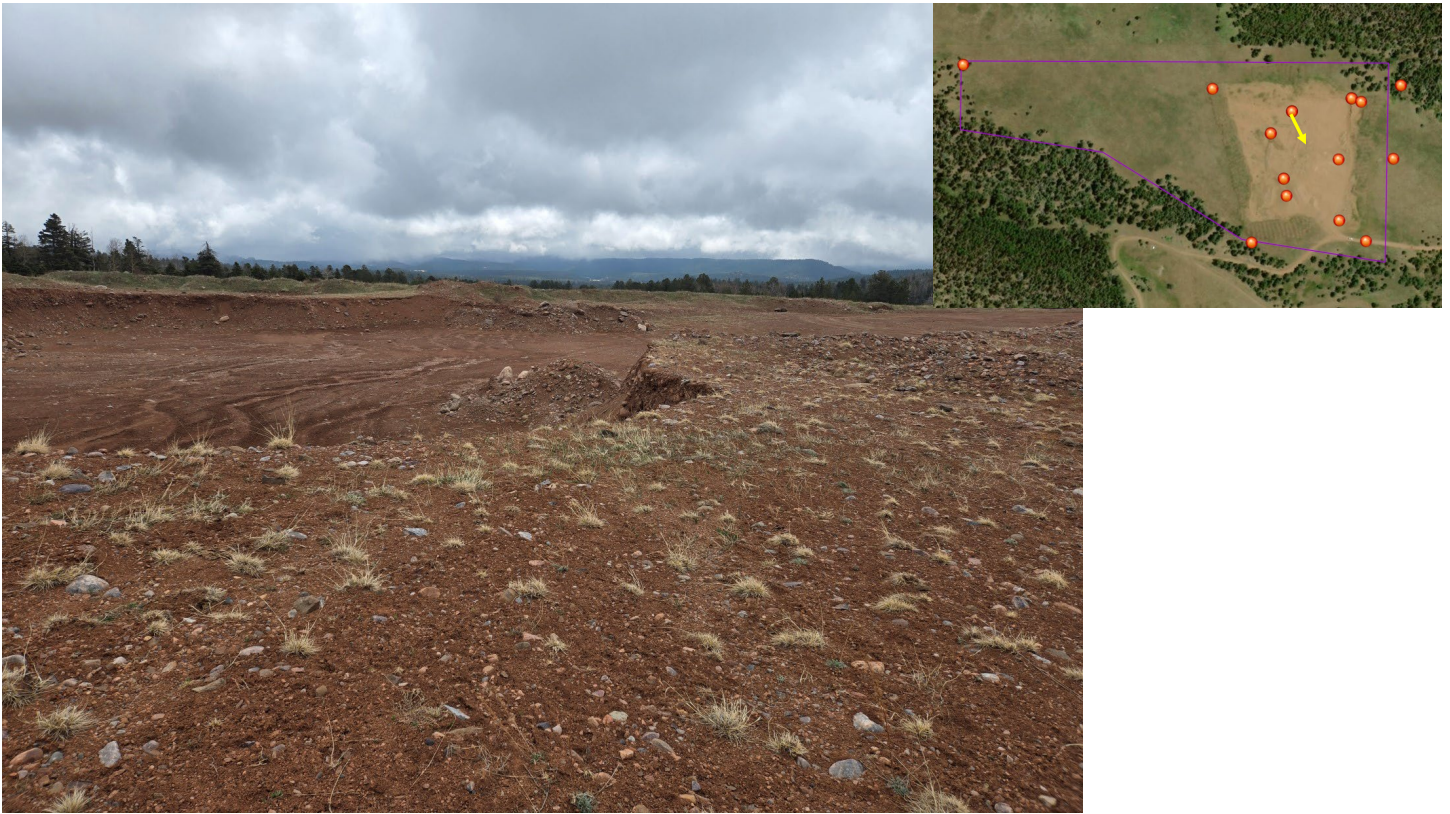
Photo 13: Looking across the pit from the elevated area.

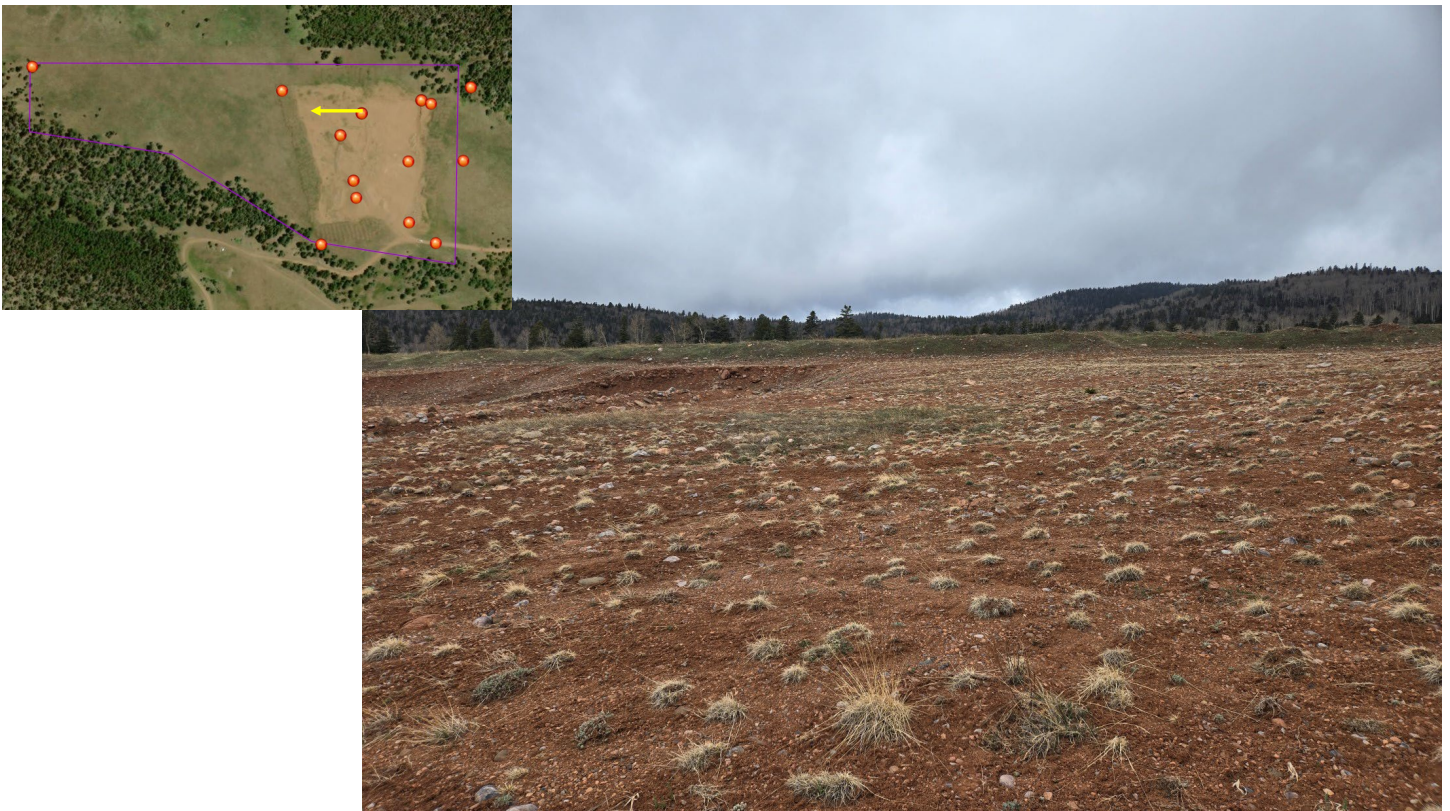
Photo 14: Looking across the elevated area where topsoil had been salvaged.

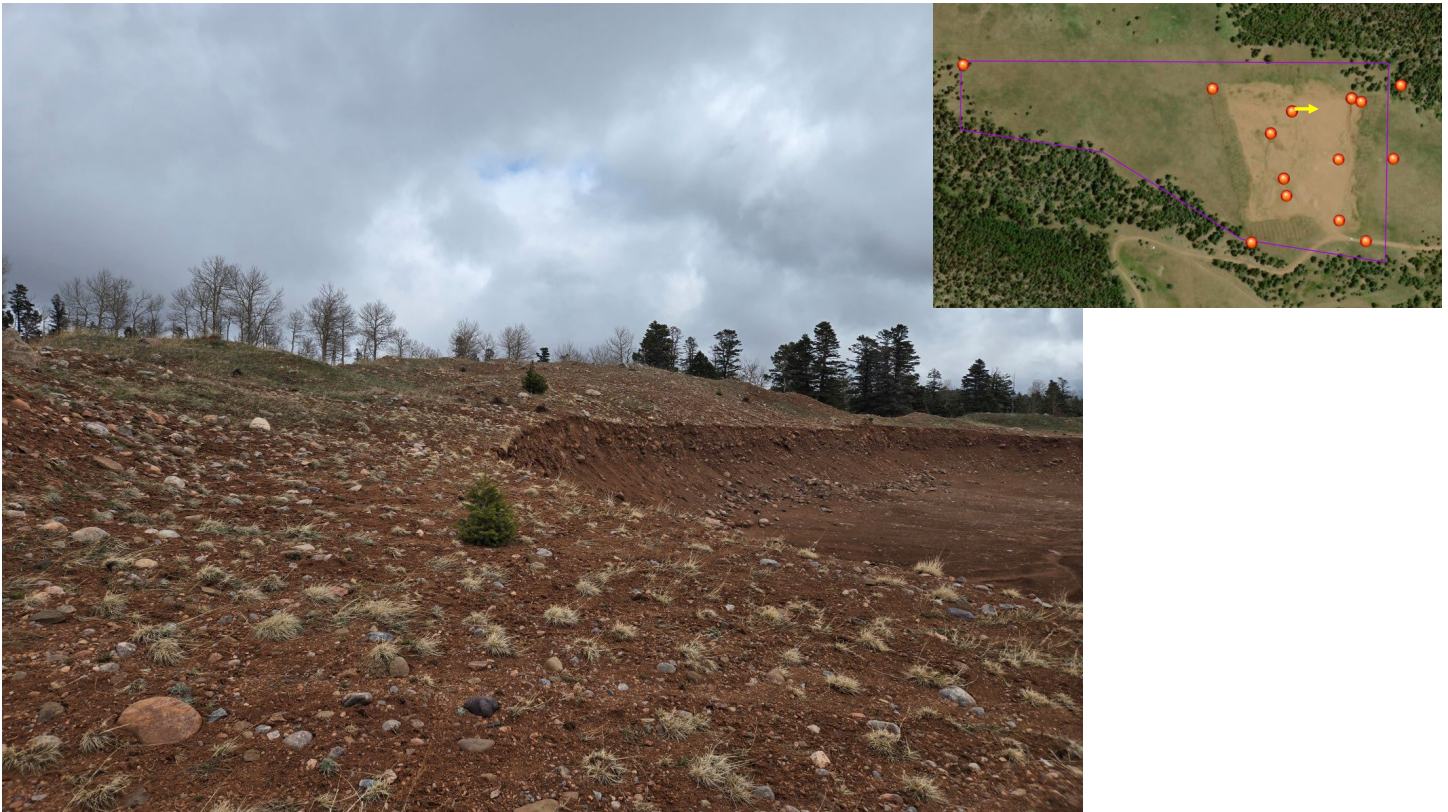
Photo 15: Looking along the northern highwall from the elevated area.

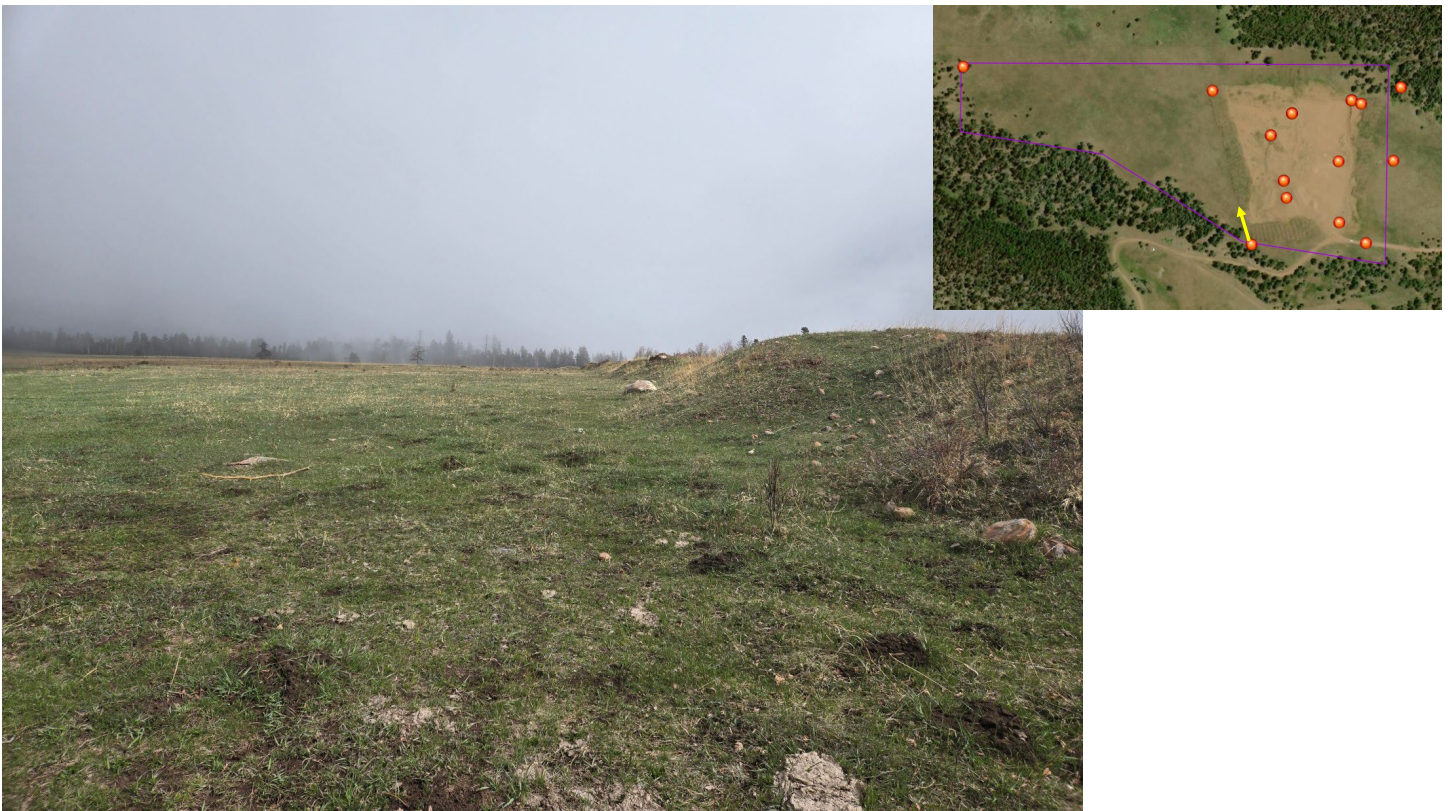
Photo 16: Looking along the west side of the western stockpile where it abuts undisturbed land within the permit boundary.

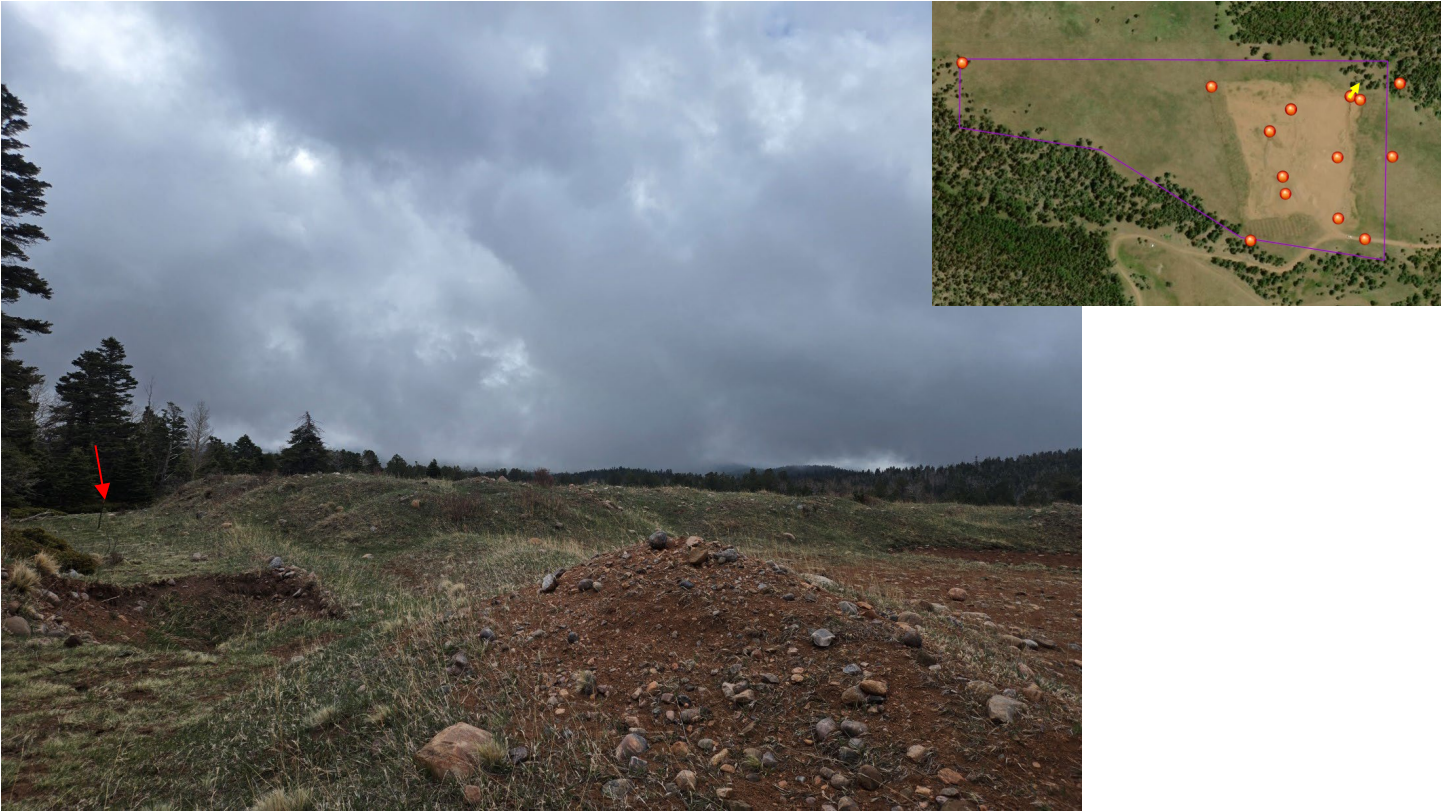
Photo 17: Looking at the topsoil stockpile in the northeast corner. The red arrow points to one of the two t-posts that are in from the permit boundary and indicated by orange slashed circles on Map 1.

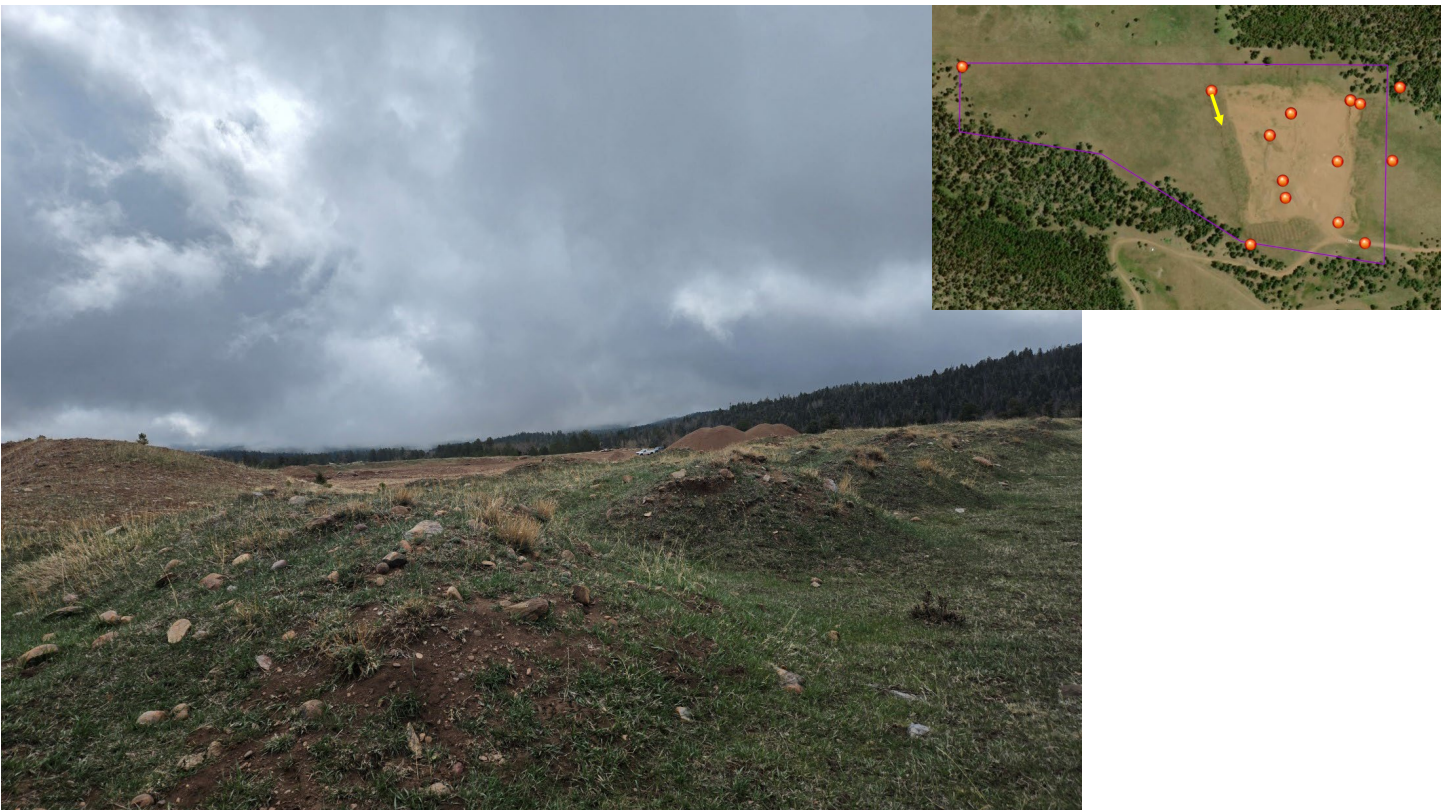
Photo 18: Looking southeast along the western topsoil stockpiles.
