MINERALS PROGRAM INSPECTION REPORT
PHONE: (303) 866-3567

MINE NAME: MSF/Feister Pit #1	MINE/PROSPECTING ID#: M-2006-010	MINERAL: Sand, gravel and borrow material for construction	COUNTY: Las Animas
INSPECTION TYPE: Monitoring	WEATHER: Foggy	INSP. DATE: April 25, 2025	INSP. TIME: 08:30
OPERATOR: Las Animas County	OPERATOR REPRESENTATIVE: Keith Woodring	TYPE OF OPERATION: 112c - Construction Regular Operation	
REASON FOR INSPECTION: Normal I&E Program	BOND CALCULATION TYPE: None	BOND AMOUNT: \$0.00	
DATE OF COMPLAINT: NA	POST INSP. CONTACTS: None	JOINT INSP. AGENCY: None	
INSPECTOR(S): Amber M. Gibson	INSPECTOR'S SIGNATURE:

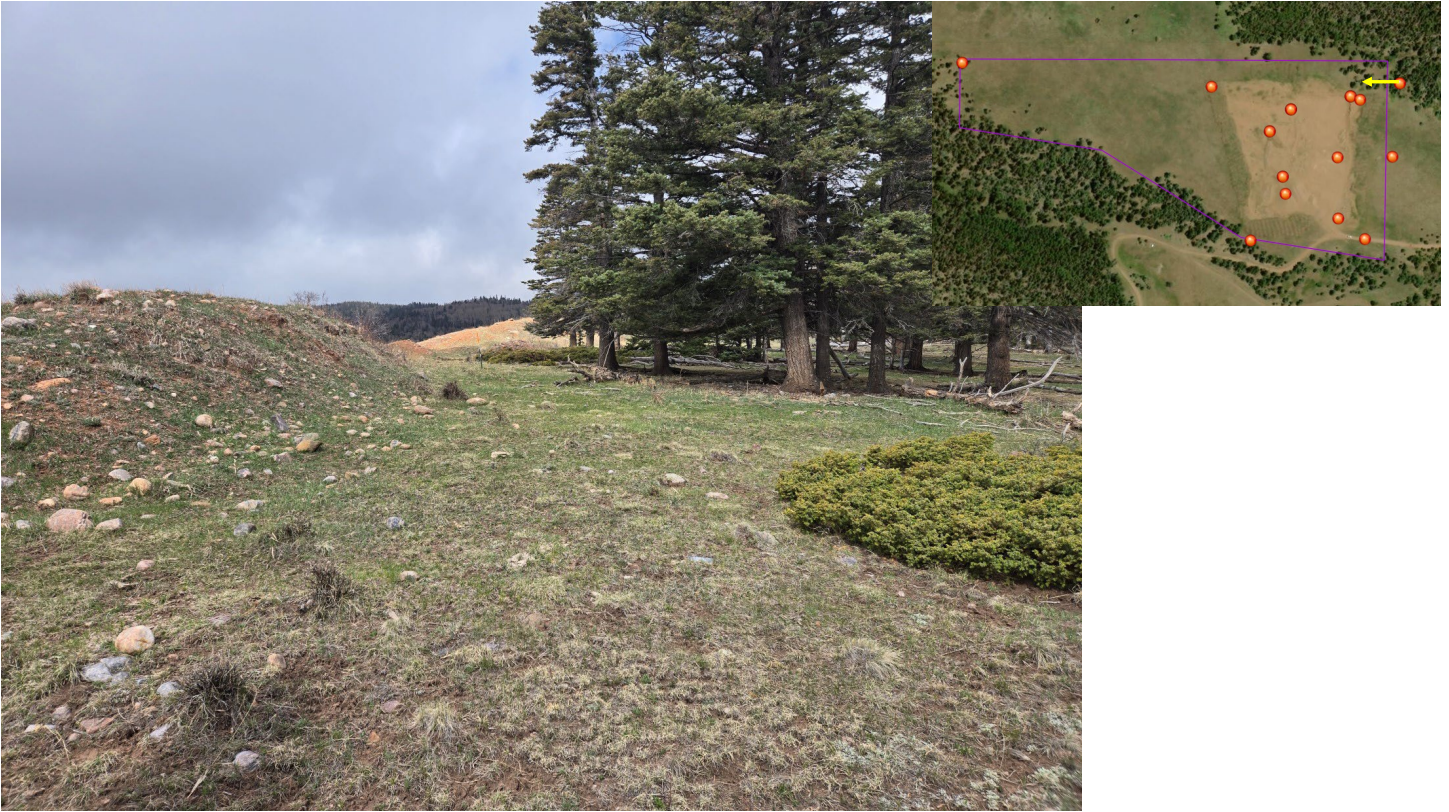
Photo 19: Looking west along the northern topsoil stockpiles where the disturbance abuts the undisturbed northern area within the permit boundary.

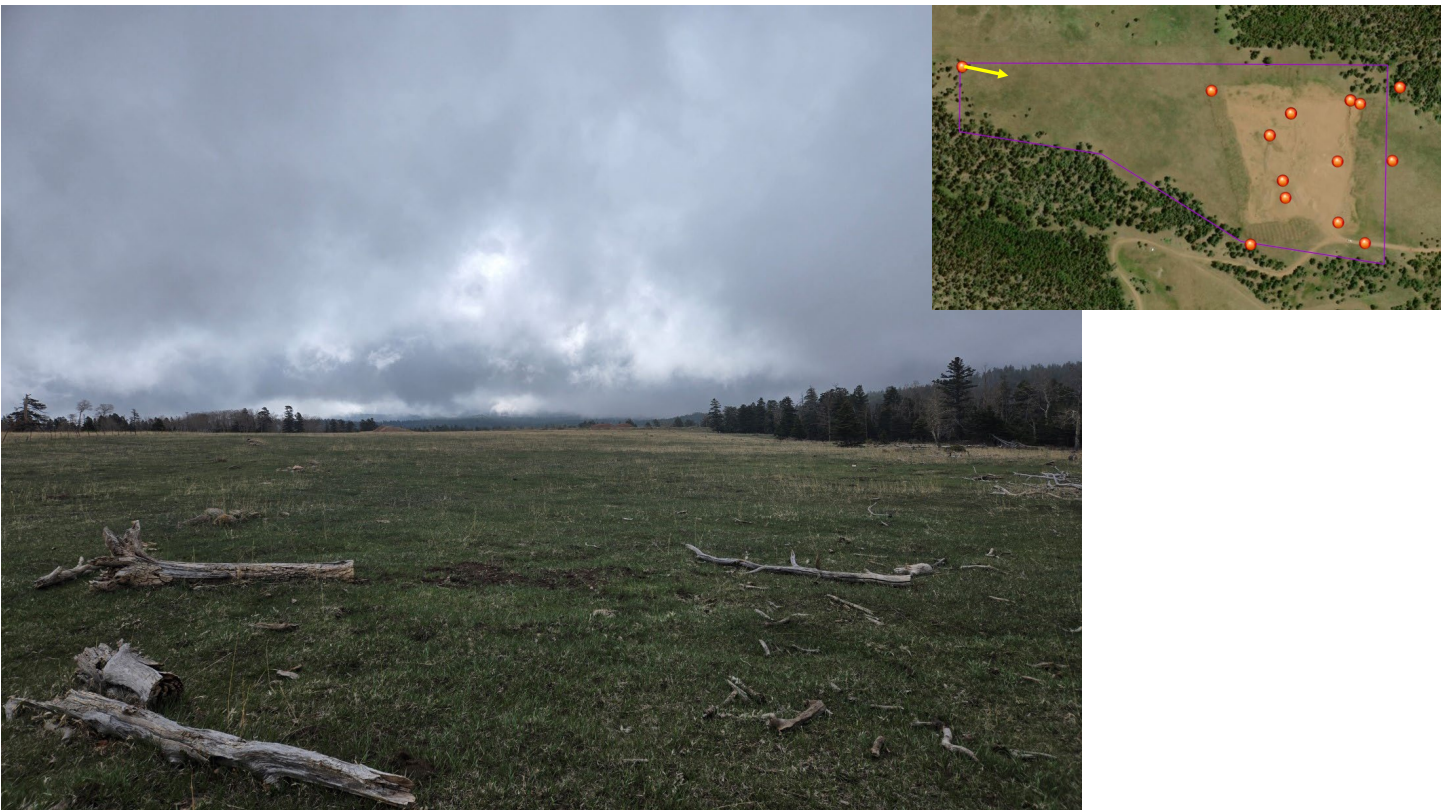
Because the mine is only allowed to operate for a few months out of the year, the Operator states that it has been difficult to make much progress. However, hauling has still occurred regularly during the active months. The west side of the permit boundary has not yet been affected by mining (Photo 20).

Photo 20: Looking east towards the pit from the northwestern permit boundary marker. This area has not yet been disturbed.

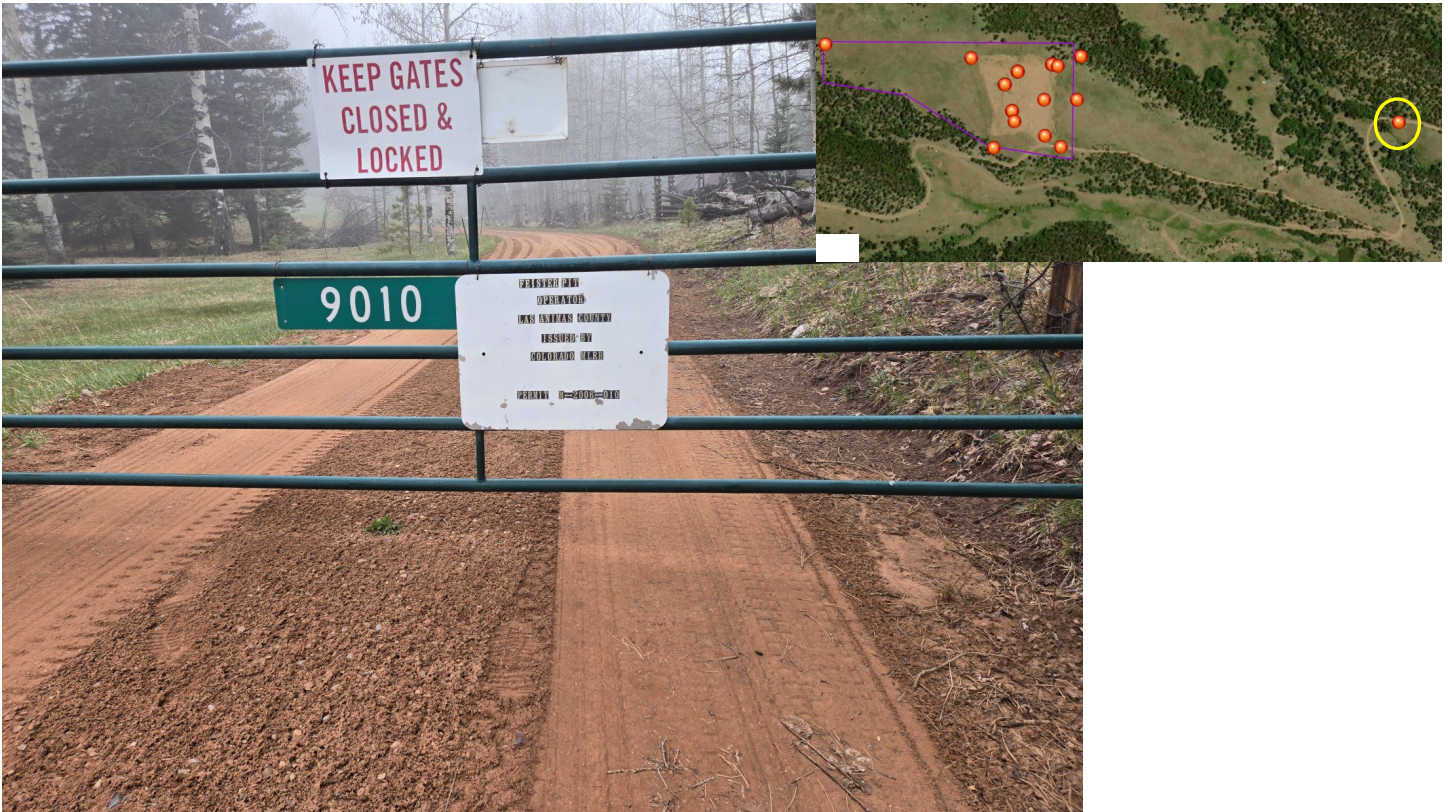
Photo 21: Looking at the mine sign posted on the entrance gate located to the east along the restricted road.

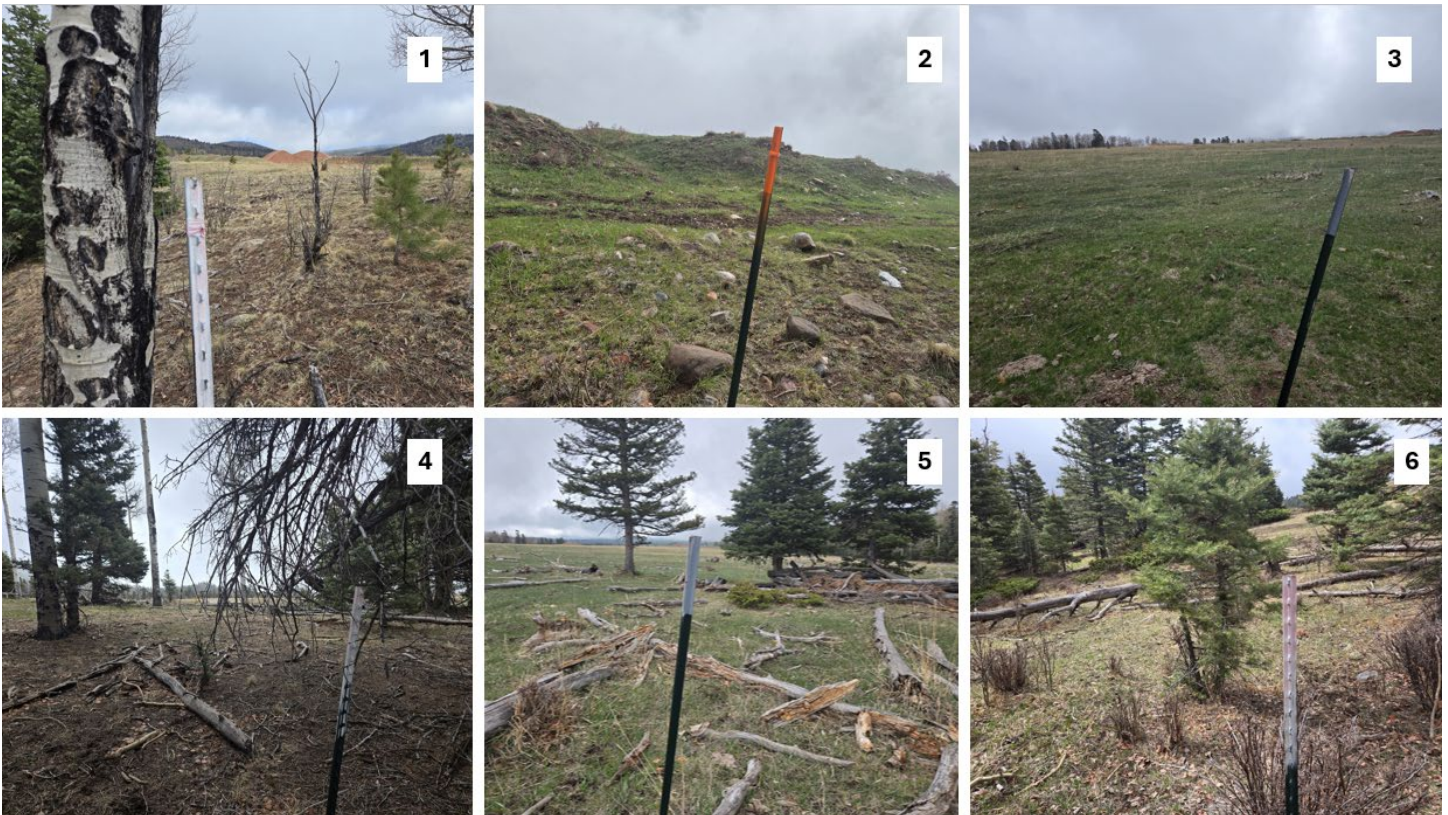
Photo 22: Permit boundary markers around the permit boundary. The photo numbers correspond with the labels on Map 1.
