**MINERALS PROGRAM INSPECTION REPORT**  
**PHONE: (303) 866-3567**

<b>MINE NAME:</b> Sooner Lucky Strike Mine and Mill	<b>MINE/PROSPECTING ID#:</b> M-1982-020	<b>MINERAL:</b> Gold and silver	<b>COUNTY:</b> Gunnison
<b>INSPECTION TYPE:</b> Monitoring	<b>WEATHER:</b> Clear	<b>INSP. DATE:</b> April 29, 2025	<b>INSP. TIME:</b> 11:30
<b>OPERATOR:</b> ALSH, LLC	<b>OPERATOR REPRESENTATIVE:</b> None	<b>TYPE OF OPERATION:</b> 110d - Designated Limited Impact	
<b>REASON FOR INSPECTION:</b> Normal I&E Program	<b>BOND CALCULATION TYPE:</b> Complete Bond	<b>BOND AMOUNT:</b> \$49,992.54	
<b>DATE OF COMPLAINT:</b> NA	<b>POST INSP. CONTACTS:</b> None	<b>JOINT INSP. AGENCY:</b> None	
<b>INSPECTOR(S):</b> Dustin Czapla	<b>INSPECTOR'S SIGNATURE:</b>

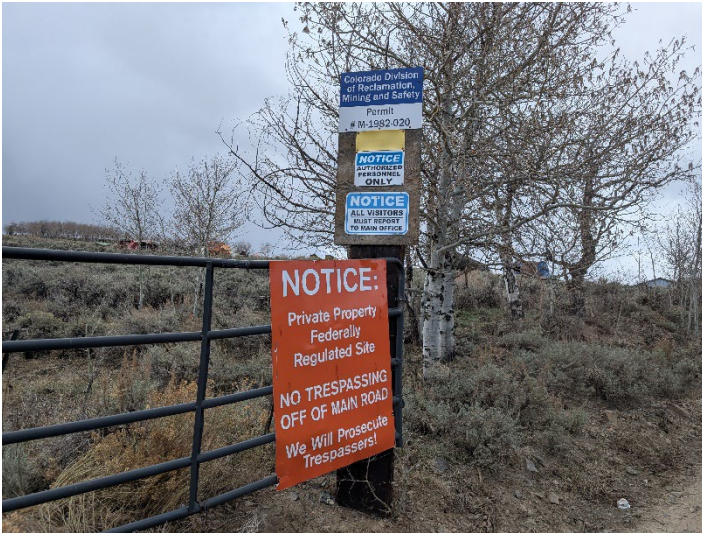
Adequate mine identification signage was noted at the entrance to the site.

Sign at entrance

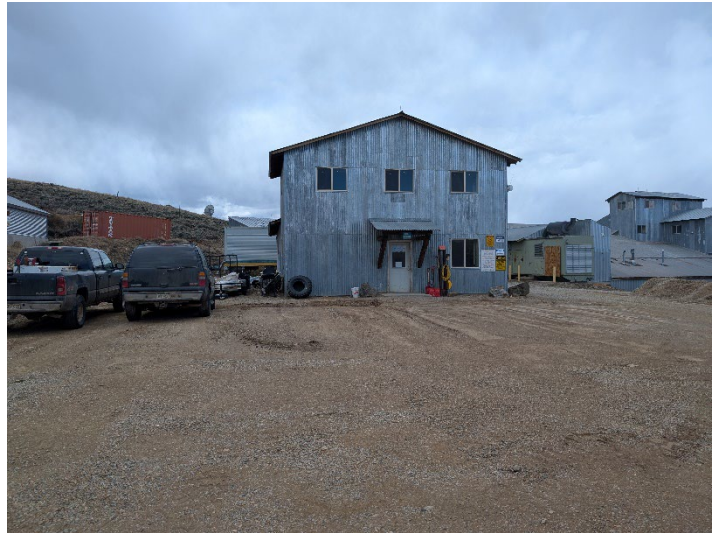
Office building near entrance

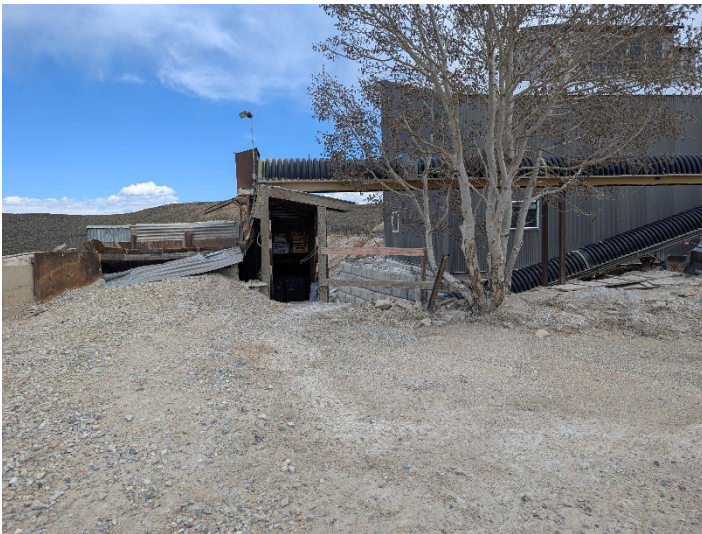
Crusher circuit on backside of mill building

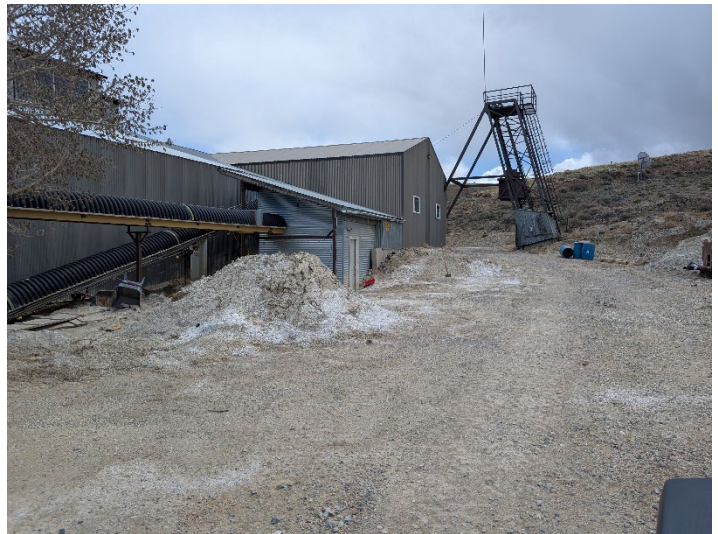
Crusher circuit on backside of mill building

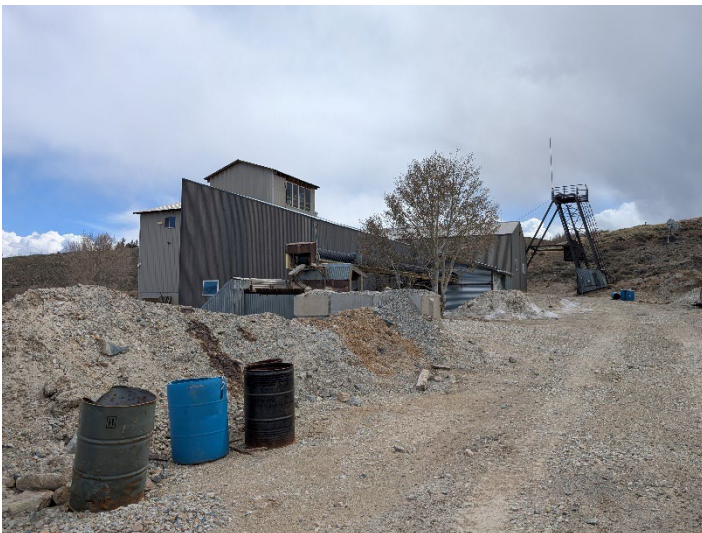
Mill building

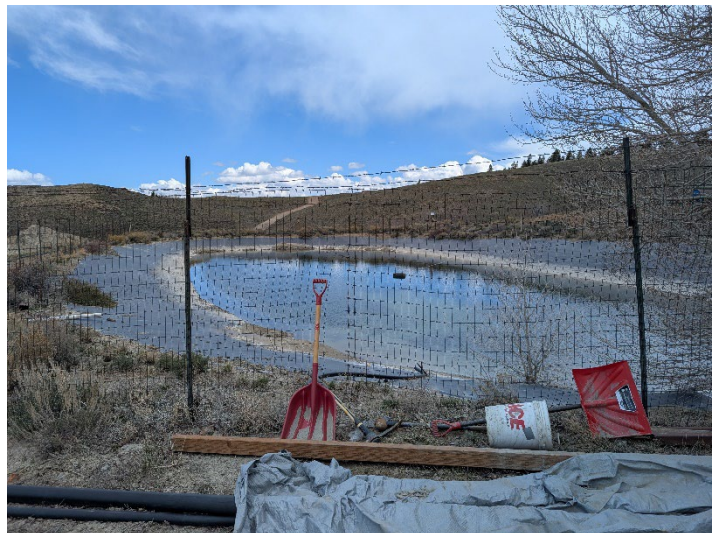
Lined recirculation pond

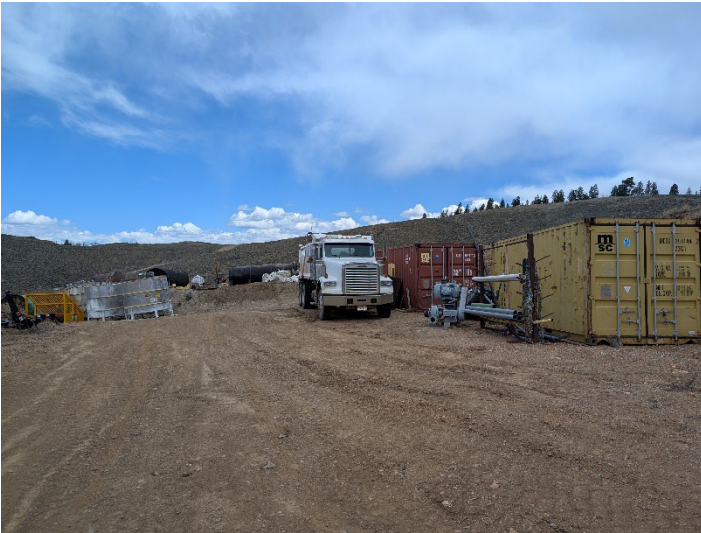
Equipment storage area

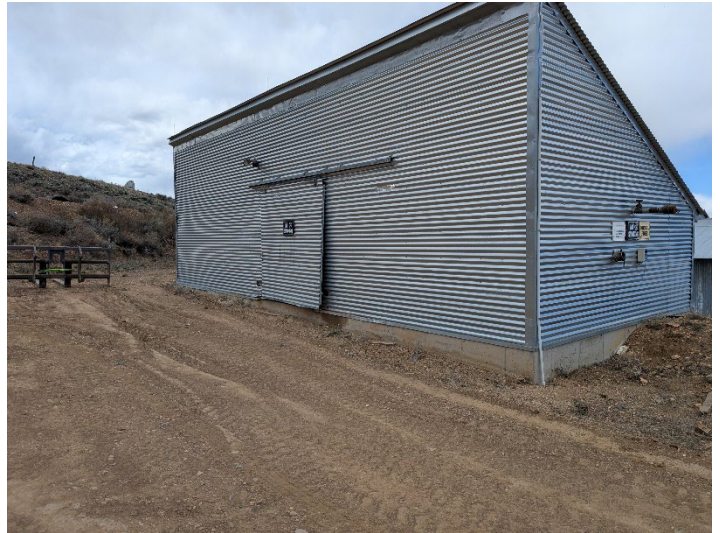
Fuel storage shed

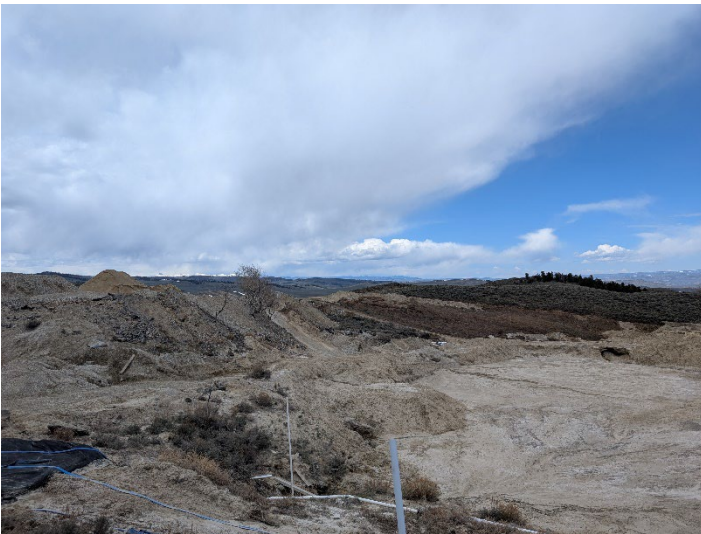
Tailings disposal area

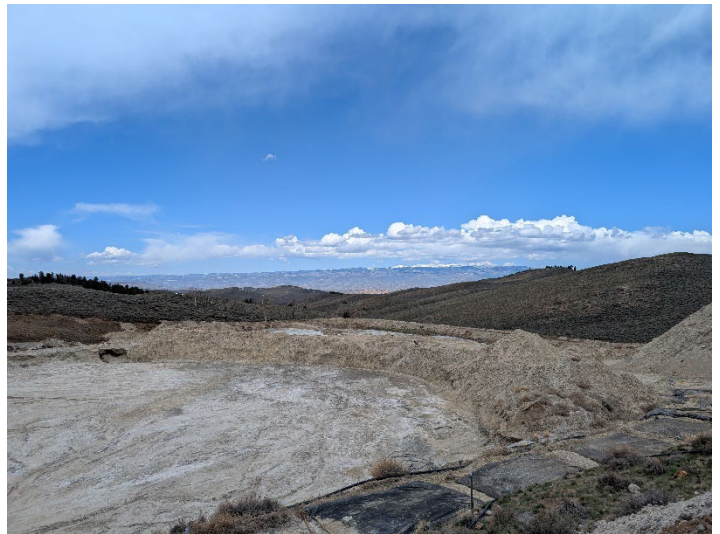
Tailings disposal area

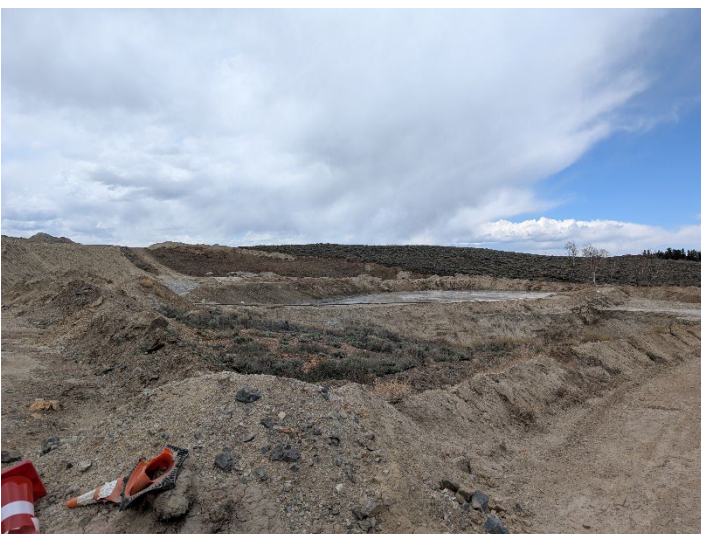
Tailings disposal area

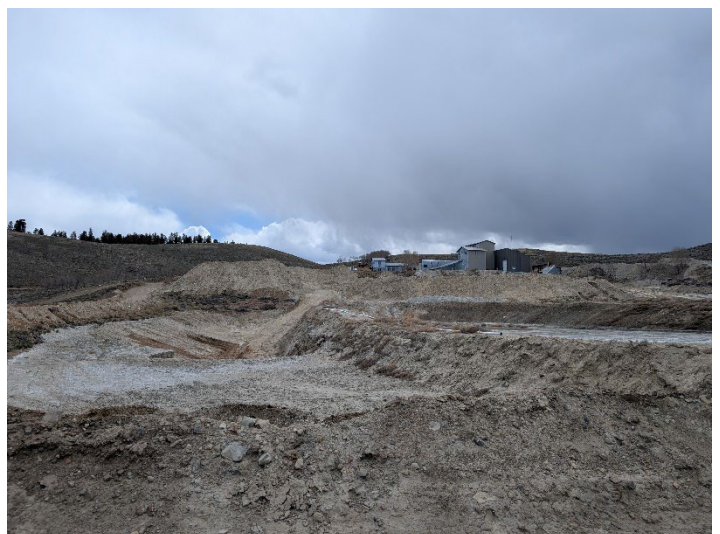
Tailings disposal area

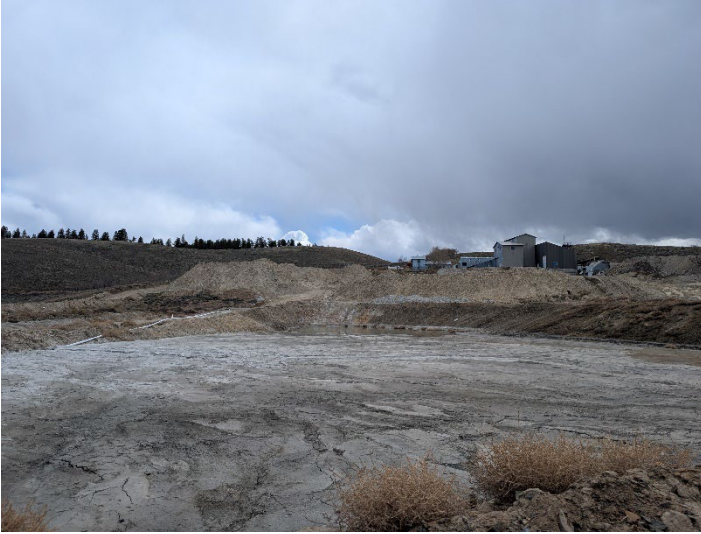
Tailings disposal area

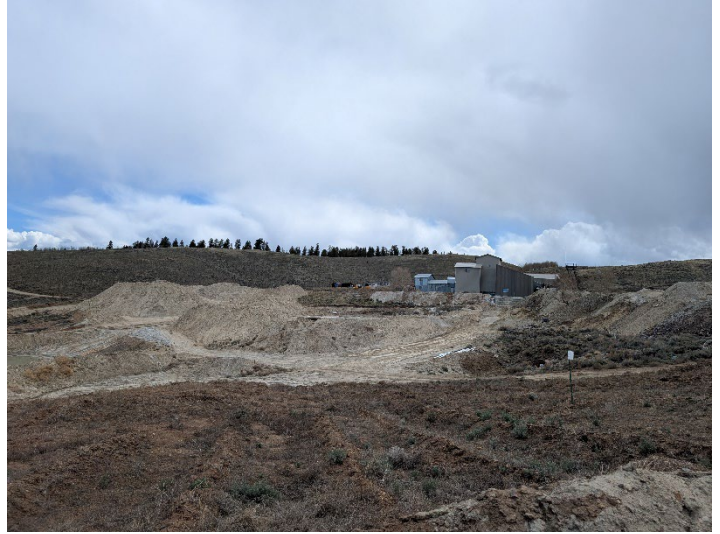
Tailings disposal area

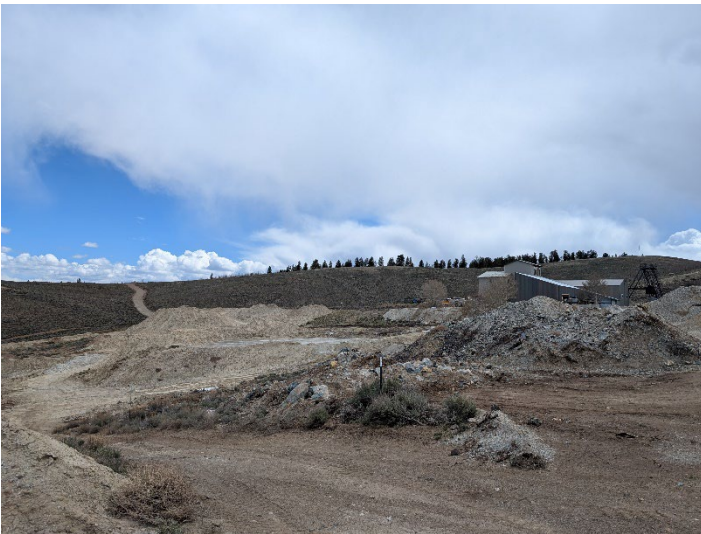
Tailings disposal area

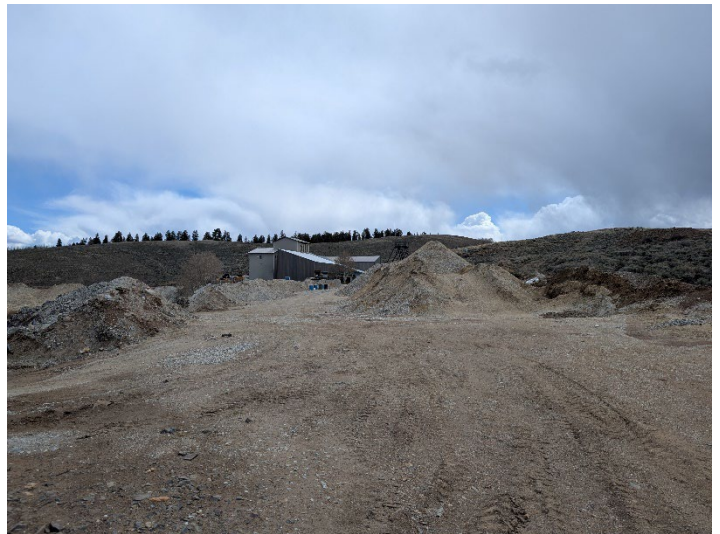
Tailings disposal area
