STATE OF  
COLORADO

Here are the inspection reports for the Foidel Creek Mine, C-1982-056, and the HGLO, C-1992-081.

**PERMIT INFORMATION**

**INSPECTION INFORMATION**

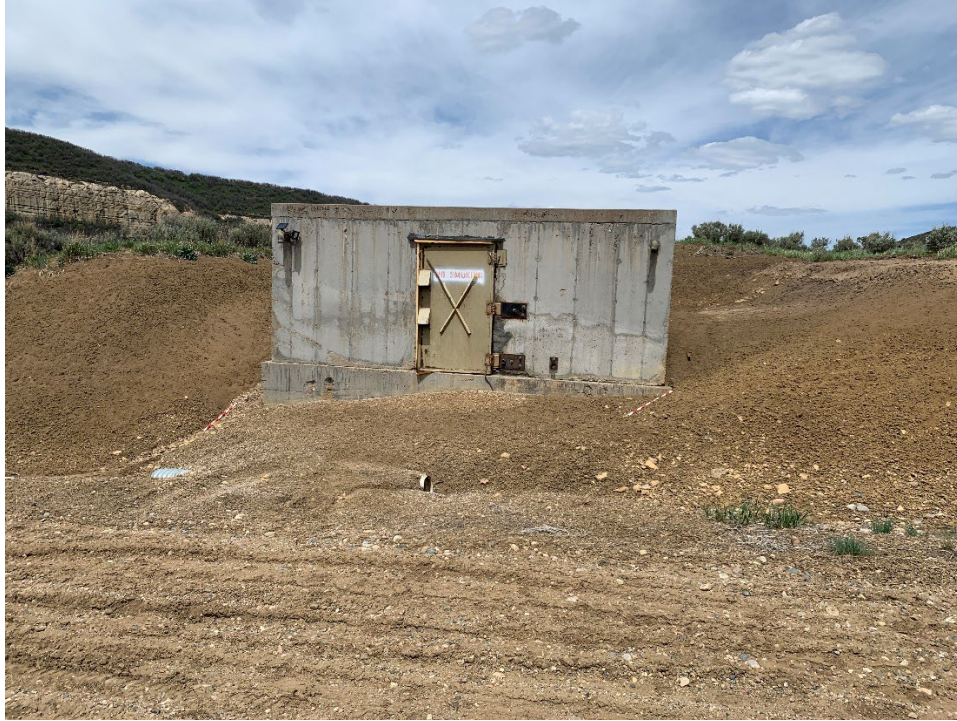
The explosive lockers were locked, unobstructed, and the immediate surrounding area was free of vegetation (photo 1).

Photo 1- Explosive locker by Pond T

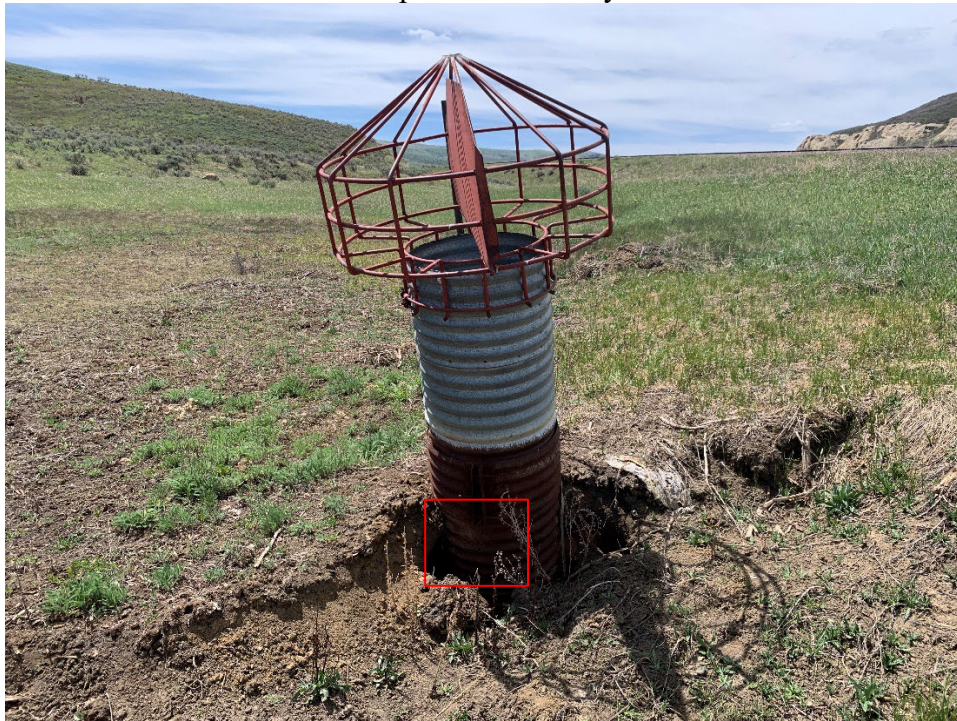
The primary spillway is a vertical culvert with a trash rack on top that is no longer in operable condition. The vertical part of the culvert is significantly leaning to the north. Due to the tilt, the rim is most likely not at the designed elevation (photo 2). The spillway rim elevation needs to be verified that it is at the designed elevation. A rust hole formed on the lower section of the vertical part of the culvert (photo 3). The hole compromises the operational integrity of the spillway and it no longer operates as designed. The hole needs to be repaired. The spillway structure from inlet to the outlet needs to be inspected to determine if it is structurally sound and to check for additional holes created by rust.

A significant amount of soil is missing from around the base of the spillway inlet pipe (photo 2) and around the

Photo 2- Pond T primary spillway needs to be maintained. See close-up of red square in Photo 3

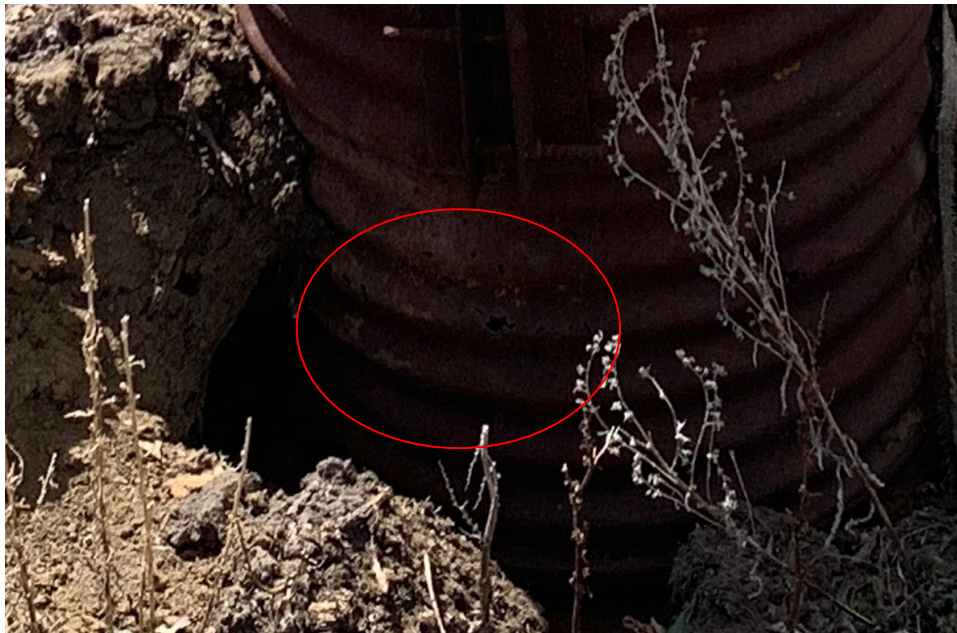
Photo 3- Holes rusted through culvert metal.

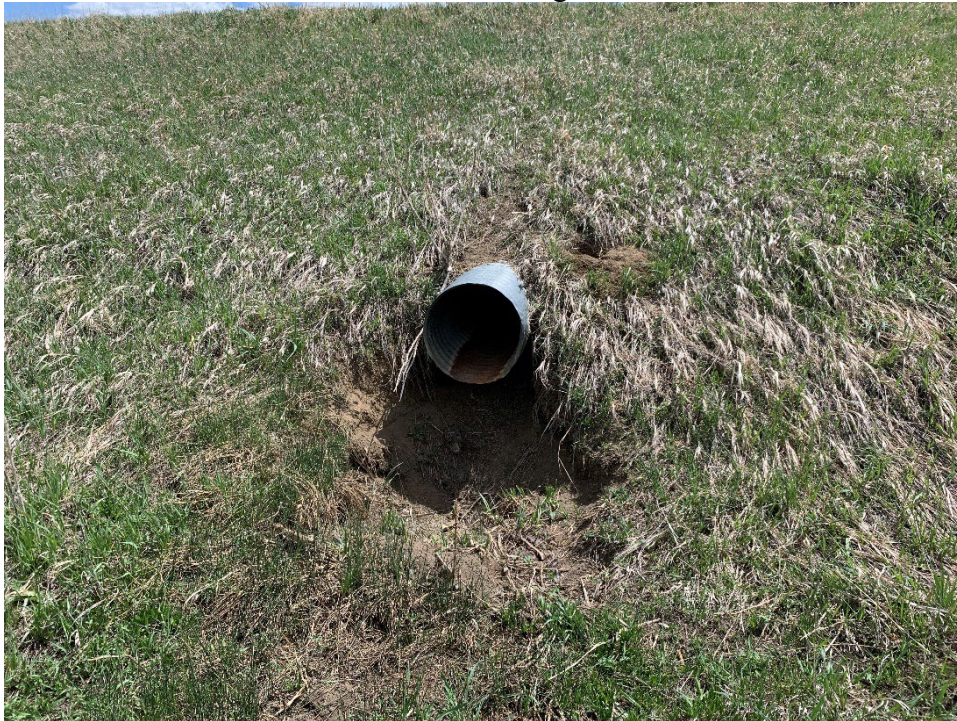
outlet pipe (photo 4). The soil voids around the pipe need to be investigated to determine if water is piping around the spillway pipe and eroding the soil of the embankment.

Photo 4- Pond T primary spillway outlet pipe

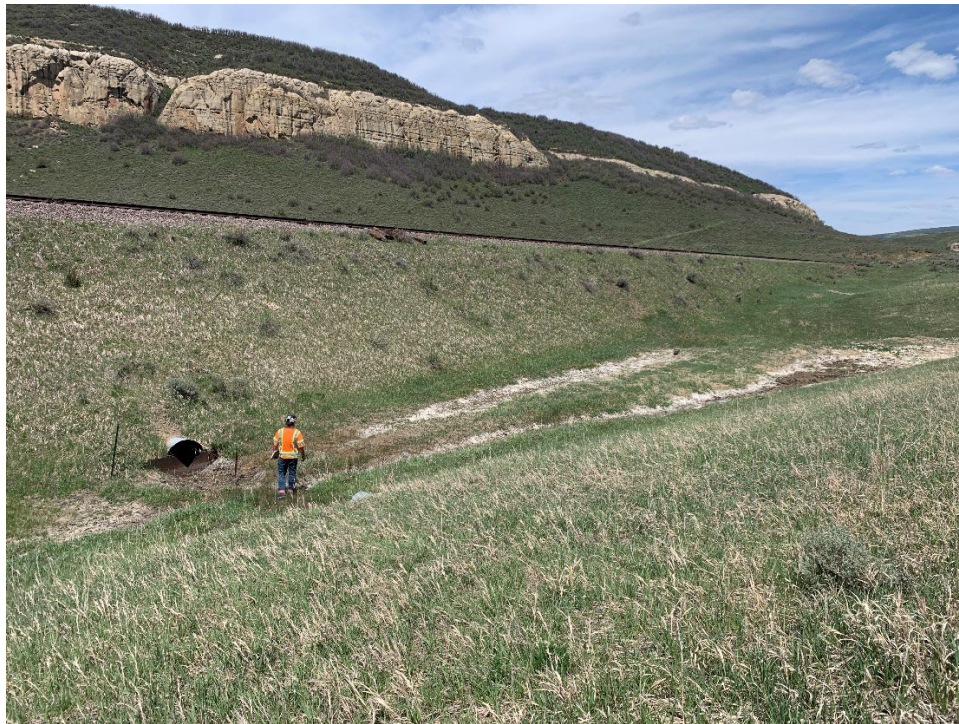
The Pond T SAE is located between the pond embankment and the railroad spur. This area is well vegetated and has a v-notched weir that creates a sediment catch basin before water is released into the culvert under the railroad. It appears there is a water seep on the north side of the SAE area (photo 5). The seep area is white with salt and mineral deposits.

Photo 5- Pont T SAE between embankment and railroad spur, facing north

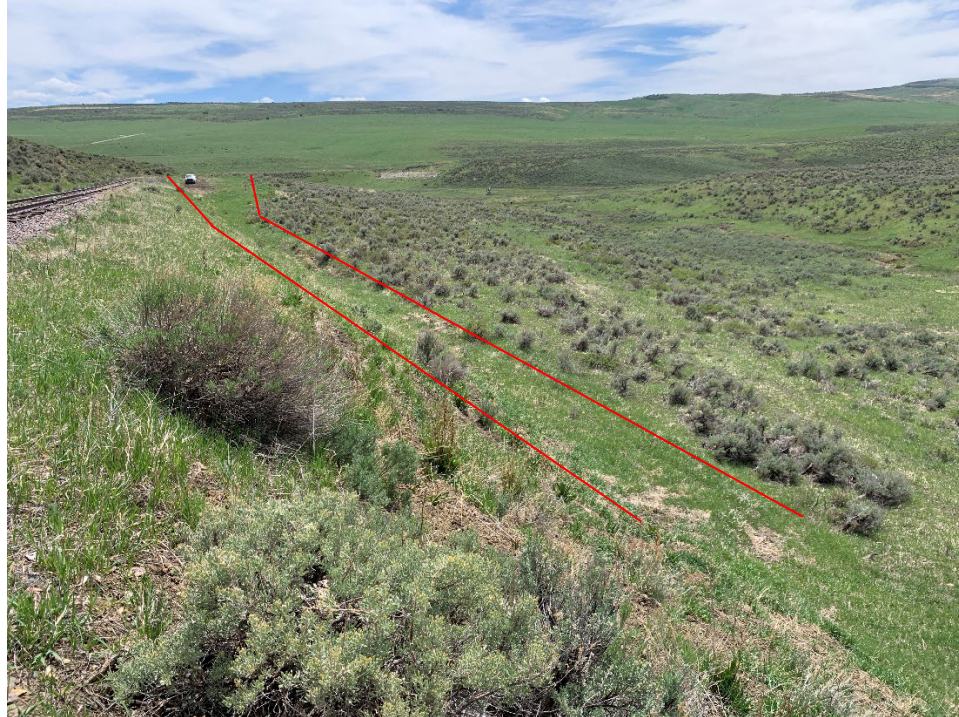
The railroad spur extension SAE is located at the end of the railroad spur. The SAE is bordered on the east by the railroad track and on the west by a berm (photo 6). The SAE is long, narrow and sloped to the north directing water from the soil exposed south end to the well vegetated north side. There is several hundred feet of dense vegetation between the soil exposed area and Foidel Creek.

Photo 6- Railroad spur SAE, water flows from upper left to lower right, facing south

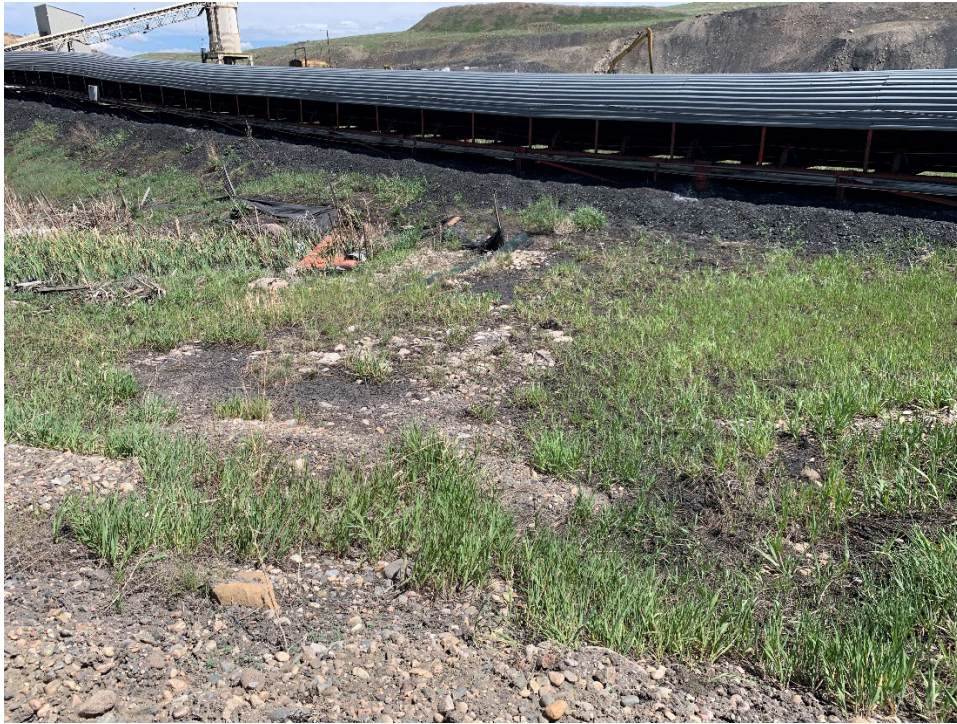
The SAE west of the Pond D discharge point needs to have the check dam sump cleaned (photo 7). The two-track access road that parallels the coal conveyor belt also needs some maintenance. The berm that separates the two-track road and Foidel Creek needs to be built up better to direct runoff water to the sump check dam.

Photo 7- Pond D West SAE needs the sump cleaned.

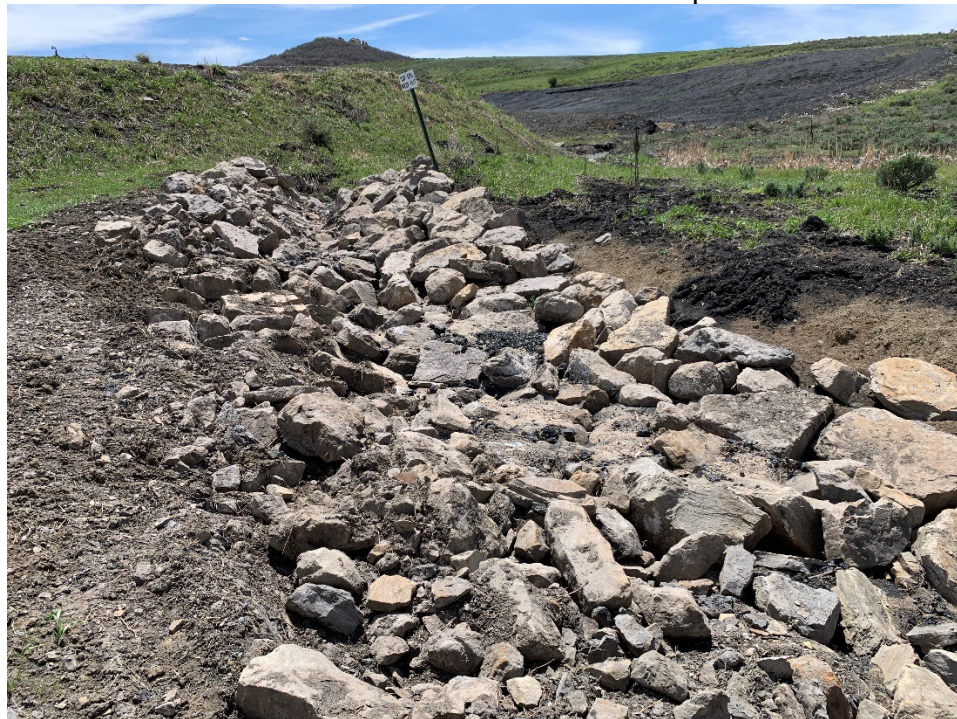
The Pond B sump has been cleaned and is in operating condition. Water was being discharged into the sump, however the sump water level was below the spillway. The spillway had been re-lined with new rocks. The ditch from the BOB area had also been ripped with large rocks (photo 8). A misplaced topsoil stockpile sign was placed in the ditch.

Photo 8- Rock lined ditch from the BOB to Pond B sump
