Inspection reports

Permit Number: C-1992-081 Mine Name: Hayden Gulch Loadout Operator: Hayden Gulch Terminal, LLC Operator Address: Ms. Miranda Kawcak 29515 Routt County Road 27 Oak Creek, CO 80467	County: Routt Operation Type: Loadout Permit Status: Active Ownership: Private
	Operator Representative Present: N/a
Operator Representative Signature: (Field Issuance Only)

Inspection Start Date: May 14, 2025 Inspection Start Time: 10:00 Inspection End Date: May 14, 2025 Inspection End Time: 10:15	Inspection Type: Coal Complete Inspection Inspection Reason: Normal I&E Program Weather: Clear
Joint Inspection Agency: None	Joint Inspection Contacts:
Post Inspection Agency: None	Post Inspection Contacts:
Inspector(s): Brock Bowles	Inspector's Signature:

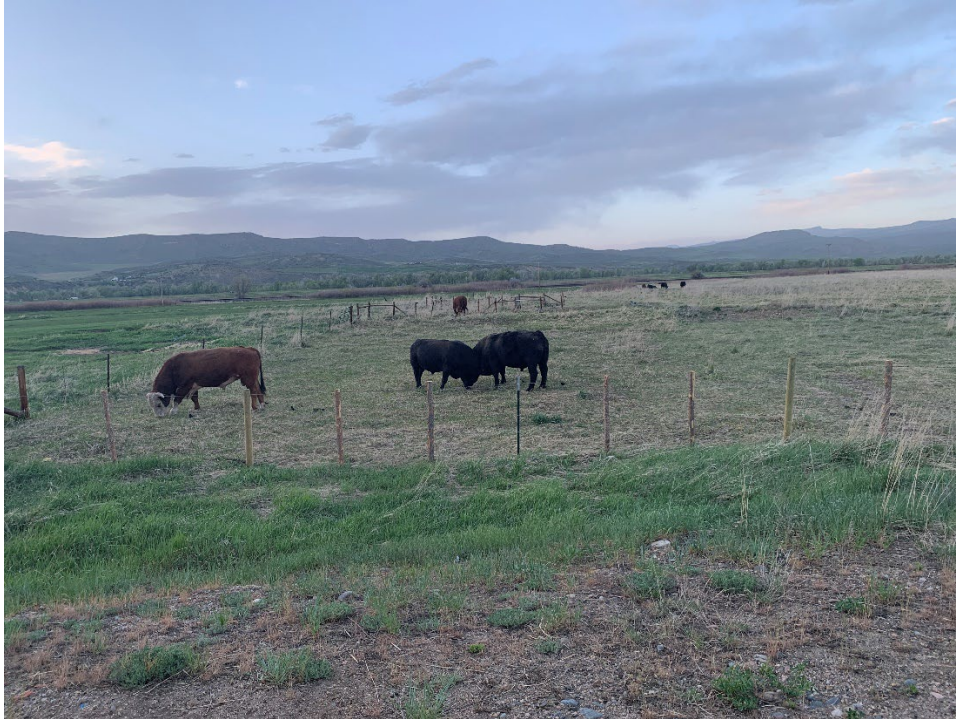
The fence on the north side that parallels Hwy 40 has been replaced and is in great condition. Ten cow bulls were grazing the northern reclaimed area between Hwy 40 and the railroad mainline (photo 1). This area was not inspected due to access and safety issues.

Photo 1- Cattle grazing the northern reclaimed area between Hwy 40 and railroad mainline.

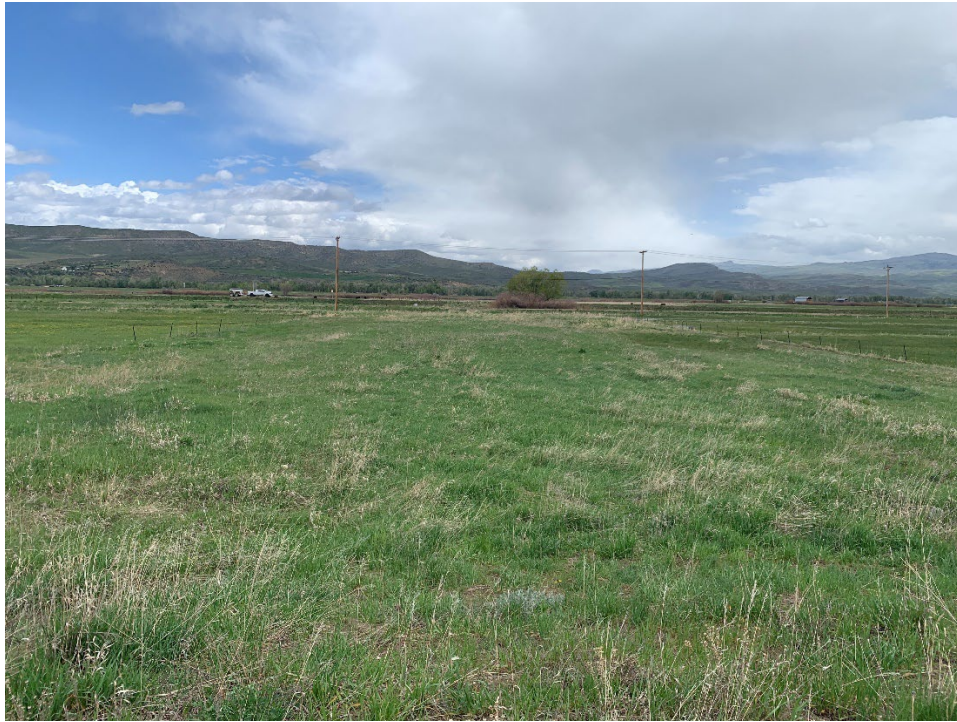
The reclamation south of Hwy 40 has two areas: a northern section and southern section. The northern section is characterized by being a few feet lower in elevation and closer to the water table. This area was flooded from the snow melt during the March 2025 inspection. The vegetation in this area is dense, stable, it is controlling erosion and is supporting the post mining land use. It is well established because it is subirrigated for a significant part of the spring (photo 2). The southern section, immediately south of the trailhead parking lot, is several feet higher in elevation than the northern section. The soil is drier because it is above the water table resulting in the less dense vegetation and a few more weeds. The vegetation looks very good for the conditions it is growing in, and it is effectively controlling erosion. Several houndstongue and Canada thistle plants were noted in this area that need to be treated.

Photo 2- The vegetation in the northern section south of Hwy 40 is well established.

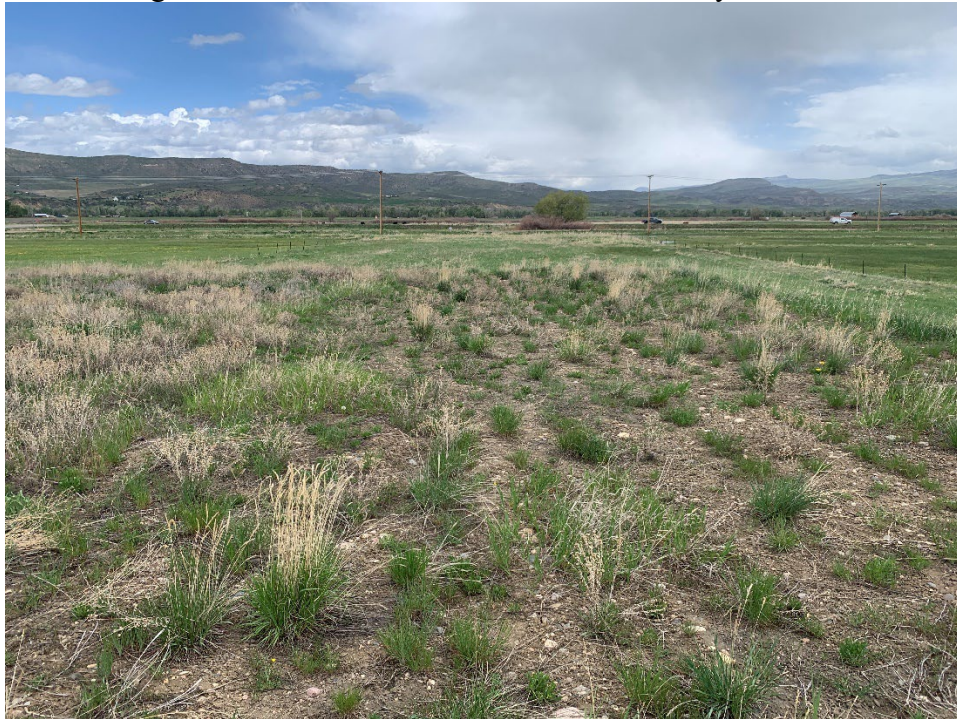
Photo 3- The southern section south of Hwy 40 is higher in elevation.
